Site of National SignificanceWye House, Maryland

National Survey of Historic Sites and Buildings

Wye House, Talbot County, Maryland

# Maryland Historical Trust State Historic Sites Inventory Form

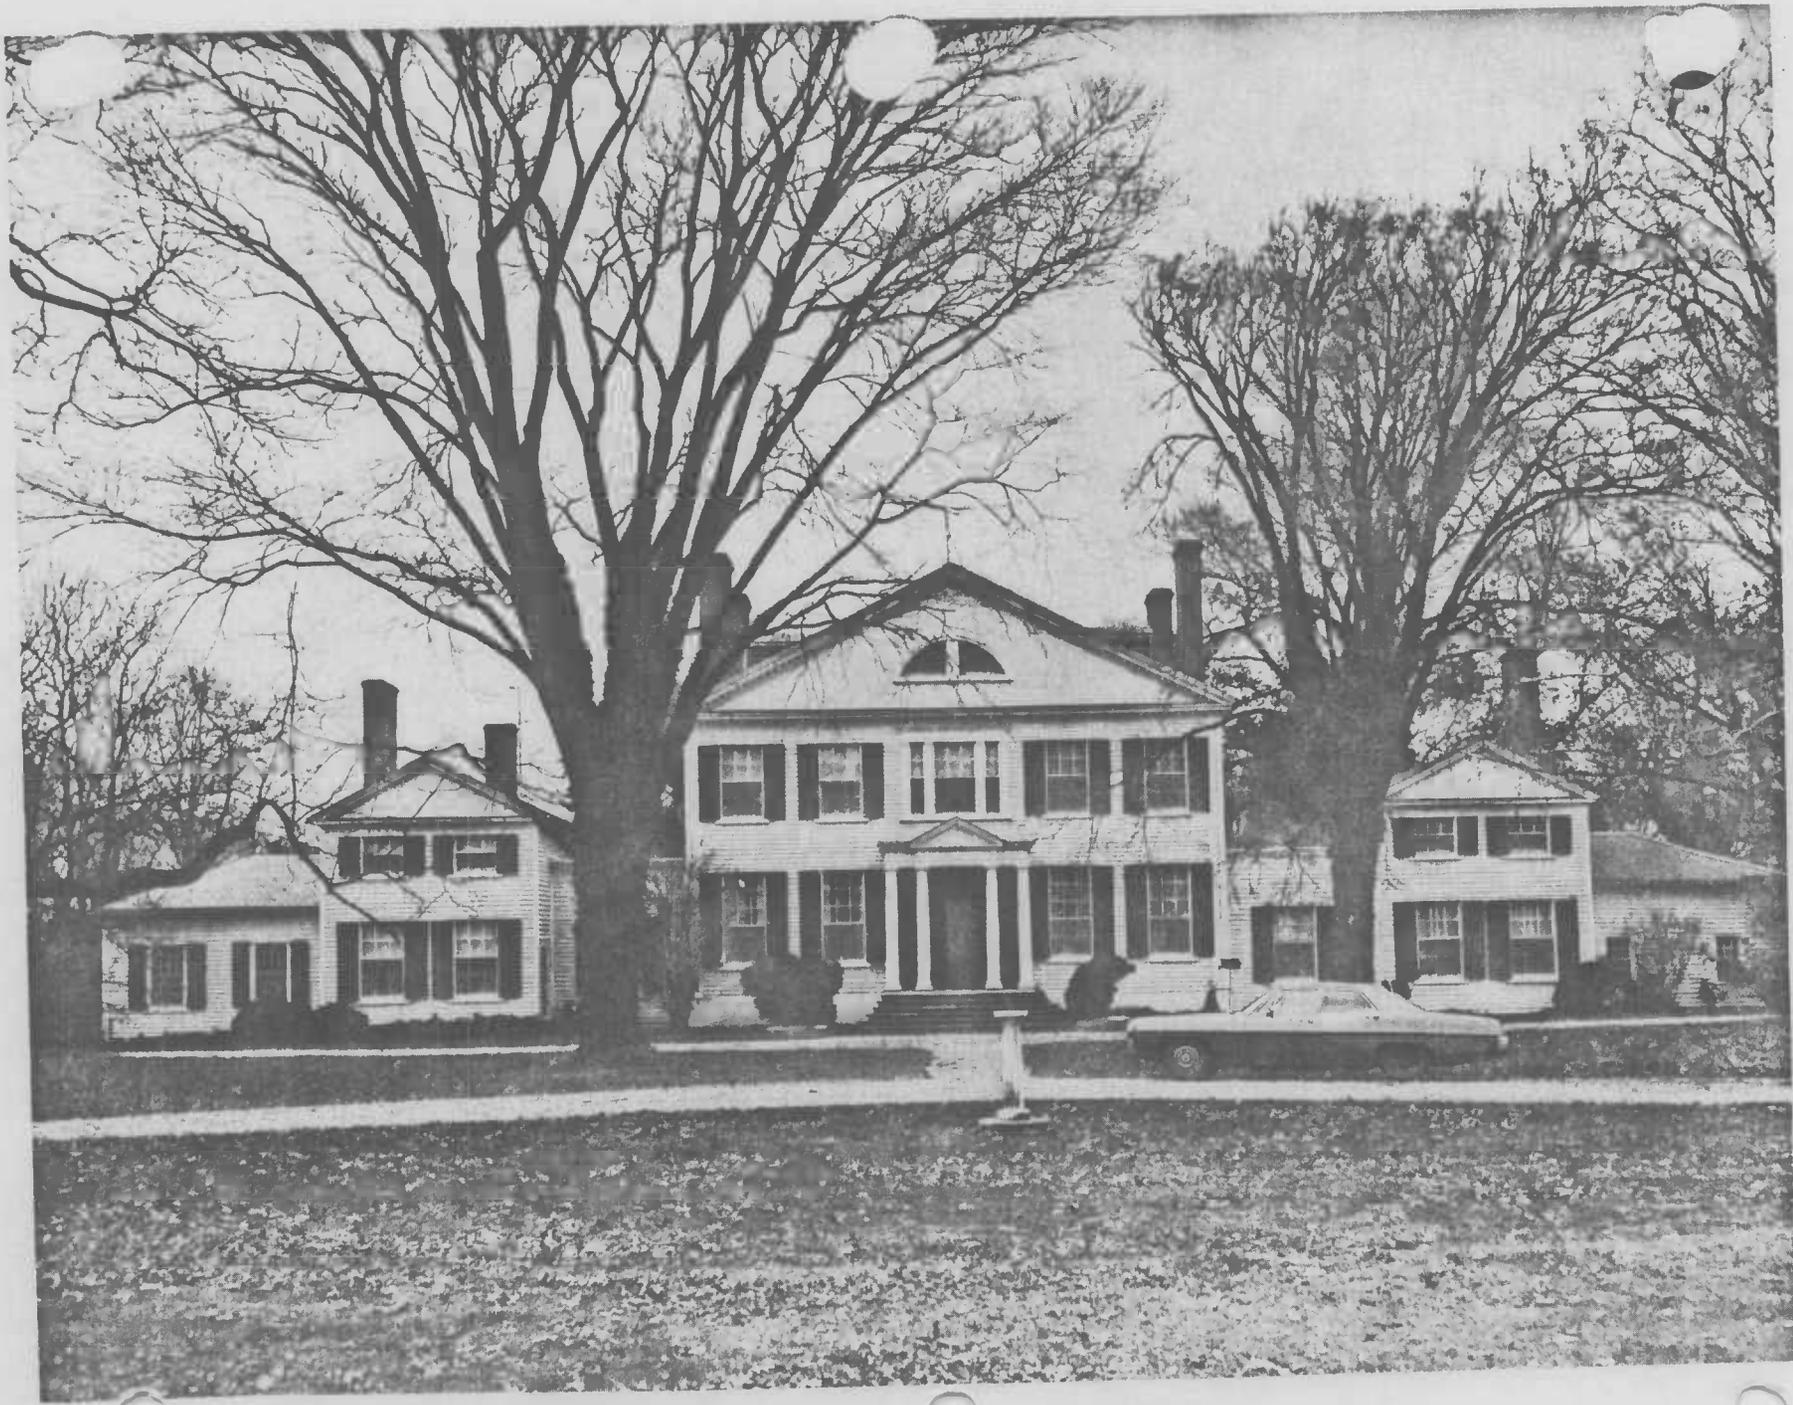
Wye House, Miles River Neck, Maryland

Southwest elevation

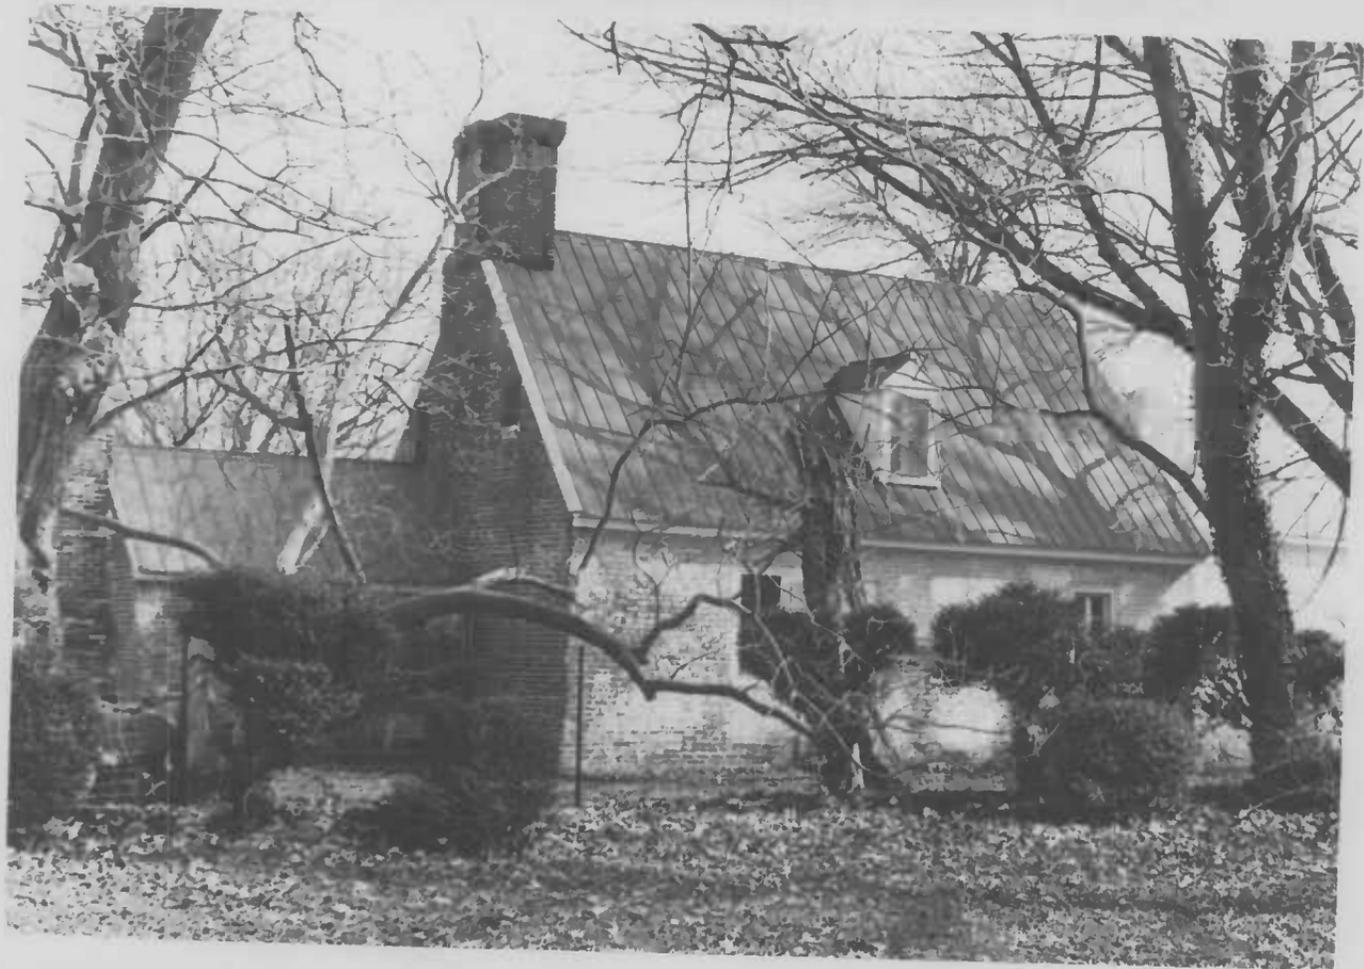
CAPTAIN'S House - Wye House - T-54

A few yards northwest of the smokehouse is a story-and-a-half Flemish bond brick dwelling that is known as the Captain's House. Although an exact date of construction is unknown for this building, architectural evidence suggests it was erected during the second quarter of the eighteenth century. Skirting the base of the building is a low watertable. The steeply pitched roof is covered with seamed tin, and the eave is finished with a boxed cornice. Extending to the north is a single-story, five-course common bond brick kitchen wing. The house faces east with the gable roof oriented on a north/south axis.

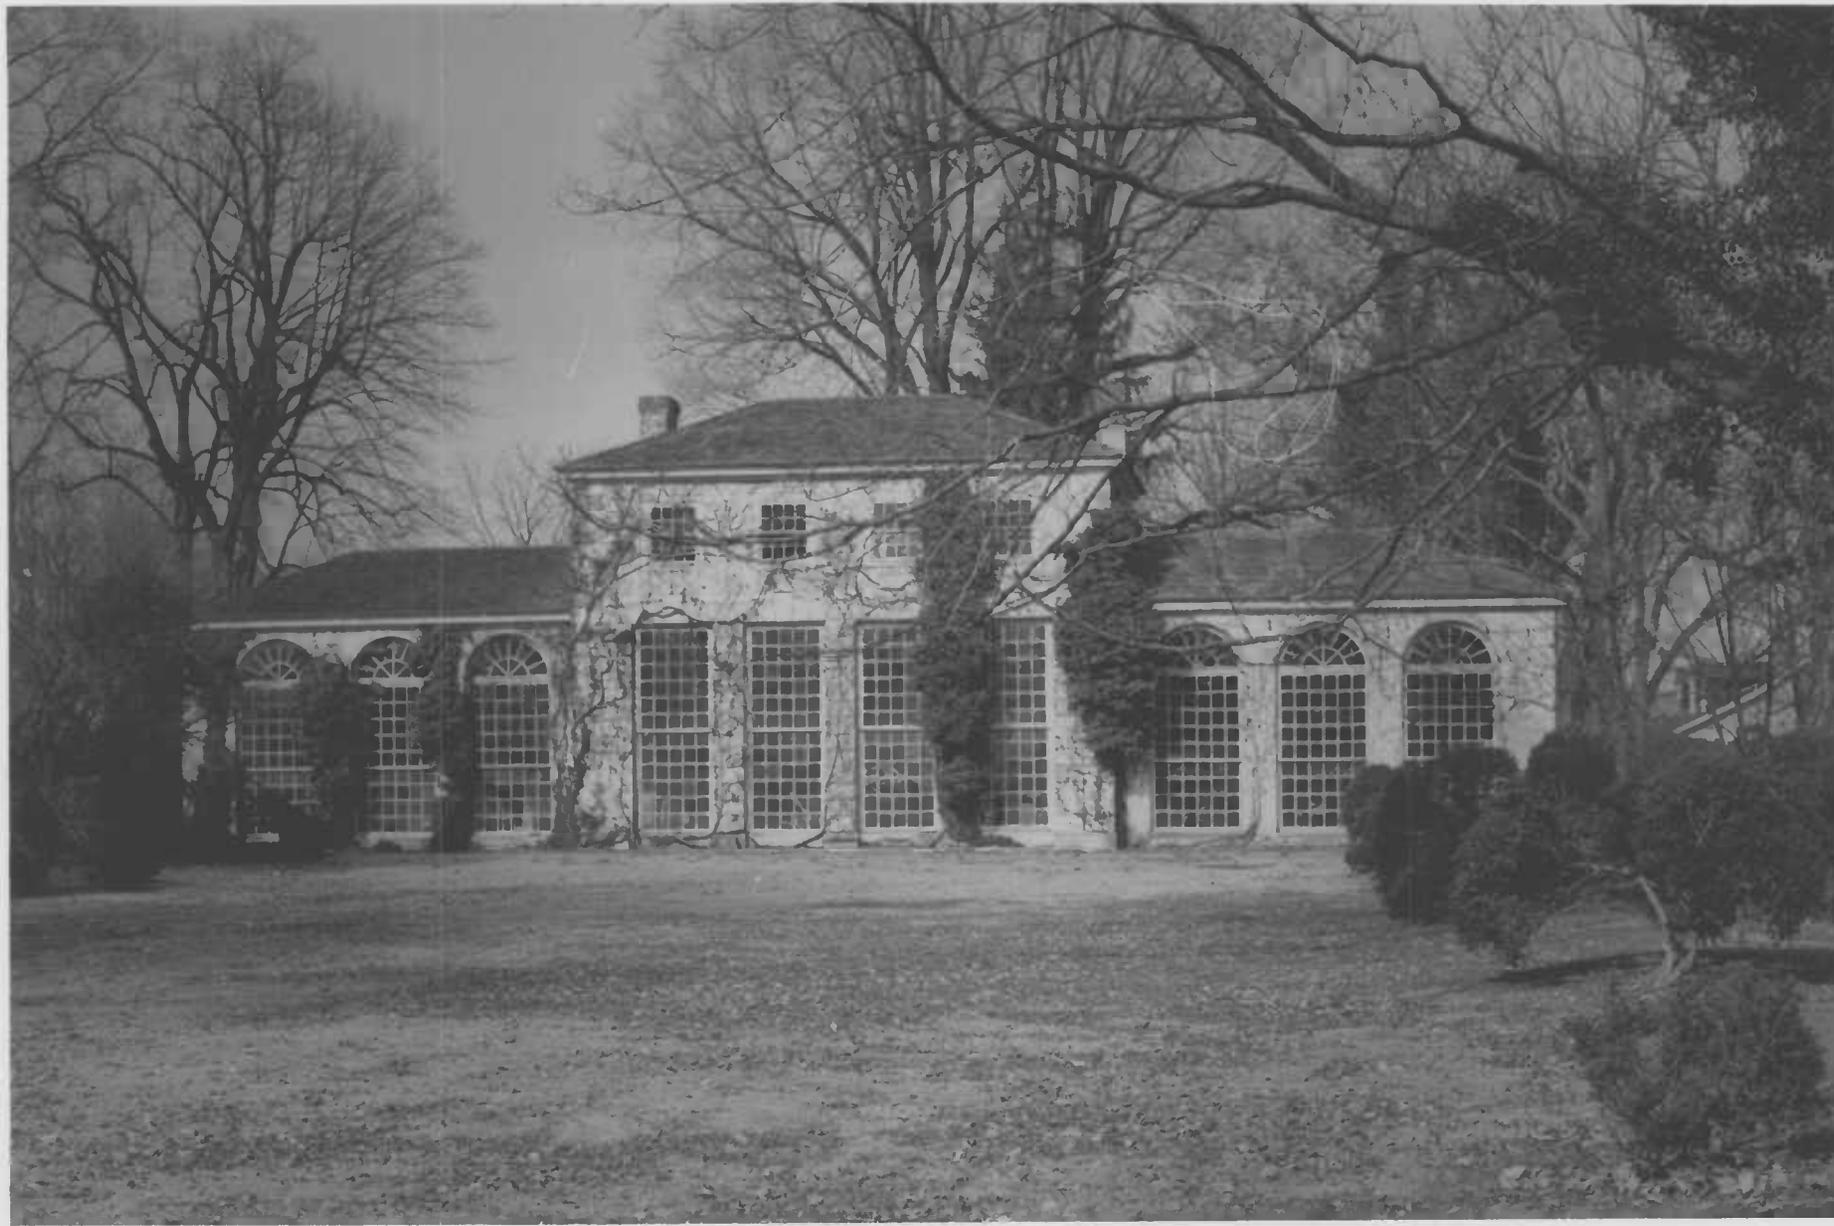
Wye House ORANGERY

North of the house is a grass lawn about 50 feet wide and 100 yards long. At the northern end of this green is located the architecturally noteworthy Orangerie, a brick structure incorporating within its walls the remains of a earlier similar building. The Orangerie is  $85\frac{1}{2}$  feet long, with a central two-story section flanked by lower wings, and in its present form dates from the 1790s. The two-story hipped-roofed central portion is four bays long and has very tall one-story rectangular windows on the first floor. The brick walls are covered with stucco that is rusticated in imitation of stonework and the second story windows are small and square. The flanking hipped-roof wings, each 26 feet and three bays long, are raised one step above grade, and have very tall one-story arched windows. The building was used to grow orange and lemon trees and the center second-story contained a 18th century billard room. The Orangerie still contains a rare example of an original 18th central heating system (hot air duct system). On both sides of the green are original 18th century formal gardens that cover between four and five acres. On the west side of the green stands the Captain's House, which is believed to have been an original dependency of the first Wye House, built by Edward

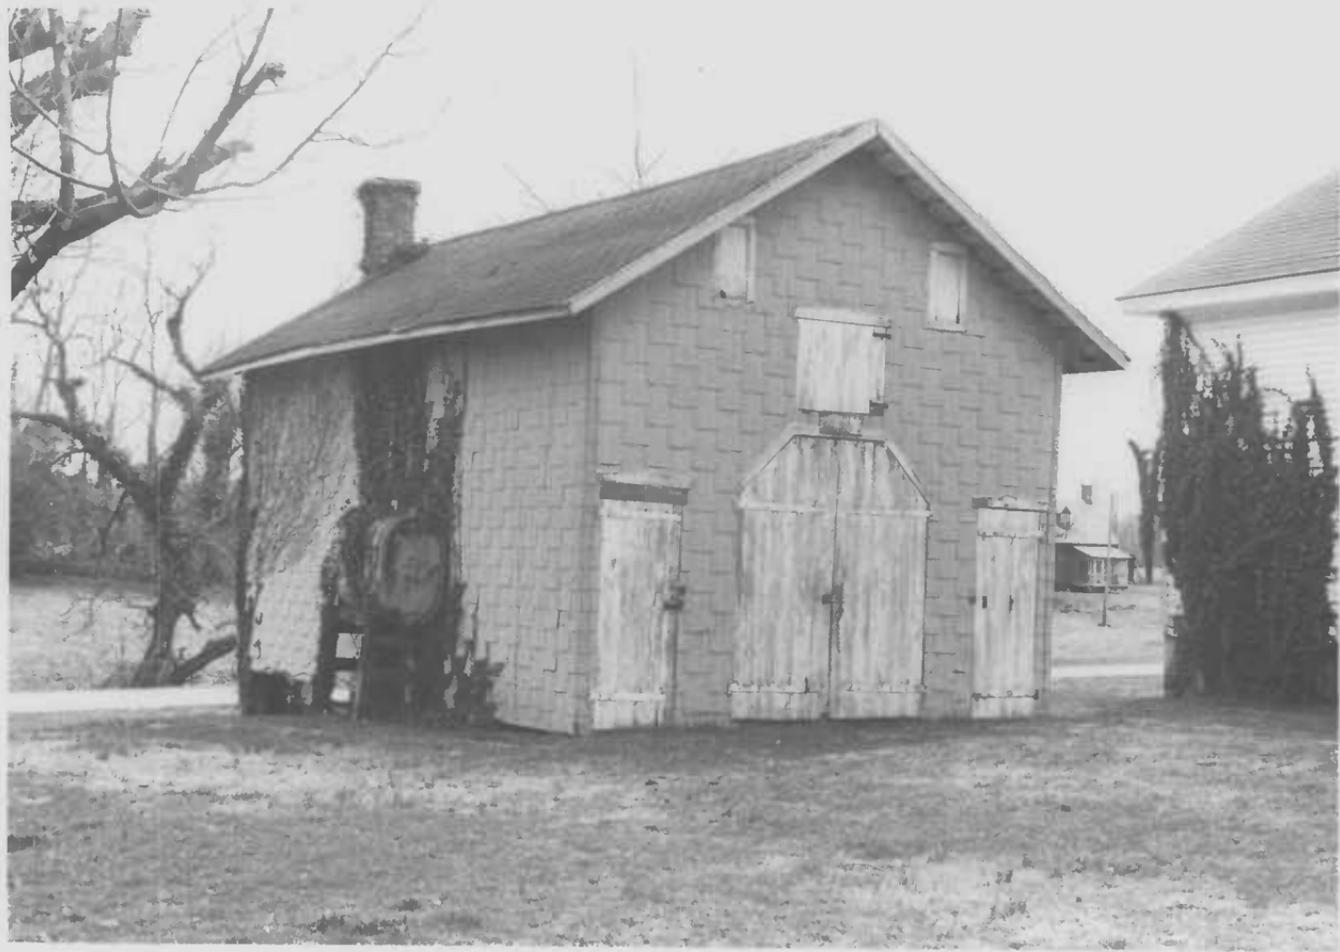
Easton vicinity, Talbot County, MD  
Carriage house, northwest elevation  
3/89, Paul Touart, photographer  
Negative/MD Historical Trust

Directly east of the Captain's House is a two-story nineteenth-century frame carriage house and a two-story twentieth-century frame garage. The carriage house, supported by a brick pier foundation, is sheathed with asphalt shingles and covered with a medium pitched asphalt shingle roof. Facing west the roof of the rectangular building is oriented on an east/west axis. The west (front) facade is symmetrically arranged with a center double-door entrance and flanking single board doors. Each door is hung on long strap hinges. The outer single doors are topped by shallow wooden pediments. Piercing the upper level is a small board door and two blocked up window openings. Shallow wooden pediments top each of these openings as well. The north side of the building is a plain wall covered with asphalt shingles, while the east (back) wall is pierced by a sash window. In addition, a single flue brick stack rises against the gable end. The south side is pierced by a sash window also.

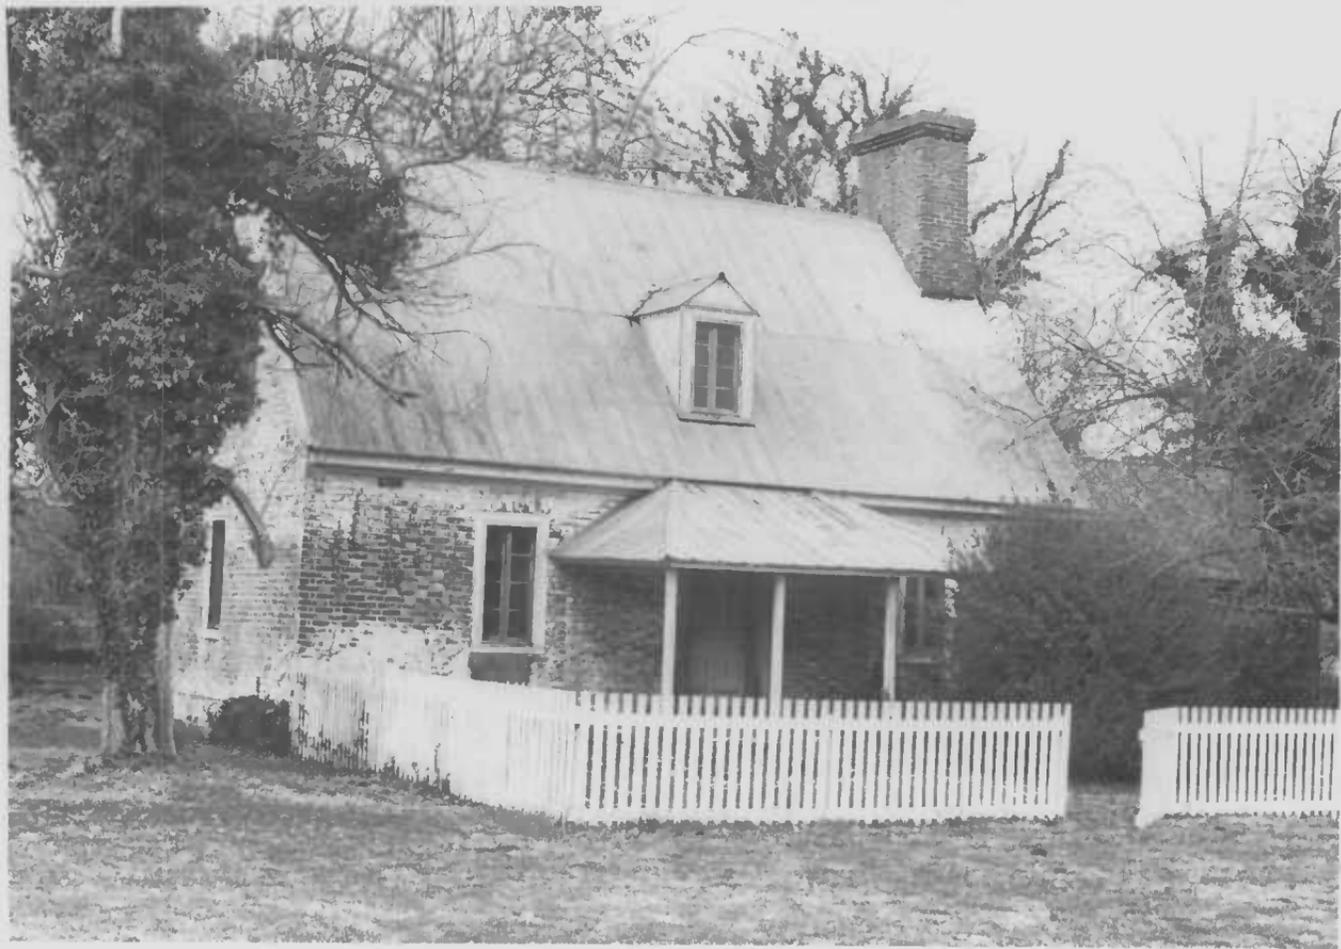
Easton vicinity, Talbot County, MD  
Captain's house, southeast elevation  
3/89, Paul Touart, photographer  
Negative/MD Historical Trust

The east (main) facade is a story-and-a-half, three-bay Flemish bond elevation with a checkerboard brick pattern of glazed headers. A central entrance is flanked by casement-type windows which are topped by jack arches. The center bay, filled with a six-panel front door, is sheltered by a hip-roofed porch supported on square posts. The steeply pitched roof is marked by a single gabled dormer filled with a casement-type window.

The south gable end has been reworked extensively with several bricked up openings. Centrally positioned openings filled with casement-type windows illuminate the first and second floors. The gable end is flush, and it is finished with a plain bargeboard.

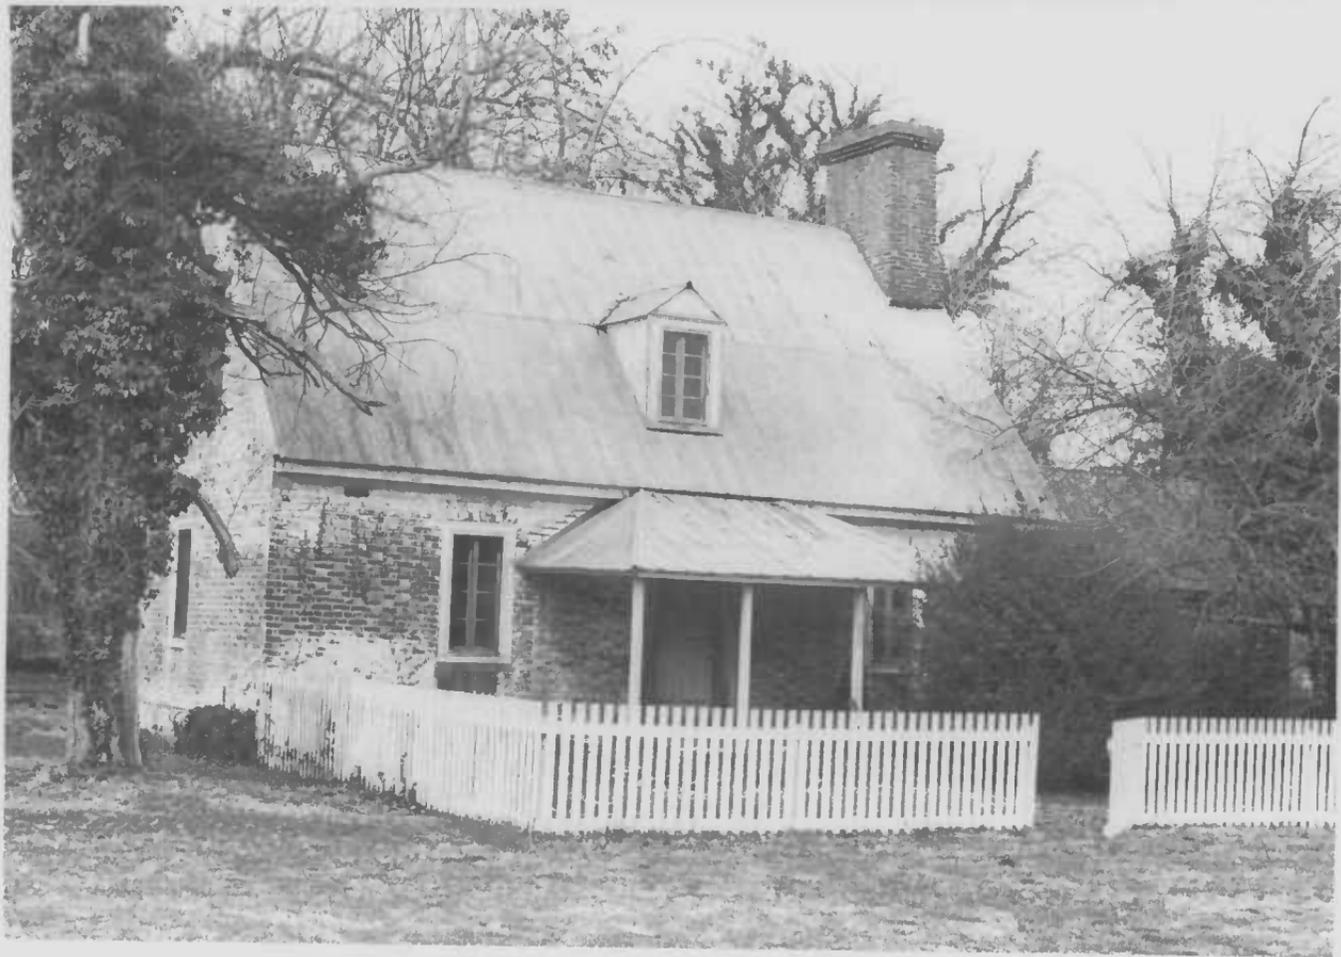
Easton vicinity, Talbot County, MD  
Captain's house, southeast elevation  
3/89, Paul Touart, photographer  
Negative/MD Historical Trust

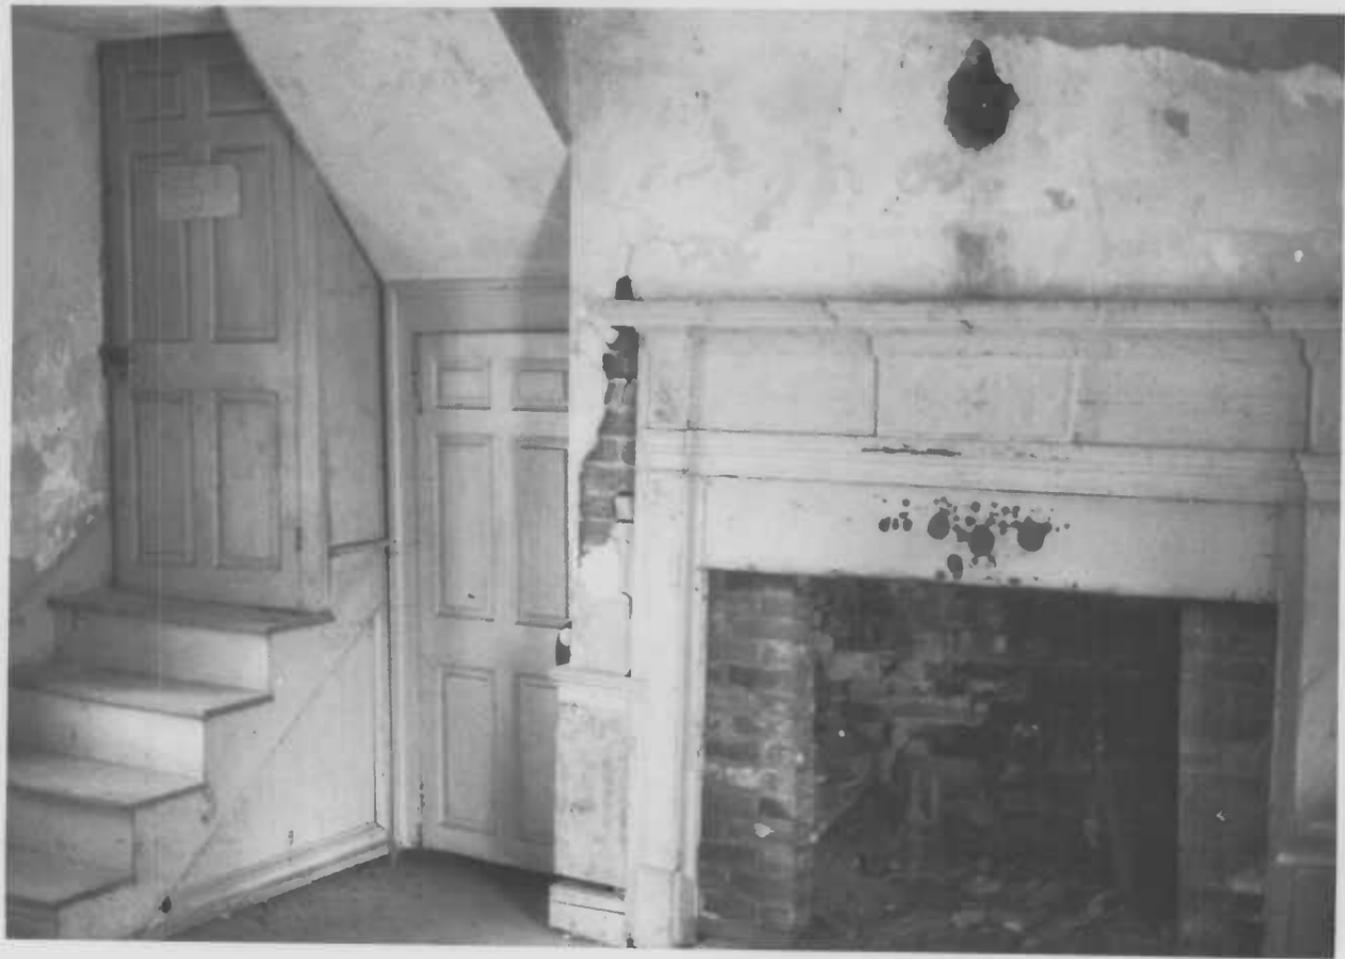
Easton vicinity, Talbot County, MD  
Captain's house, first floor hearth  
wall

The first floor of the house follows a hall/parlor plan, and it is finished with plastered walls and a combination of eighteenth- and nineteenth-century woodwork. The hearth is framed by an early nineteenth-century Federal style mantel with diagonal and herringbone pattern reeding that enriches the pilasters and frieze blocks. The broken mantel shelf is composed of several bed and crown moldings. Fixed in the corner of the room is an enclosed stair with four exposed steps, but no balustrade. A raised six-panel door does remain along with another six-panel door that opens into the stair closet below. The room is fitted with

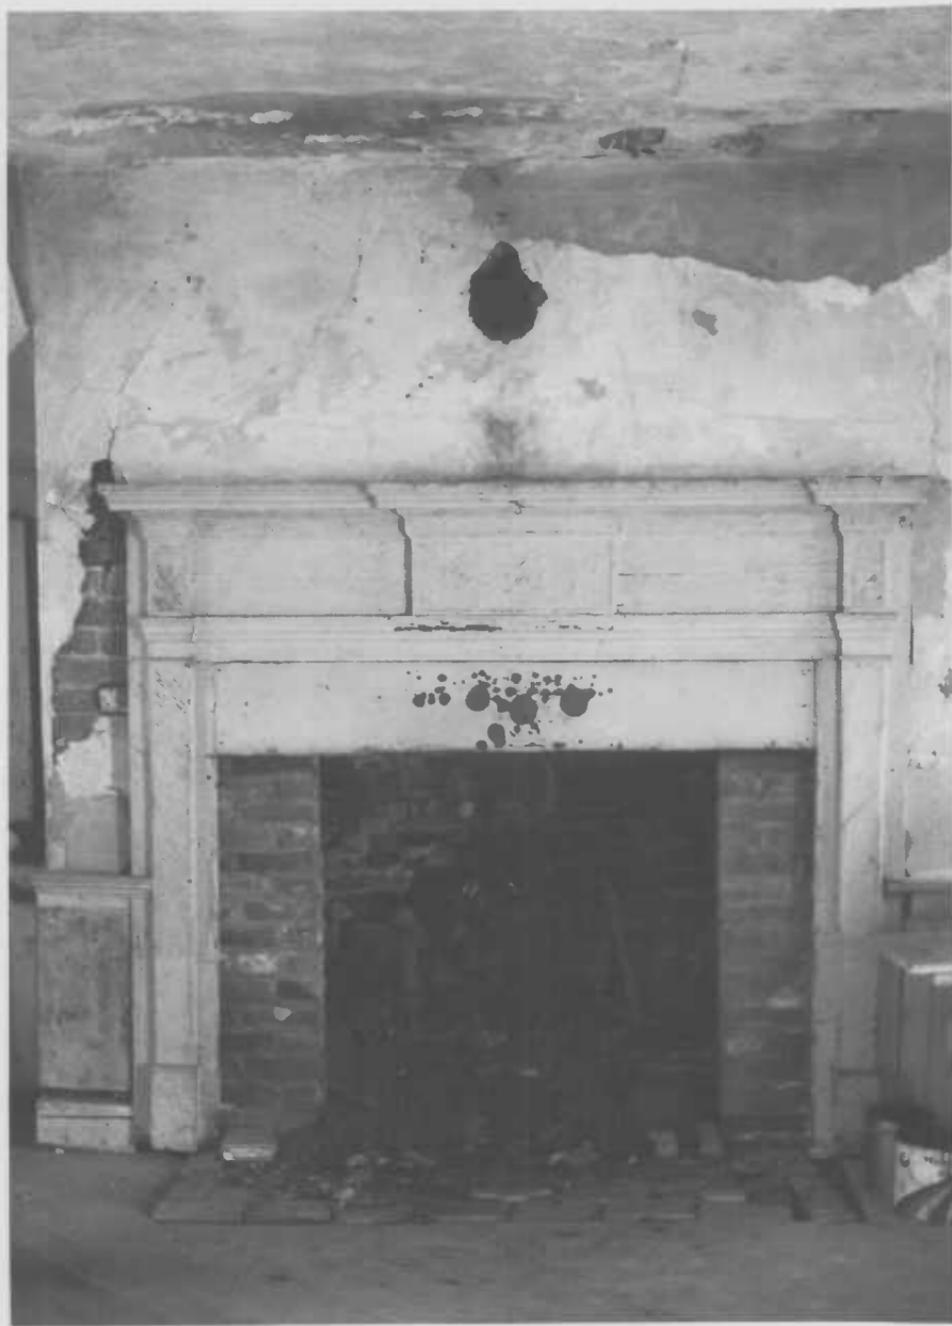
Easton vicinity, Talbot County, MD  
Captain's house, first floor mantel  
3/89, Paul Touart, photographer  
Negative/MD Historical Trust
