**National Register of Historic Places  
Inventory—Nomination Form**

historic Cannonball House

street & number 200 Mulberry Street

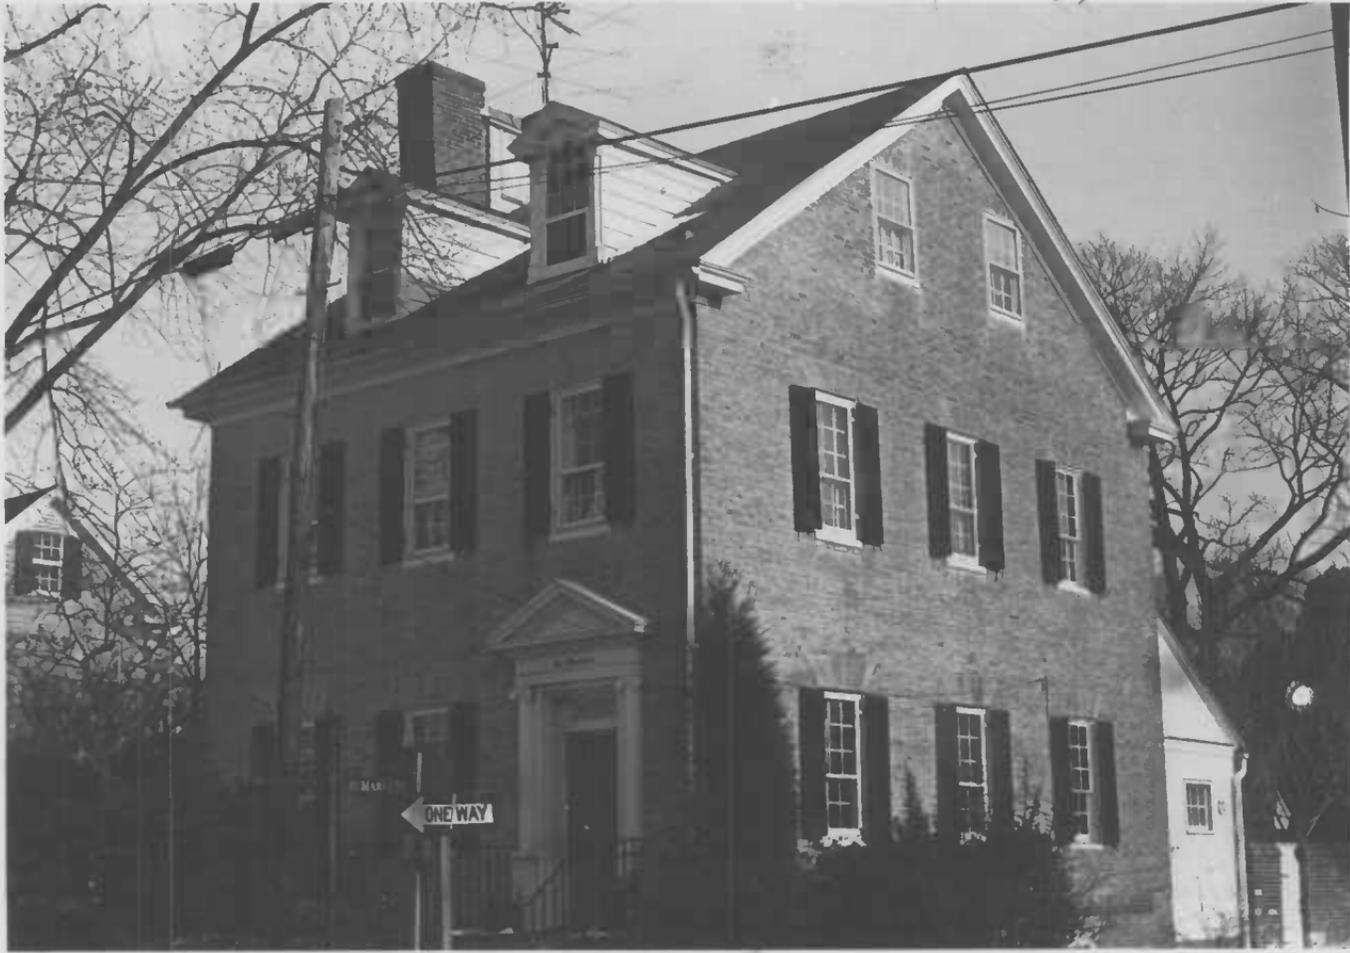
Maryland Historical Trust, Annapolis, MD  
Northwest elevation.

The facade or north elevation of the main block has three bays with the entrance located in the west bay, a two light window with three wooden ventilator bays centered in the foundation below the first floor windows, and a wooden boxed cornice resting on a plain fascia with complex bed molding and topped by a series of crown moldings with a middle cyma.

The elevation along St. Mary's Square (west) is also three bays wide with two windows in the gable and two in the foundation. The gable windows have six-over-six light double-hung wooden sashes with splayed brick flat arches and wooden sills. The arch windows are not as high as those of the lower levels. The foundation windows have a single light protected by three wooden ventilator bars each. The returns from the north and south elevation cornices are moderate and the rakeboard continues the facade moldings.

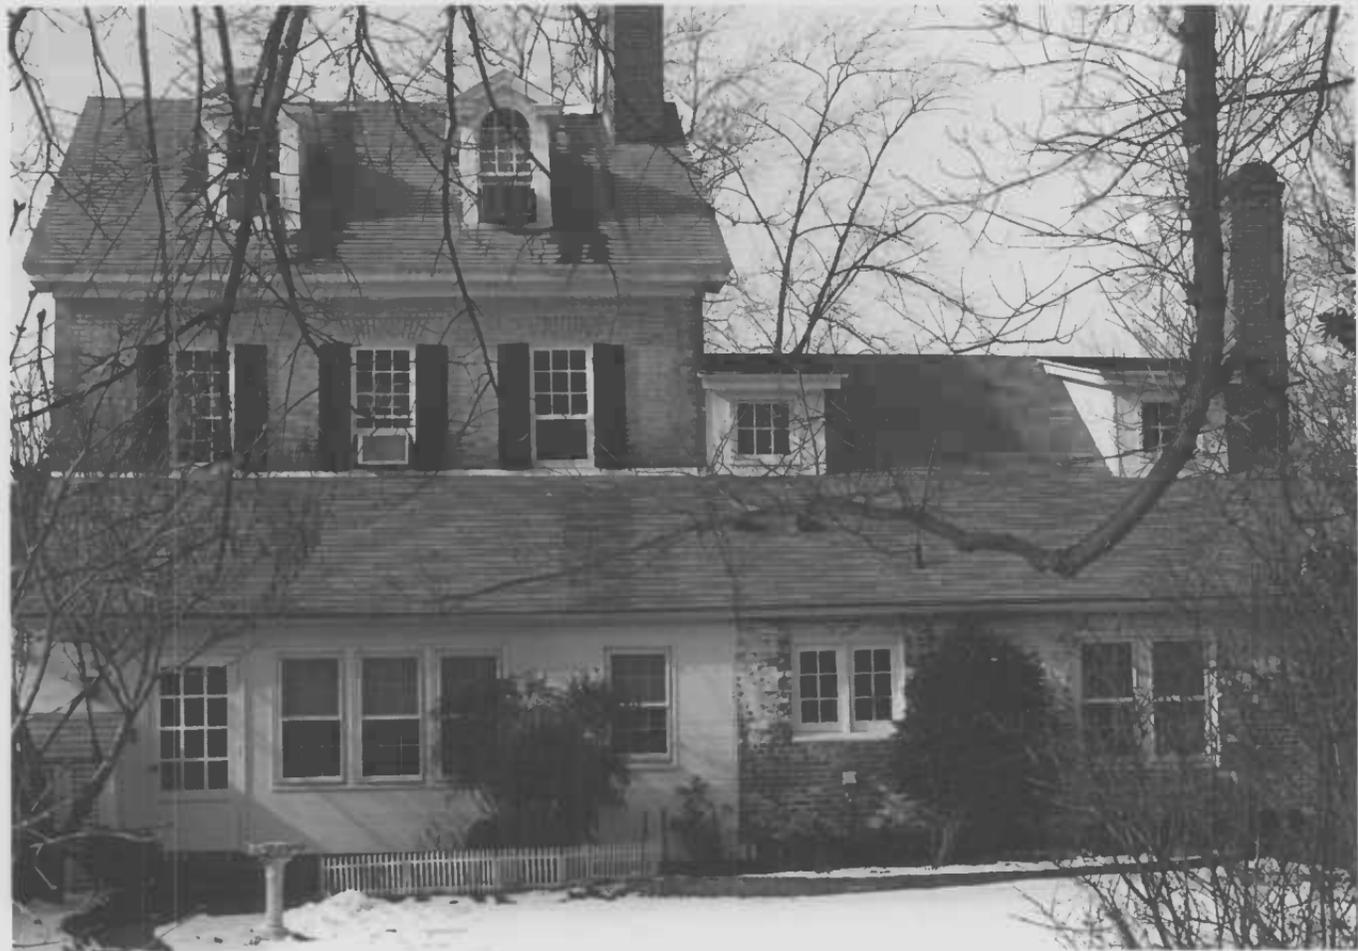
South (rear) facade.

The rear or south elevation is three bays wide with two gable-roofed dormers projecting from the roof and a shed-roofed enclosed frame porch stretching across the first story. The dormers are pedimented with nine-over-six double-hung round arch windows with beaded surrounds but without columns supporting the entablature. Modern siding sheaths the sides of the dormers. The second story has nine-over-six double-hung windows detailed similar to those on the front elevation. The enclosed porch has flush wood siding with a modern door and windows. The section of the wall covered by the porch contains a nine-over six window lighting the south parlor and flanked by six-panel doors (original) opening into the parlor and hall.

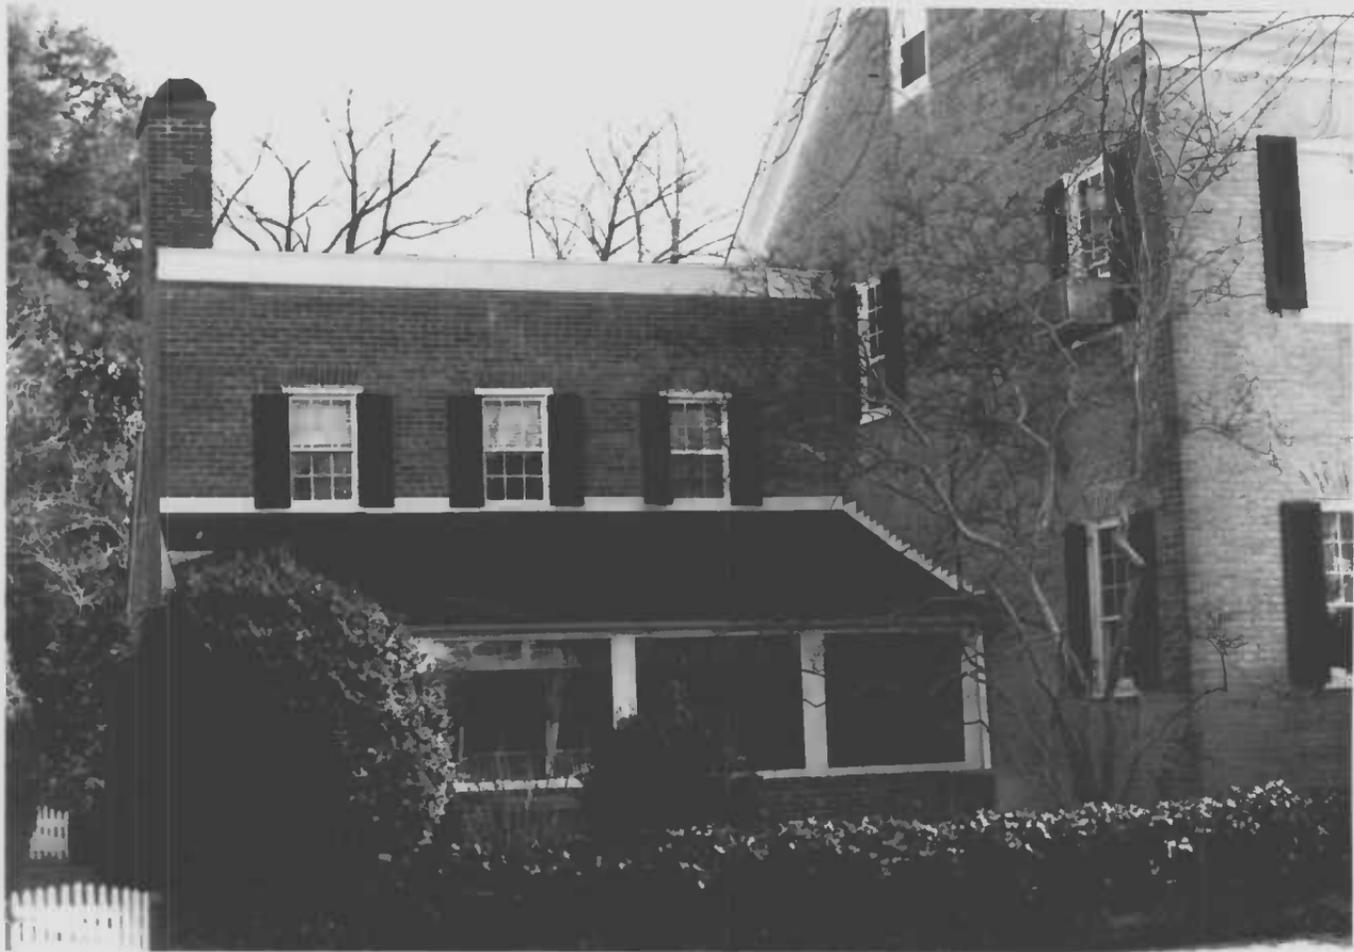
Kitchen wing, northeast elevation.

The Mulberry Street facade of the kitchen wing, laid in the five course common bond, contains in its enclosed first story a door flanked by two six-over-six double hung windows with beaded fascia surrounds. All three openings are topped with splayed jack arch lintels. Three six-over-six double hung windows symmetrically placed above the first story fenestration with double fascia surrounds and single-course splayed jack arch lintels light the loft of the kitchen wing.

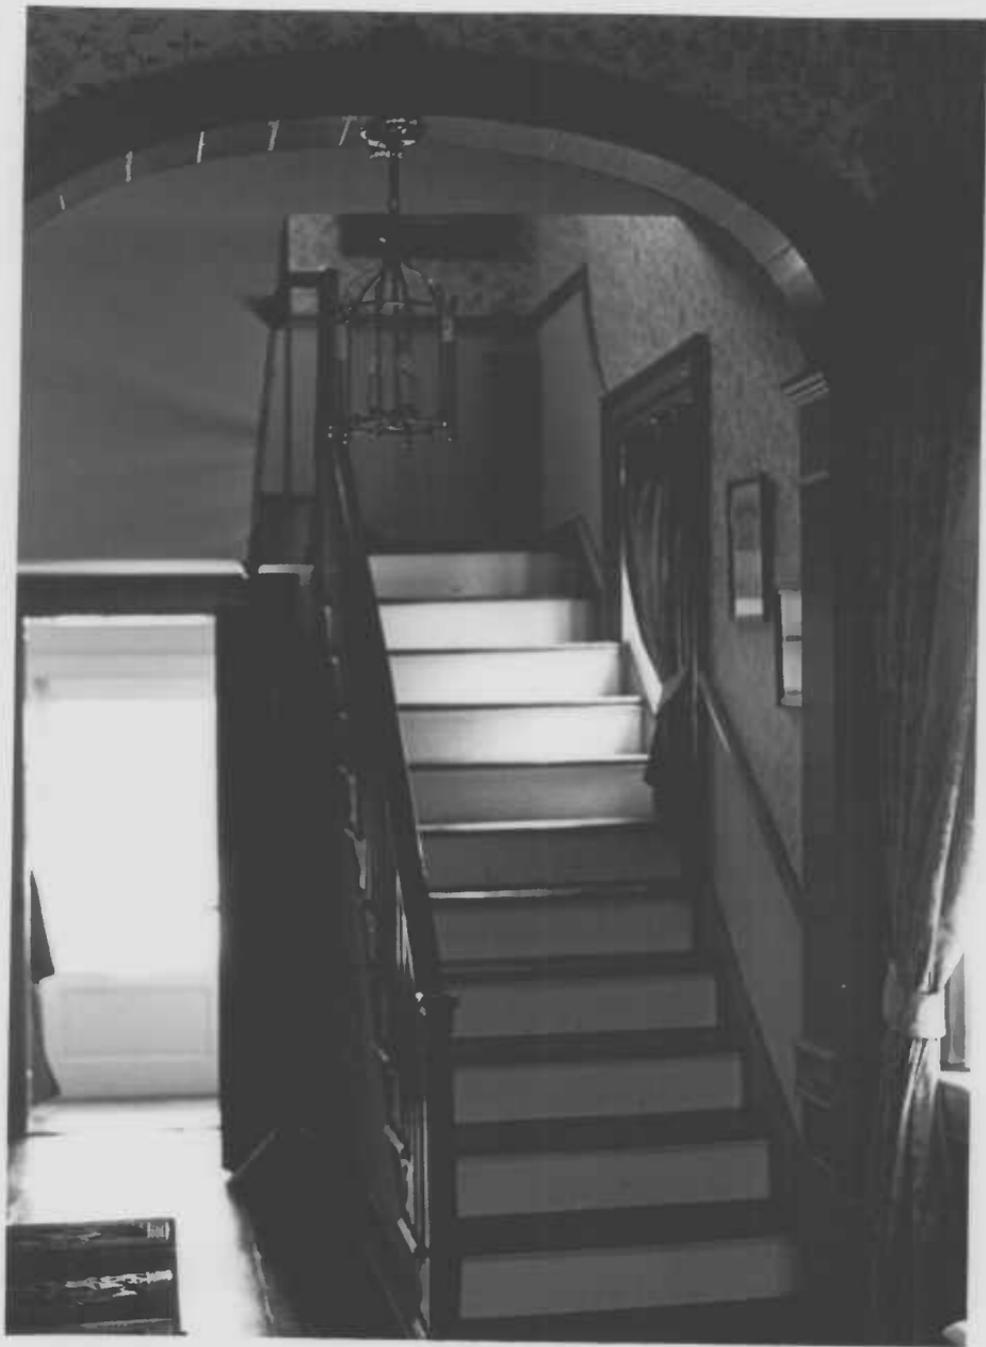
Interior: first floor stairhall.

The interior of Cannonball house is characterized by a hall/double parlor plan. The six-panel Mulberry Street facade door, which retains its brass box lock, opens into a hall lit on its west side by the three windows, one of which is crossed by the stairs. The architrave surrounds of the windows and two exterior doors at either end of the hall and two doors to the parlors all consist of the same moldings (fascia quarterbead recessed fascia, cyma, recessed fascia and innerbead bounding the jambs). A chairrail distinguished by a carved herringbone pattern in the frieze bounded on the top by a cyma and projecting fascia and on the bottom by a bead runs continuously in this hall except where a modern closet has been inserted to the west of the front doorway. A beaded baseboard also runs continuously around the hall. A triumphal arch which frames the stair consists of two strip pilasters decorated with incised flutes and bisected by the chairrail which breaks forward to accommodate the pilasters application to the wall. Plain molded capitals support an elliptical arch with plain paneled soffit and architrave surrounds with keystones. The open string stair is elaborated with a tapered newel and carved brackets under the treads which are in turn bounded by architrave moldings topped by a scotia and concluding in a quarter round bead. Underneath the stair is a four-panel door leading to the basement stair with a simpler surround (large quarter bead, recessed fascia and inner bead). Original six panel doors are found at the entrances to the front and rear parlors.
