INVENTORY FORM FOR STATE HISTORIC SITES SURVEY

Beaver Neck

1. STATE Maryland COUNTY Talbot TOWN Easton VICINITY Matthews STREET NO. Rt 328 1.1 mile east of Matthews (South to house) ORIGINAL OWNER ORIGINAL USE dwelling PRESENT OWNER Bayshore Foods Inc. PRESENT USE dwelling Philip Beaver WALL CONSTRUCTION NO. OF STORIES 1 1/2	HISTORIC AMERICAN BUILDINGS SURVEY INVENTORY T-108
	2. NAME Beaver Neck DATE OR PERIOD 18 th Century STYLE Colonial ARCHITECT BUILDER
	3. FOR LIBRARY OF CONGRESS USE

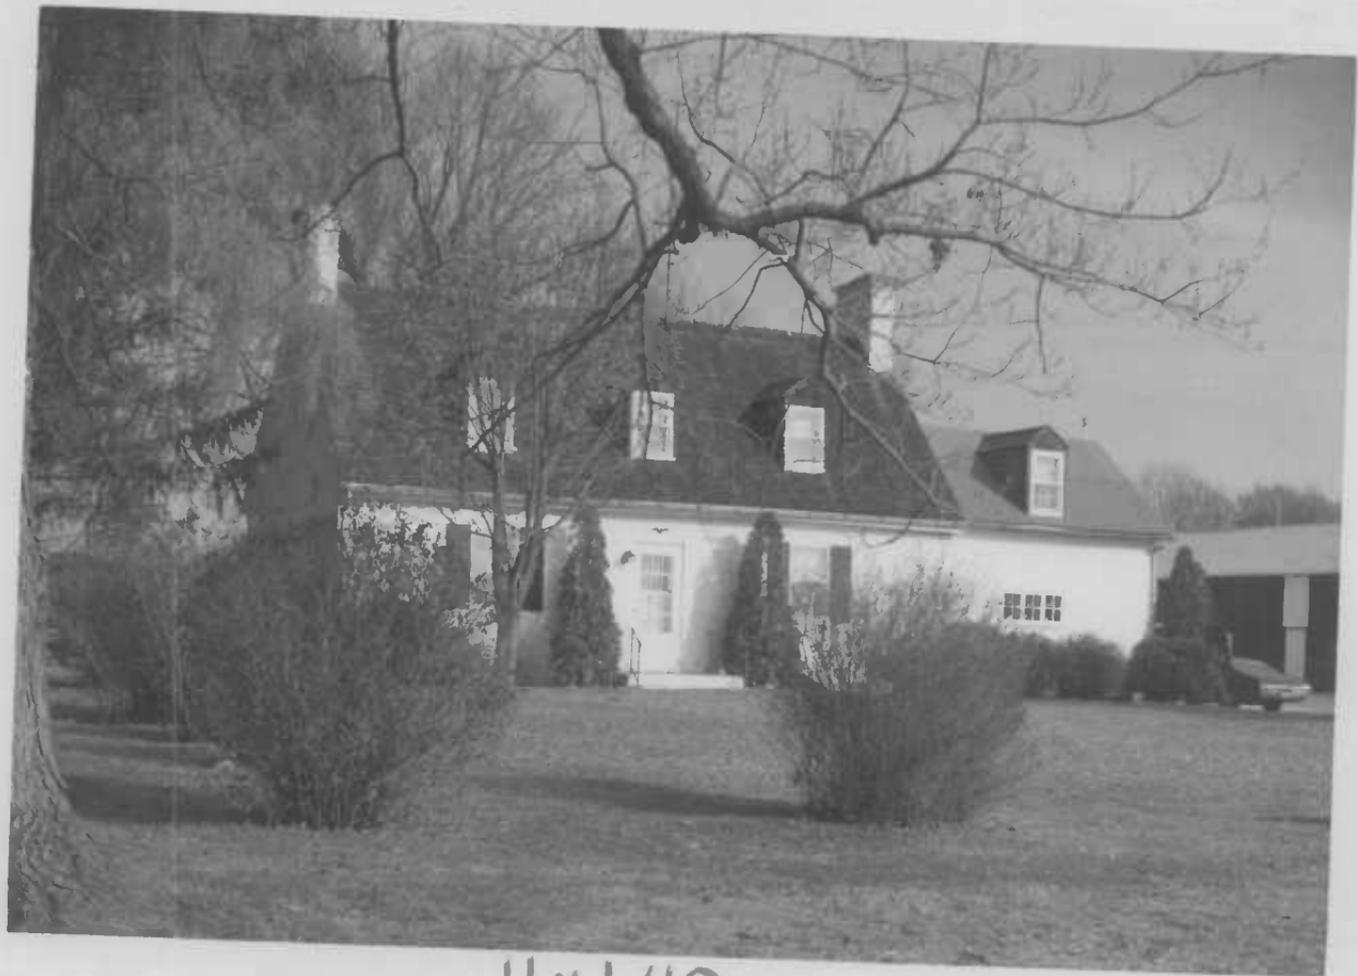
SW. elev

Essentially it is a 1 1/2 story brick structure, 3 bays long and one room deep with a one bay 1 1/2 story frame wing. The entire structure is painted white so it is difficult to see the Flemish bond with glazed headers on the northwest and southwest facades. Within each gable is a chimney still retaining what appears to be an original cap. Where the bargeboards abut the chimney a one brick band (or belt) protrudes, protecting the end of the barge. The door is located in the center bay of both facades. Three dormers pierce the "A" roof only on the southwest side. Windows throughout have 6/6 sash. Arches on the northeast side are comprised of a row of vertical headers.
