**MARYLAND HISTORICAL TRUST
NR-ELIGIBILITY REVIEW FORM**

Property Name: Byrne-Magee Farm Inventory Number: MHT Inventory No. M-13-24

Project: Old Baltimore Road Transmission Tower Agency: Apex Environmental, Inc.

Byrne-Magee Farm
MHT Inventory No. M-13-24
Montgomery County, Maryland

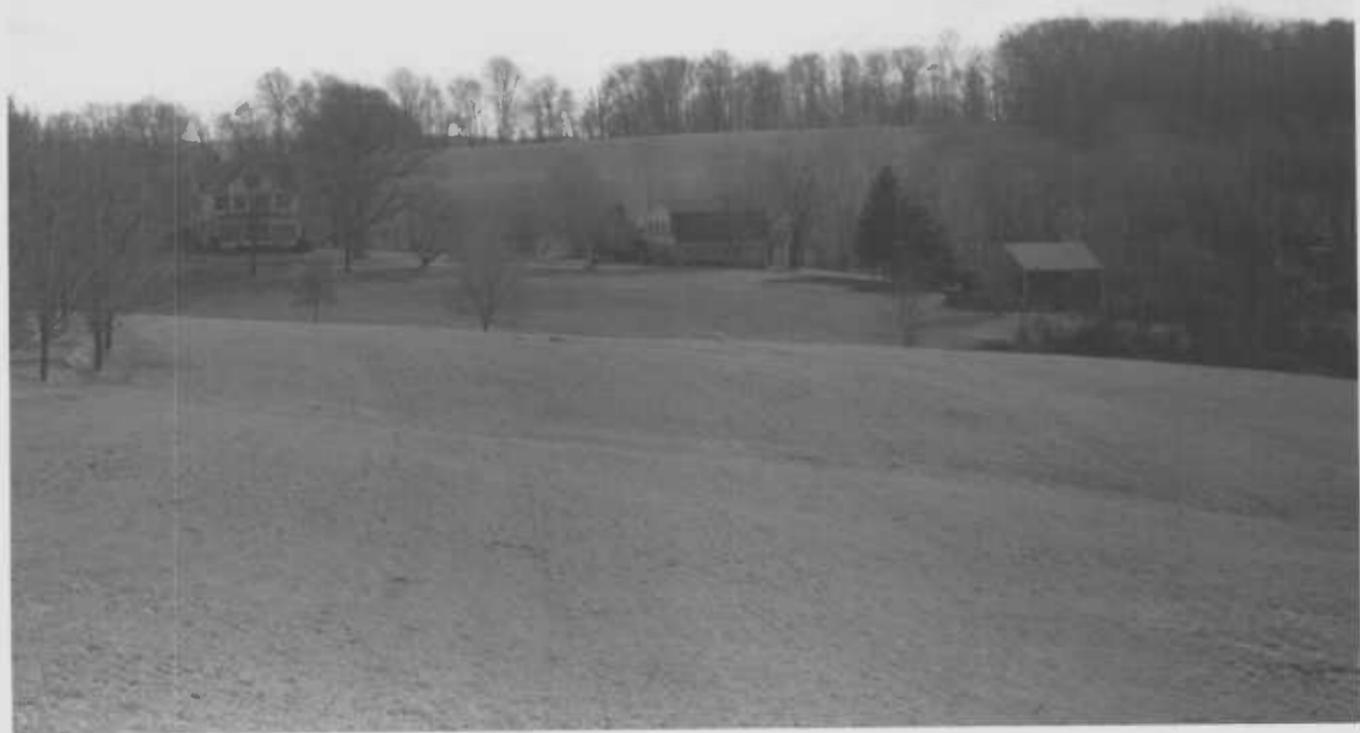
1 of 8

General overview, facing southeast from Clarksburg Rd.

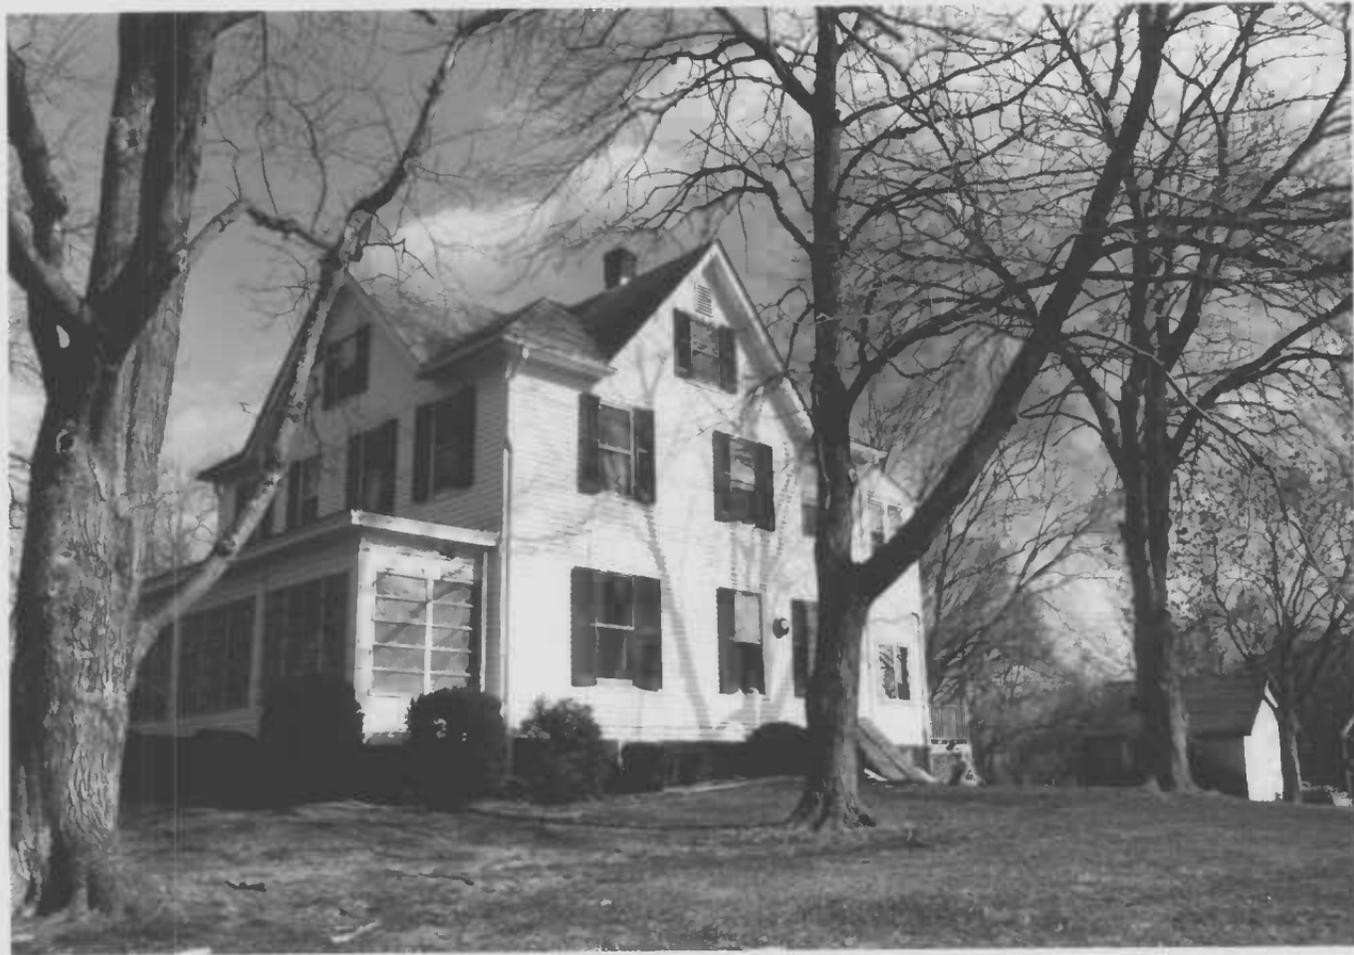
2 of 8

Farmhouse, facade (west) with enclosed porch and
south elevation, facing east. Smoke house in background.

On the main facade (west), what was formerly an open porch has been enclosed with louvered windows by the present owner; the original square posts (with their molded trim pattern) are still visible. The porch has retained its seamed-metal roof.

Behind the enclosed porch, the original design of the main facade has been retained. The twin entranceways have large, oval glass centers and are topped by transom lights. They open into separate (north and south) sections of the house with the north entrance leading to a parlor and stairway to the second floor and the south entrance leading to a dining room, with the kitchen at the rear. A second stairway to the second floor is located at the rear of the house.

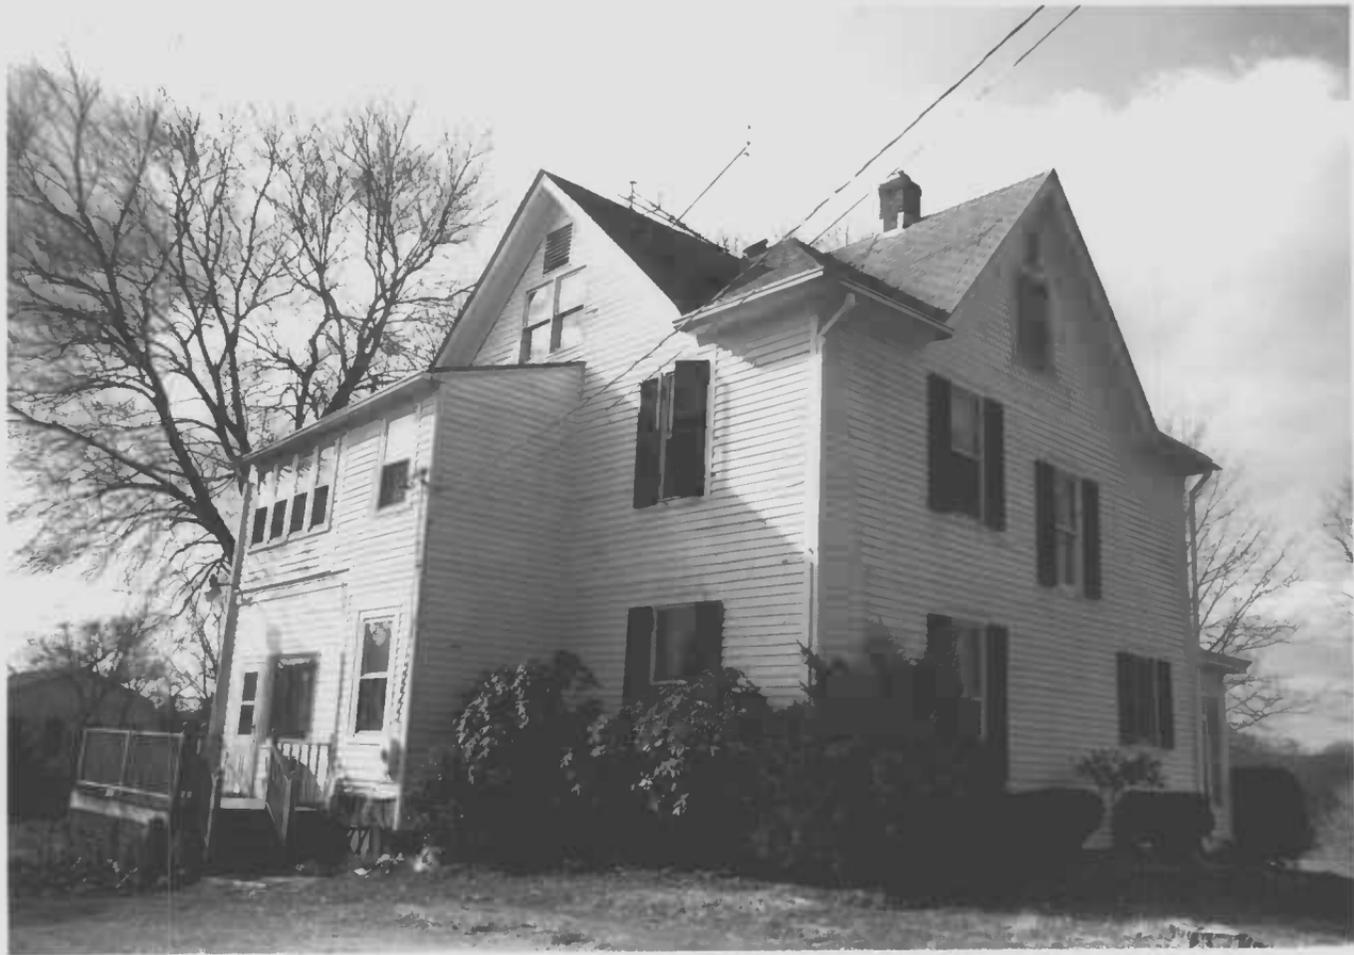
3 of 8

Farmhouse, north and rear (east) elevations with
rear addition, facing west.

The rear facade has a square, two-story, projecting shed-roof addition at the southeast corner which was added when Joseph Higgins (who owned the property from 1960-1962) enclosed the first and second story porches. The present owner added the ground-floor deck, which is built over the pump; the pump house was demolished.

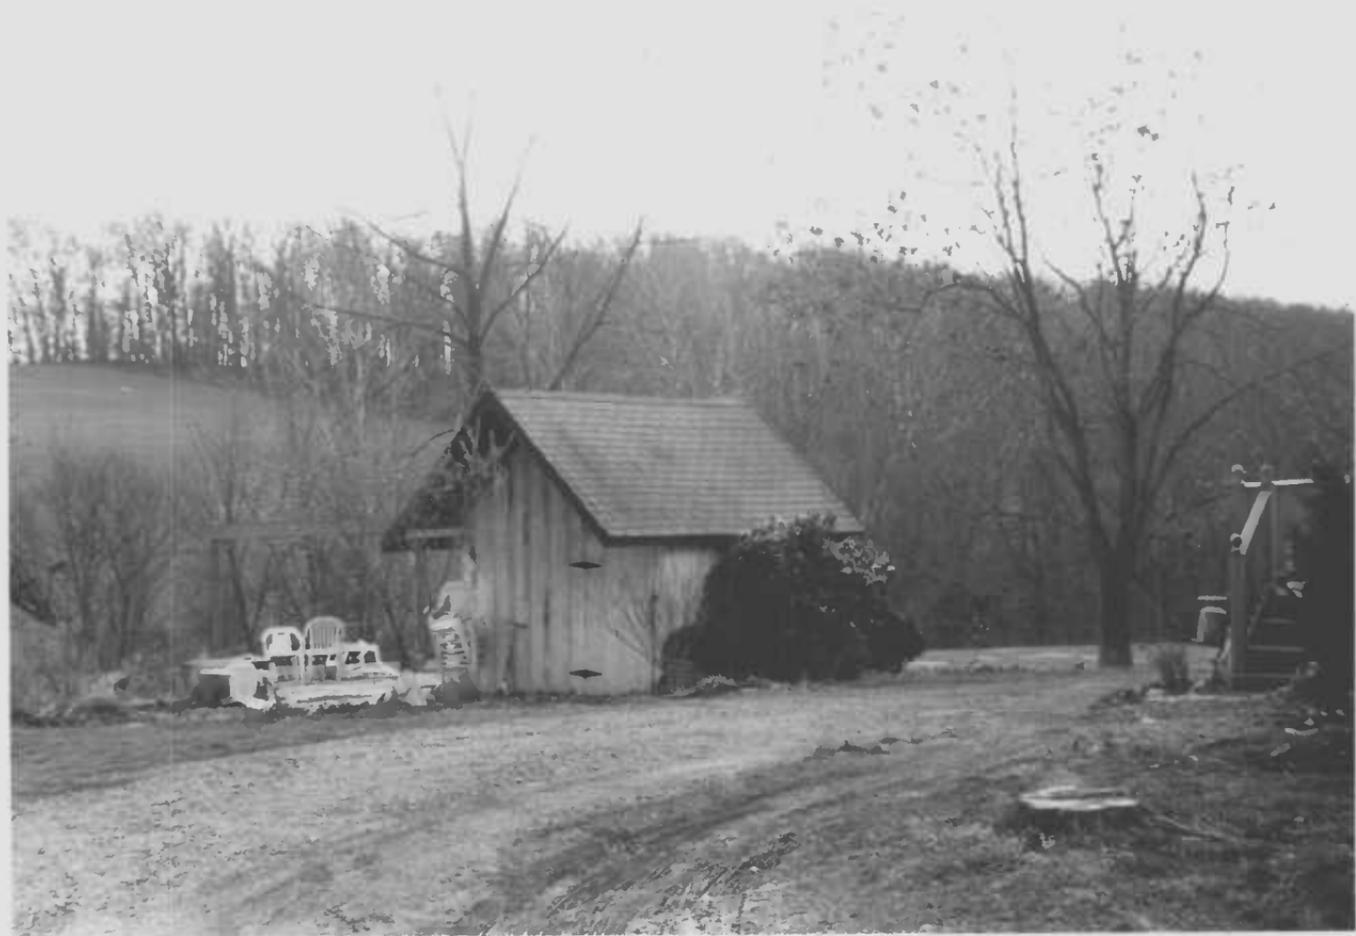
4 of 8

Smoke house, north gable end with overhanging roof
and entry, facing south.

There is also an adjacent concrete-block dairy equipment building with quoined corners; a gable-roof, board-and-batten smokehouse at the rear of the farmhouse with an asphalt shingle roof and strap-hinged doors; a shed-roofed, plank-sided hen house; a plank-sided corn crib and machine shed with a cat-slide roof; and the now- deteriorated vertical plank-sided bank barn, erected about 1900, with painted windows and a stone foundation. A more recent metal-roofed garage with board-and-batten siding also stands at the rear of the farmhouse. Several other small outbuildings were demolished by the present owner.

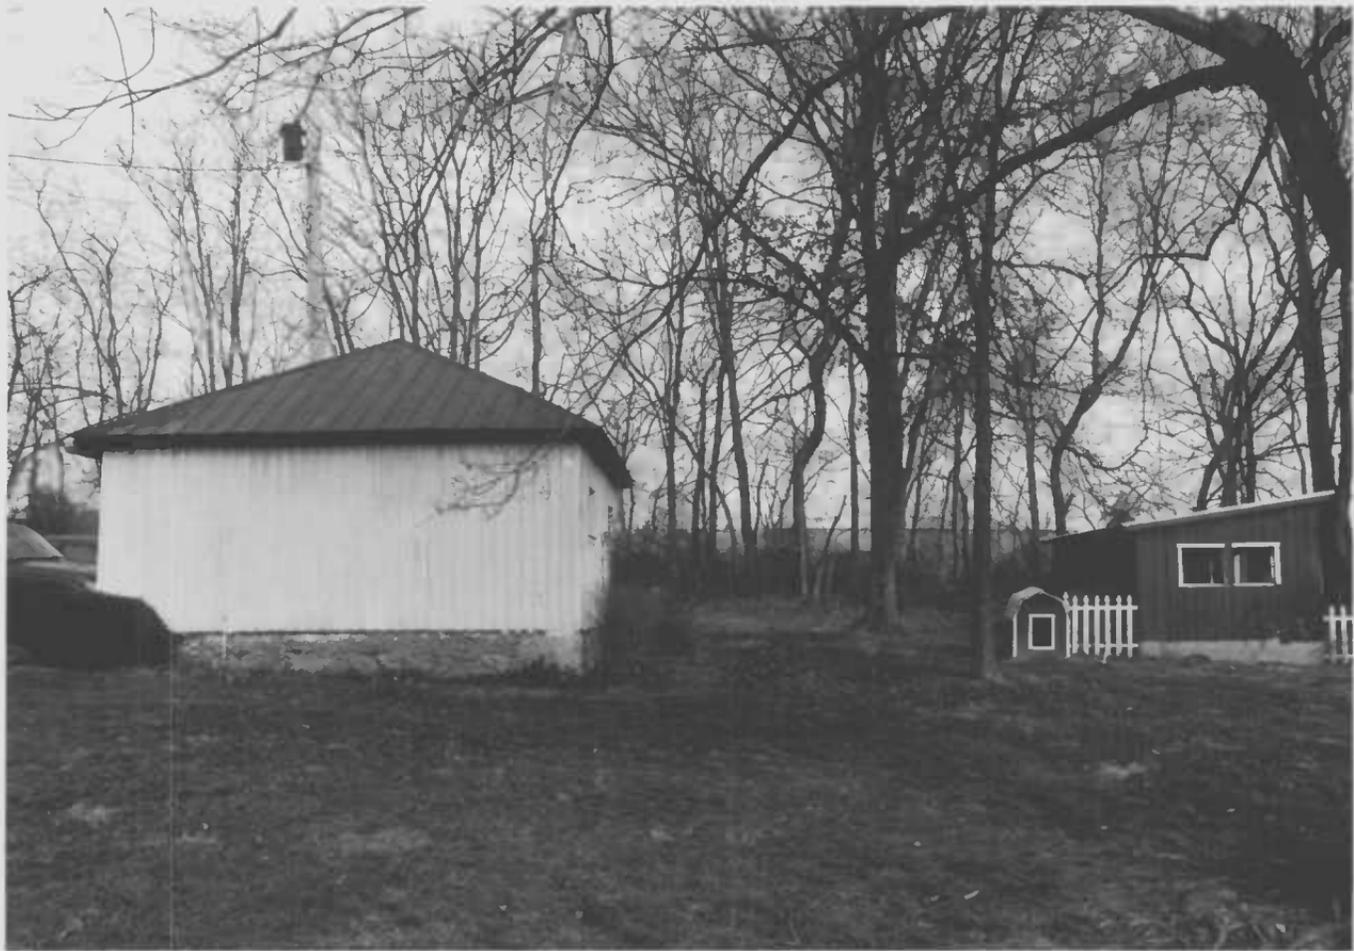
5 of 8

Garage and hen house, facing northeast.

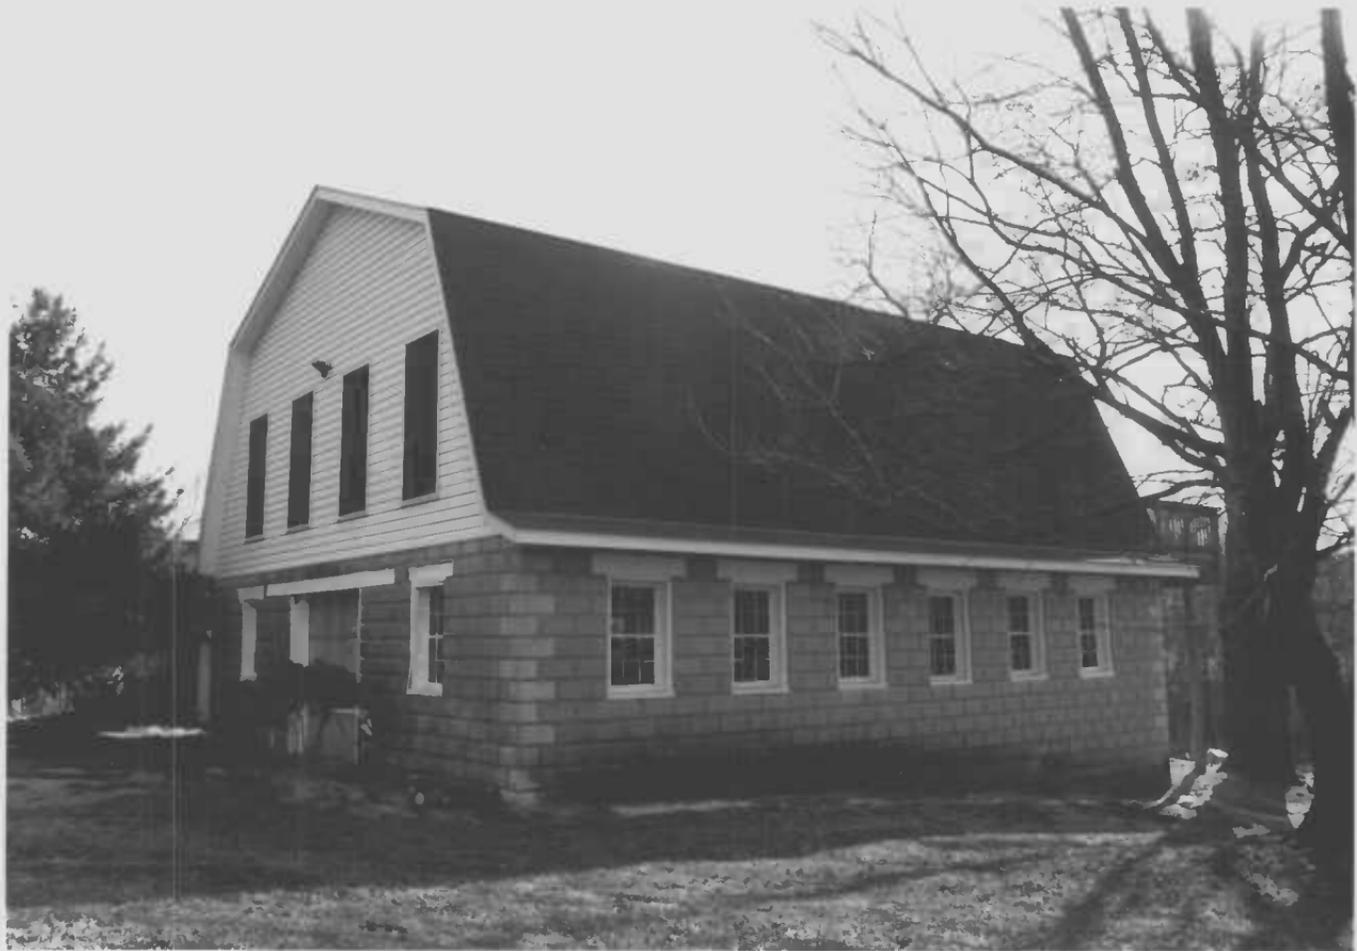
6 of 8

Dairy barn, north gambrel end and west elevation,
facing southeast.

There are a number of early-mid twentieth century outbuildings including a gambrel-roof dairy barn of concrete block and clapboard with quoined corners and stone lintels which was probably erected in the early 1940s; the barn has more detailing than most. As Andrea Rebeck notes in her report on Montgomery County barns, "Attention was paid to aesthetics by providing blocks of contrasting color for window and door surrounds and quoins at corners."⁽¹⁾

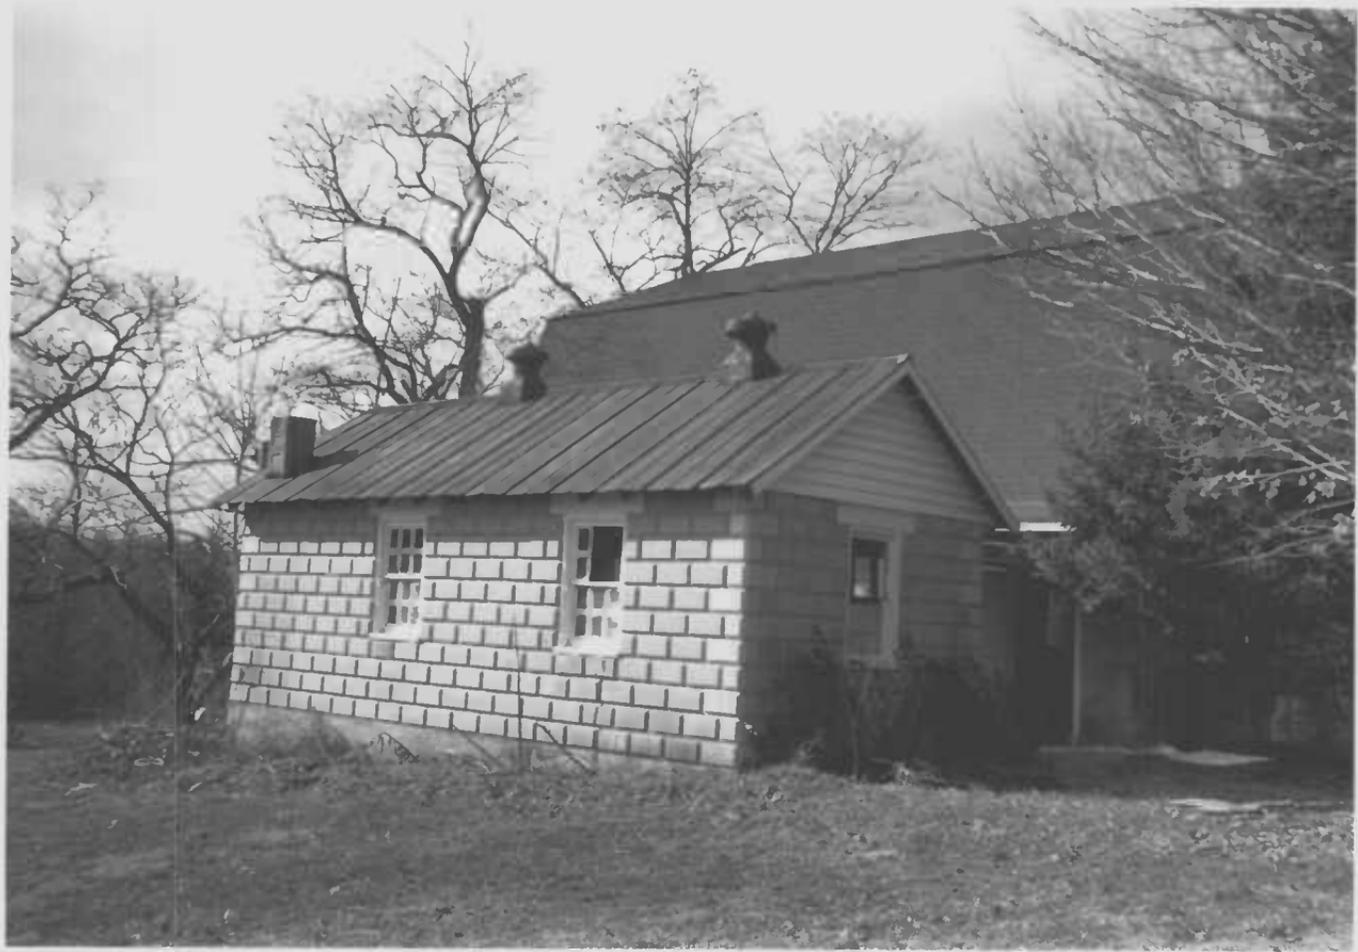
7 of 8

Milkhouse, east side elevation, facing west

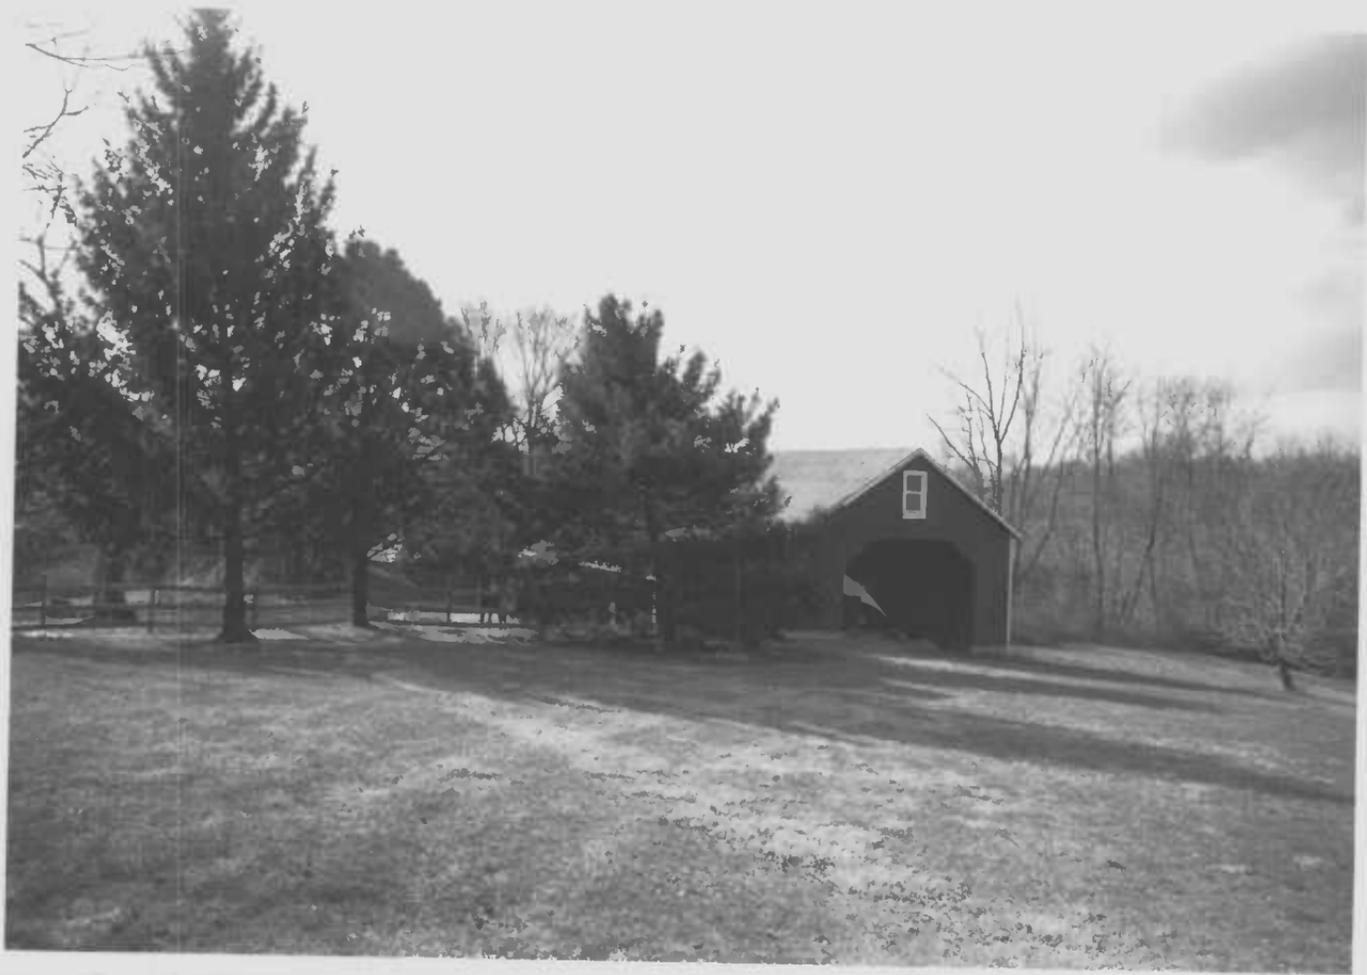
8 of 8

Corncrib/wagon shed, north gable end, facing southwest.
