M-14-3  
ETCHISON-WARFIELD LOG HOUSE  
Damascus  
Private

## INVENTORY FORM FOR STATE HISTORIC SITES SURVEY

THE ETCHISON/WARFIELD LOG HOUSE:  
A Century of Changes in Montgomery County

Terry Lynn Prokopp  
Vernacular Arch. 351  
April 1981

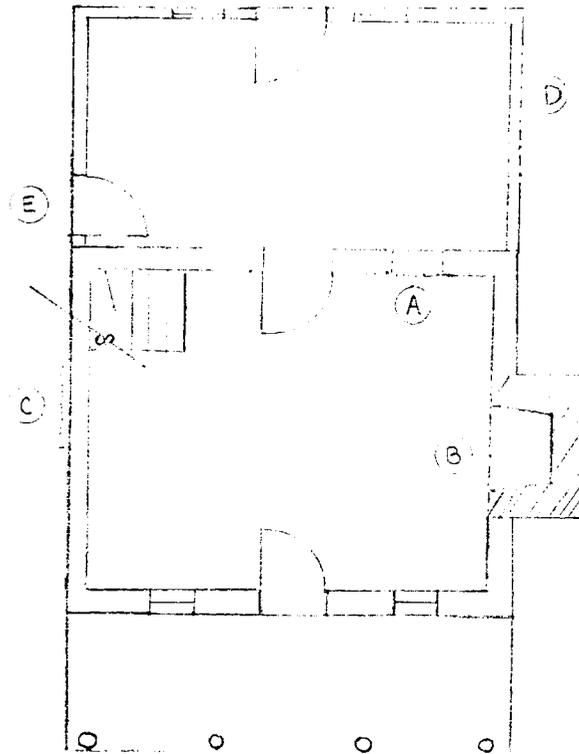
- A. CRACKS IN PLASTER INDICATE PRESENCE OF EARLIER WINDOW
- B. FIREPLACE COVERED UP AND ADAPTED FOR STOVE PIPE
- C. DUGOUT AREA OF EARTH AND STONE LEADING TO CELLAR
- D. EVIDENCE INDICATING LOCATION OF EARLIER STONE CHIMNEY
- E. DOOR LEADING TO EAST KITCHEN WING

The original south exterior wall is still visible as the partition wall between the north and south rooms. On its inner and outer faces it is plastered to a boxed cornice with a beaded board fascia. This south facade consists of a central doorway of vertical beaded boards similar to the door of the north facade. Cracks in the plaster on the interior of the wall indicate that a window may have originally flanked the door on the southwest side. (See Plan 1.)

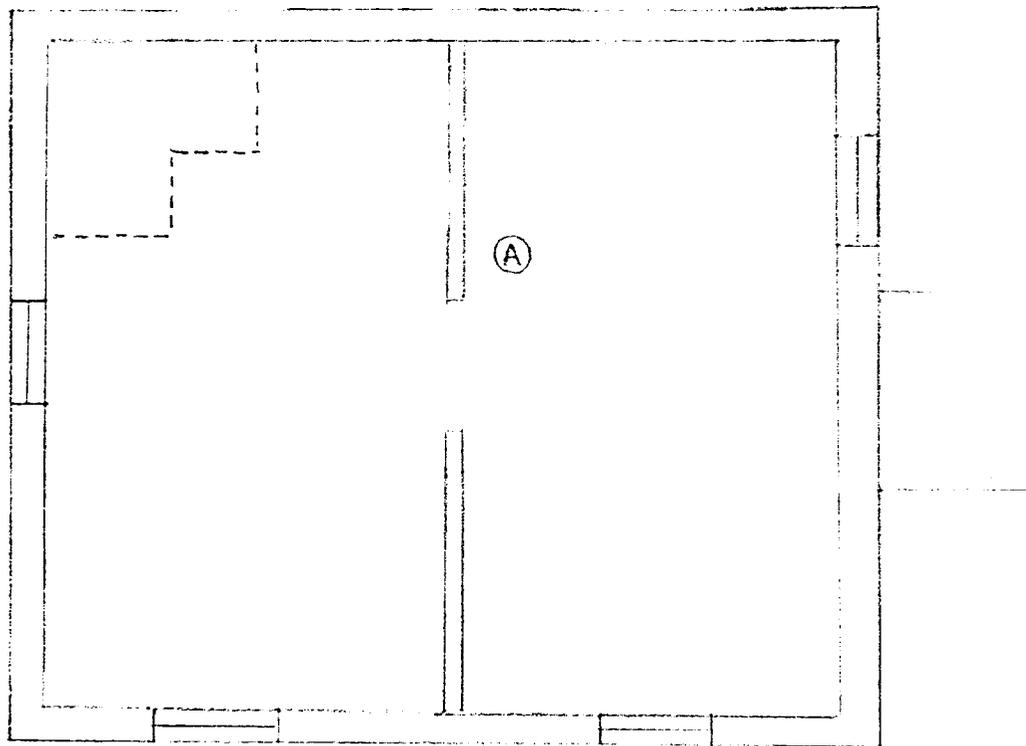
LOFT

A. BEADED BOARD  
PARTIAL WALL

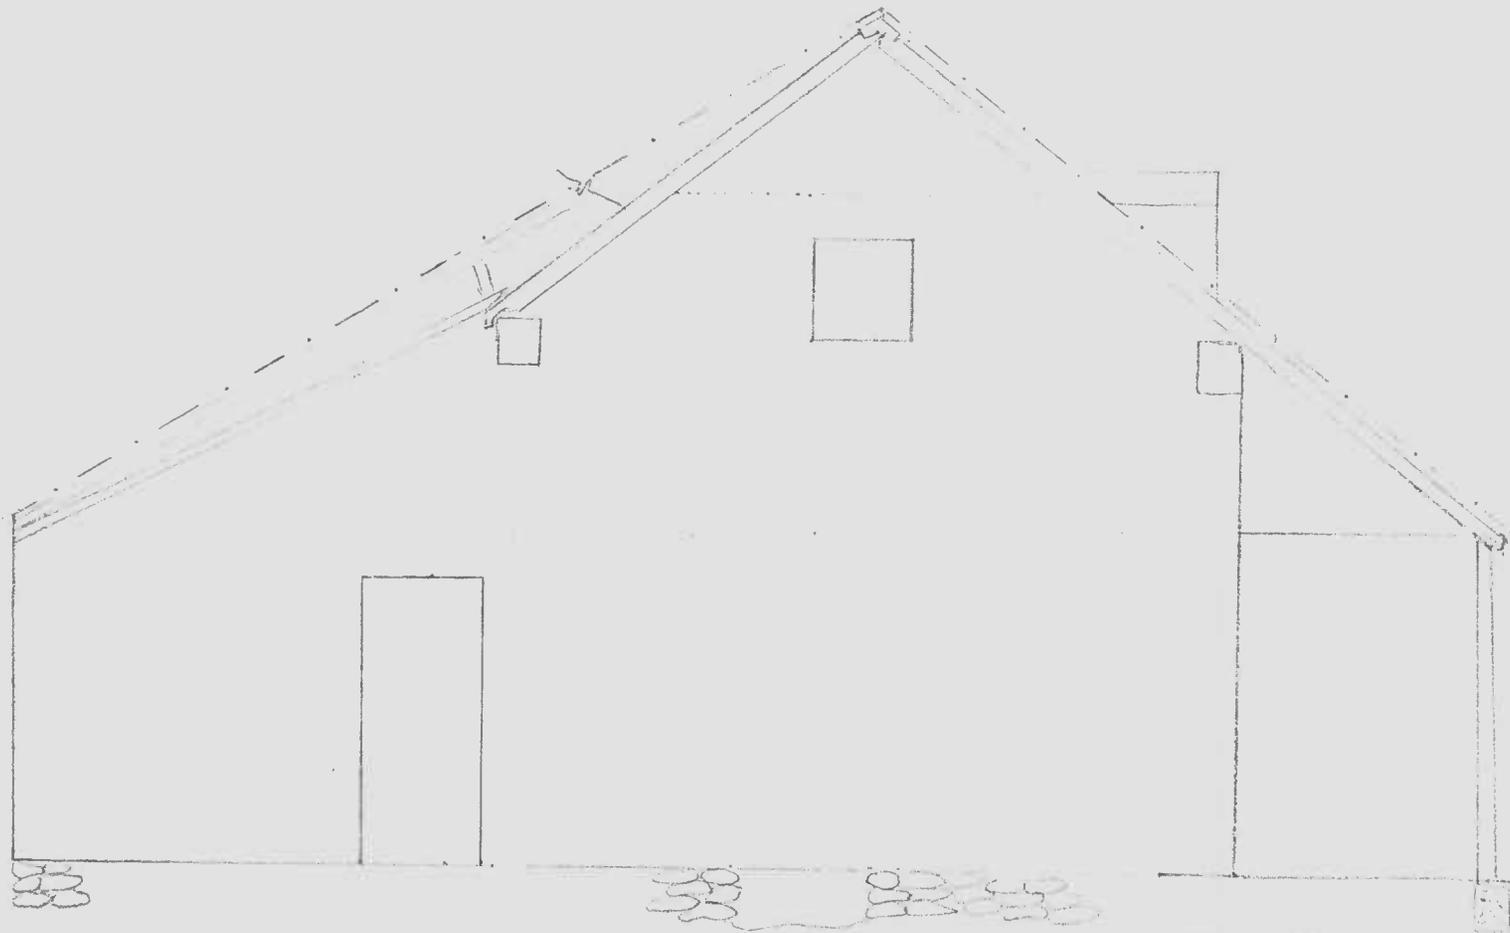
SECTION: ROOF CONSTRUCTION

EAST GABLE END

The roof framing consists of log rafters birdmouthed over the uppermost log which is chamfered on its outer face. The rafters support nailers of rough-sawn lumber and sheathing. On the north slope, the roofing material is tin; on the original south slope, it is riven clapboards, cut in about two foot lengths, overlapping both longitudinally and latitudinally.

Rather than roofing the addition with an extension of the original south roof slope, which would cause a visual break in the roof line, an entirely new roof was constructed over the earlier roof. (See Plan 3.) The upper rafters of this roof were nailed to the original roof at the ridge and extend to the rear wall of the addition. Wide weatherboards were used to cover the open space between this upper roof line and the original south slope. (See H.A.B.S. photo 3.)

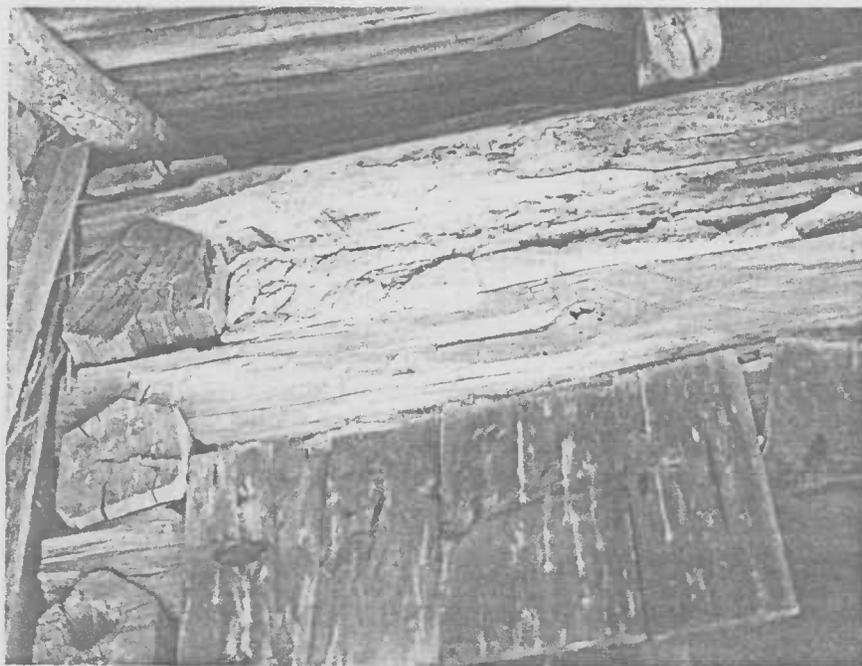
4

Detail of log construction. Northeast corner beneath porch roof. (Shingles covering facade above doorhead also visible) March 1981

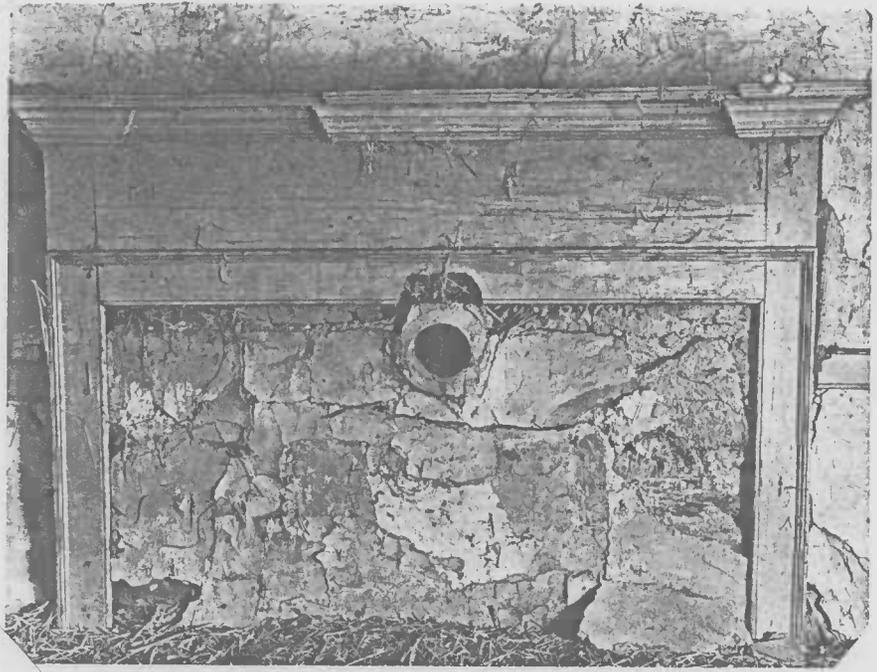
5

Detail of Fireplace, March 1981.

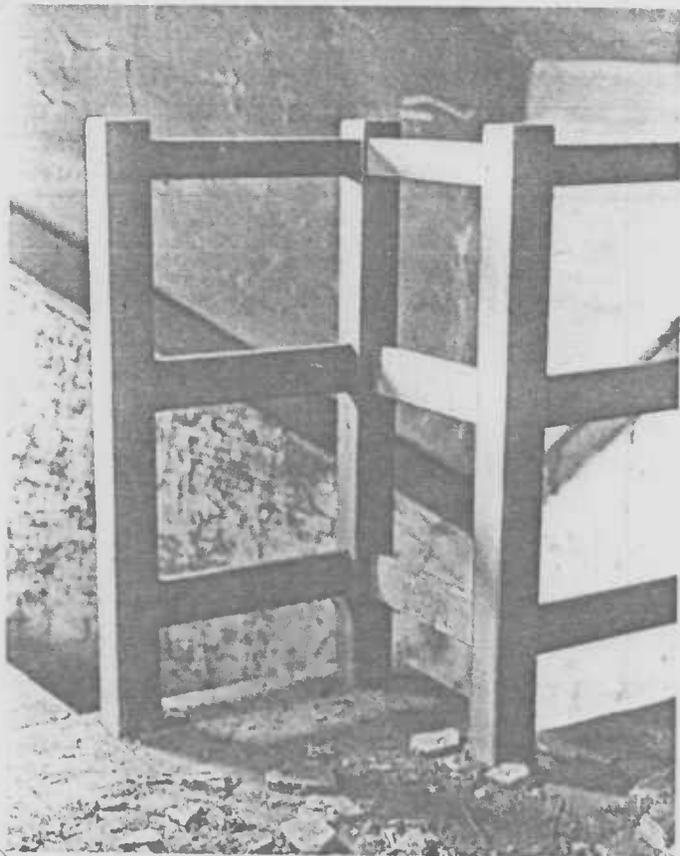
6

Detail of balustrade and chair rail, loft room, Southeast corner. March 1981.

The rail around the stair well consists of square posts, beaded at each corner. The top rail has the same profile as the posts, while the other two rails are narrow beaded boards. The rails are mortised into the posts. The rooms are ceiled at the collars, short pieces of lath being nailed to the collars with cut nails.

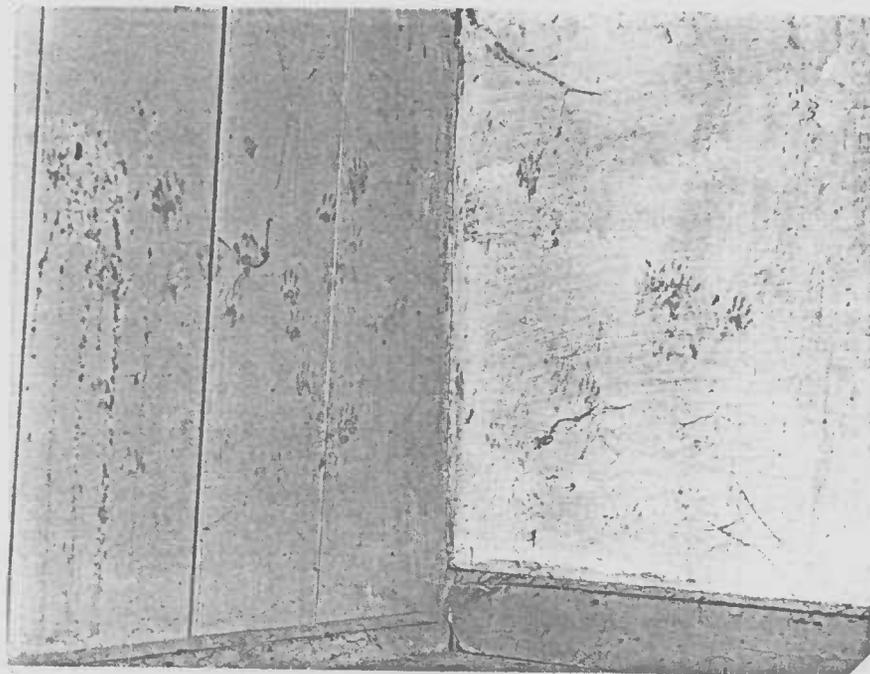
7

Detail of southeast corner of West loft room showing partition wall and baseboards.

The loft is divided into two rooms with a lateral partition wall of vertical beaded boards. Both rooms have a chair rail identical to the one on the first floor. At the corner staircase, the chair rail follows the slope of the stairs to form a "V" in the corner of the room. The baseboards vary, however; in the east room, it serves as a nailer for the partition wall and is thus a horizontal board with a chamfer and bead on the outer face. The other baseboards are beaded boards, varying only in height.

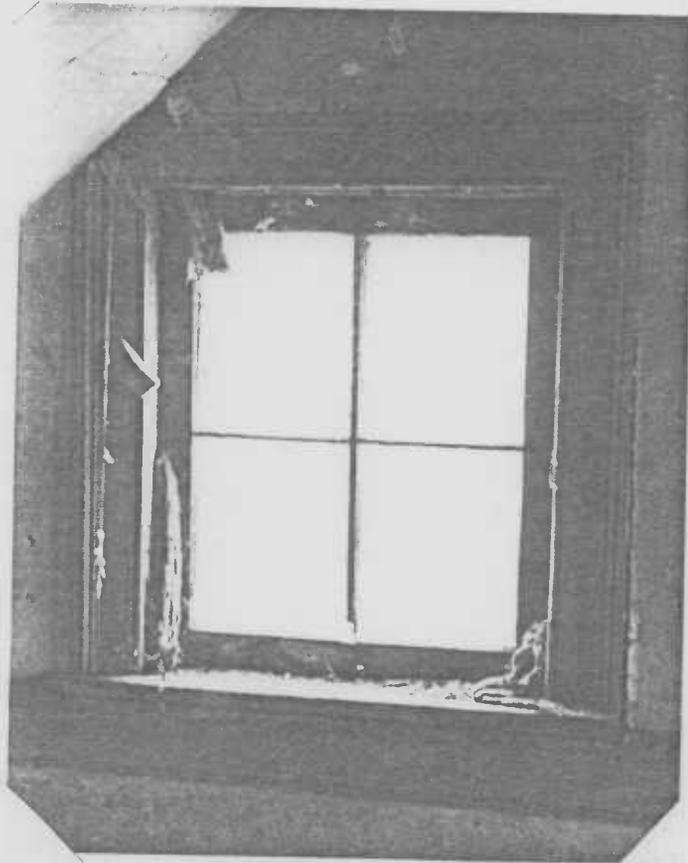
8

Detail of window, loft room, West gable end. March 1981.

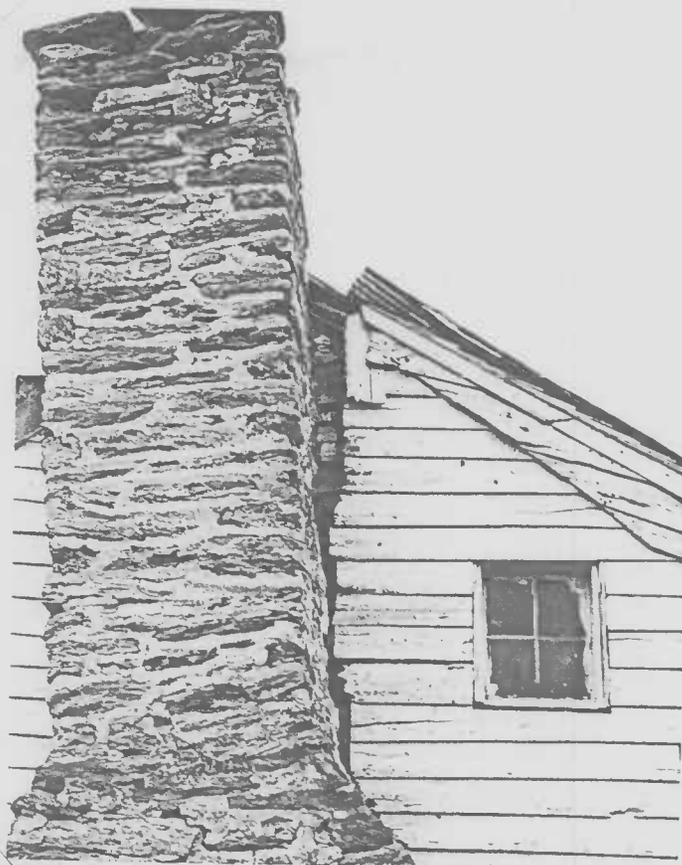
9

Detail of West gable end. Earlier weather-board siding and roof line of north log section visible to right of chimney. March 1981

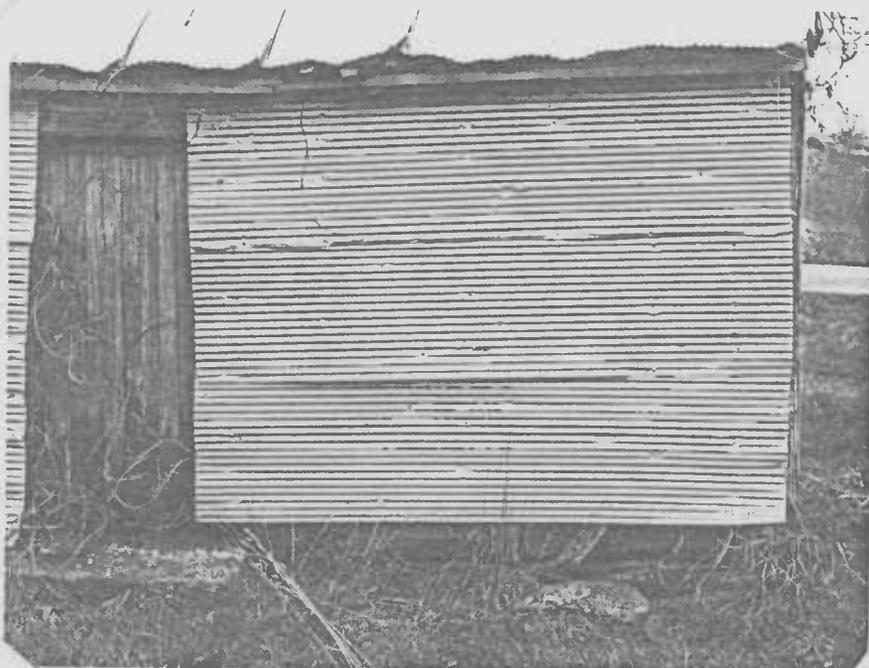
10

View Northeast. Detail of rear façade of shed addition showing central doorway. Frame wall

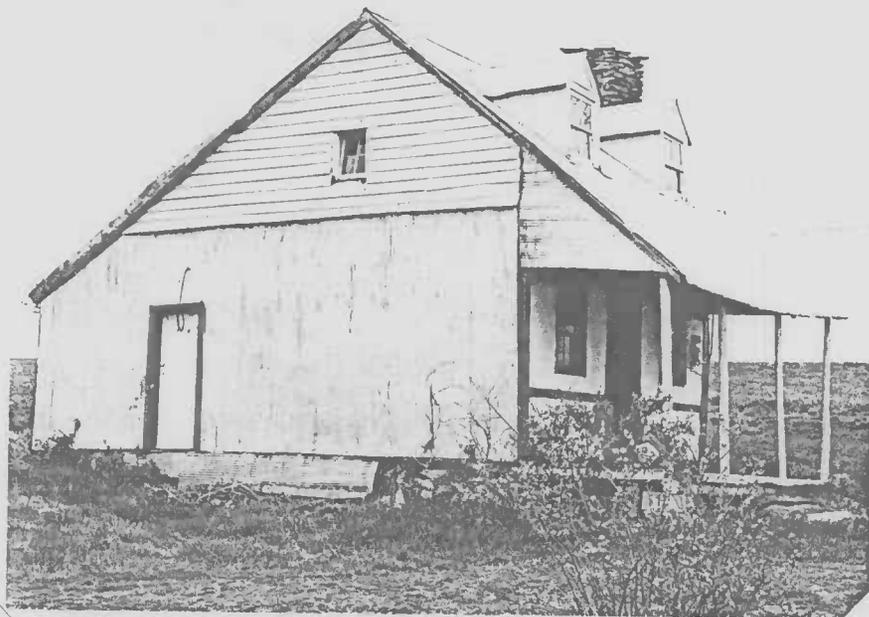
11

View West. Interior door to east Kitchen wing visible. Entrance to cellar is directly below gable end window. March 1981.

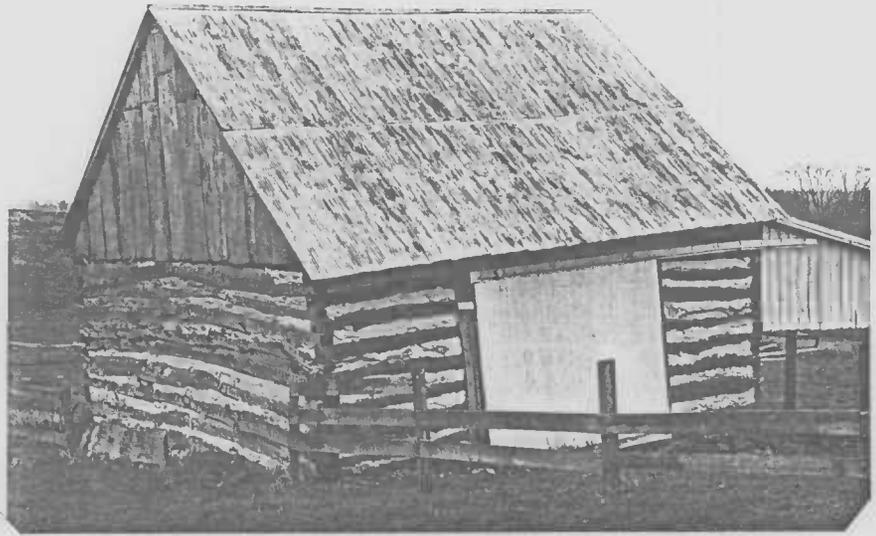
15

View East. Log tobacco house on North side of Rte. 108. Original doorways now replaced by sliding metal door. March 1981.

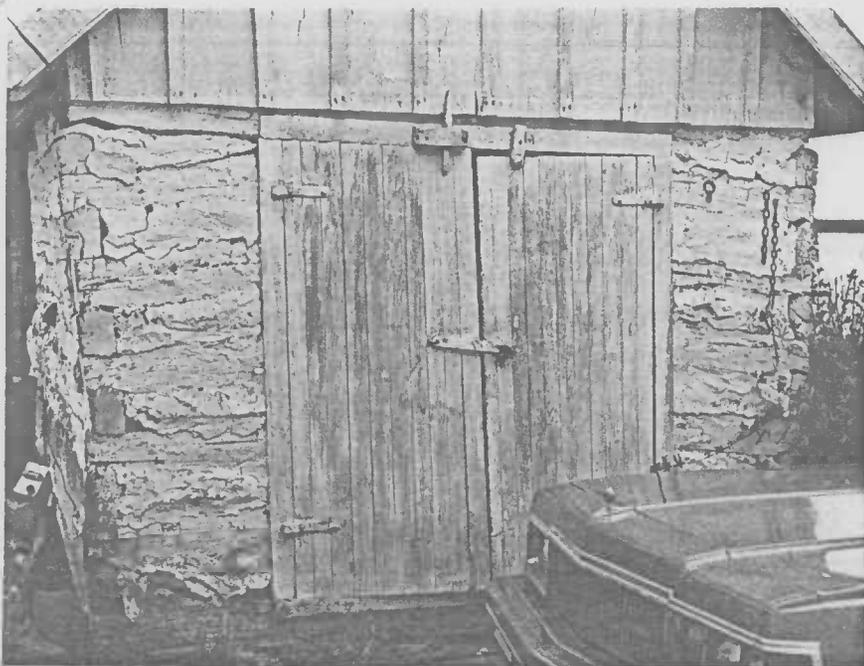
18

Detail of doorway and log construction.  
Meathouse. March 1981.

house must have been built at a later date. One small meat house stands behind the Victorian I house built by Basil Warfield in 1893. The meat house is built of V-notched log construction, as were the two tobacco houses, and stands on a fieldstone foundation. The gable roof is covered with tin and part of the facade is covered with "board and batten". It is possible that this meat house is the one mentioned in the resurvey of 1814. However, it is more likely that the meat house and tobacco house were built by Lloyd Etchison between 1854 and his death in 1878. (See photographs 15 - 18.)

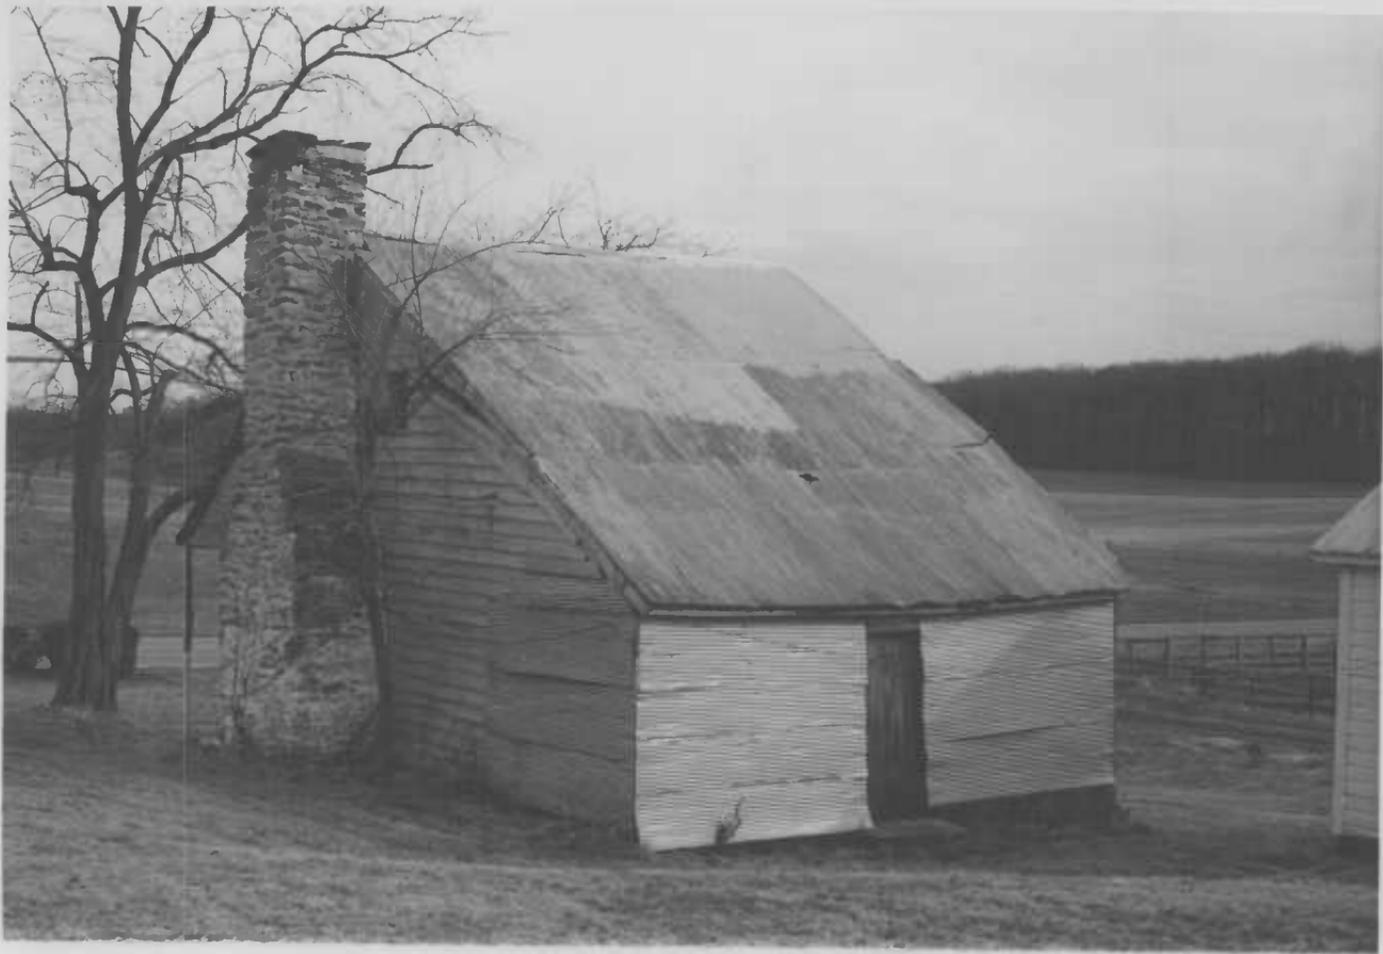
FACADE N - FRONT PORCH

An integral shed-roofed porch runs across the north facade; four thin poles presently supporting the porch roof replace large square posts evidenced in old photographs. The windows flanking the door are 4/4 double hung sash, the glazed panes of which are wider than high. The logs of the facade are lathed diagonally and plastered; a chair-rail and baseboard protect the plaster. At one time, the plaster may have extended to the plate, but at present the front wall above the height of the doorhead is shingled. On the north roof slope, are two dormers with triangular heads. The windows are 2/2 double hung sash.

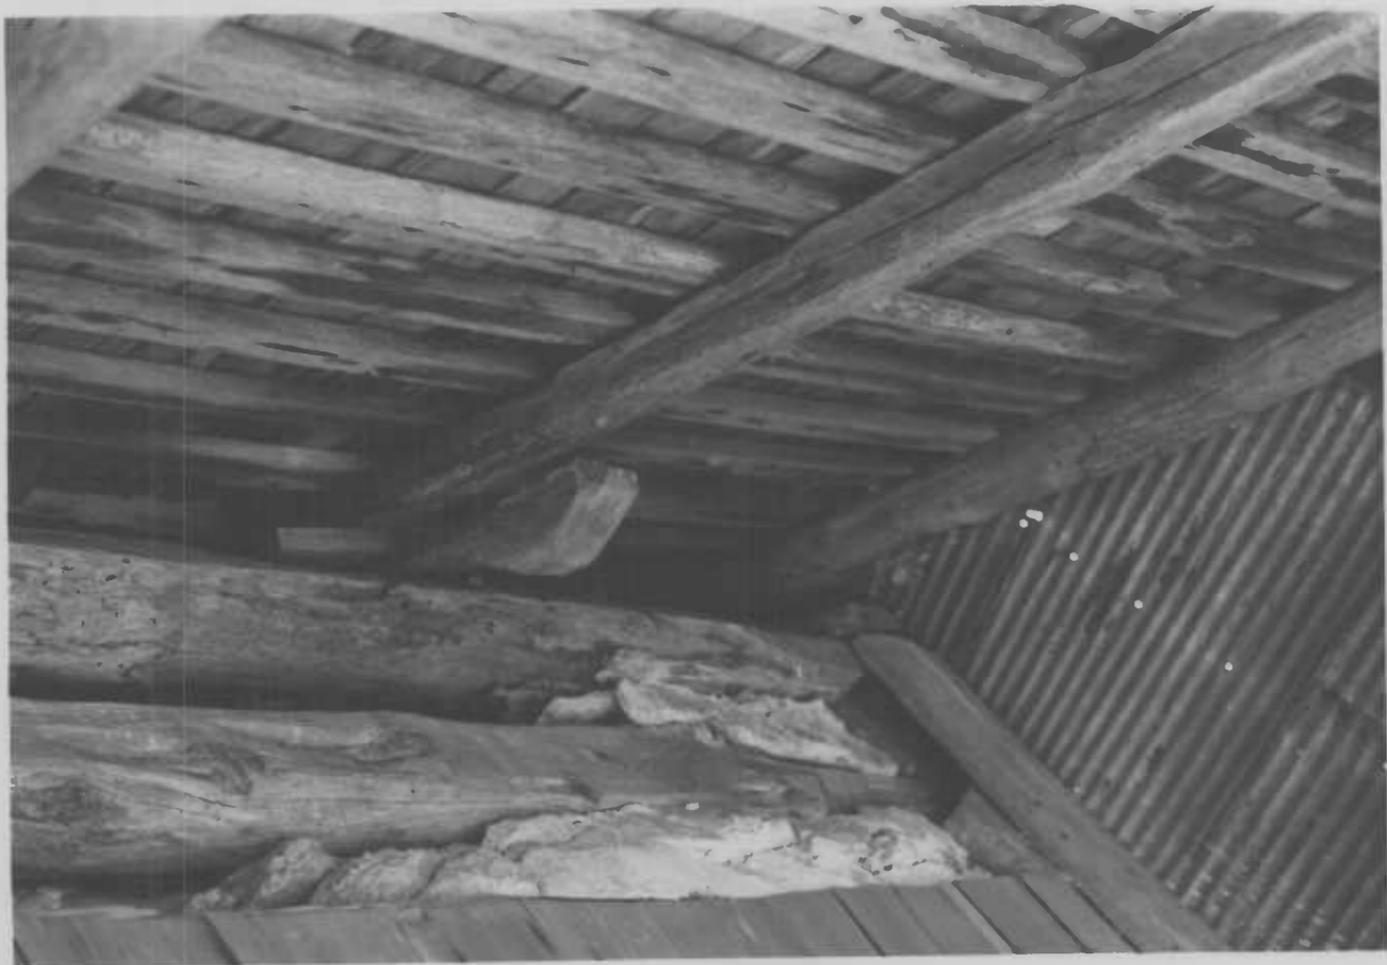
FACADE N - EAVES, FRONT PORCH

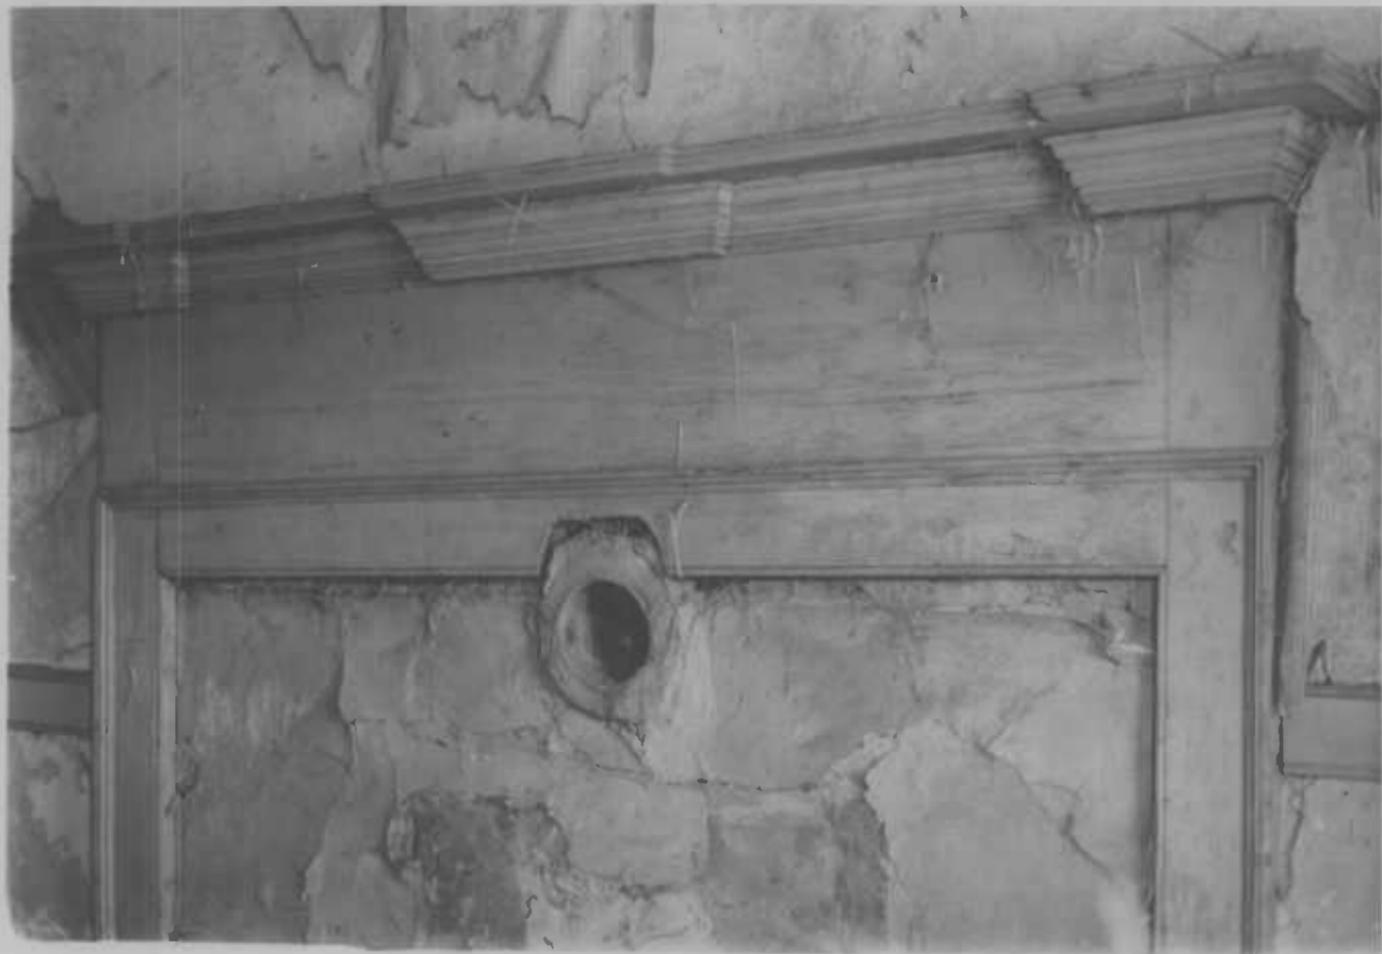
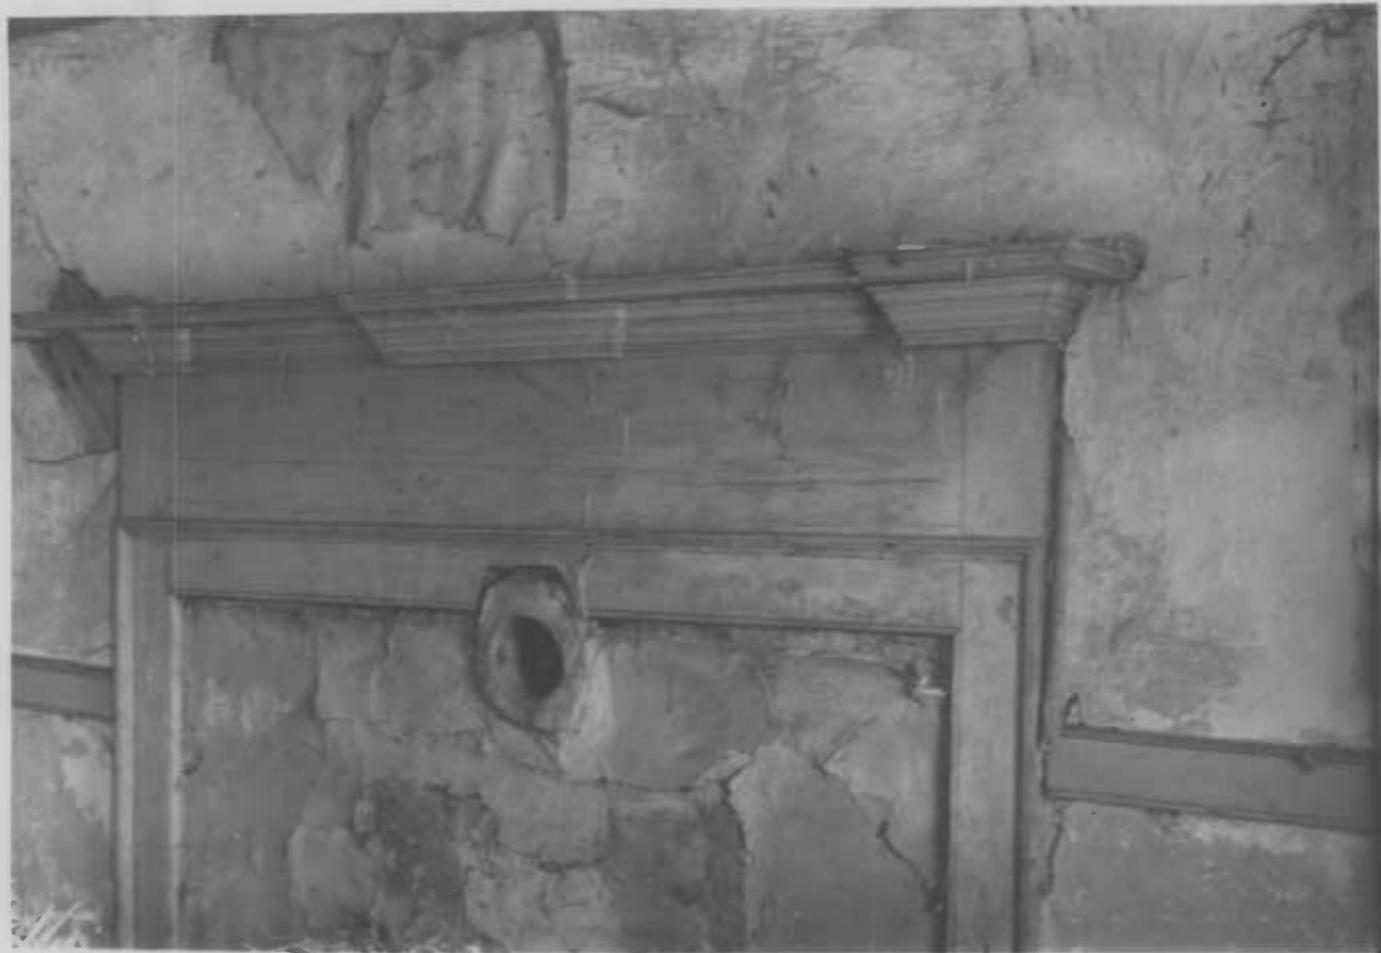
FACADE INT. - MANTEL IN W WALL
