M 15-30

Log Tobacco Barn

Montgomery Co.; MD

**Maryland Historical Trust  
State Historic Sites Inventory Form**

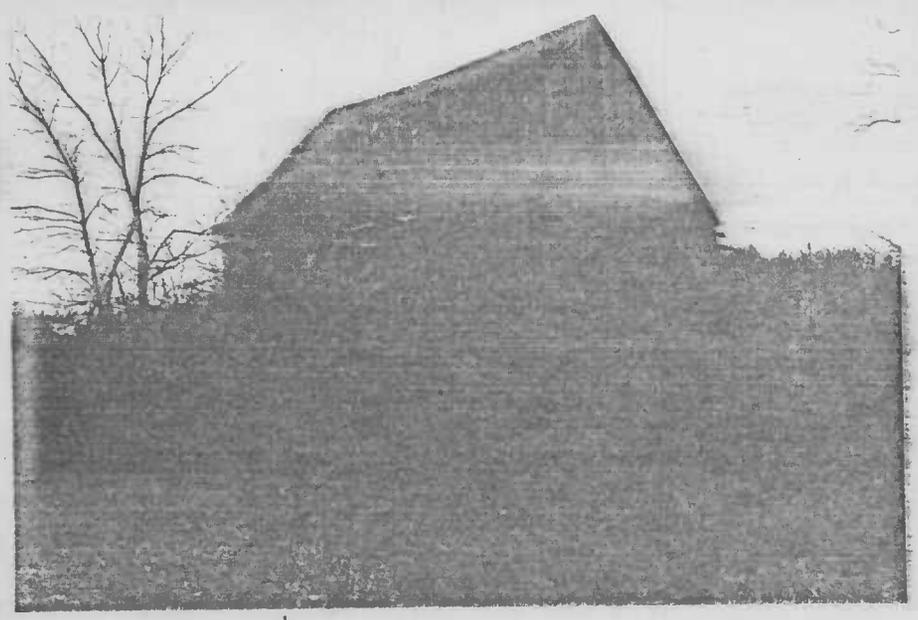
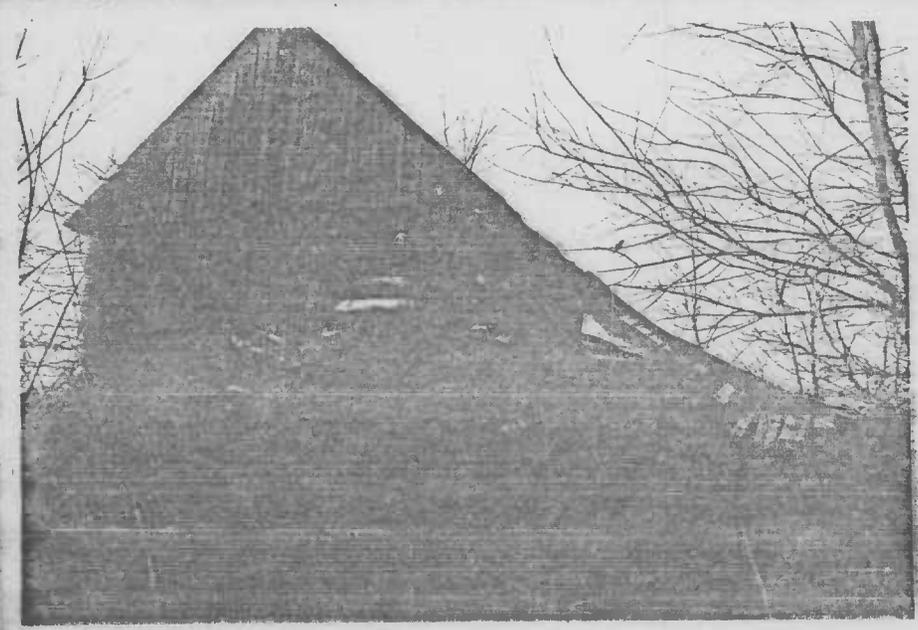
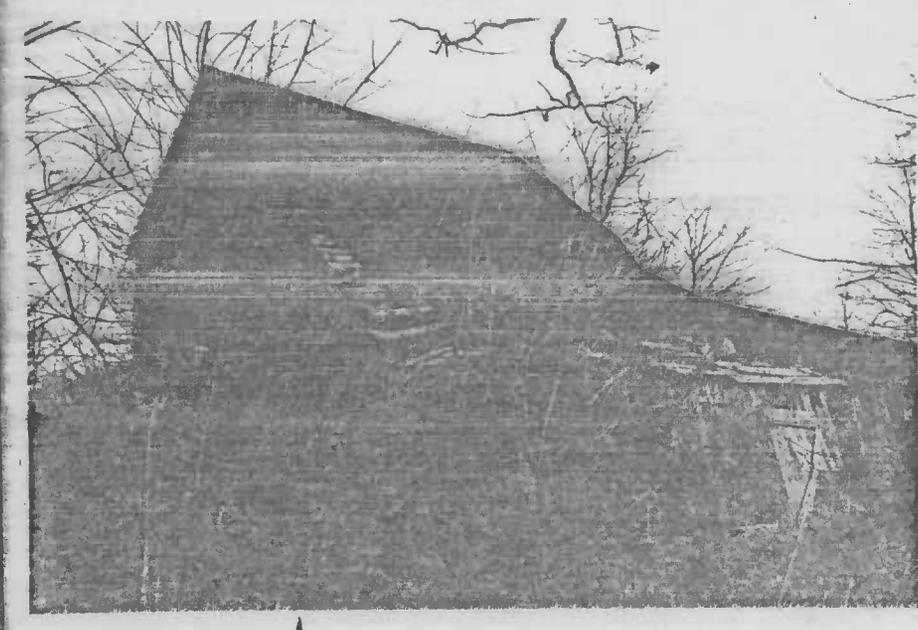
15-30 Log Barn M.15-30

The Log Barn is an eighteen-foot by twenty-four foot structure with a shed wing on its south side. The barn is constructed of logs hewn on two sides and  $\frac{V}{2}$ -notched at the corners. The log<sup>sills</sup> rest on stone piers. The structure has a gable roof covered in sheet metal. The tall height of the original structure gives the appearance of a log tobacco barn, although there are no interior framing systems for hanging the tobacco, <sup>remaining in the structure.</sup> The addition of the south side of the structure is framed in rounded logs with posts resting on the ground. It extends slightly longer than the barn on the east facade. It has a shed roof covered in sheet metal. It is covered in vertical board siding except for the west side which remains open. This section served as animal shelter and machinery storage area.

The log barn is a rectangular plan structure that rises two stories and has dimensions of eighteen by twenty-four feet. The logs are hewn on two sides and  $\frac{V}{2}$ -notched at the corners. There are ground level entrances on the north and south facades. The east and west gable ends have windows on the second story. The gables are covered in vertical boards siding. The gable roof is covered in sheet metal. The log sills rest on stone piers.

Top - North & West Facades  
Mid - West Facade  
Bot - West & South Facades

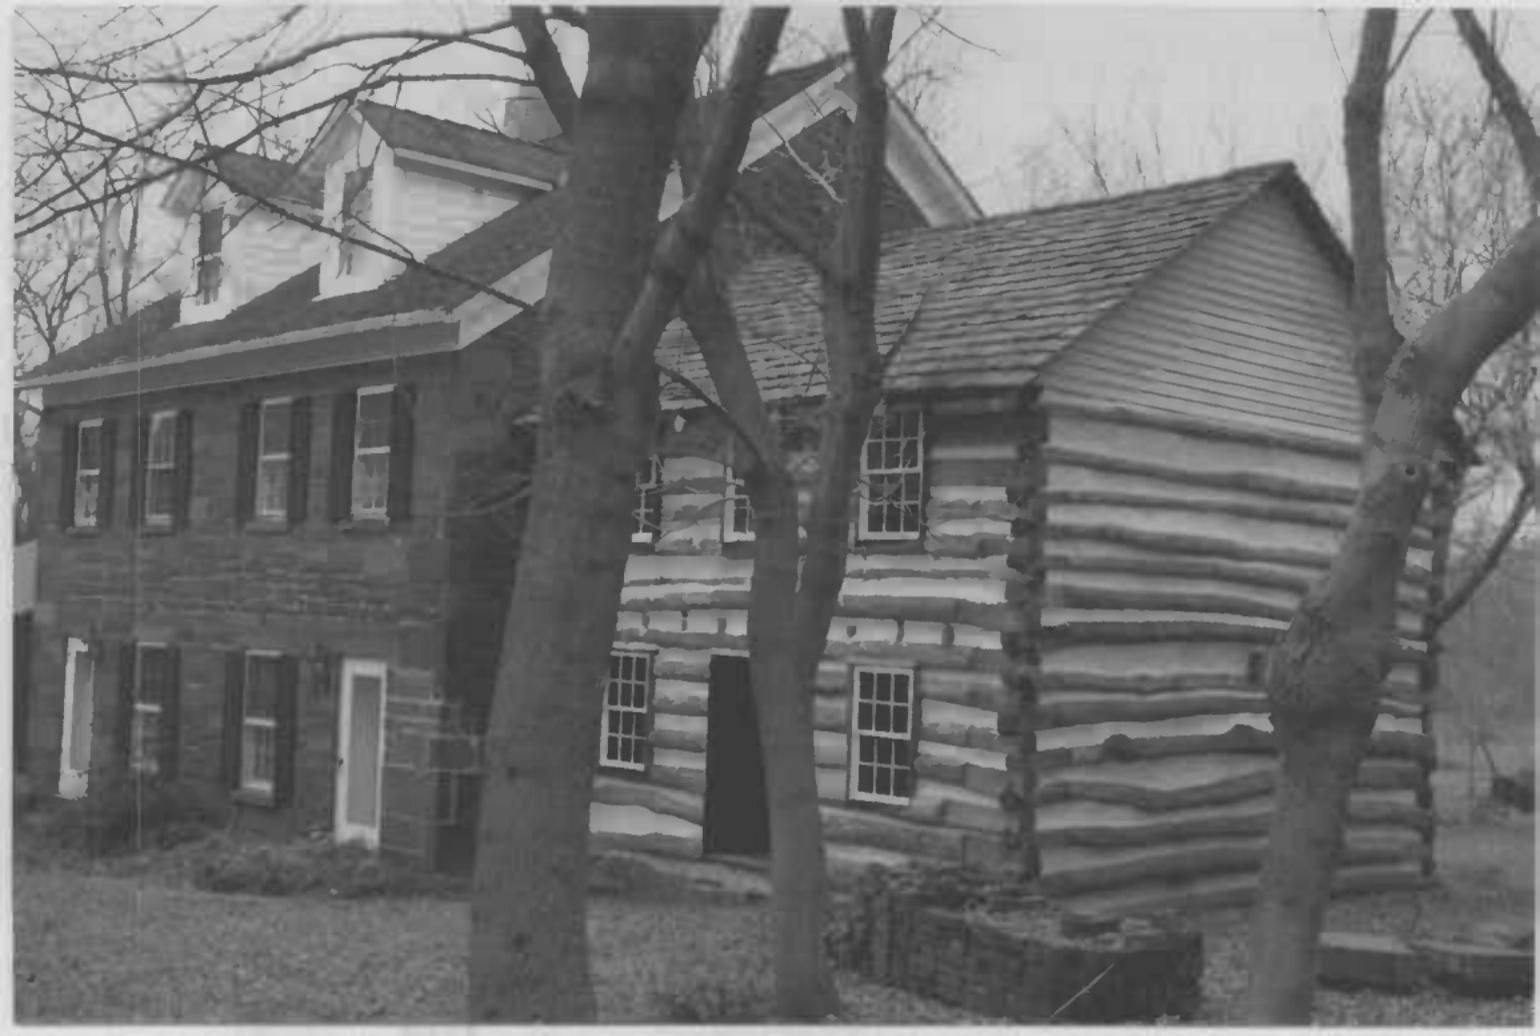
N.E. ELEVATION

This log tobacco barn has been moved from its original location on Halterman Road near Etchinson in Montgomery County, to the Quarry Masters House in Seneca Creek State Park in Montgomery County. The curator at the Quarry Masters House, Bob Albiol, dismantled the barn and reconstructed it directly next to the house. At the original site the logs were in danger of deteriorating due to the loss of the roof on the structure, however with its new location the barn has a new roof and will be protected from the elements.

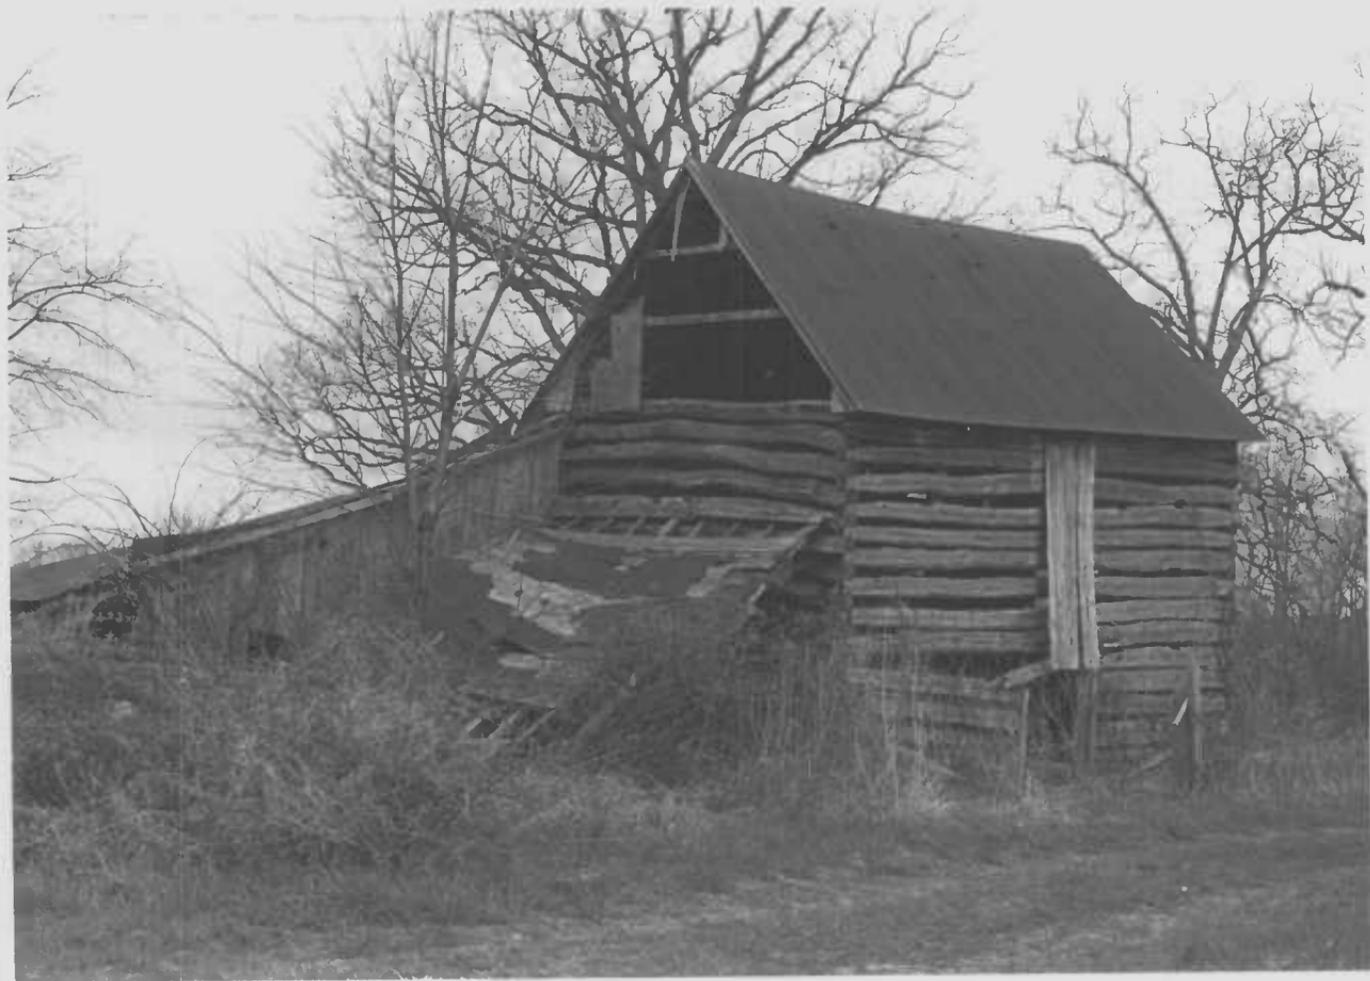
M 15-30; DNR-87

TobaccoBarn  
end of Madcap (Halterman) Road  
off Hipsley Mill Road  
Patuxent State Park  
Damascus, MD

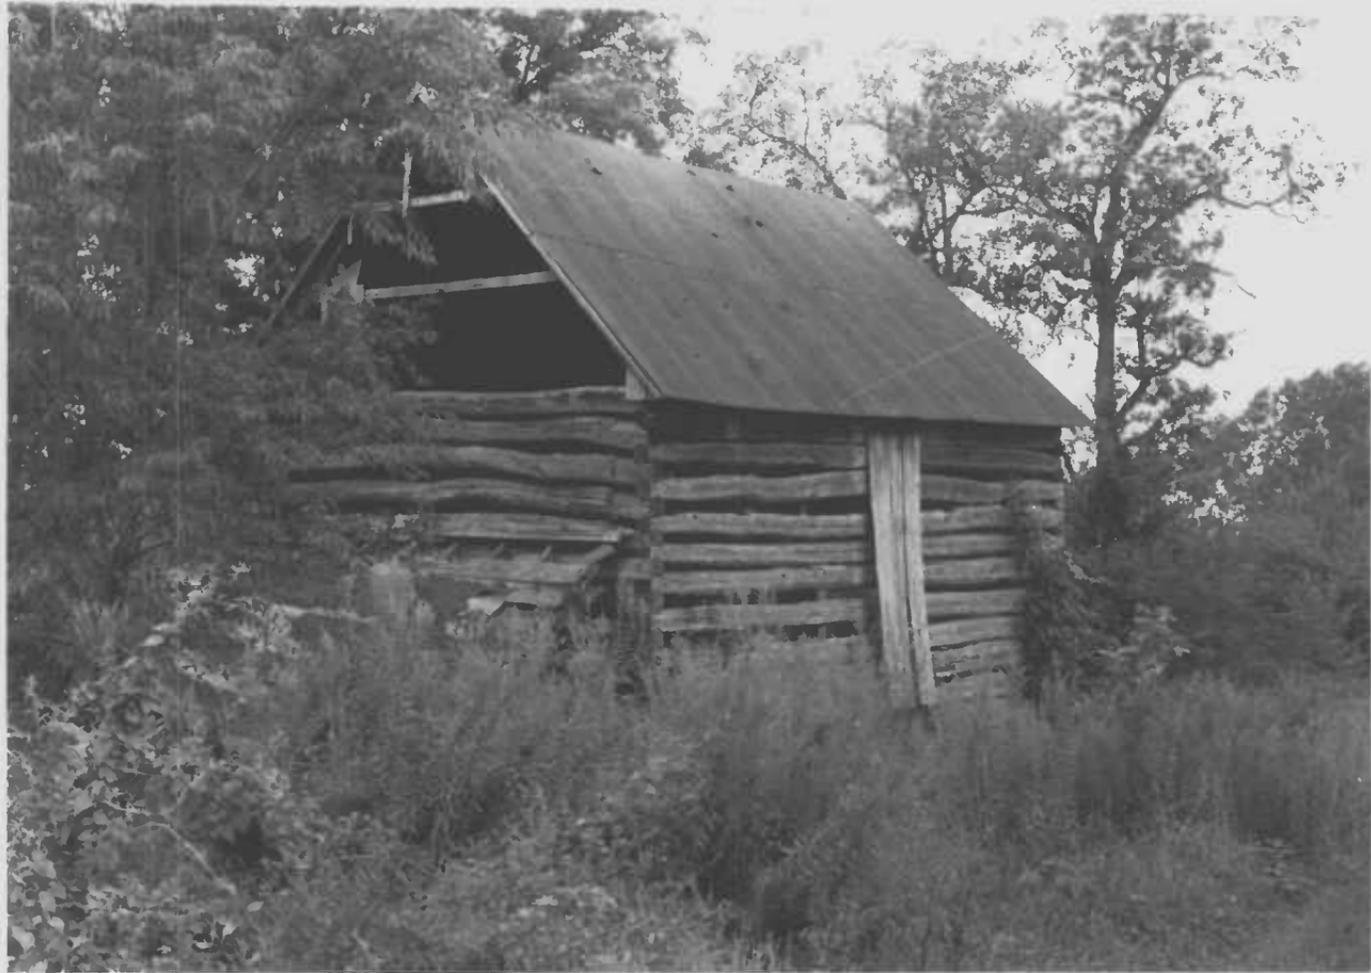
M15-30; DNR-87

TOBACCO BARN  
END OF MADCAP (HALTERMAN) ROAD  
OFF HIPSLEY MILL ROAD  
PATUXENT RIVER STATE PARK  
DAMASCUS MD
