Martha Carter Log House
Boyds
Private

c.1890

INVENTORY FORM FOR STATE HISTORIC SITES SURVEY

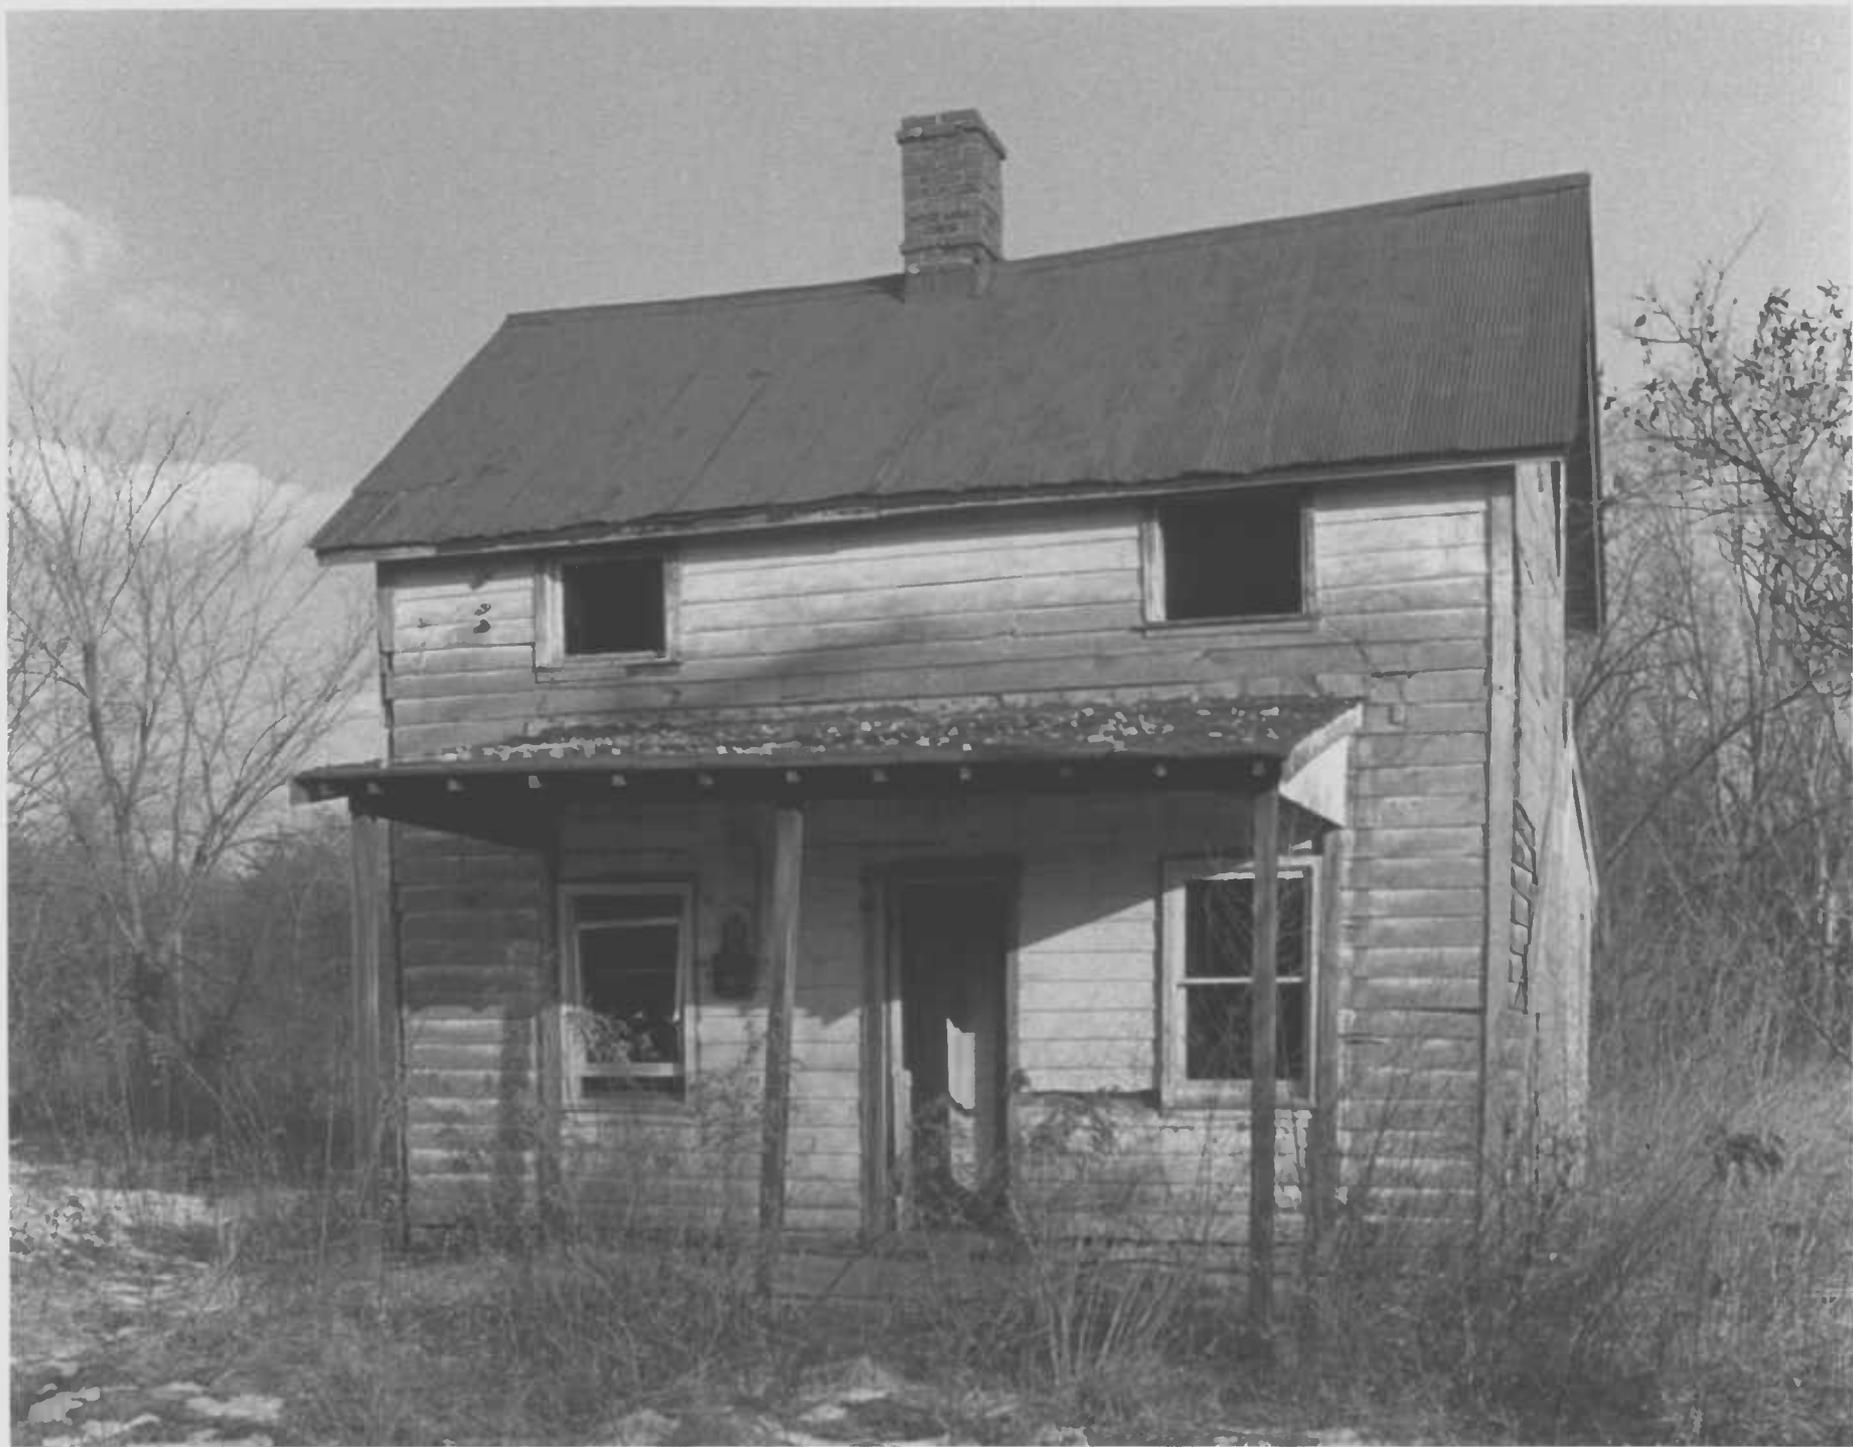
CARTER Log House
M: 18-11-2
Facade - south

This one and a half story log dwelling stands on the north side of Hoyles Mill Road. It is abandoned and is rapidly deteriorating. The logs of the house were sheathed in the 1930s with weatherboards, according to Mrs. Edna Duffin Johnson, who was born in the White Grounds community in 1891. During her youth, the logs were exposed and whitewashed as were all the homes of Black families in the community. In addition to the weatherboards, a shed porch was added to the front of the house and trims around the windows. In recent years, a cinderblock kitchen was added to the back of the house replacing the earlier frame shed kitchen that had been there during the time that Mrs. Mary Naylor lived here in the 1930s.

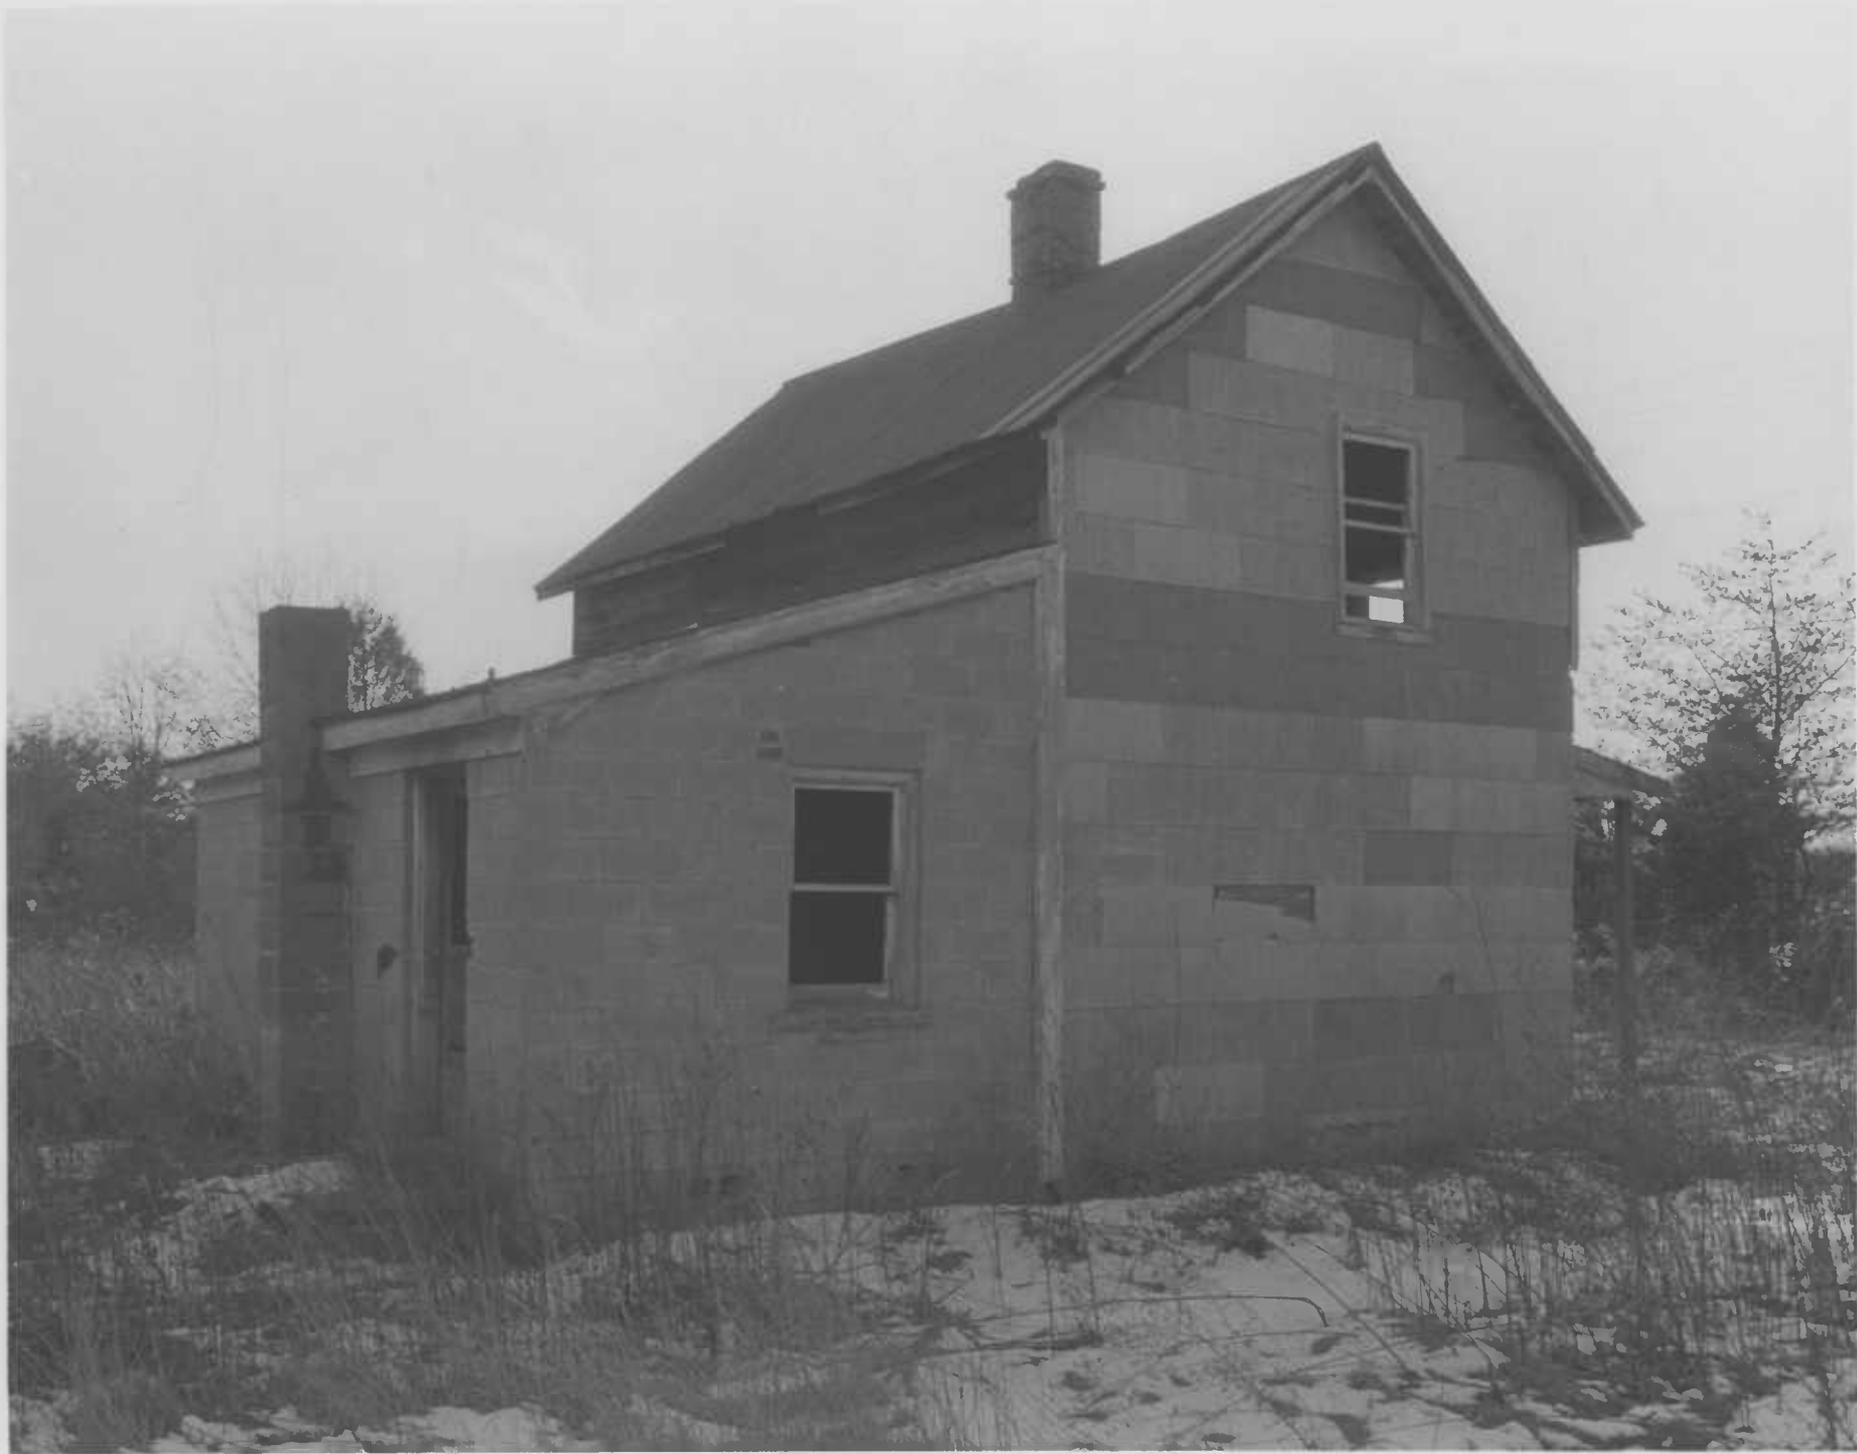
Carter Log House
M: 18-11-12

Abandoned house of basic log construction.

Side and rear view. Looking SSW.

N.W. Elevation

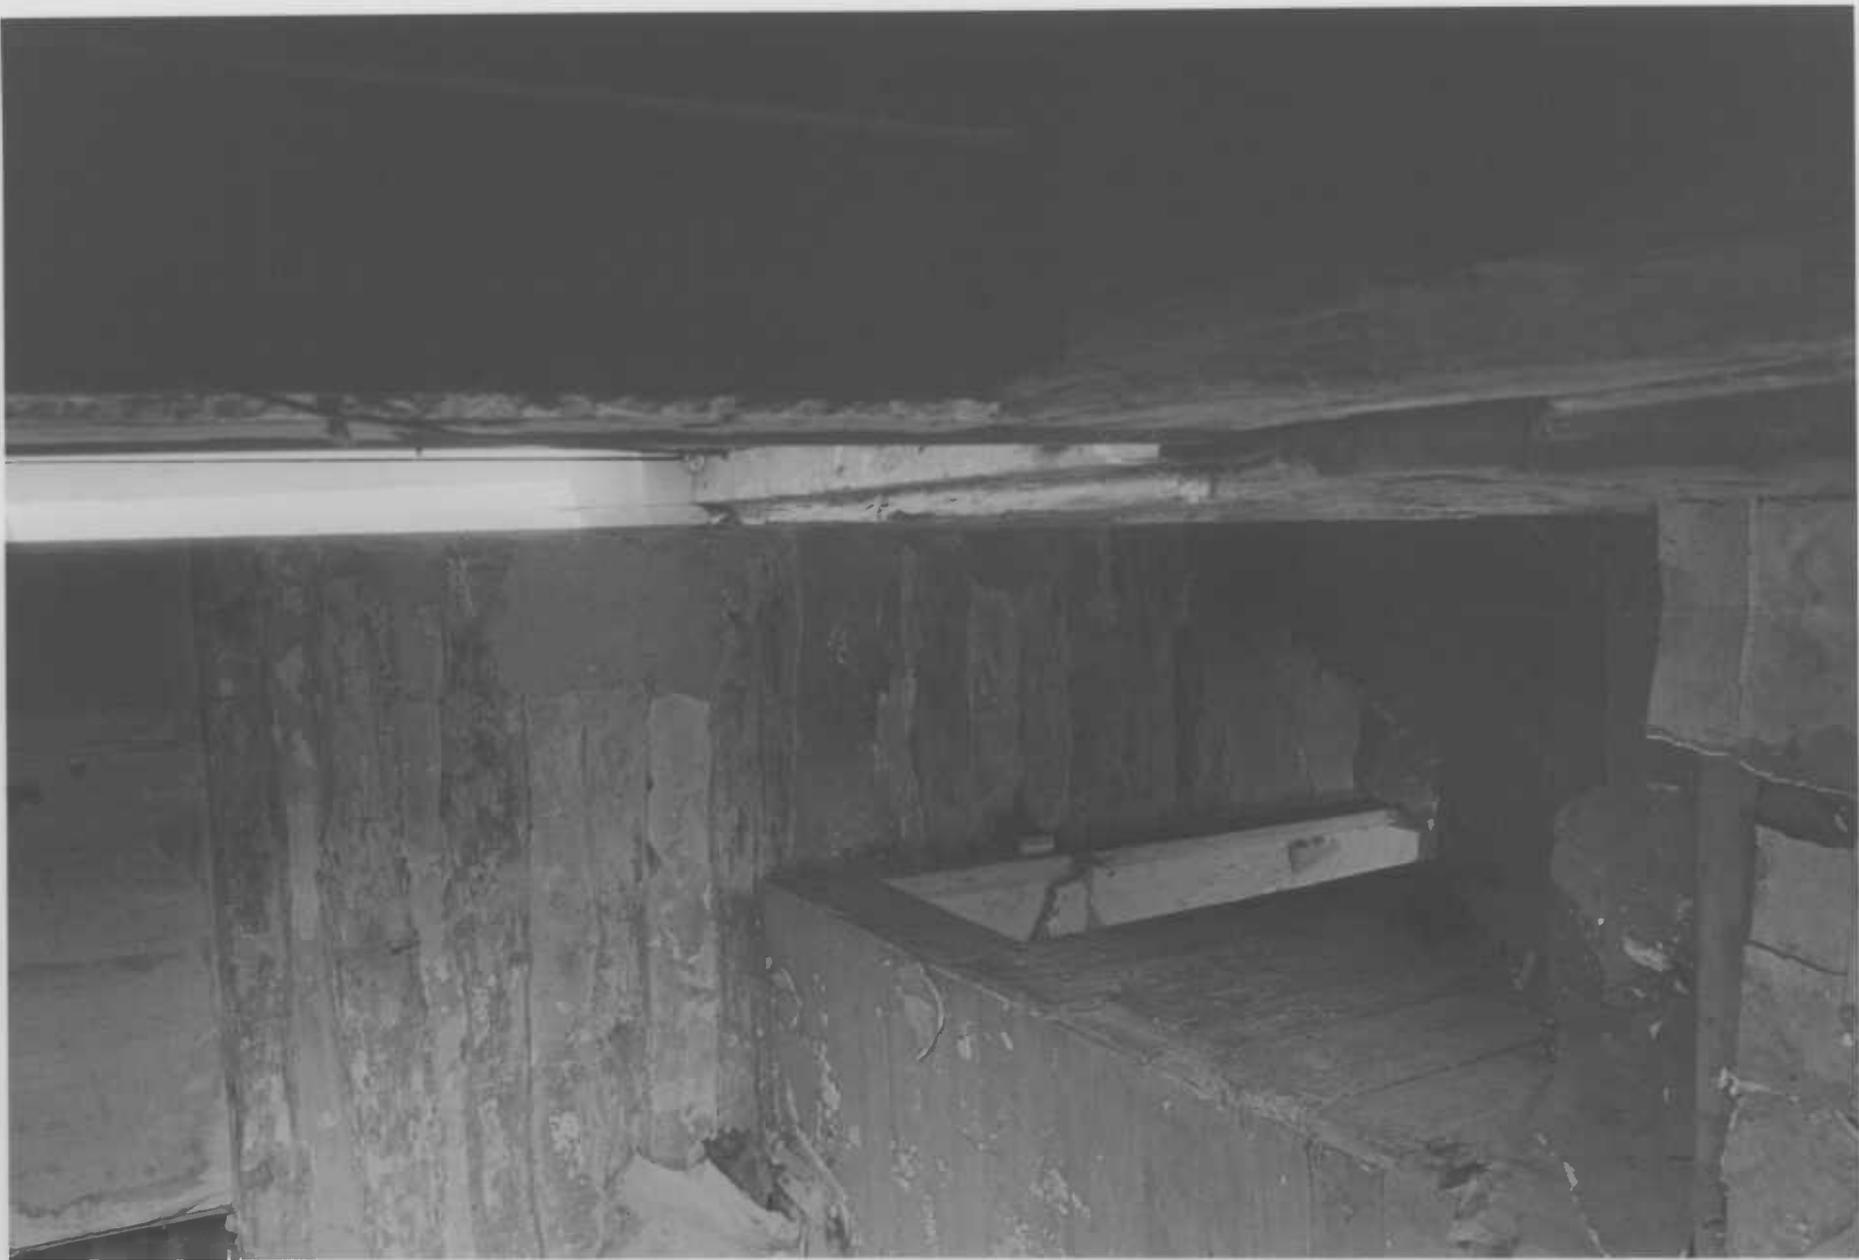
CARTER Log House
M: 18-11-2

The plan of the house consists of two rooms down and two rooms up. In the front room a boxed stairway ascends along the eastern gable end to the rooms upstairs. Underneath the stairway was a small closet, a typical arrangement in small houses of this type. In the back length, in the southern portion, is a window opening indicating that this part of the back length did not have a room attached to it. In the western part of the back length, there is a back door leading into the current cinderblock kitchen, which in earlier years had been a one room frame kitchen. The joists are exposed but, instead of hewed logs, are 2" by 6" sawn lumber. Separating the two rooms is a thin partition of tongue and groove siding and a brick stove flue with openings on either side for stove pipes. The flooring consists of narrow tongue and groove floorboards typical of the late 19th century. The floorboards for the upstairs are somewhat wider (about 5") but nowhere are there the wide floorboards typical of early 19th century log cabins.

Interior showing log construction.
Stairwell viewed from upper left room.
Looking E.

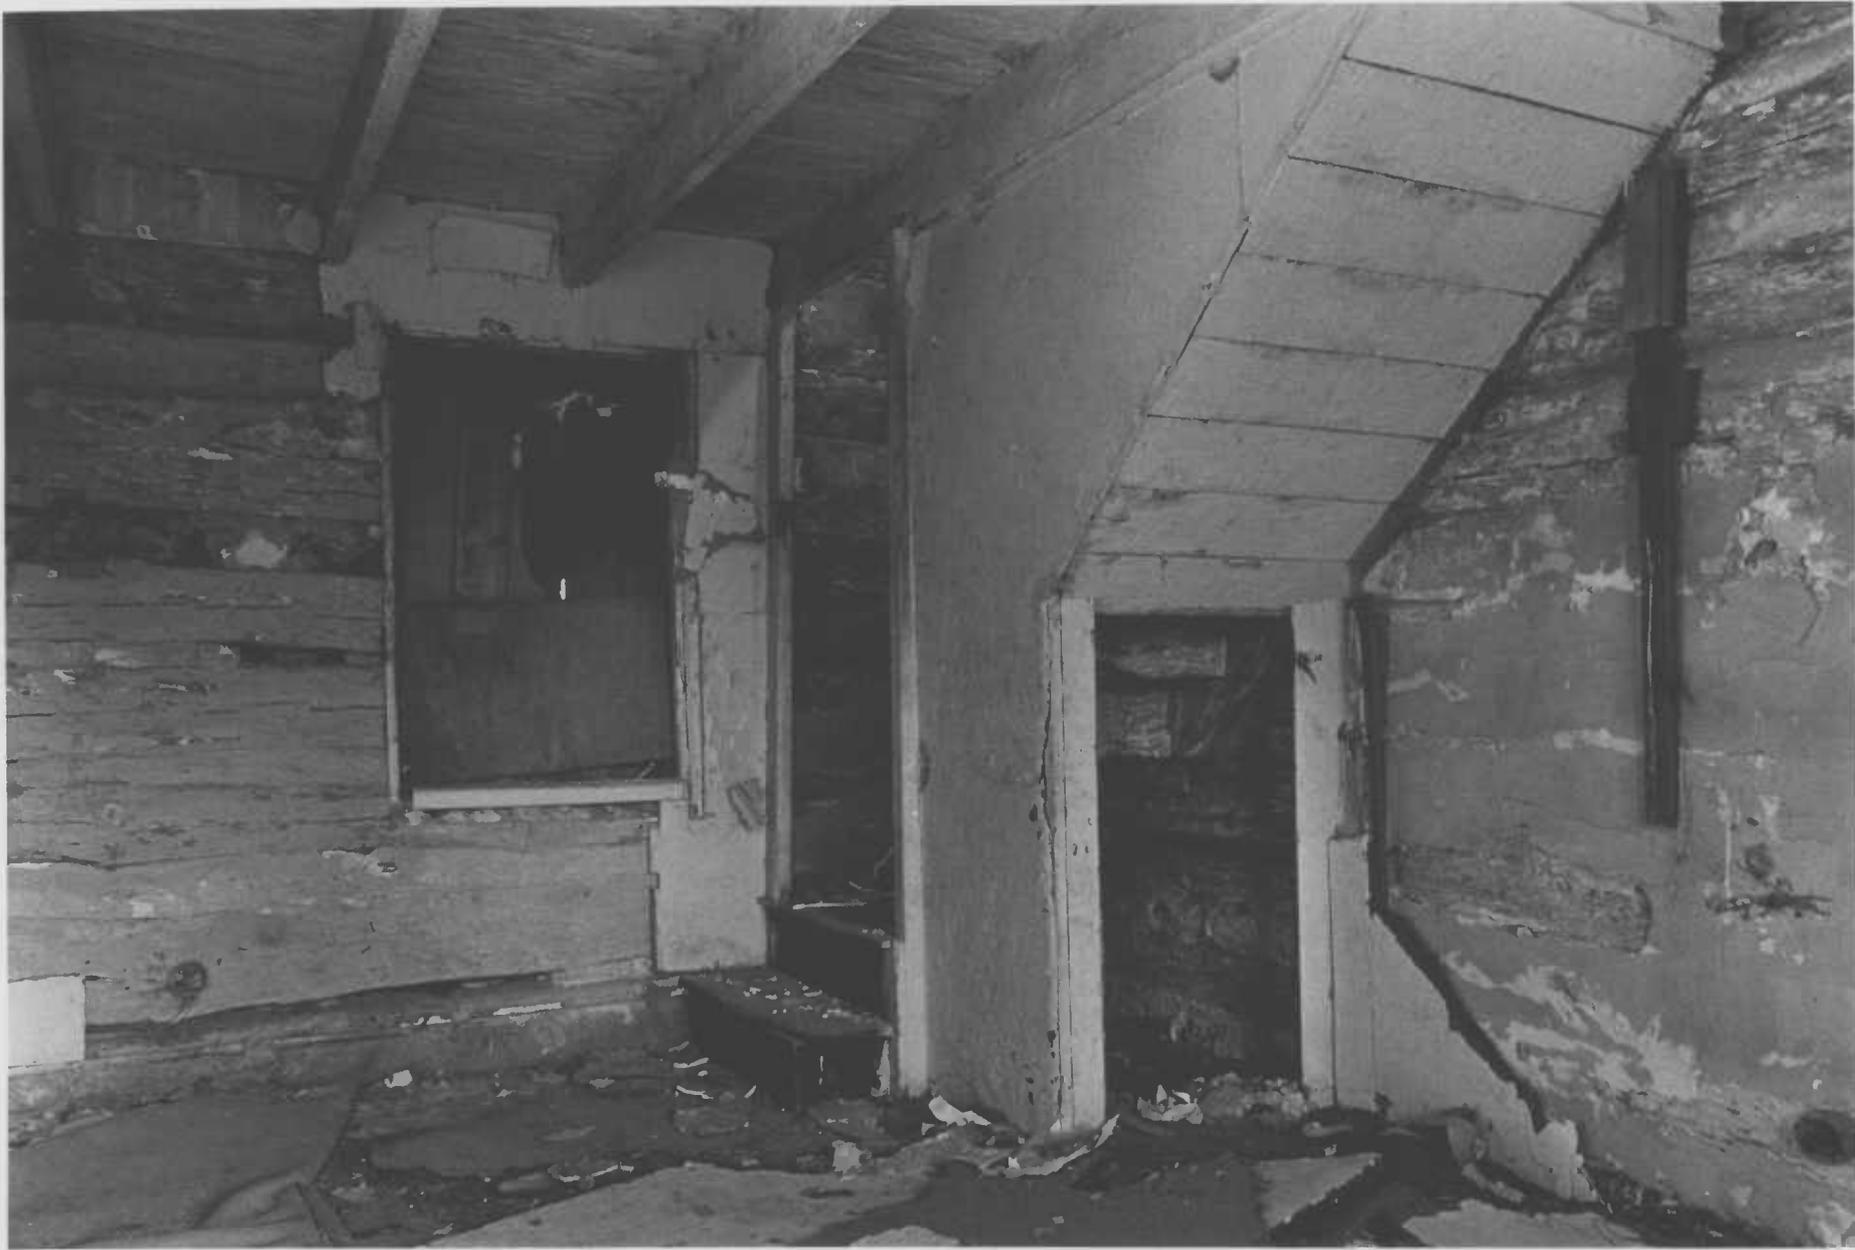
CARTER Log house

Downstairs stairway

Interior showing log construction-
lower left room. Looking SE.

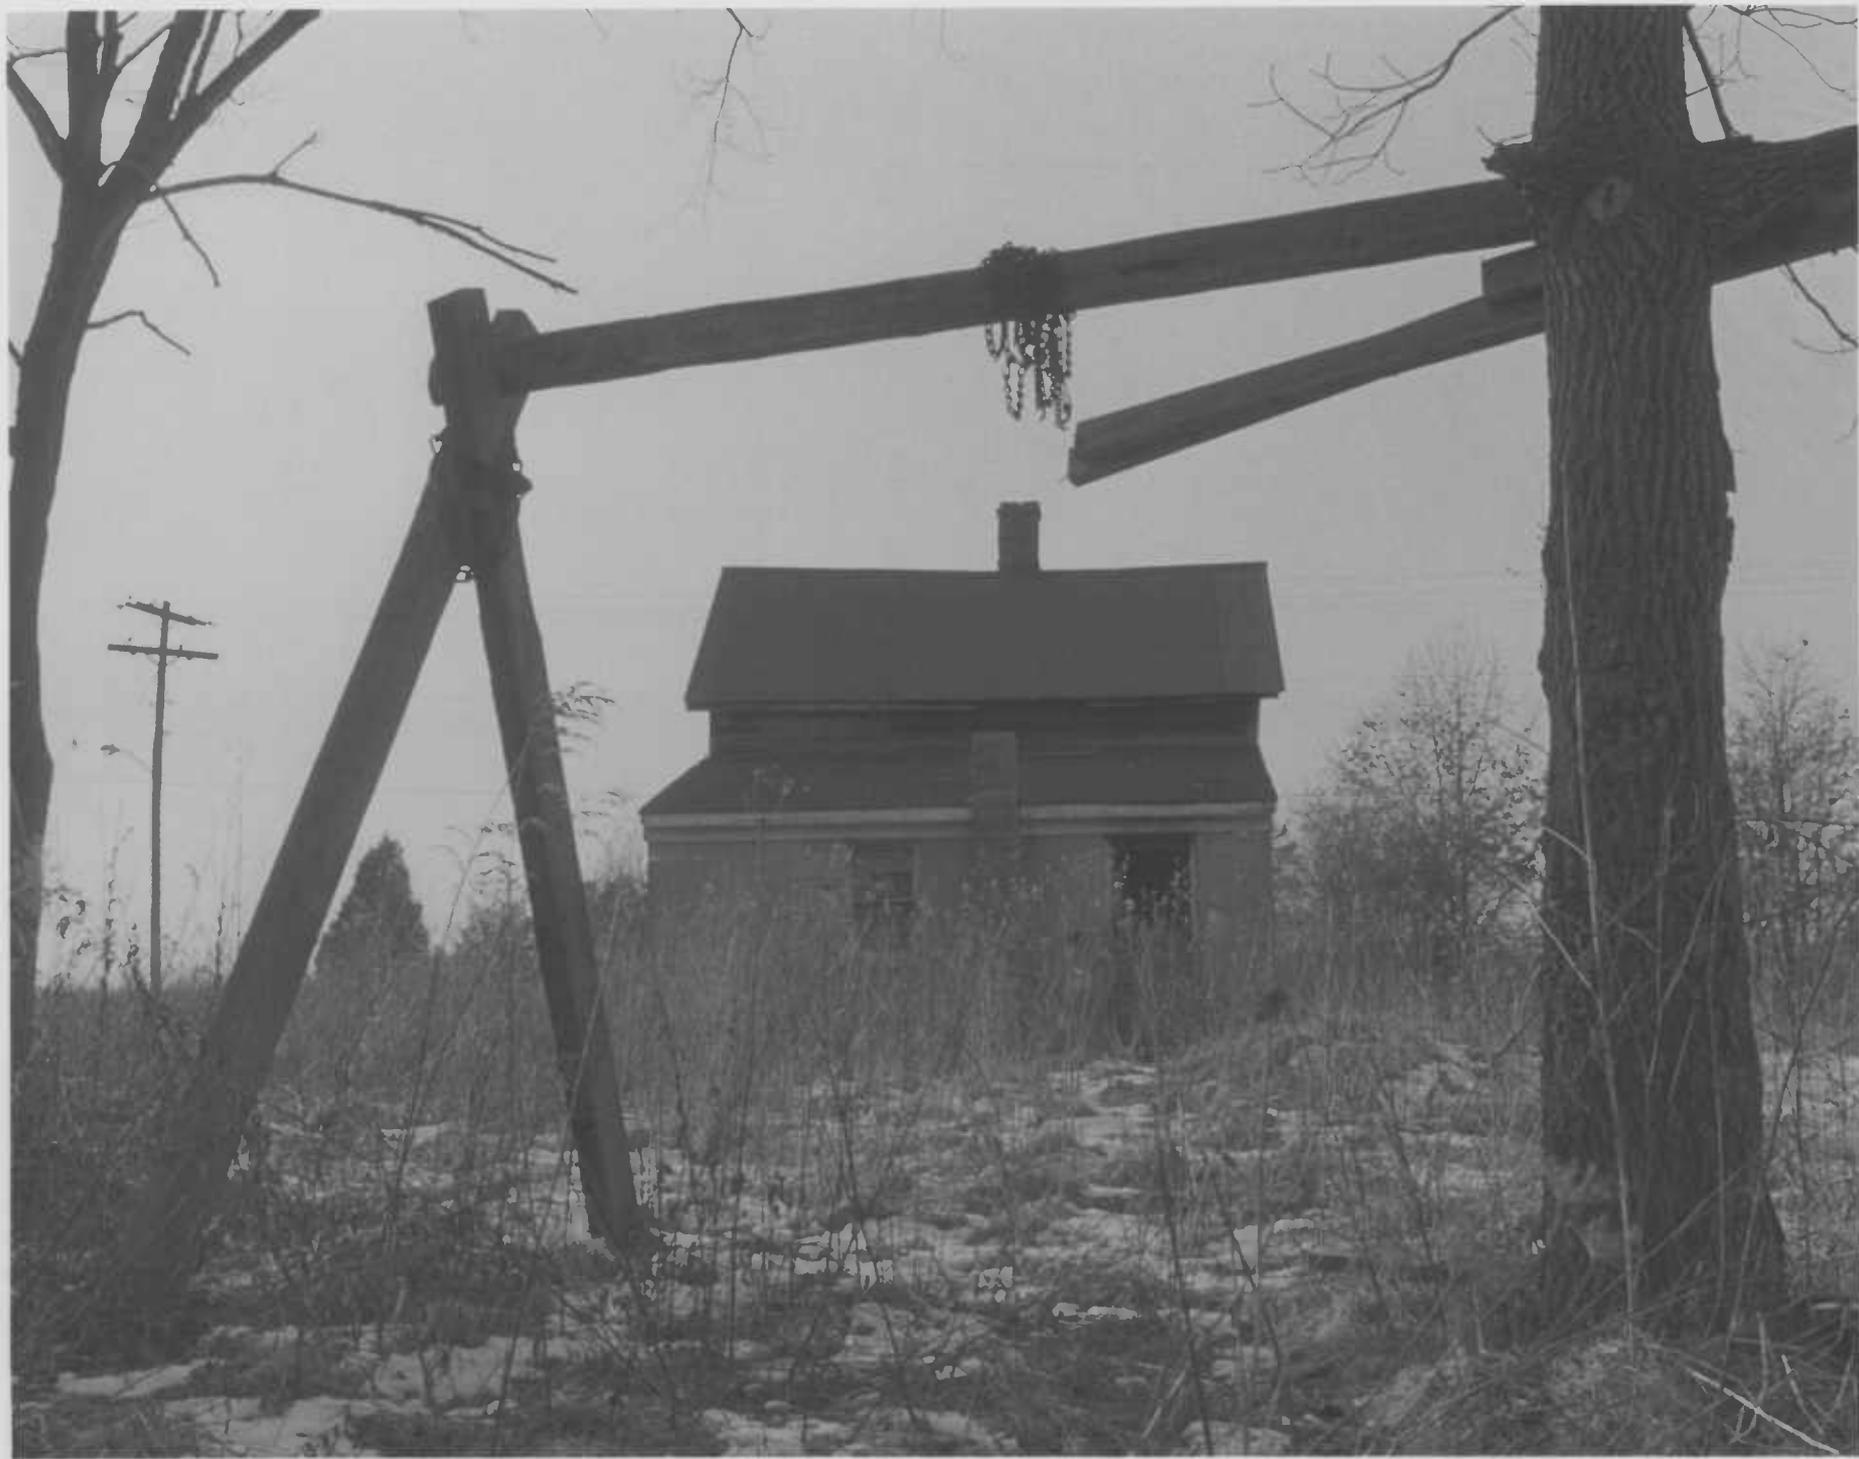
Carter Log House

North Elevation: Rear
Length

Rear view through rack - use not known.

Possible uses of rack: Car repair
Hog butchering

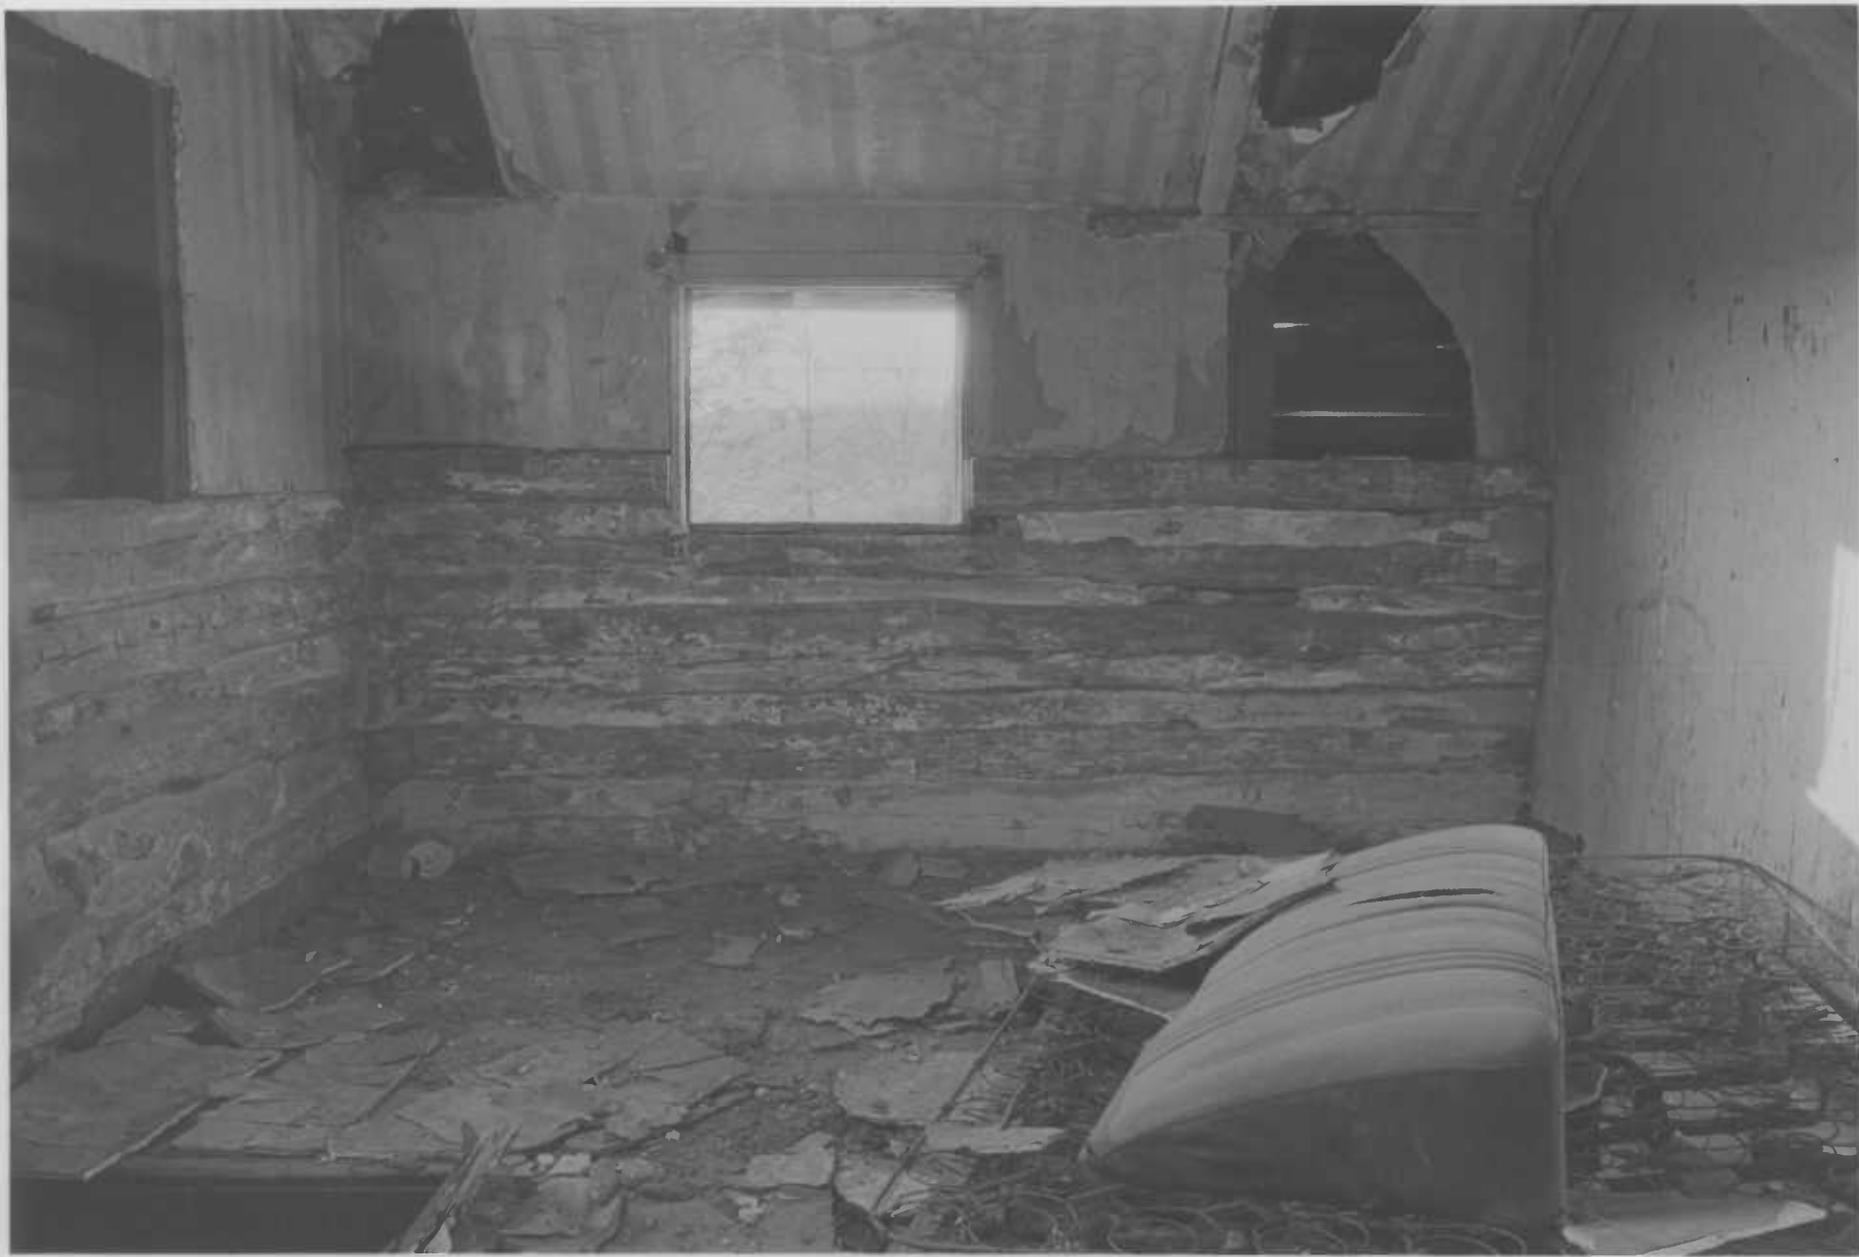
CARTER Log house
N: 18-11-2
Upstairs Room

In the upstairs of the house the logs are exposed in both rooms. The rooms are divided in a similar fashion as the rooms downstairs. Some studs in the frame of the roof truss are sawn, while some are 4 by 4 and yet others are 2 by 4s. They are attached by wire nails. The window frames are attached to the ends of the log by wire nails also. At the peak of the roof, the rafters are joined by wire nails which have been toed into place. There is no evidence of traditional framing such as mortice and tenon joints in any of the roof truss. The wire nails indicate that the roof was built after the 1880s.

Interior showing log construction -
left upstairs room. Looking W.

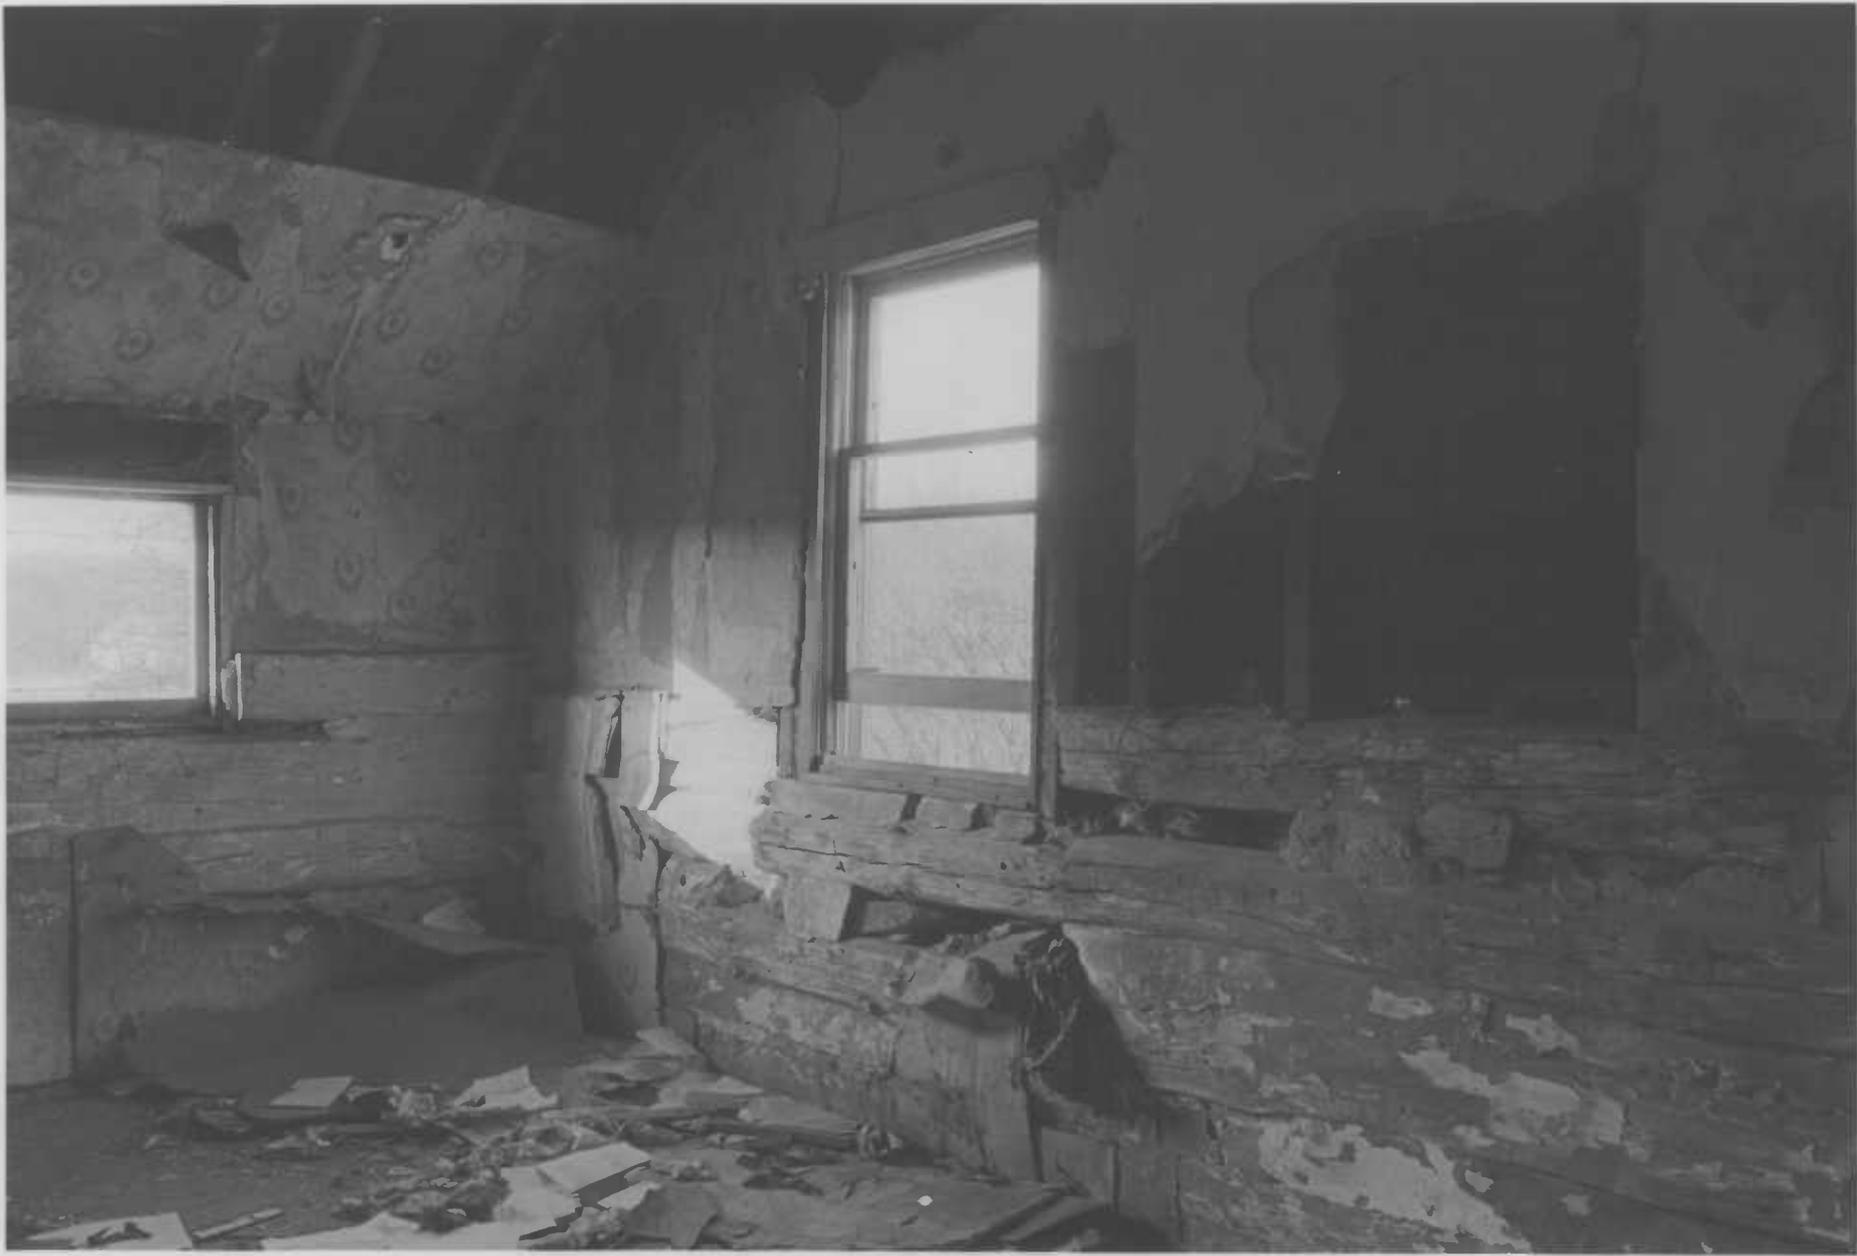
Carter Log House

Interior: Upstairs, showing log construction by window.

Interior showing log construction -
right upstairs room. Looking NW.
