INDIVIDUAL PROPERTY/DISTRICT
MARYLAND HISTORICAL TRUST
INTERNAL NR-ELIGIBILITY REVIEW FORM

Property/District Name: Leaman Farm, 13820 Clapper Rd Survey Number: 19/17 + 19/17-1
Boyd's, MD - Montgomery Co.
Project: MD 117 from MD 121 to MD 124 Agency: FSHA

Maryland Historical Trust State Historic Sites Inventory Form

and/or common John Leaman Farm

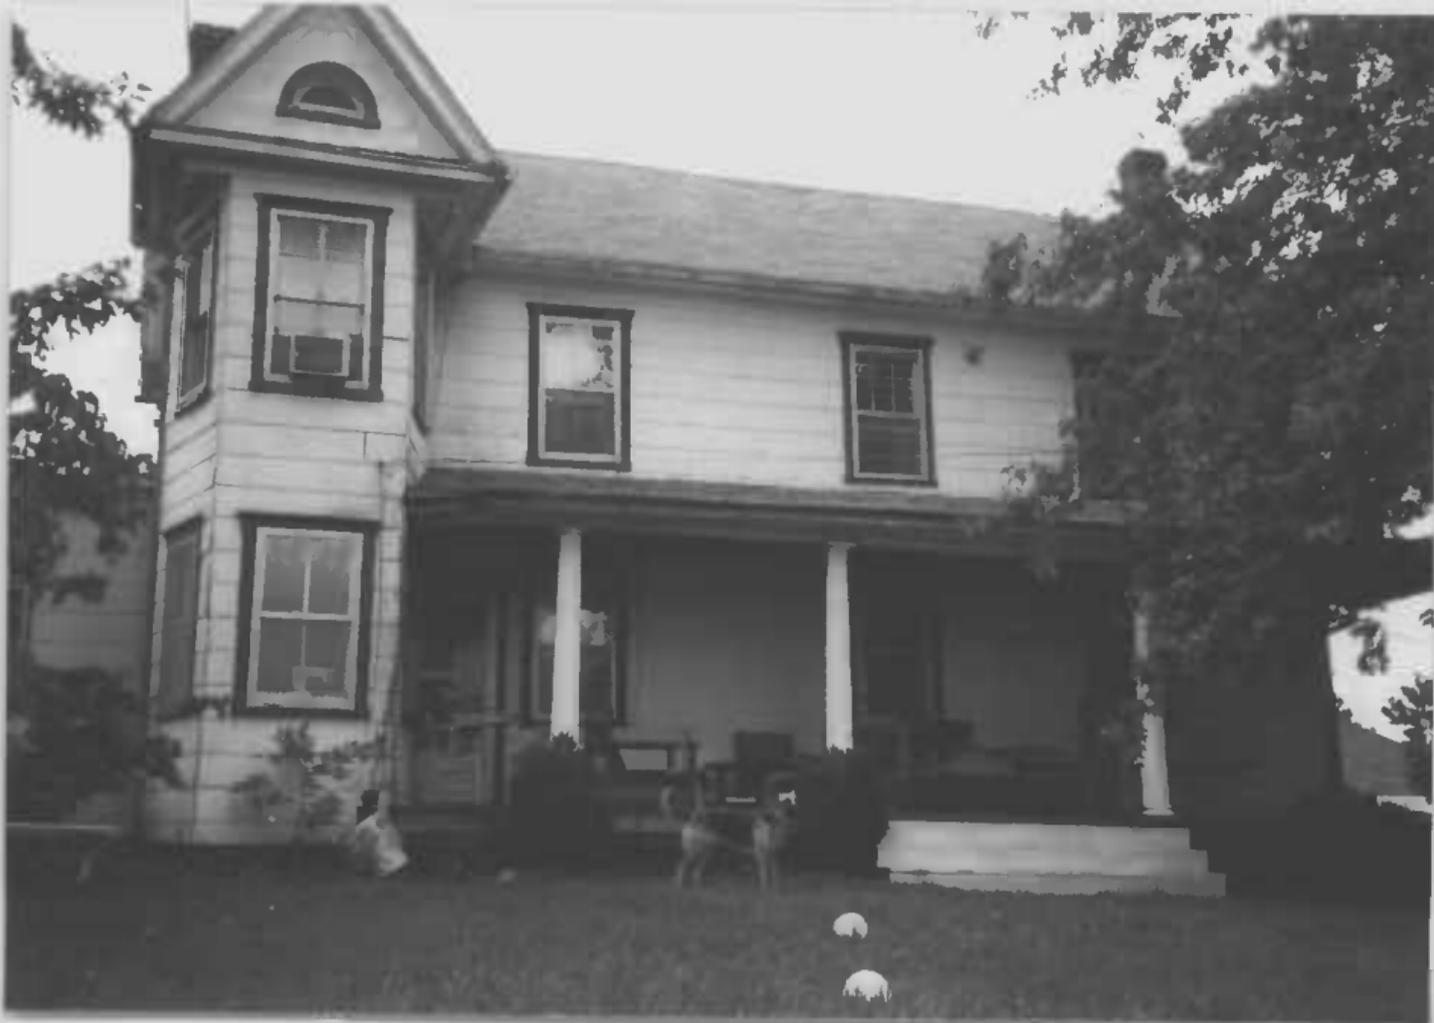
OLD GERMANTOWN #19/17/1

LEAMAN FARM

W

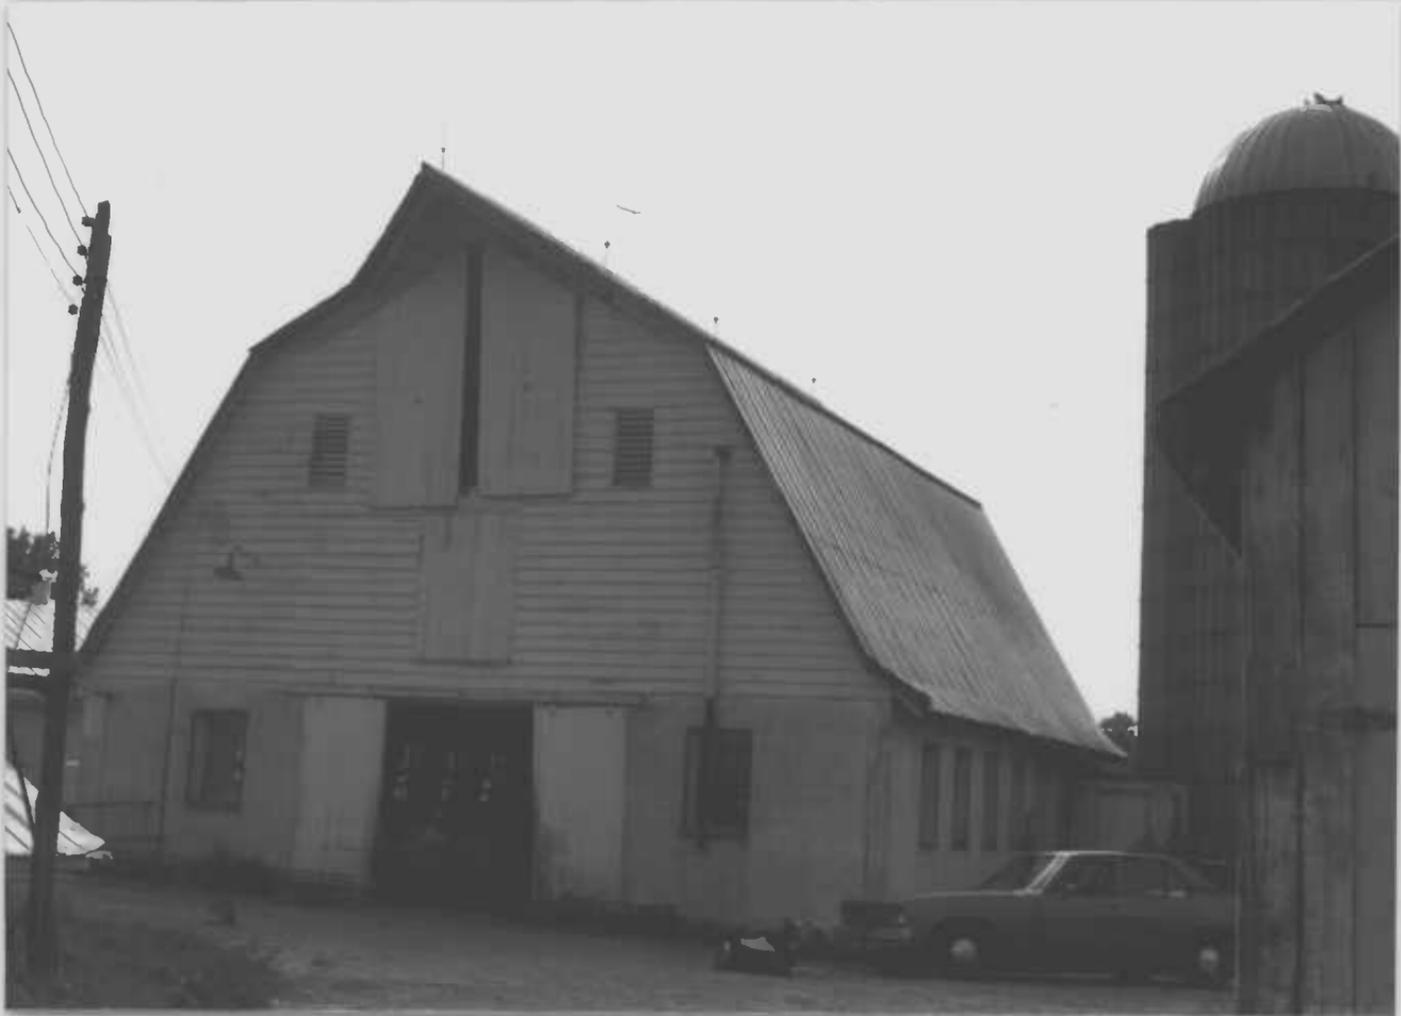
M:19-17-1

The Leaman farm is a functioning dairy farm with a relatively new dairy barn and several earlier outbuildings. Built in 1944, this concrete block, gambrel roof barn resembles the barns of the 1930's in its form. Concrete block walls enclose the first level, with weatherboarding covering the gables above. On the southeast (front) elevation, double doors slide horizontally on a track to close the main opening into the central driveway. On either side is a wood-framed window with a 12-light sash that tilts inward to rest on triangular side pieces mounted on the inside jambs of the windows. Above the center doors is a single, hinged door giving access to the hayloft. Above this is a pair of large, vertical board doors that ride up diagonally to close the opening to the hayloft. Small rectangular louvered openings flank this upper doorway. The gambrel roof is extended to form a triangular peak over the top doorway. Four lightning arresters are mounted on the ridge of the metal-covered roof. The northwest (rear) elevation is similar to the southeast, except that in place of the large upper opening there is a third small, rectangular, louvered opening.

South elevation

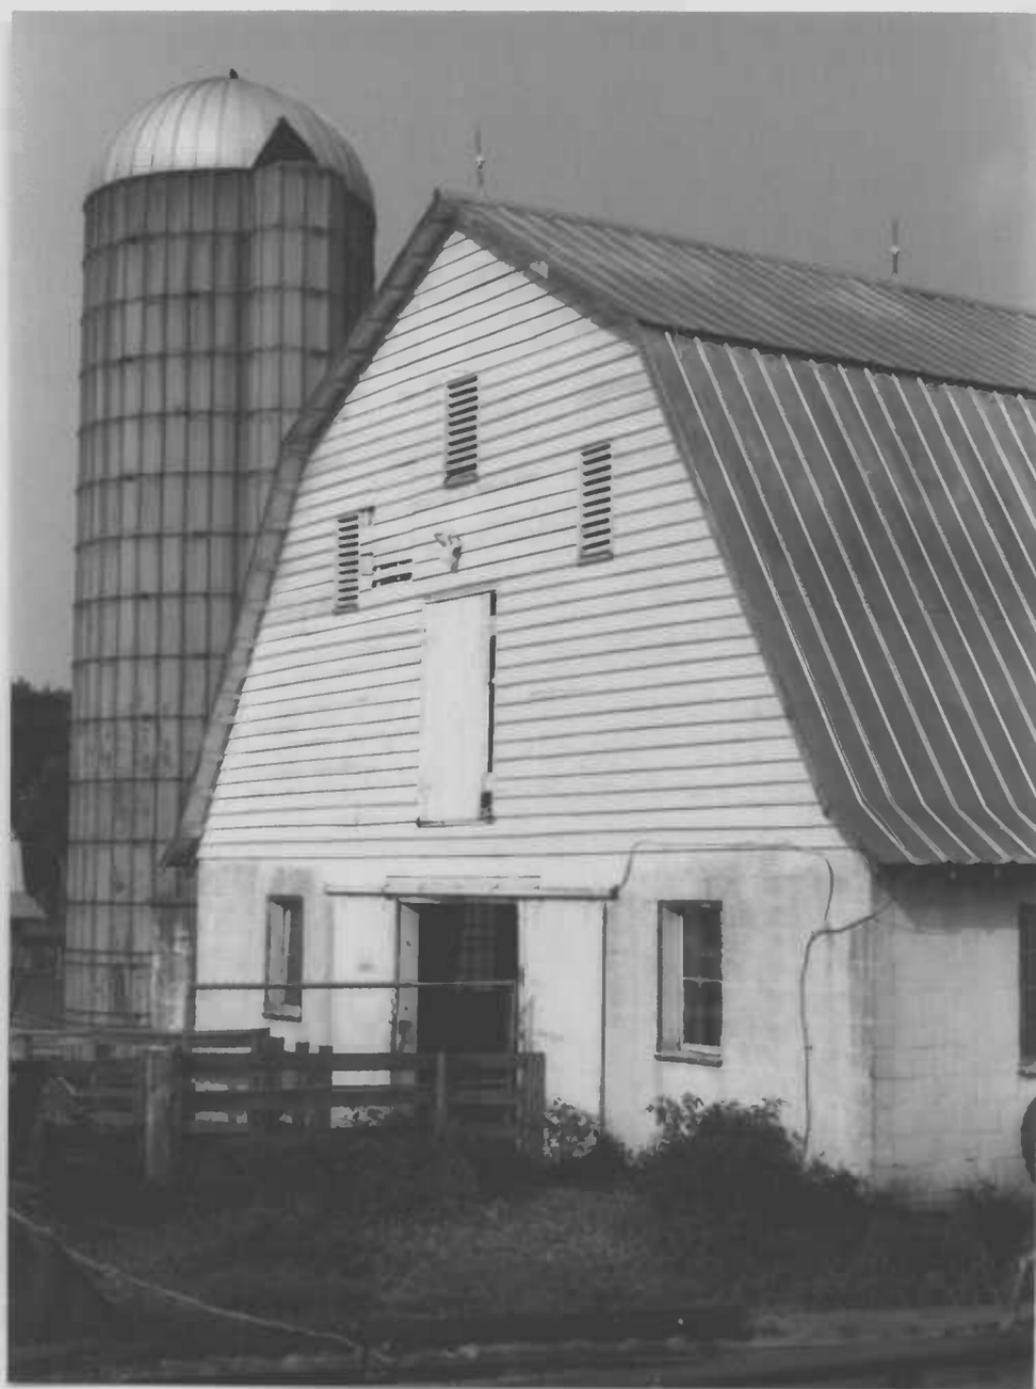
M: 19-17-1

North elevation

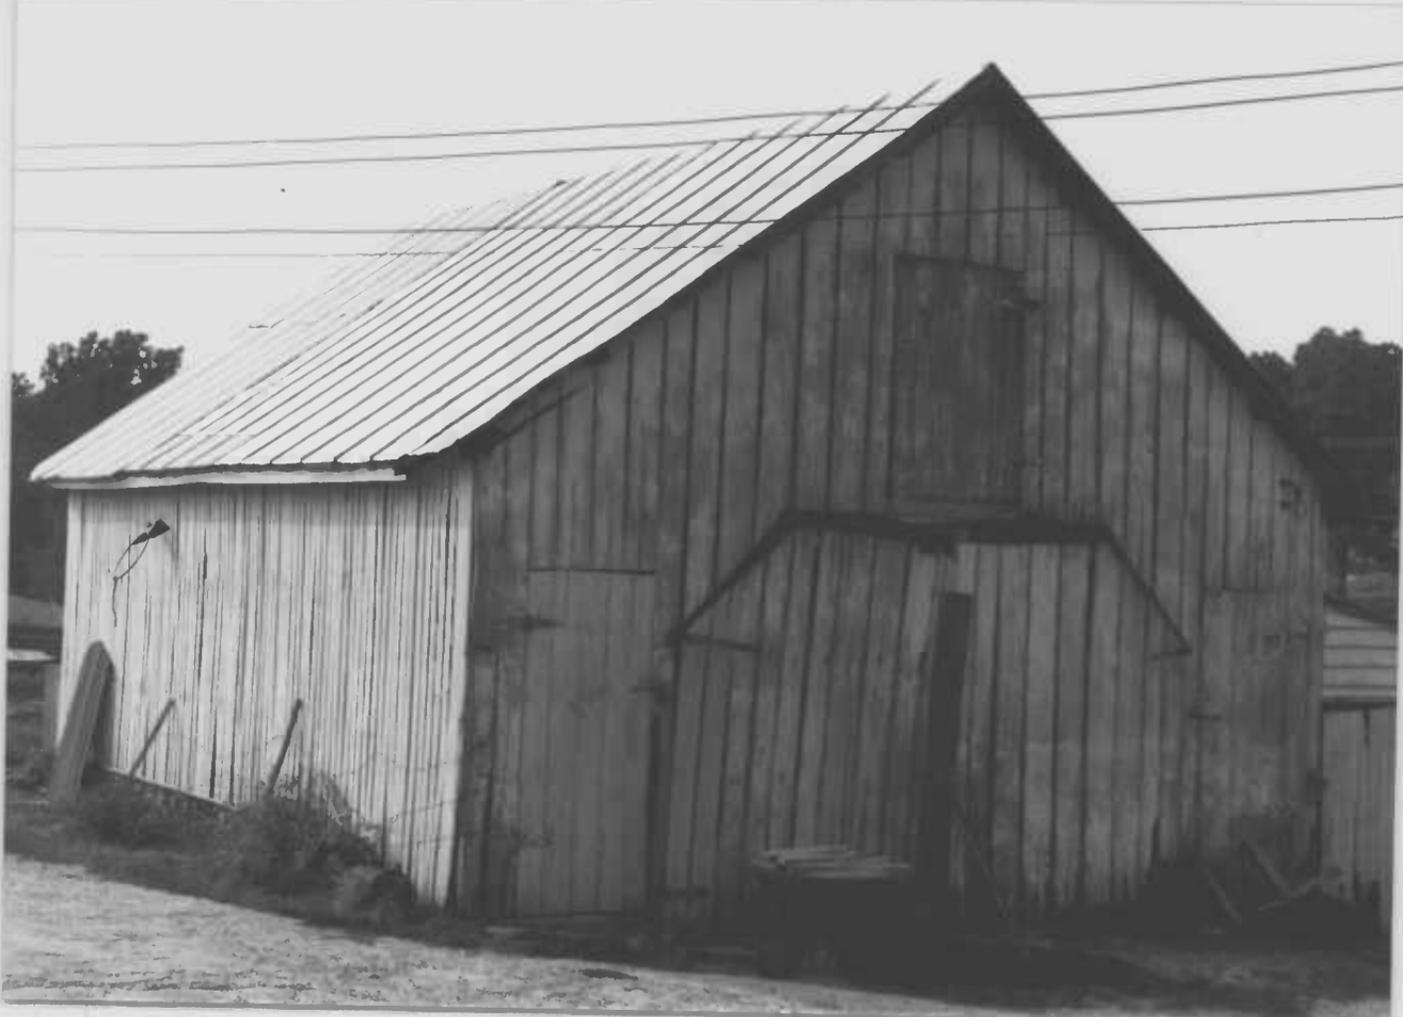
M:19-17-1

Other structures on the farm include a small wood pump house, built in 1944; a corncrib, possibly late 19th century; a shed, built 1929, which is sheathed with the remains of the pressed metal ceiling from the demolished old Germantown schoolhouse; a gambrel roof barn (close to the road) which was rebuilt c. 1960 after a fire; and a 19th century house.¹

Corncrib

Looking north
