INDIVIDUAL PROPERTY/DISTRICT
MARYLAND HISTORICAL TRUST
INTERNAL NR-ELIGIBILITY REVIEW FORM

Property/District Name: Billy King Farm Survey Number: M:20-32

BUILDING NAME: Graff/King Property (Billy King)

Name: Graff/King Property

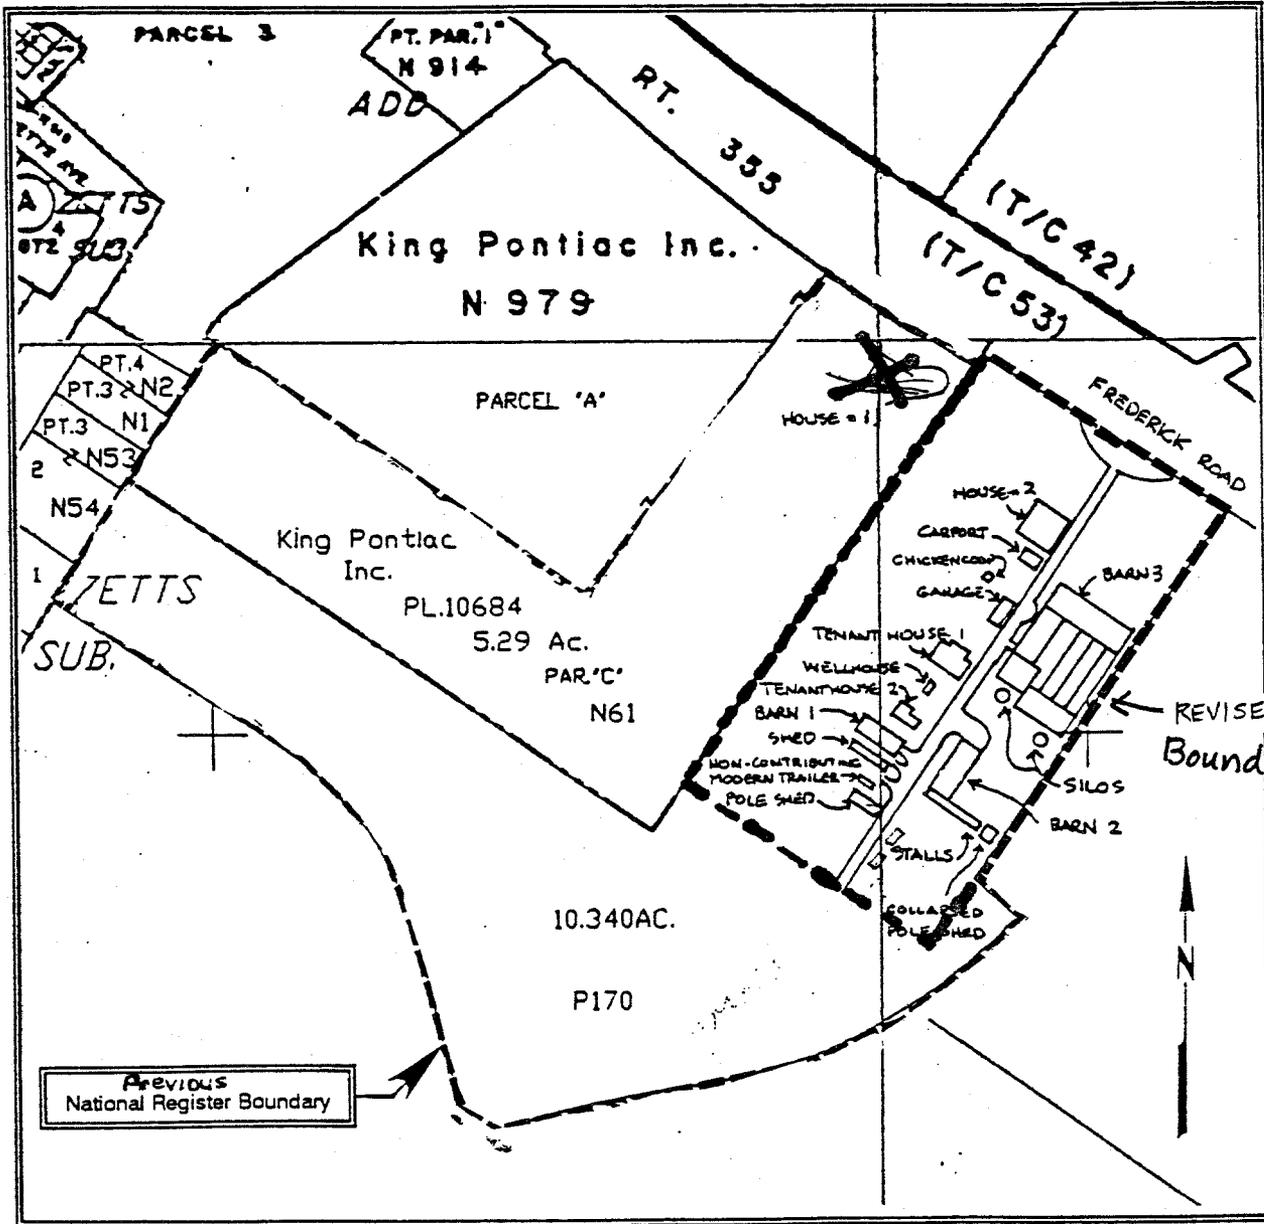
Resource Sketch Map and National Register Boundary Map:

DESCRIPTION: House #1 has been removed, and House #2 (at 16100 Frederick Road), plus the farm buildings which are located behind it, are in a state of disrepair. Some of the windows of House #2 are missing, and many of the farm buildings are deteriorating. Three metal trailers have been moved to the site and serve as offices of the King Farm developers.

BOUNDARY REDUCTION: Some of the 15.63 acres included within the original historic site boundary has been graded and is slated to be subdivided and developed. The portion retaining House #2 and possibly some of the farm buildings is slated to become a 5-acre Rockville Community Park. The new boundary encompasses ca. 5 acres, House #2 and all of the farm buildings. It is a portion of parcel 170.

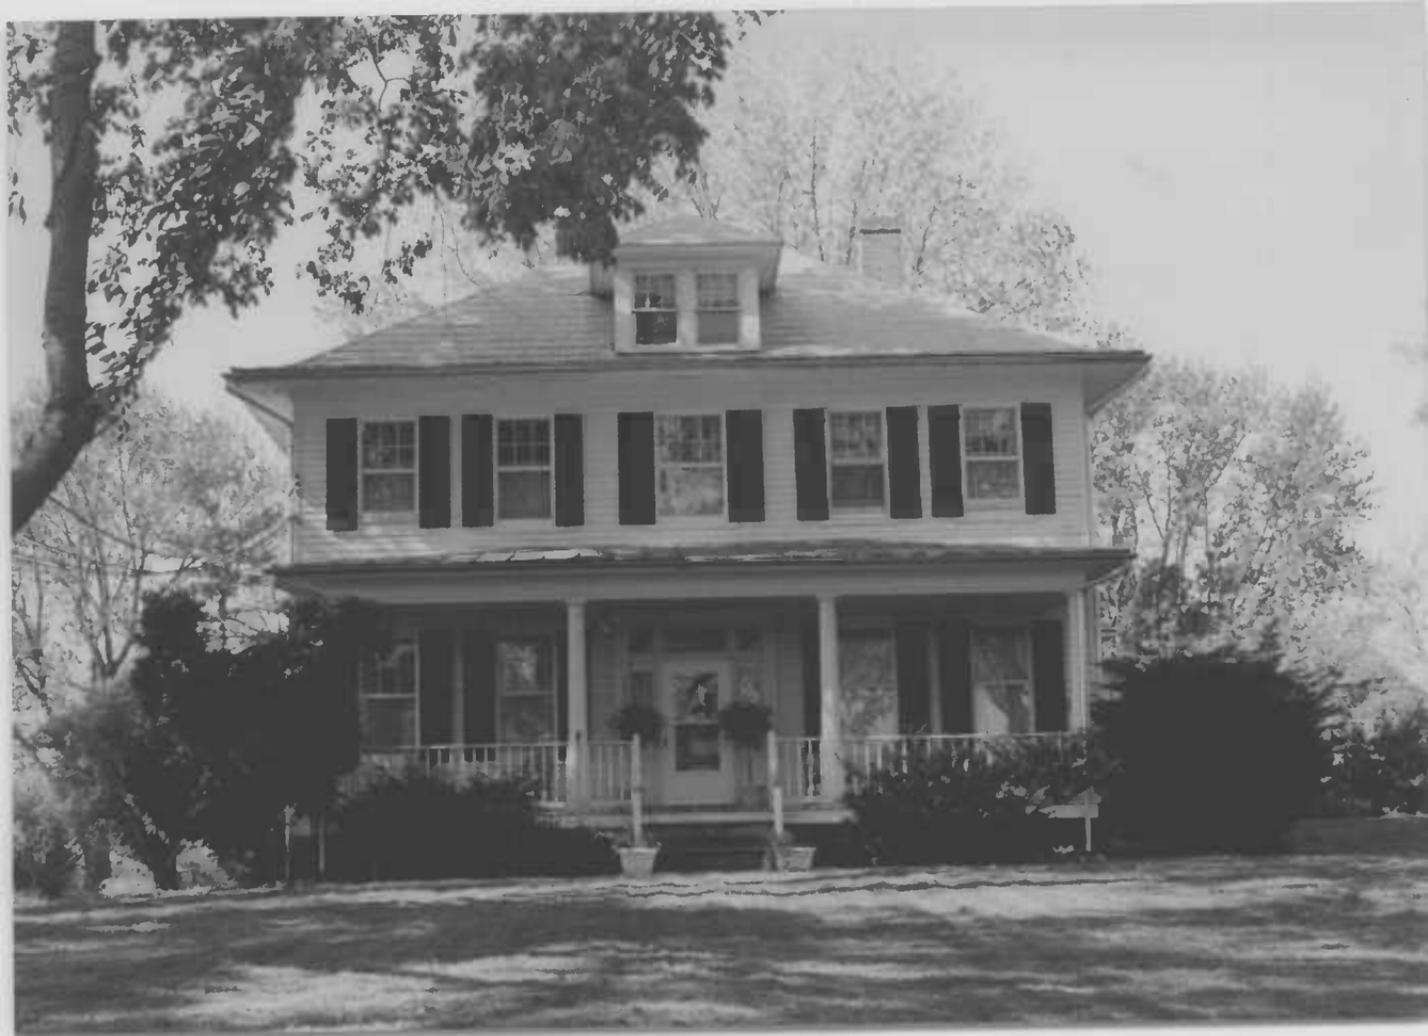
- 1 M:20-32
- 2. Graff/King Property
- 3. Montgomery Co Md
- 4. Julie Darnie
- 5. 5/98
- 6. Md 8770
- 7. SW corner, house 2
- 8. 4 of 44

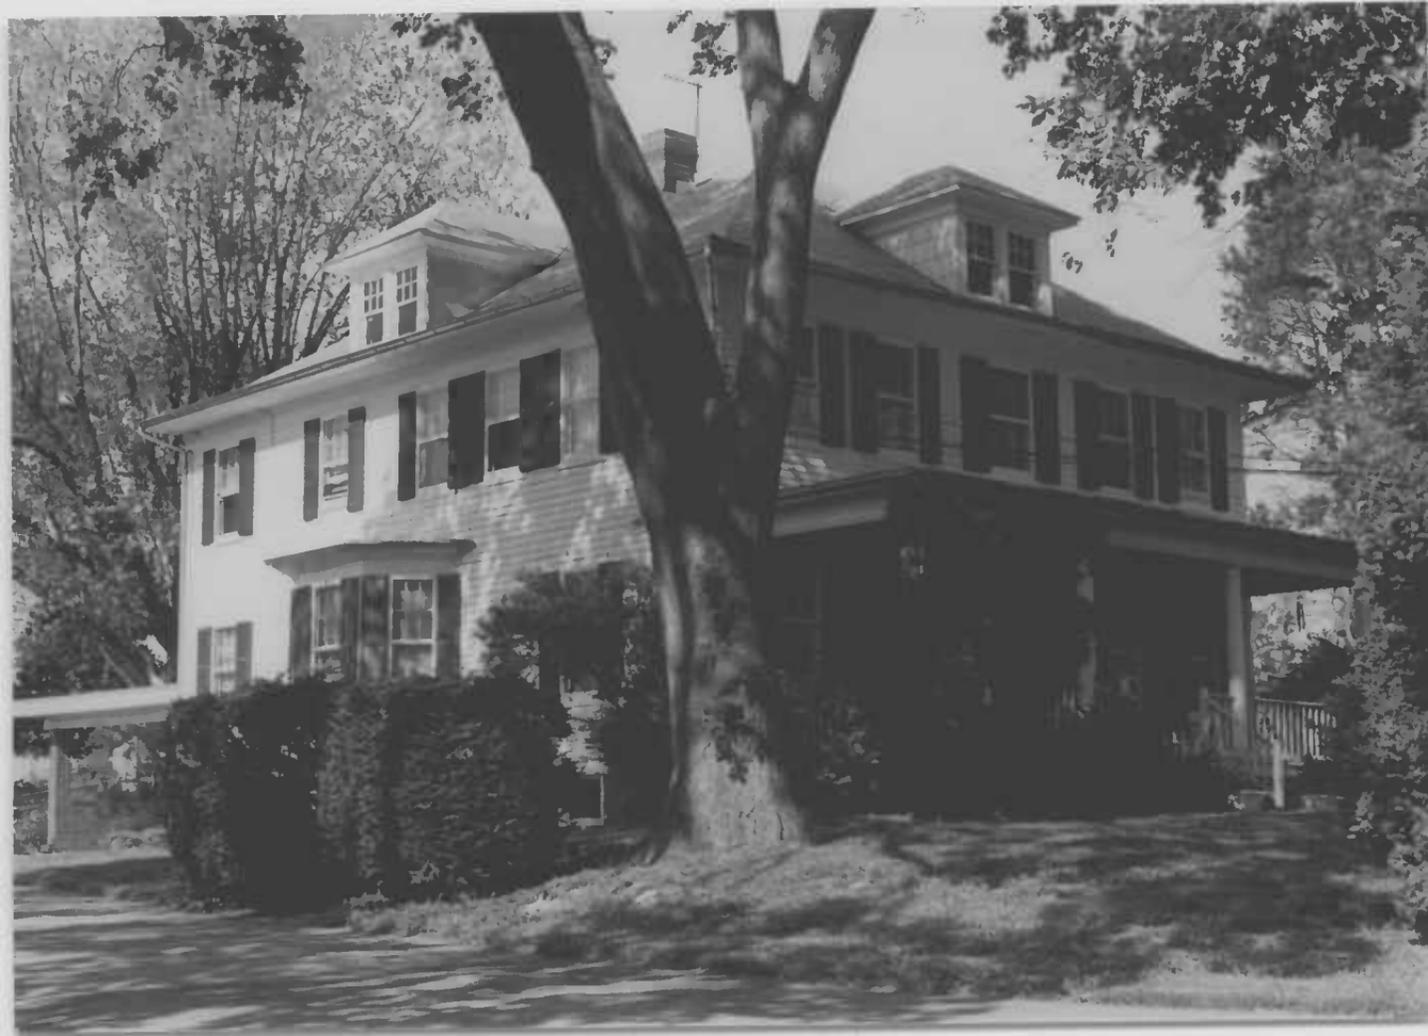
- 1 M: 20-32
- 2 Craft / King Property
- 3 Montgomery Co Md
- 4 Quince Doris
- 5 5/98
- 6 Md. 81P
- 7 SE corner - 3 houses
- 8 2.7 44

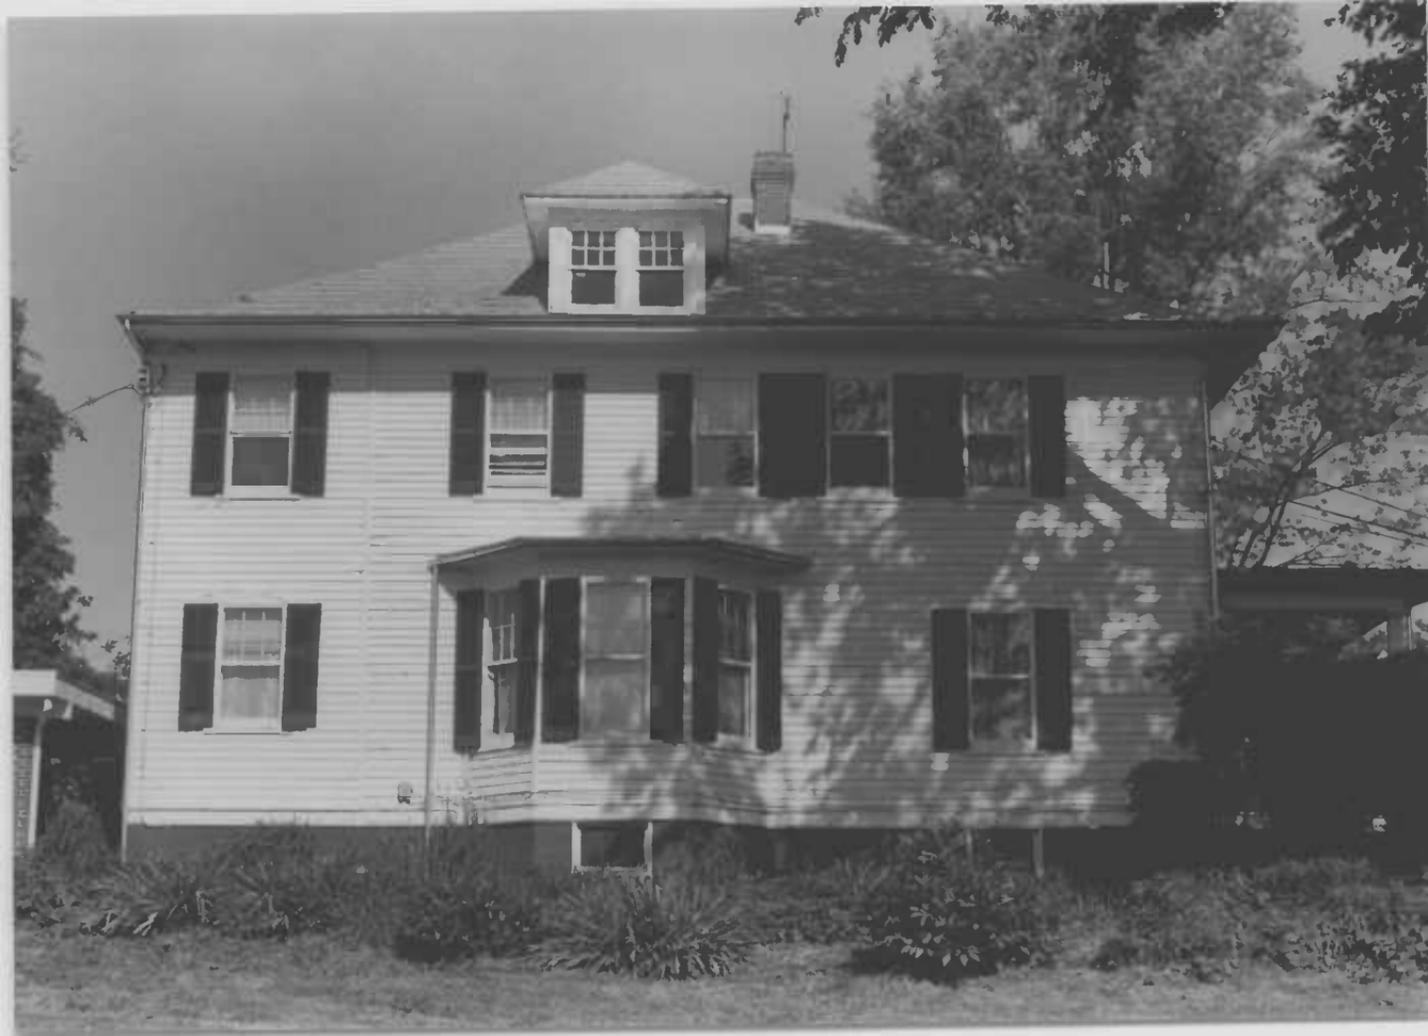
- 1 M. 20-32
- 2 Cross/King Property
- 3 Montgomery Co. Md
- 4 Jules Davis
- 5 5198
- 6 Md SHPO
- 7 5 elevations house
- 8 3 of 44

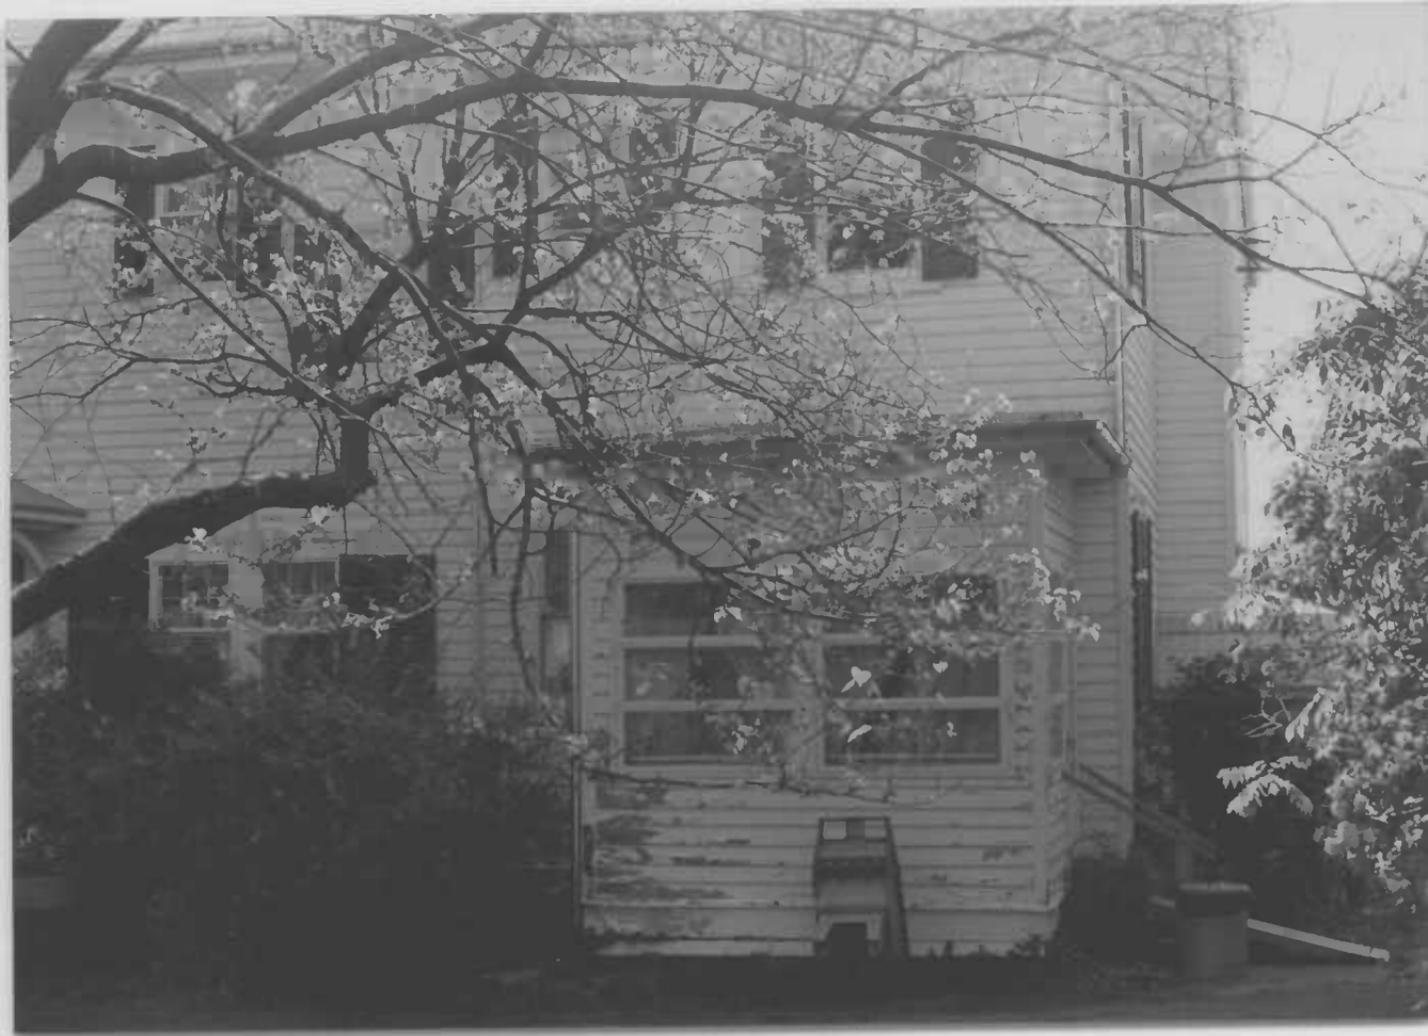
- 1 M. 20.32
- 2 Gruff/King Property
- 3 Montgomery Co. Md
- 4 Julia T. Lee
- 5 5/77
- 6 MD 8490
- 7 N. elevation, house 2
- 8 7.07 44

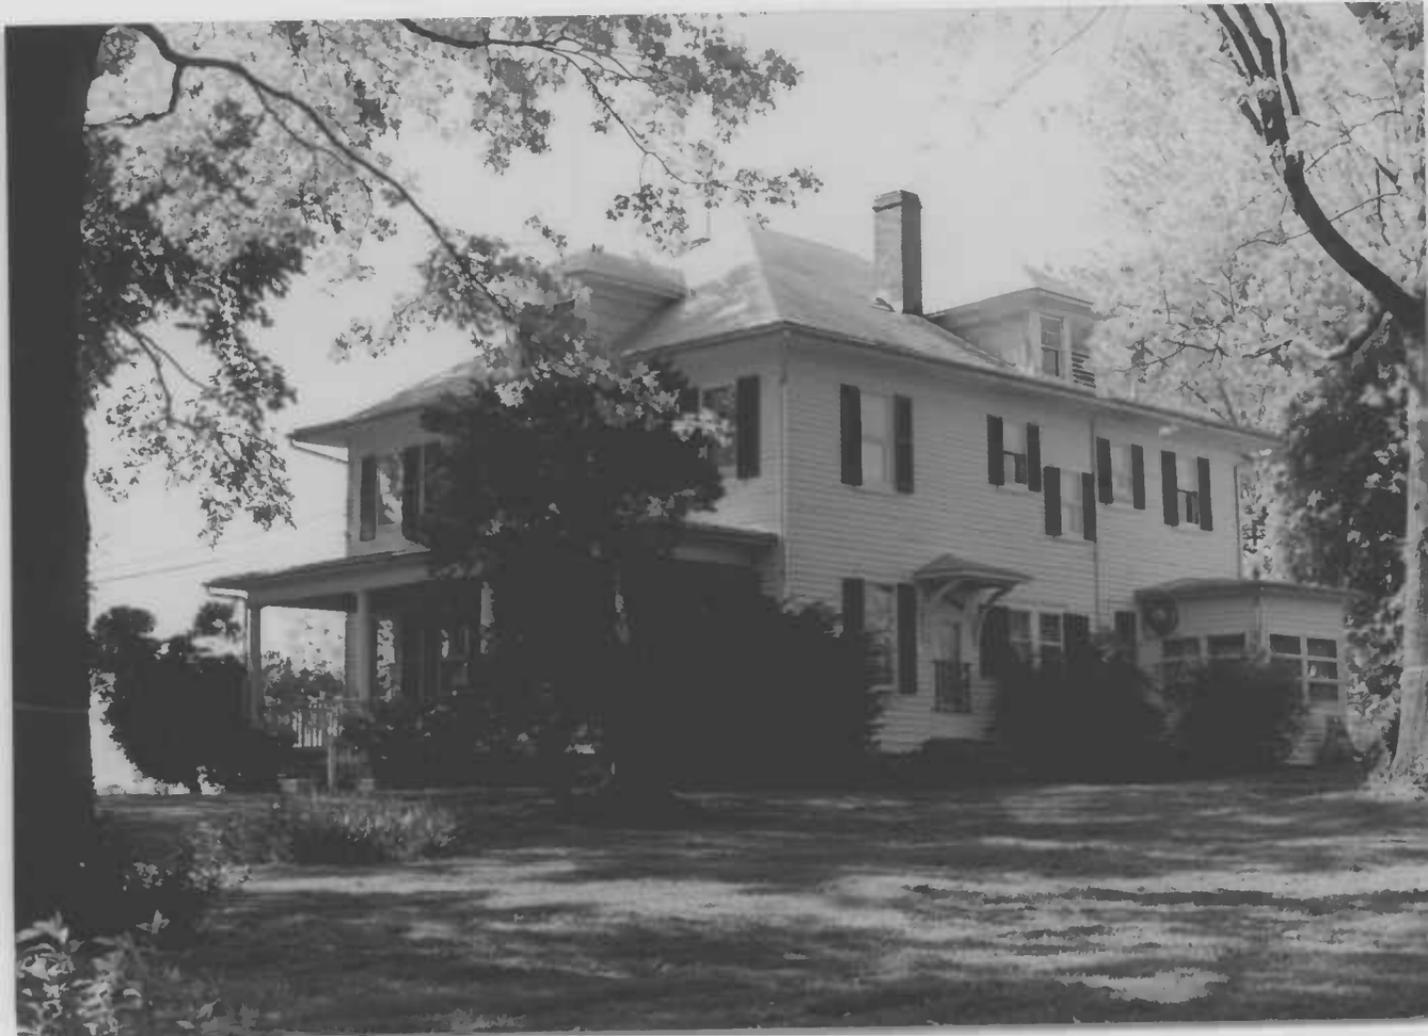
8 9 of 44

7 Garage

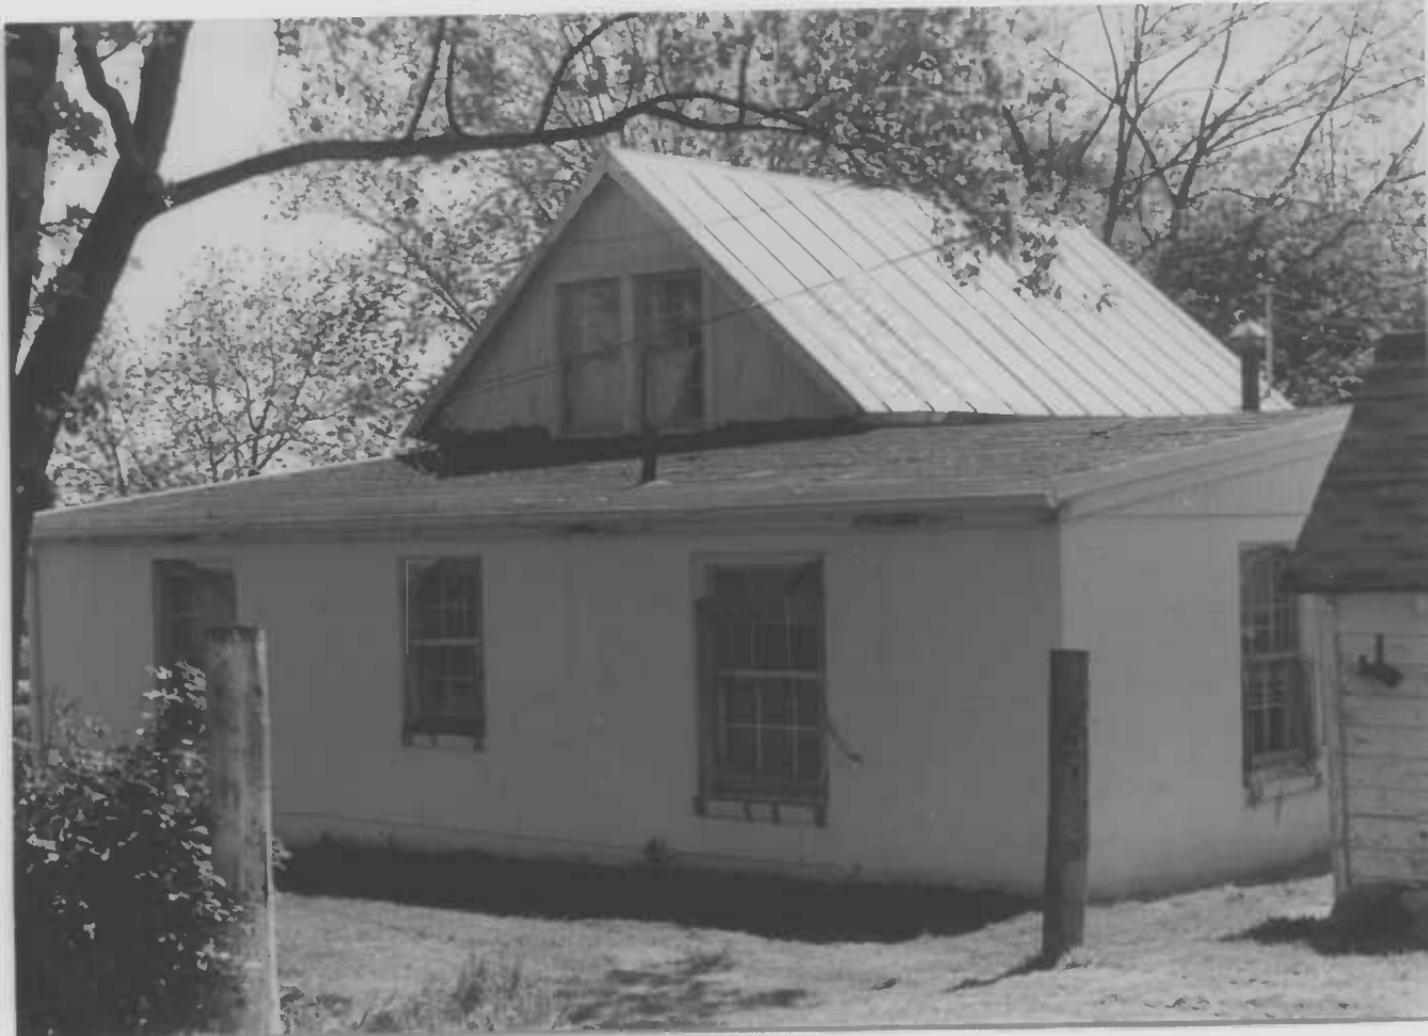
- 1 M 20-32
- 2 Gratt/King Property
- 3 M. L. Garrison Co Md
- 4 Julie Daidie
- 5 5/98
- 6 Md SHPO
- 7 Well House
- 8 13 of 44

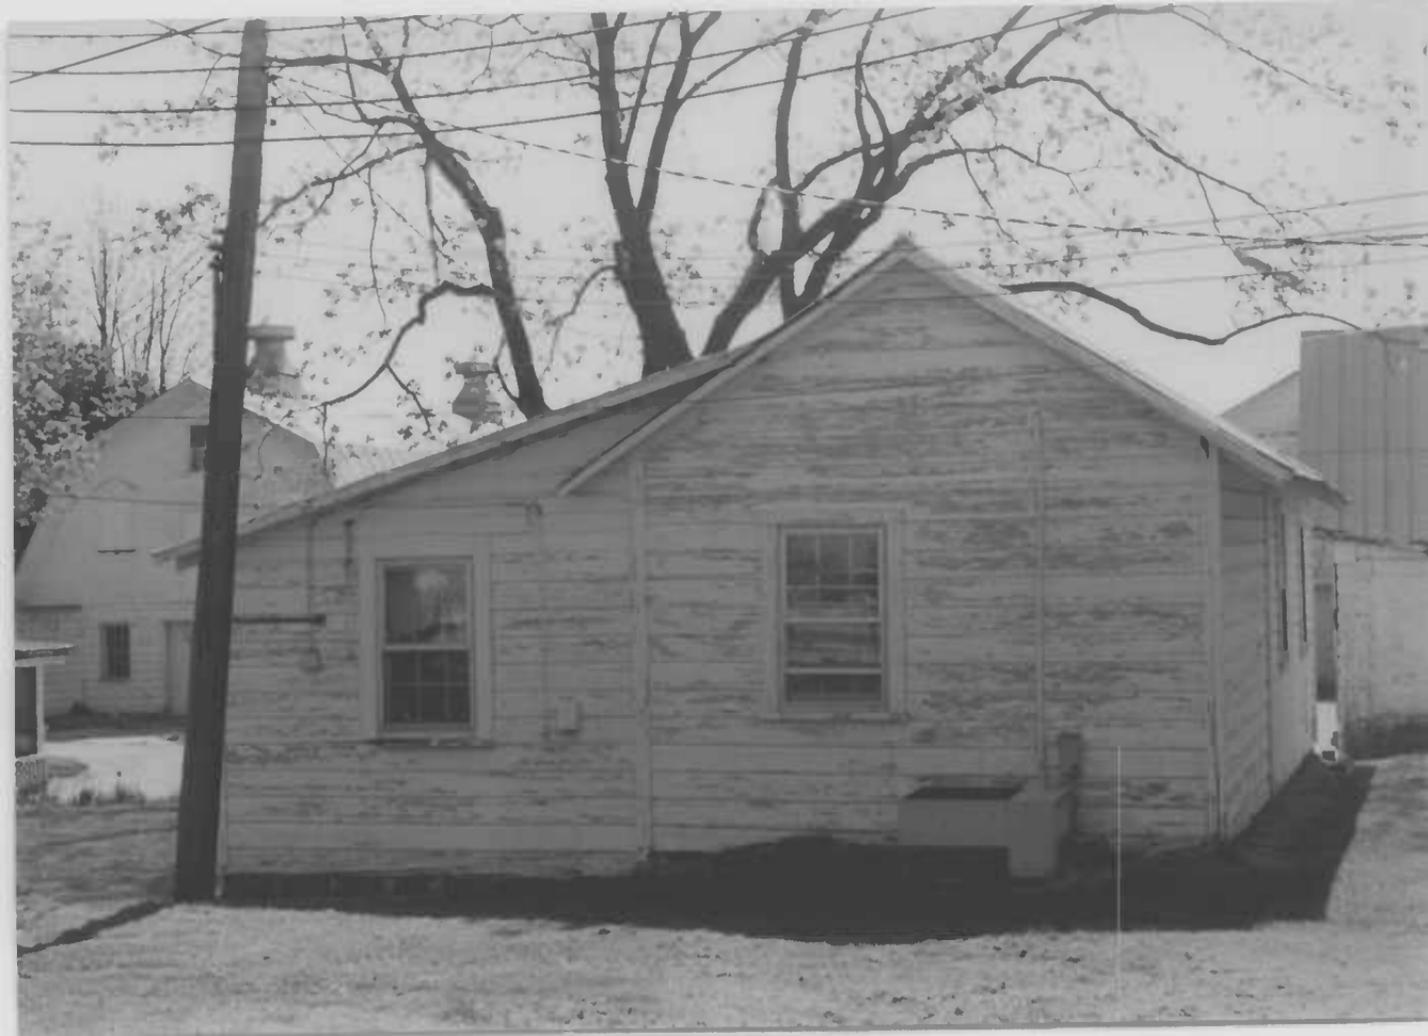
- 1 11-20-32
- 2 Shaft/King Property
- 3 Montgomery Co. Md
- 4 Julie Darsie
- 5 5/98
- 6 Md 84PO
- 7 Jenn + Horse 2
- 8 16 3 44

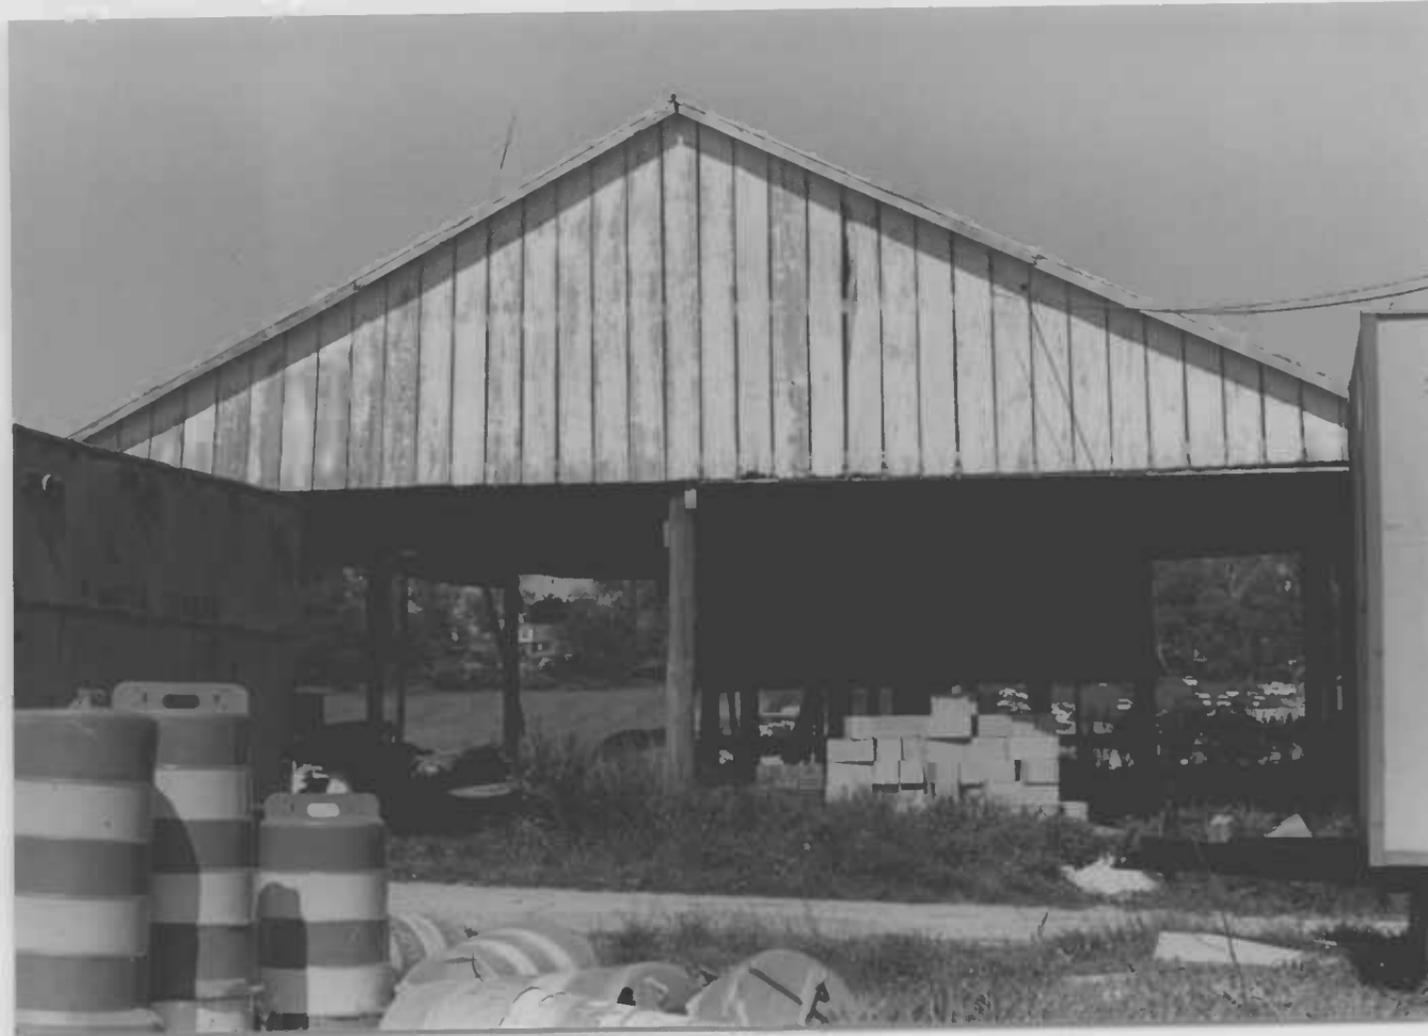
- 1 M-20-32
- 2 Trafficking Property
- 3 Montgomery Co Md
- 4 Quaker Dance
- 5 5/98
- 6 Red Stair
- 7 Pkg Shed
- 8 21 of 44

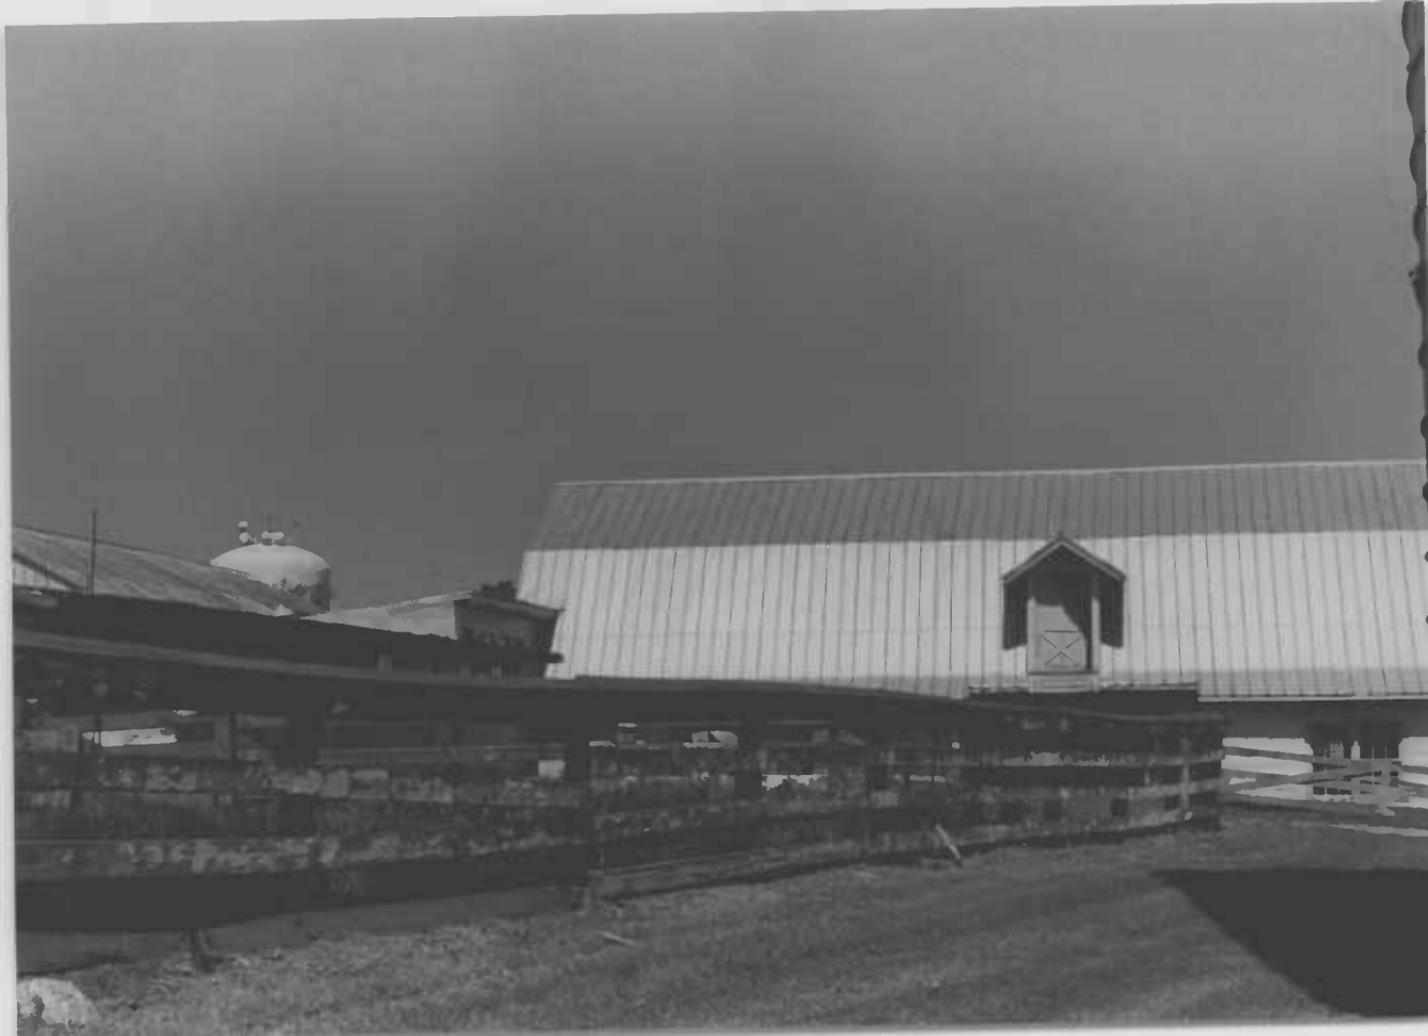
- 1 M-20-32
- 2 Haff / King Property
- 3 Montgomery Co. Md
- 4 Julie Davis
- 5 5/98
- 6 117 SHPL
- 7 Barn 2
- 8 24 of 44

South of Barn One is Barn Two. Barn Two is 3-bays wide and 2½-stories tall with a rock-faced concrete-block first story and a wood-frame second story. The standing-seam metal gambrel roof has gable dormers on the north and south elevations. The east, or front elevation of this barn has three sliding doors covering the first story. The second story has two 6/6 double-hung windows flanking double batten loft doors. The north elevation has two sets paired, 6/6 double-hung windows on the east end and double sliding doors beneath the centered dormer. West of the dormer are two sets of paired, fixed-sash windows. The south elevation is similar to the north elevation, although the sliding doors have been removed. The west elevation is covered by a 1-story stable that extends to the south. The stable has a concrete-block foundation, concrete-block walls and a standing-seam metal shed roof. A 1-story wood-frame pole shed, now collapsed, extends south from the stable.

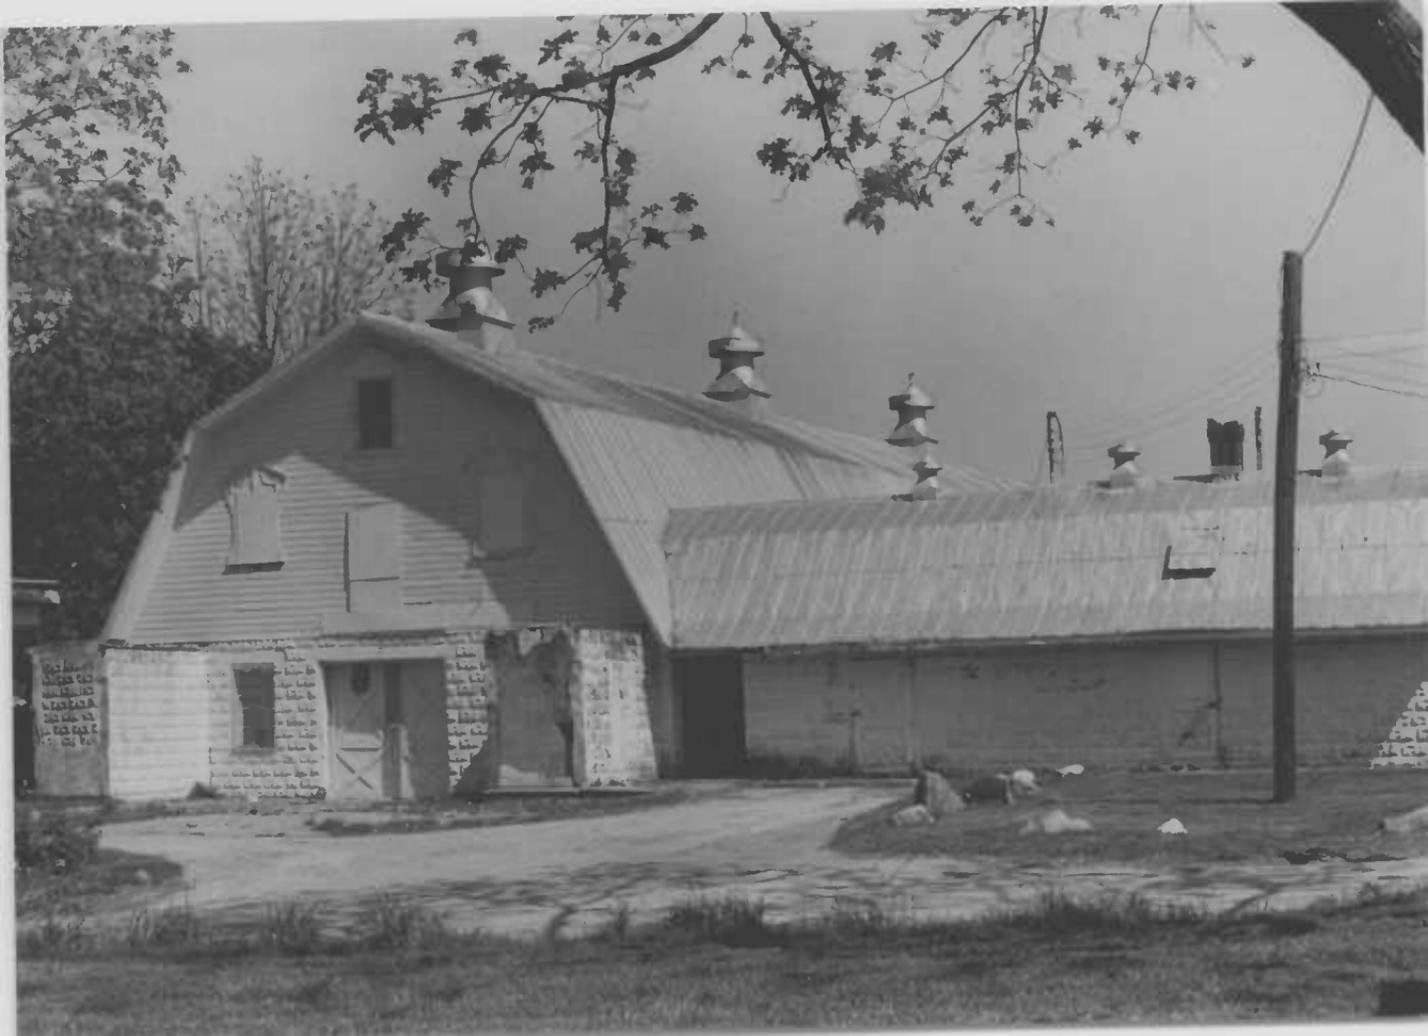
- 1 M:20-32
- 2 Grattling Property
- 3 Montgomery Co Md
- 4 Julie Dausa
- 5 5/98
- 6 Md SH-15
- 7 Barri³ M elevation
- 8 25 of 44

On the north, or front elevation, the gambrel end of the east wing has double batten doors in the center bay. A 6/6 double-hung window is located on each side of the doors, and 1-story rock-faced concrete-block walls project forward from each end of the wing. Four 2/2 double-hung windows with elaborate wood surrounds are arranged at different levels on the second story. The

north elevation of the north wing has an uncovered door opening and two batten doors. A low wall connects the north wing to the 2-story west wing. The north elevation of the two-story west wing has two sets of paired windows, now covered, on the first story and a batten loft door on the second story. The 2½-story west wing begins at the southwest corner of the 2-story west wing. The north elevation of the 2½-story west wing has double batten doors in the center bay. One-story rock-faced concrete-block walls west of the doors surround the metal silo at the northwest corner of the barn. Four 2/2 double-hung windows with elaborate wood surrounds are arranged at different levels on the second story.

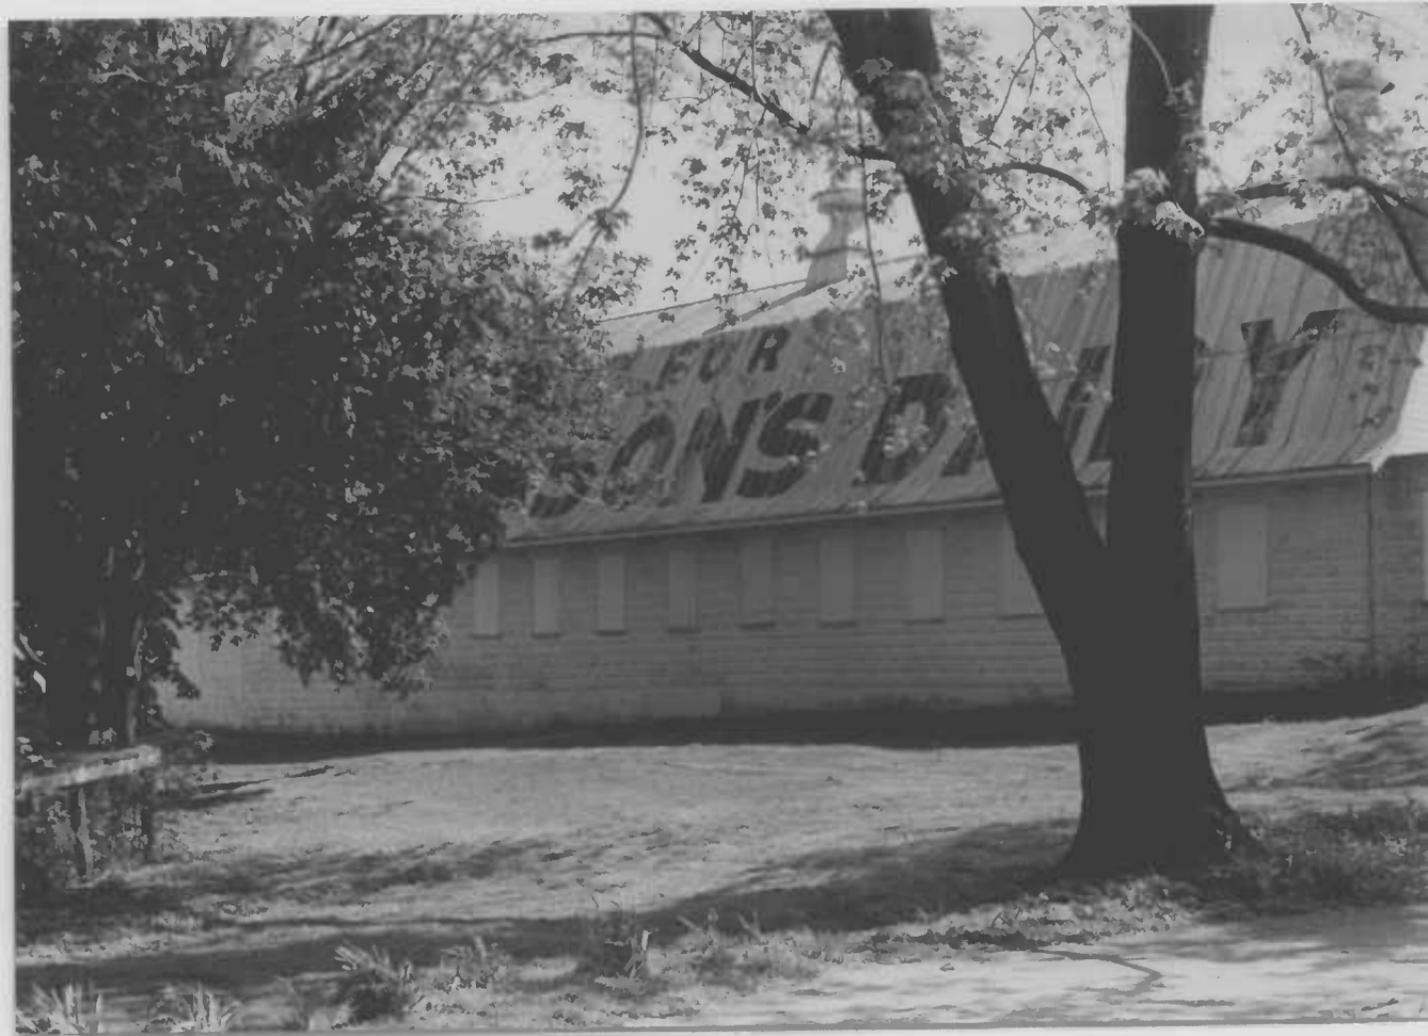
- 1 m. 20 32
- 2 Draft / King Property
- 3 Montgomery Co Md
- 4 John Davis
- 5 5/99
- 6 Md SHPO
- 7 E elevation, base 3
- 8 27 of 44

On the east elevation, the original east wing of the barn has thirteen double-hung windows, now covered. An addition constructed of concrete block extends this wing five more bays to the south. These bays have small, high windows, which are also covered. The words "Milk for Thompson's Dairy" are painted on this elevation of the gambrel roof.

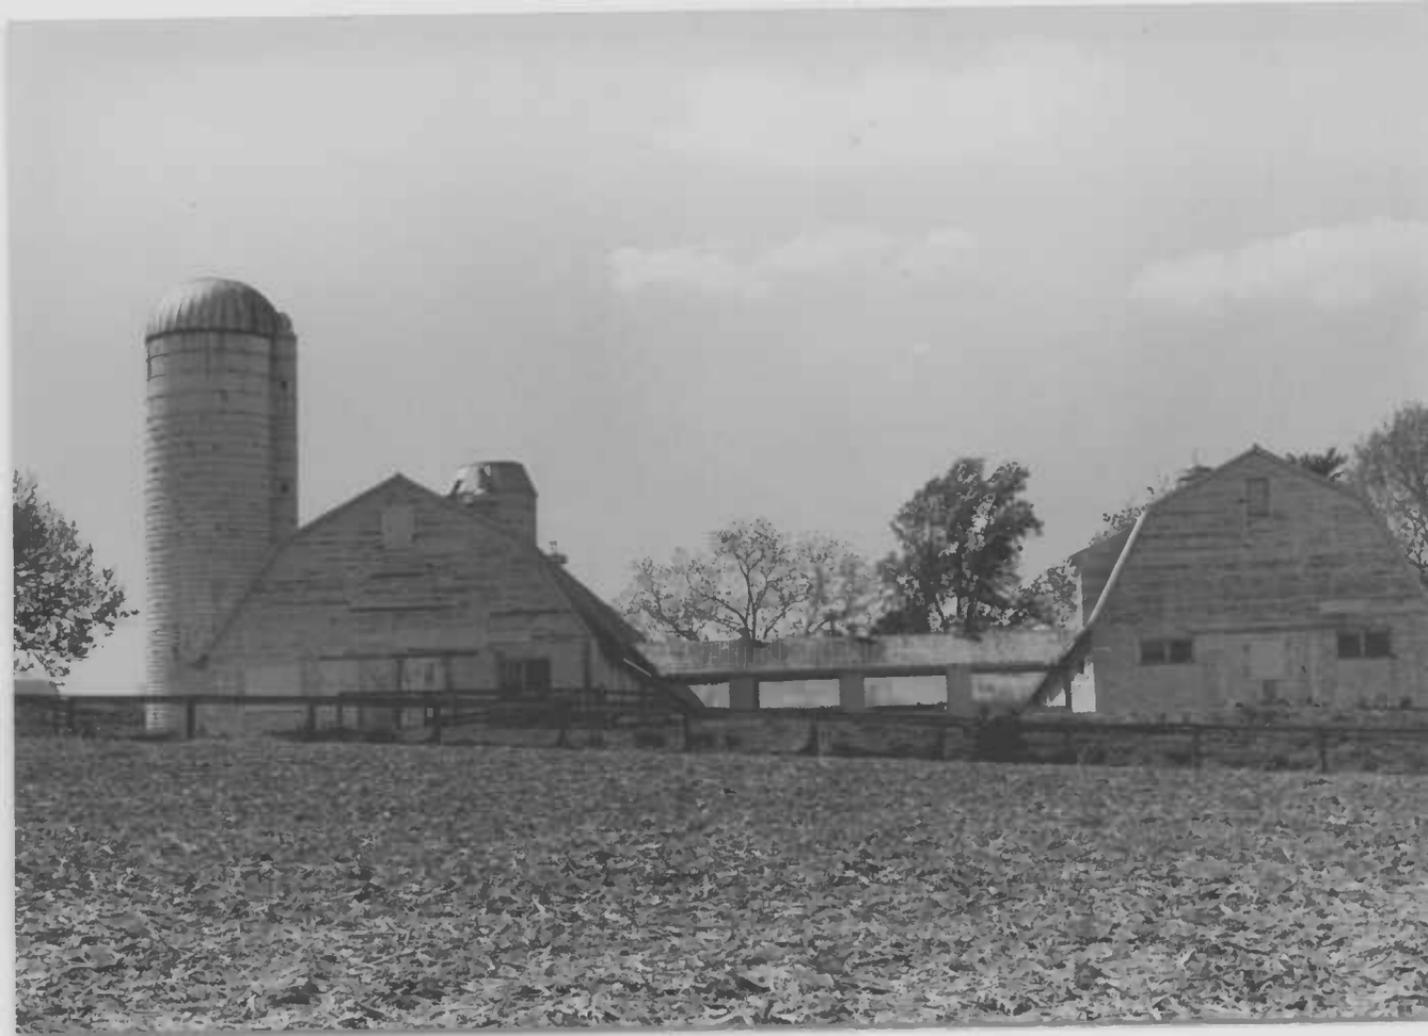
7 S. elevation, Page 3

The south elevation of the east wing has double sliding batten doors in the center bay of the first story. Paired, 6-light fixed-sash windows are located on each side of the door. A single double-hung window is located in the gambrel peak. The two crosswalks traversing the courtyard are visible on this elevation. The crosswalks have low walls and posts constructed of rock-faced concrete block. They are sheltered by standing-seam metal gable roofs. The south elevation of the west wing has double sliding batten doors in the center bay with paired, 6/6 double-hung windows on each side. A covered double-hung window is located in the gambrel peak.

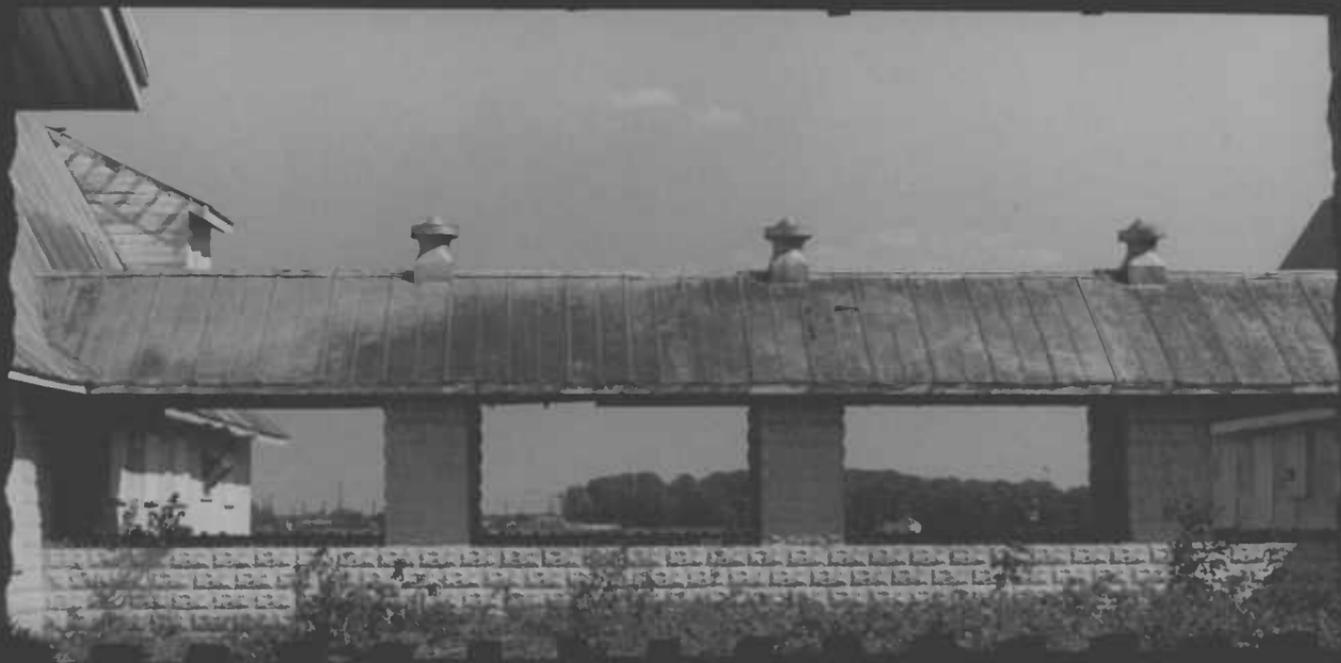
7 Courtyard E 214-3

East of Barn Two is the largest outbuilding in the complex, Barn Three. This barn is U-shaped with a courtyard facing south and has a rock-faced concrete-block first story and a wood-frame second story. The barn is comprised of a 2½-story east wing, a 1-story north wing, a 2-story west wing, a 2½-story west wing and two 1-story crosswalks. The four wings are covered by standing-seam metal gambrel roofs with deep eaves. The barn has a variety of window and door openings.
