INDIVIDUAL PROPERTY/DISTRICT
MARYLAND HISTORICAL TRUST
INTERNAL NR-ELIGIBILITY REVIEW FORM

Property/District Name: Billy King Farm Survey Number: M:20-32

BUILDING NAME: Graff/King Property (Billy King)

Name: Graff/King Property

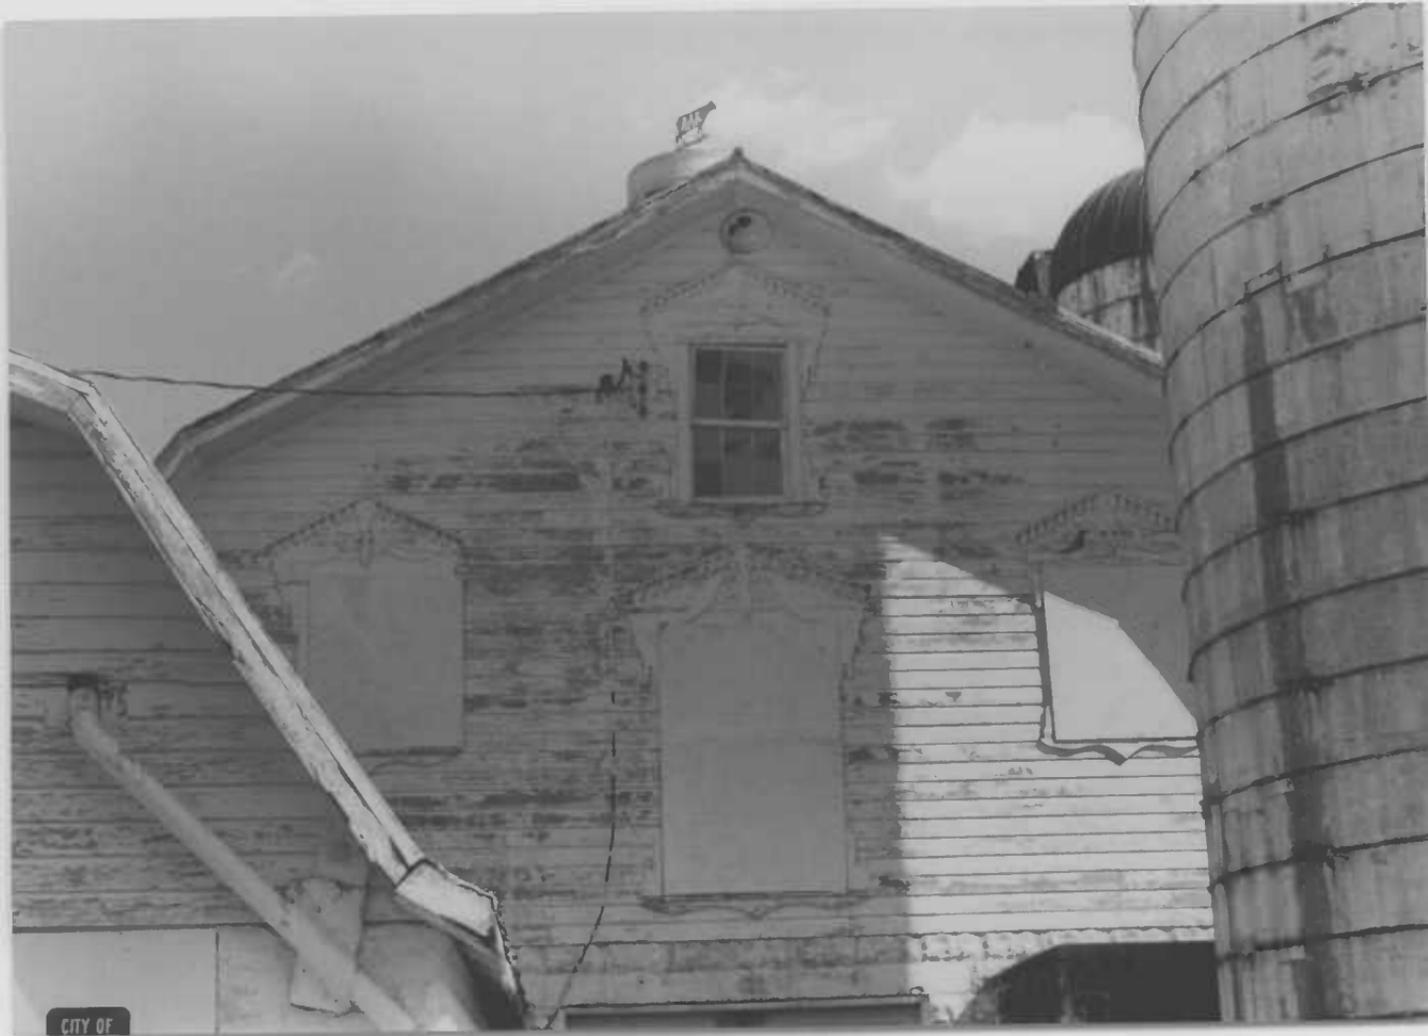
7 Table end detail, barn 3 22-51 22252

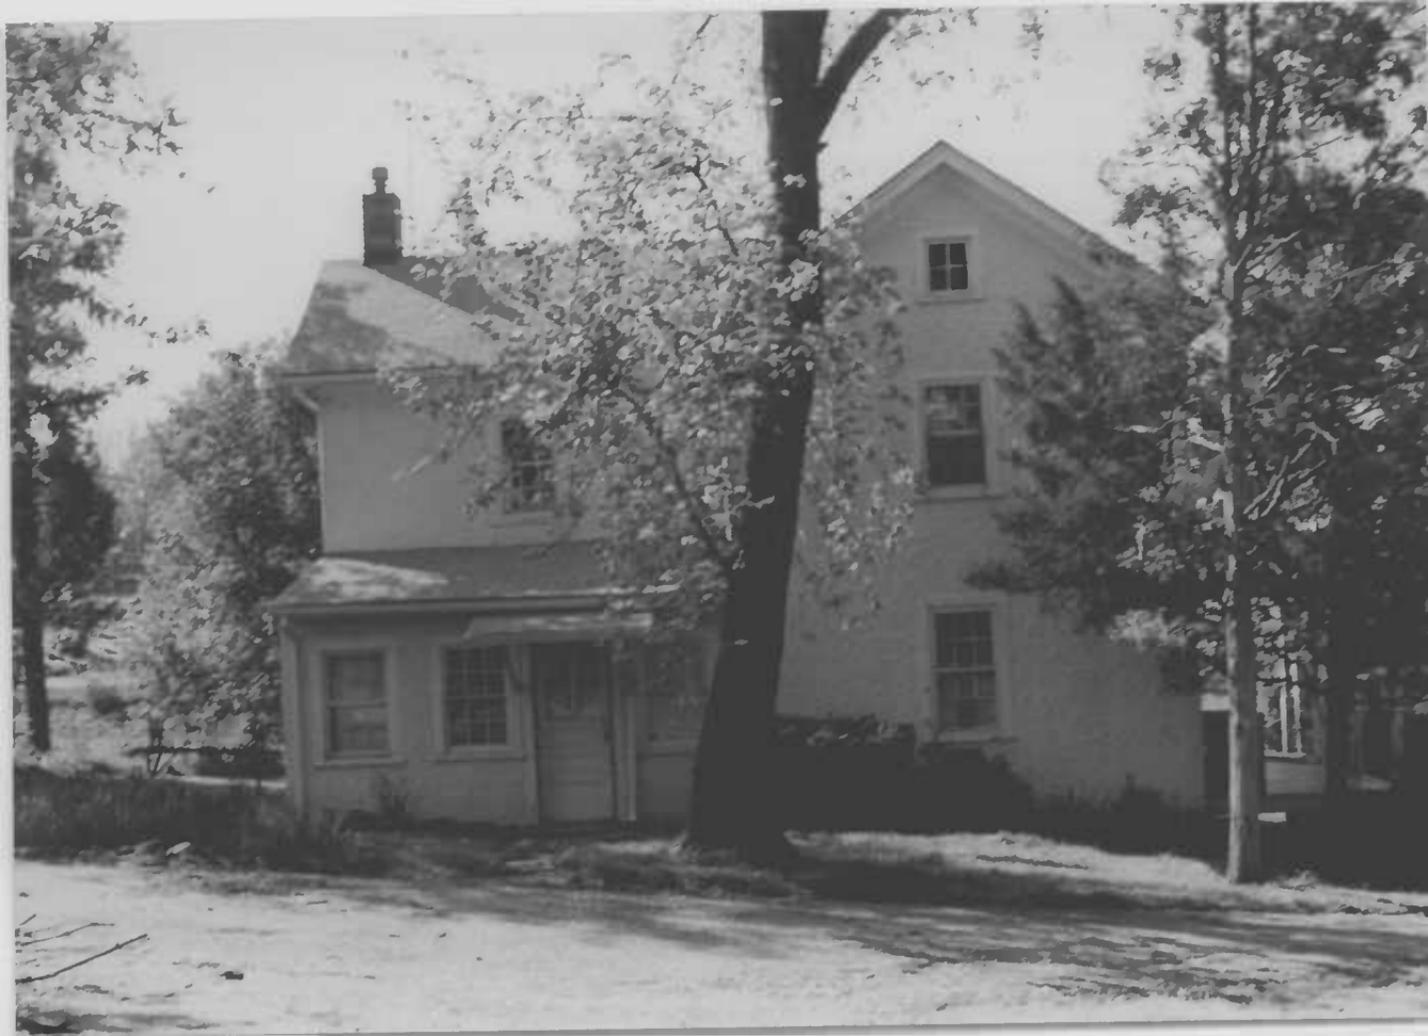
- 1 M 20 32
- 2 Craft/King Property
- 3 Montgomery Co. Md
- 4 Julie Dawes
- 5 5/98
- 6 Md. SHPO
- 7 NW corner - road
- 8 42 of 44
