CAPSULE SUMMARY

SAMUEL THOMAS MAGRUDER FARM

14800 SENECA ROAD, DARNESTOWN

Maryland Historical Trust State Historic Sites Inventory Form

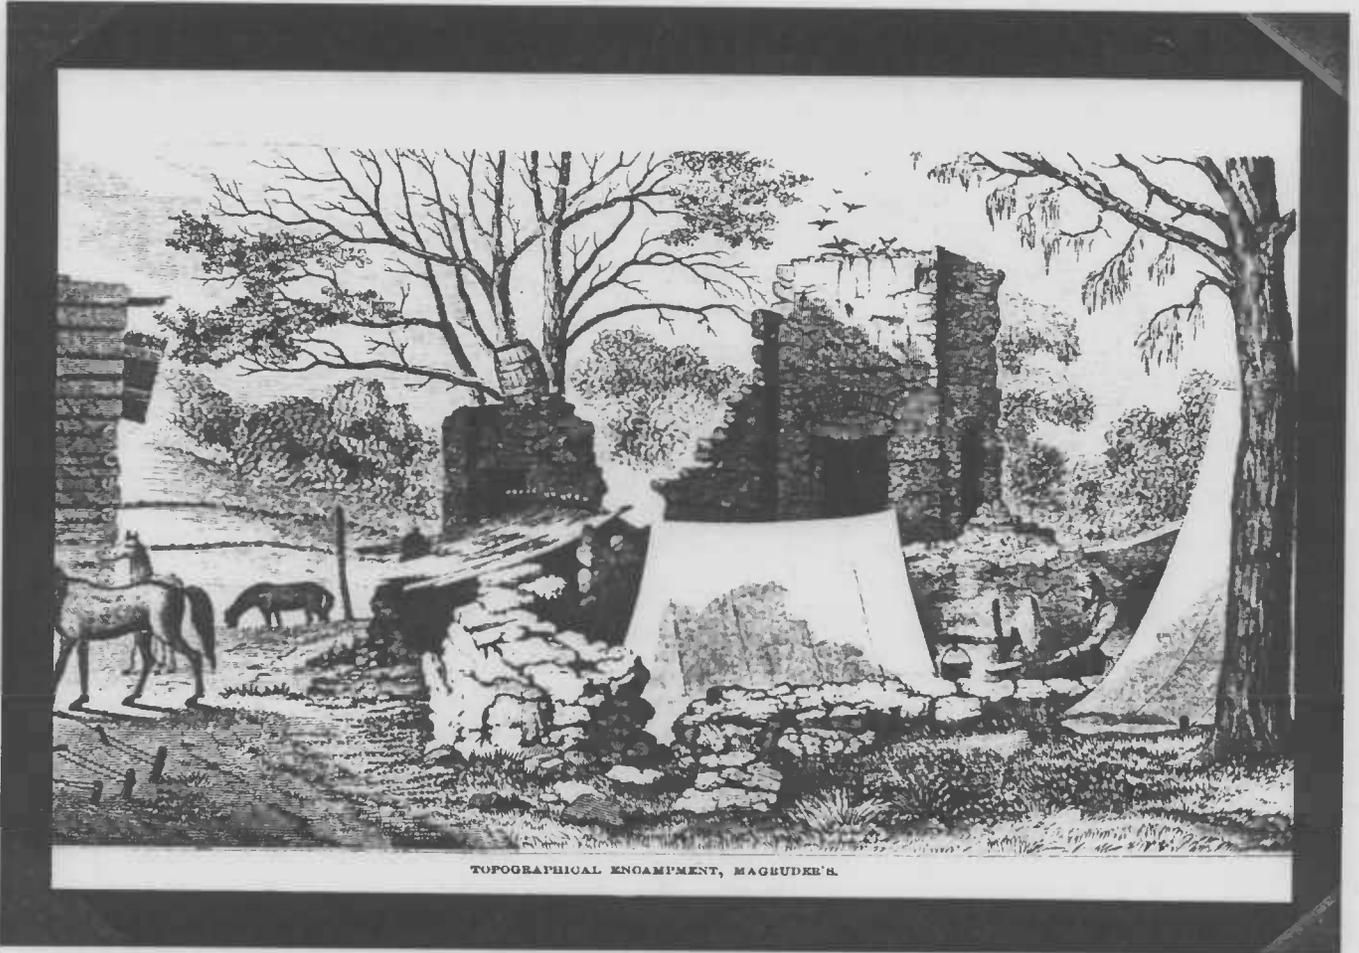
"Topographical Encampment, Magruder's"
Harper's New Monthly Magazine 33:196 (September
1866), 421.

in the crown of the tree. A camp of topographic engineers and defensive fortifications located near the tree. Sketches of signal tree station with tent and Camp Magruder showing stone foundations of unknown structure.⁵ This signal station was in use from the summer of 1861 to the fall of 1862.⁶ The tree is believed to have been located along present day Signal Tree Lane on the crest of a hill approximately 1/4 mile north of River Road. A signal corps school, about which little is known, is said to have operated from this location.⁷

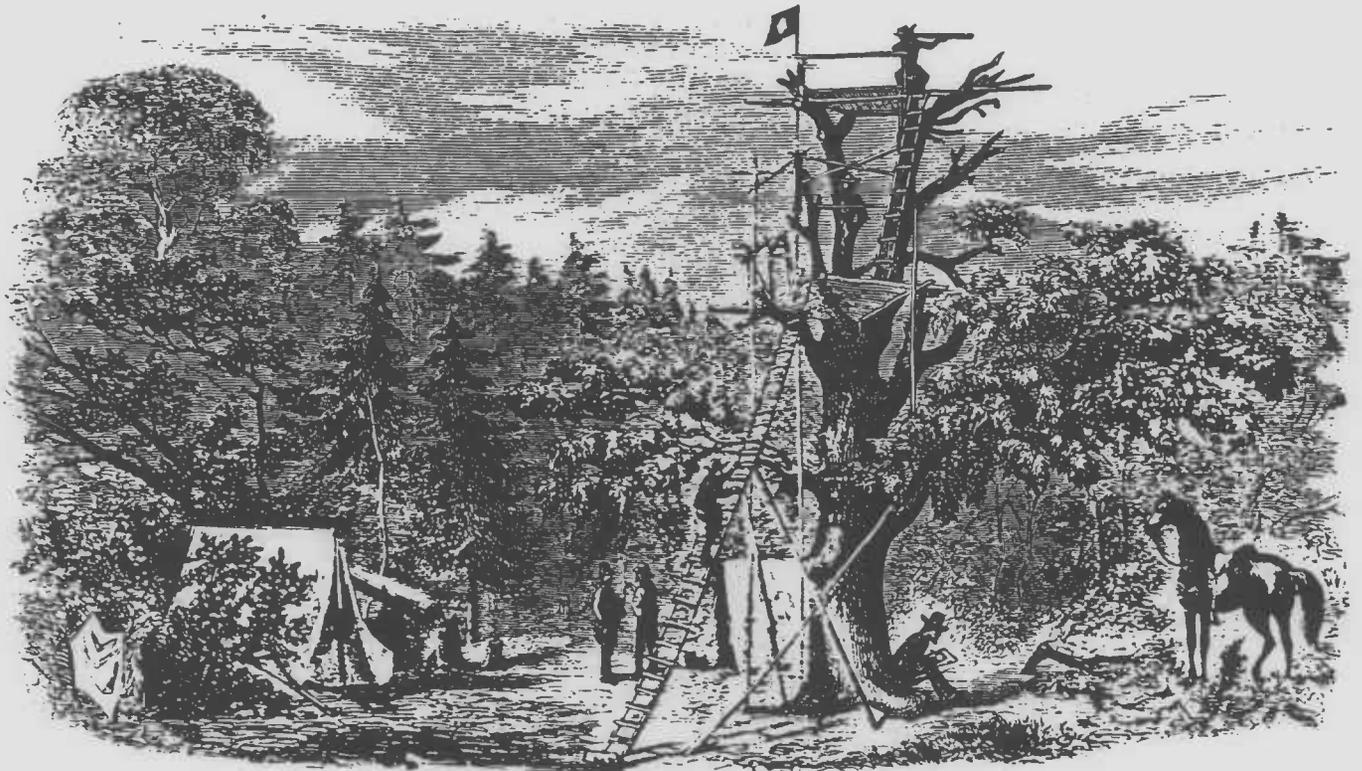
SIGNAL-STATION, MONTGOMERY COUNTY.

"Signal-Station, Montgomery County"
Harper's New Monthly Magazine 33:197 (October
1866), 547.

The signal station was located in a chestnut tree on the southwestern part of Magruder Farm. The treetop was made accessible by a system of ladders, scaffolding, leading to and from a wooden platform

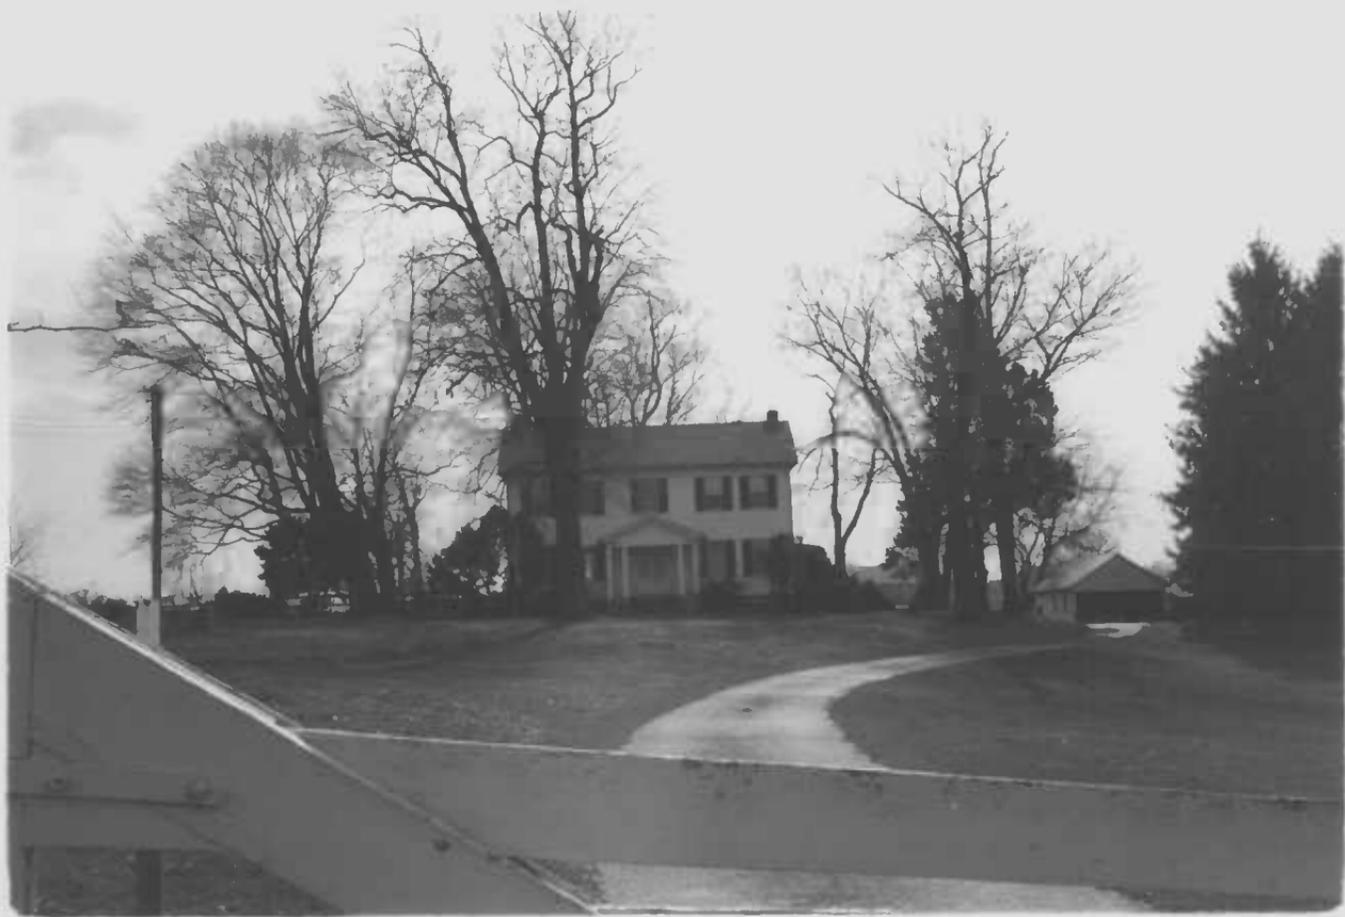
1 of 8

S Thomas Magruder Farm (View from
entrance gate)

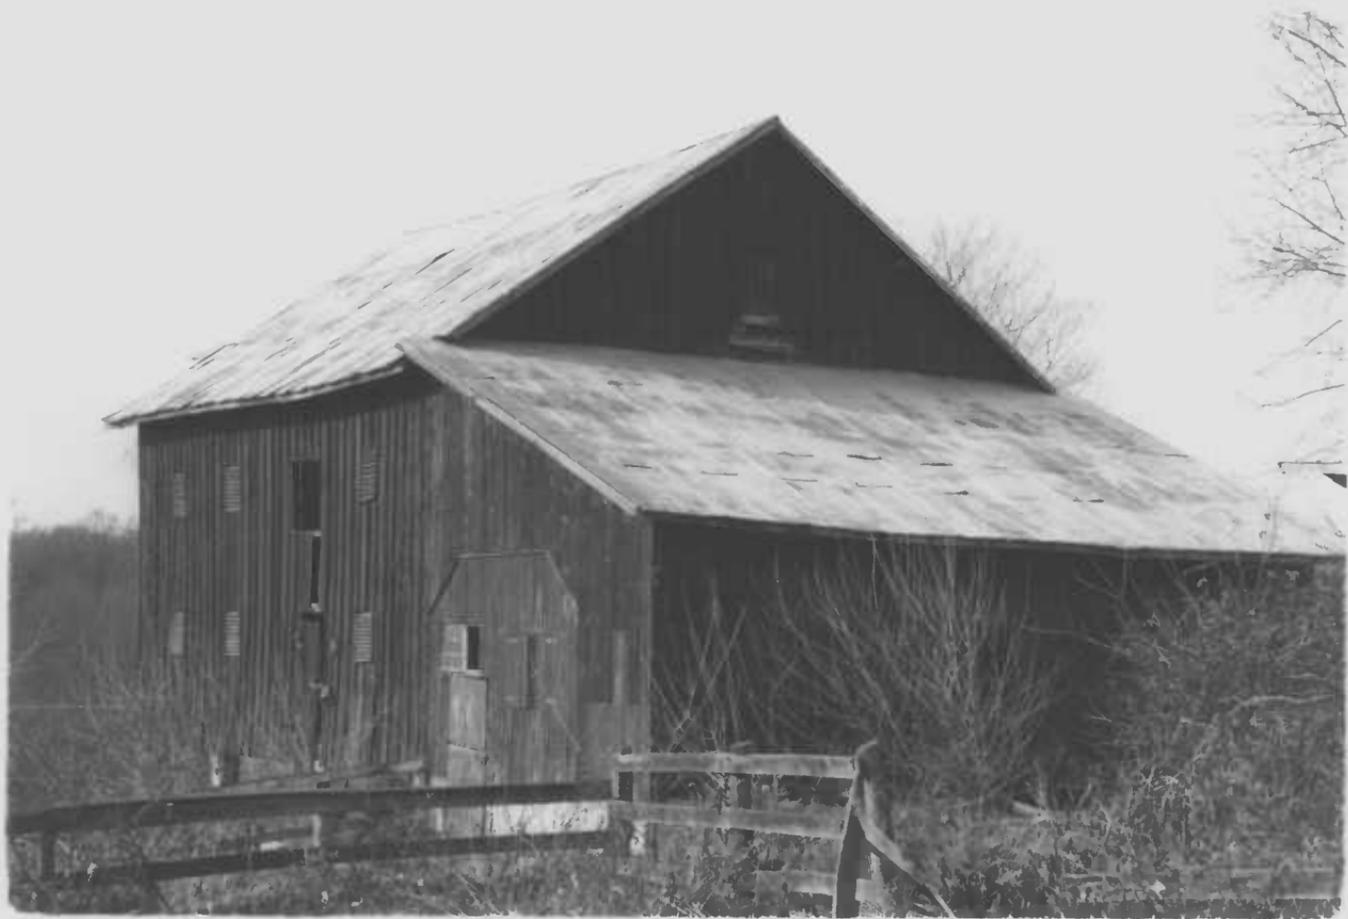
1 of 9

S. Thomas Magruder Farm (Outbldg.) (^{Bank} Barn)

To the west of the house stands a four bay bank barn with raised seam metal covering its gable roof and foundation of Seneca sandstone. Probably built in the mid 19th century, and certainly by 1884, the barn is covered with board and batten siding and ventilated by louvered windows typical of barns in that era.² The upper level is accessed by a pair of large hinged doors. A later shed roof addition was constructed on the east end as a wagon drive through. The openings were later boarded up when it was converted to horse stalls by the present owner.

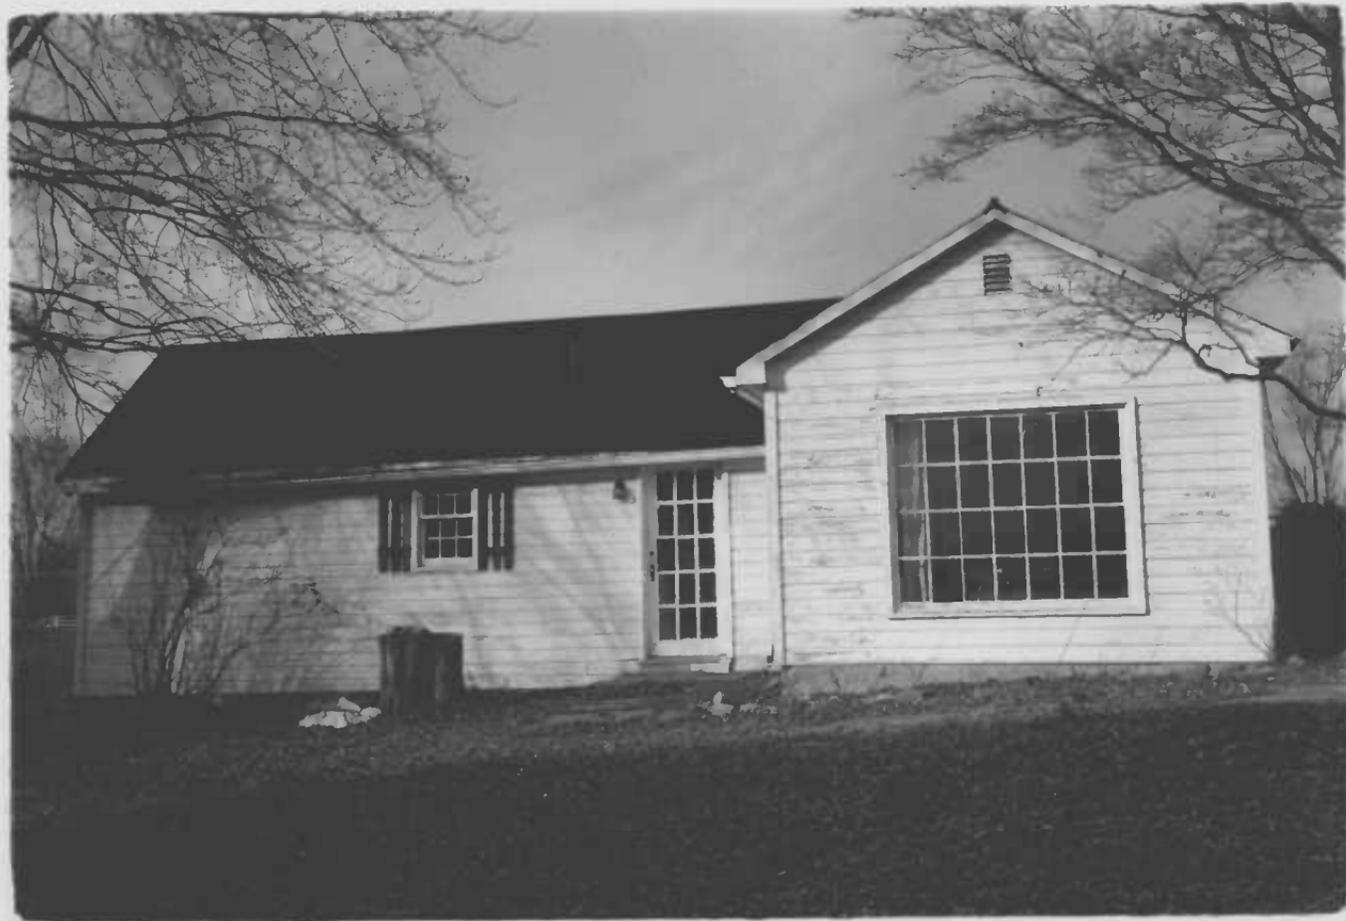
3 of 9

S Thomas Magruder Farm (Tenant House)

North of the bank barn is a one story, three bay building constructed in the early 20th century as a dairy house. Protected by a standing seam metal roof, the building has clapboard siding and concrete foundation. Window and door alterations were made when the building was converted into a tenant house by the current owner in

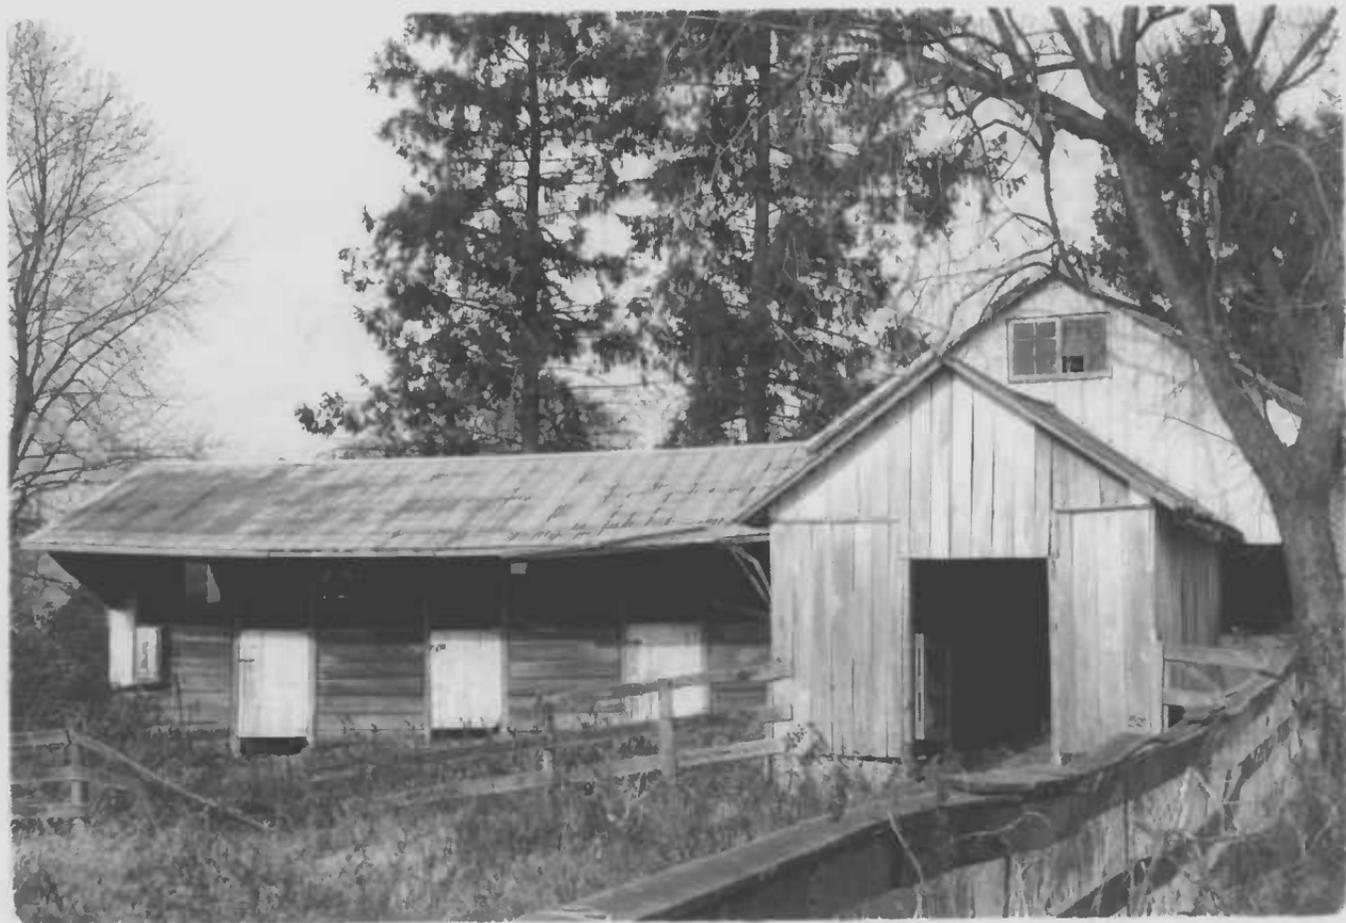
3 of 9

S. Thomas Magruder Farm (Outbldgs)

(Garage, Horse stable)

the mid 20th century. About the same time a garage and attached stable were built to accommodate the horse breeding business.

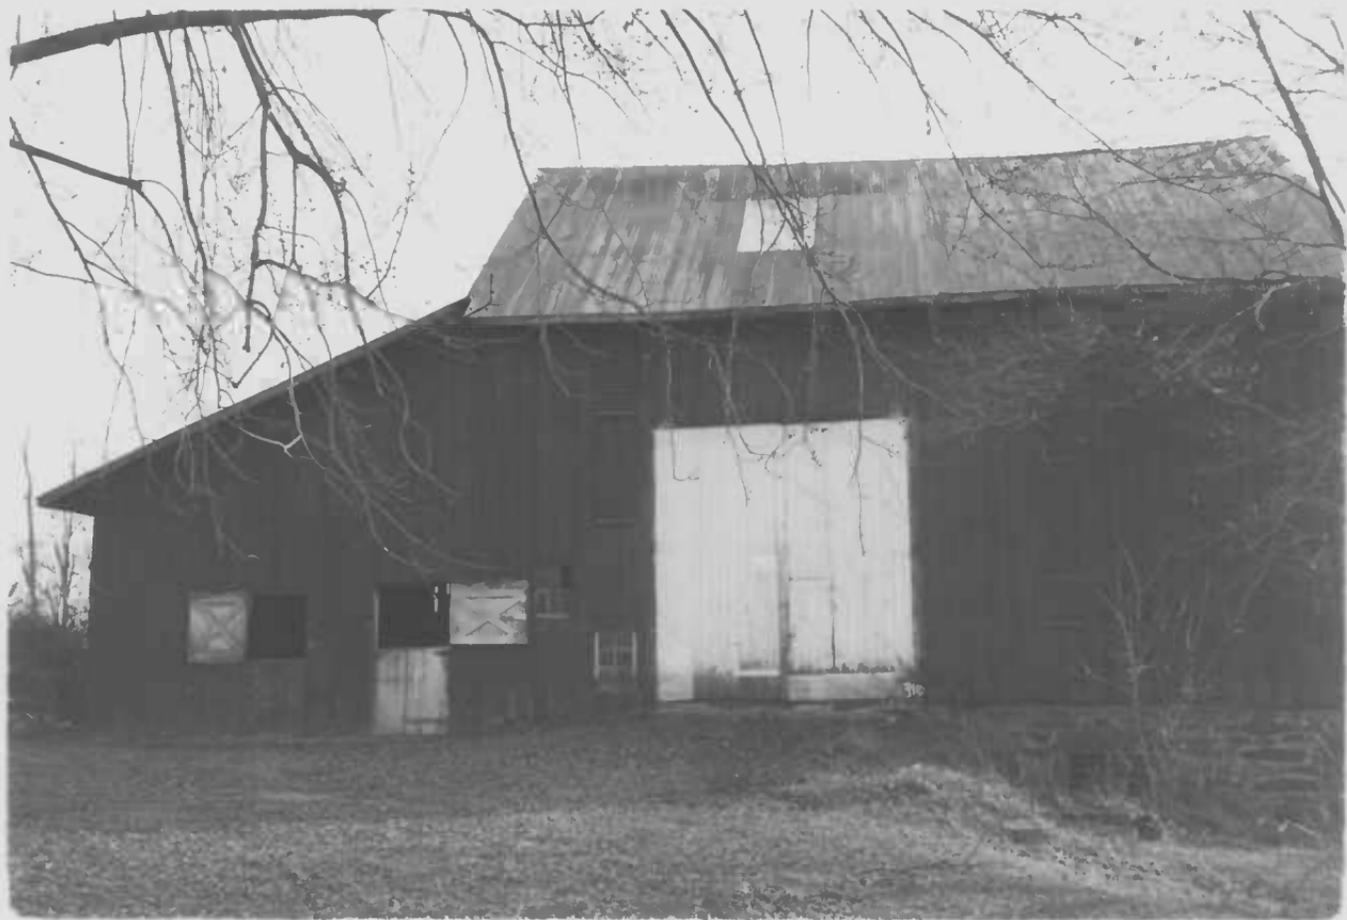
7 of 9

S Thomas Magruder Farm (^{Bank} ~~Bein~~)

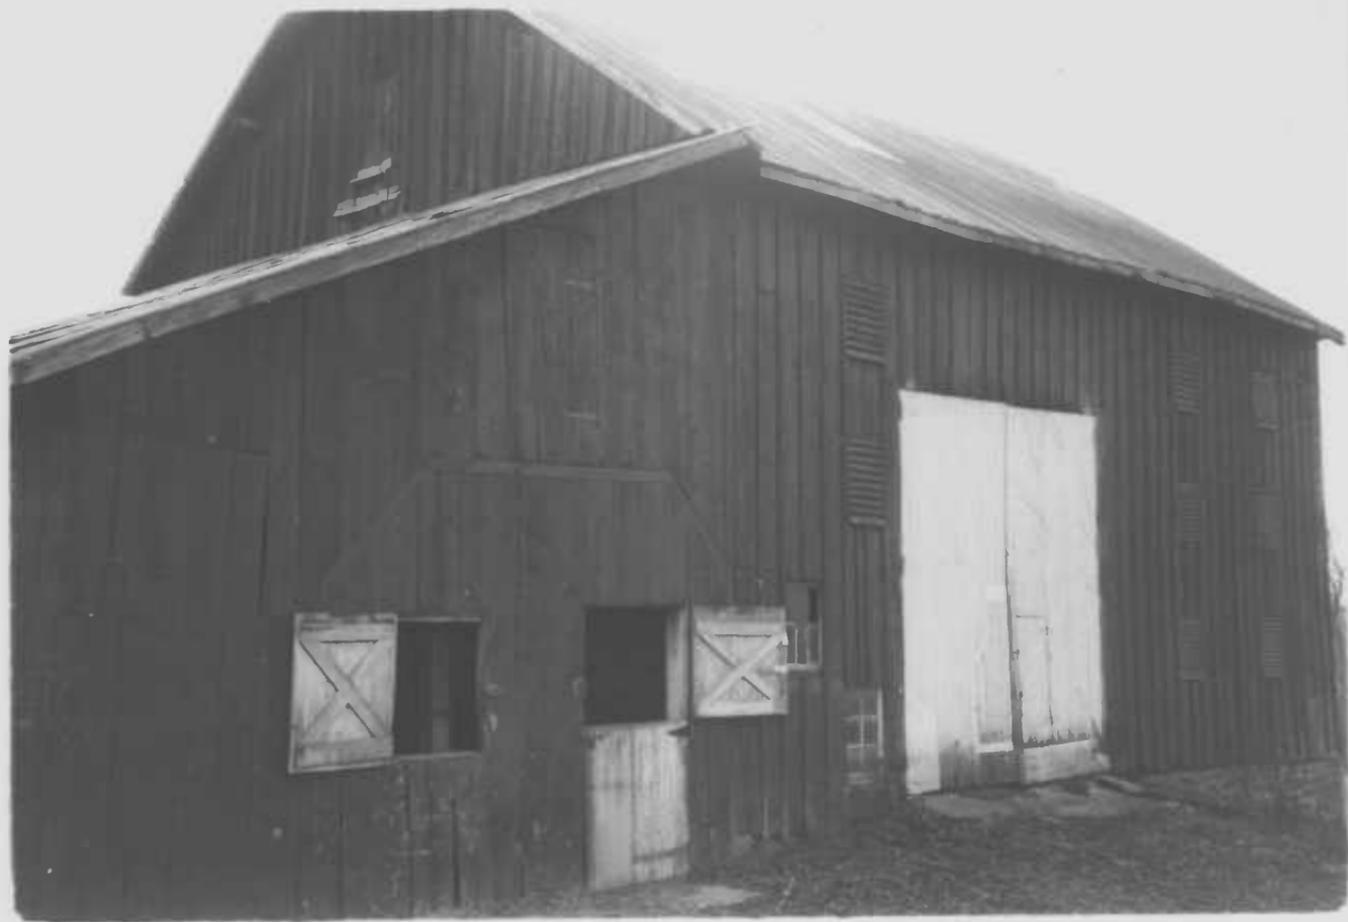
S Thomas Magruder Farm (^{Band} Barn)

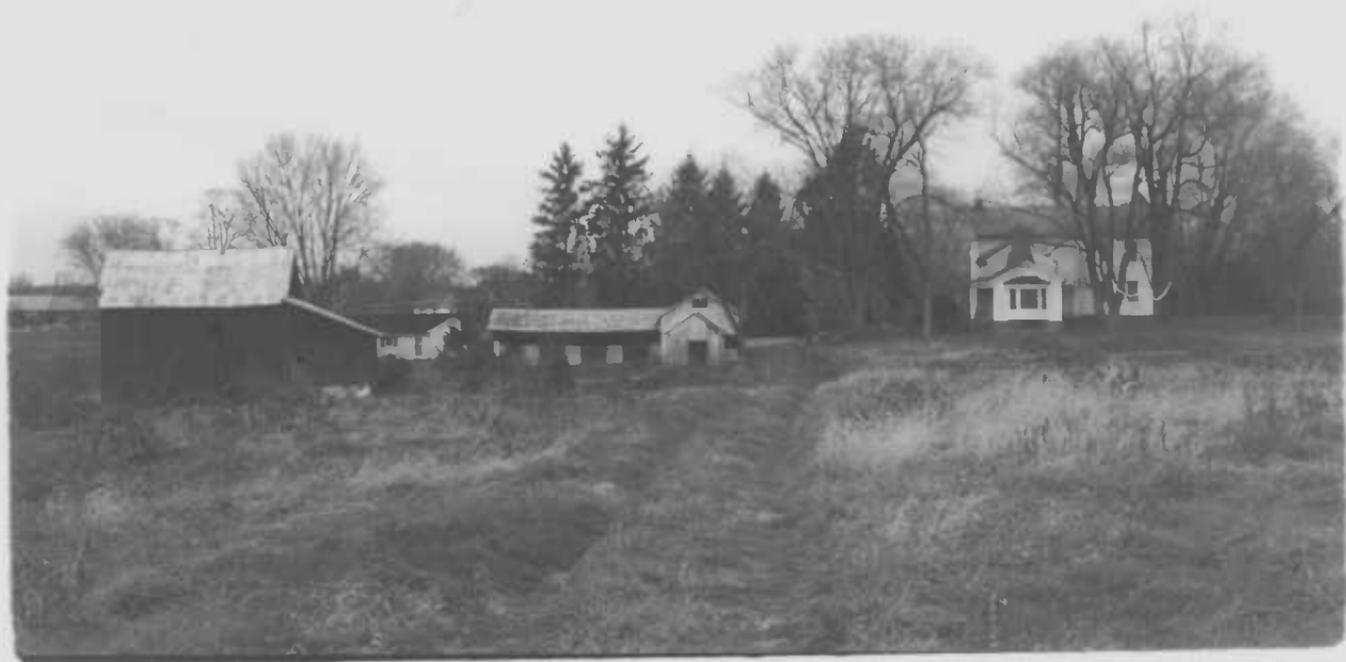
S Thomas Magruder Farm (VIEW ^{from field} OF HOUSE
& OUTBLOGS)
