The Annex / The King House

217 West Montgomery Avenue

Maryland Historical Trust State Historic Sites Inventory Form

Survey No. M.26/10/44

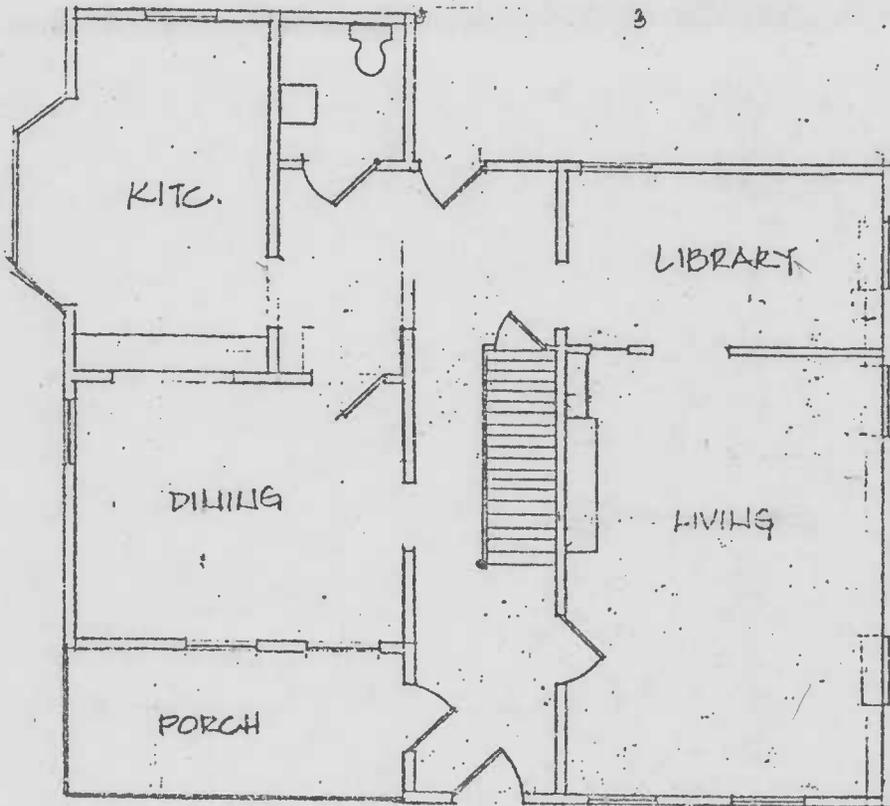
M: 26/10/44
The Annex/King House
Attachment 7.2

Interior See also floor plans 7.2, 7.3

The structure has a central entrance hall and stair with rooms flanking each side. The house maintains most of its original appearance except for a few modifications, such as the removal of a 2-over-2 double hung sash and the addition of a bay window in the kitchen. a large opening for counter space and visibility from the kitchen and dining room were also included in the kitchen renovation.

Millwork and carpentry features of the interior include: A large fireplace with panelled back wall in the living room; oak floors, moulding surrounds on doors and windows, decorative stair railings with turned spindles.

~~KINGS RESIDENCE~~

~~FIRST FLOOR PLAN~~

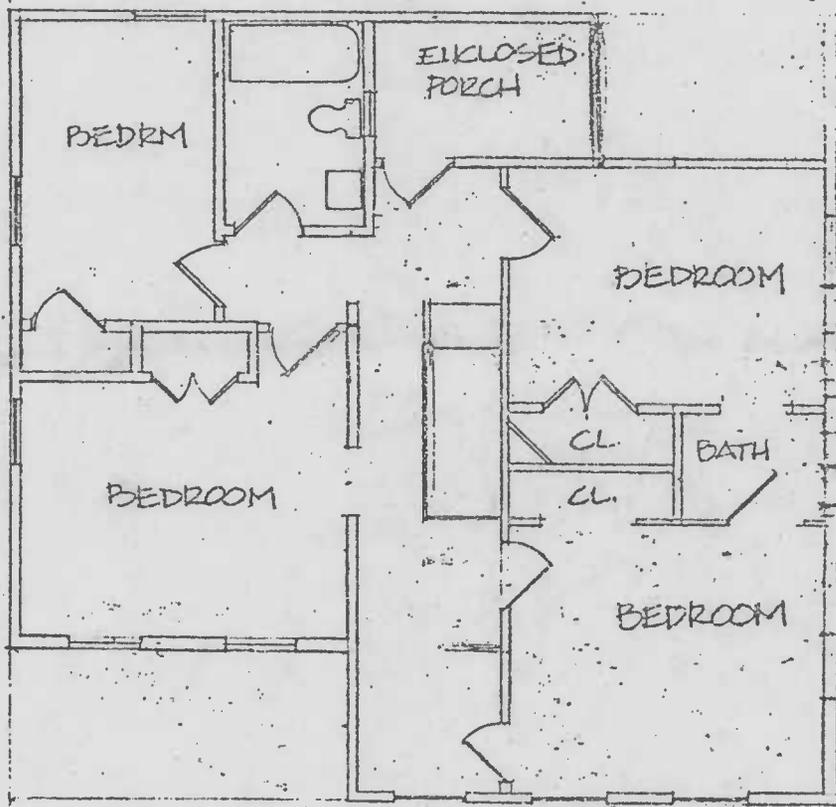
M: 26/10/44
The Annex/King House
Attachment 7.3

KING'S RESIDENCE
2ND FLOOR PLAN
NOT TO SCALE

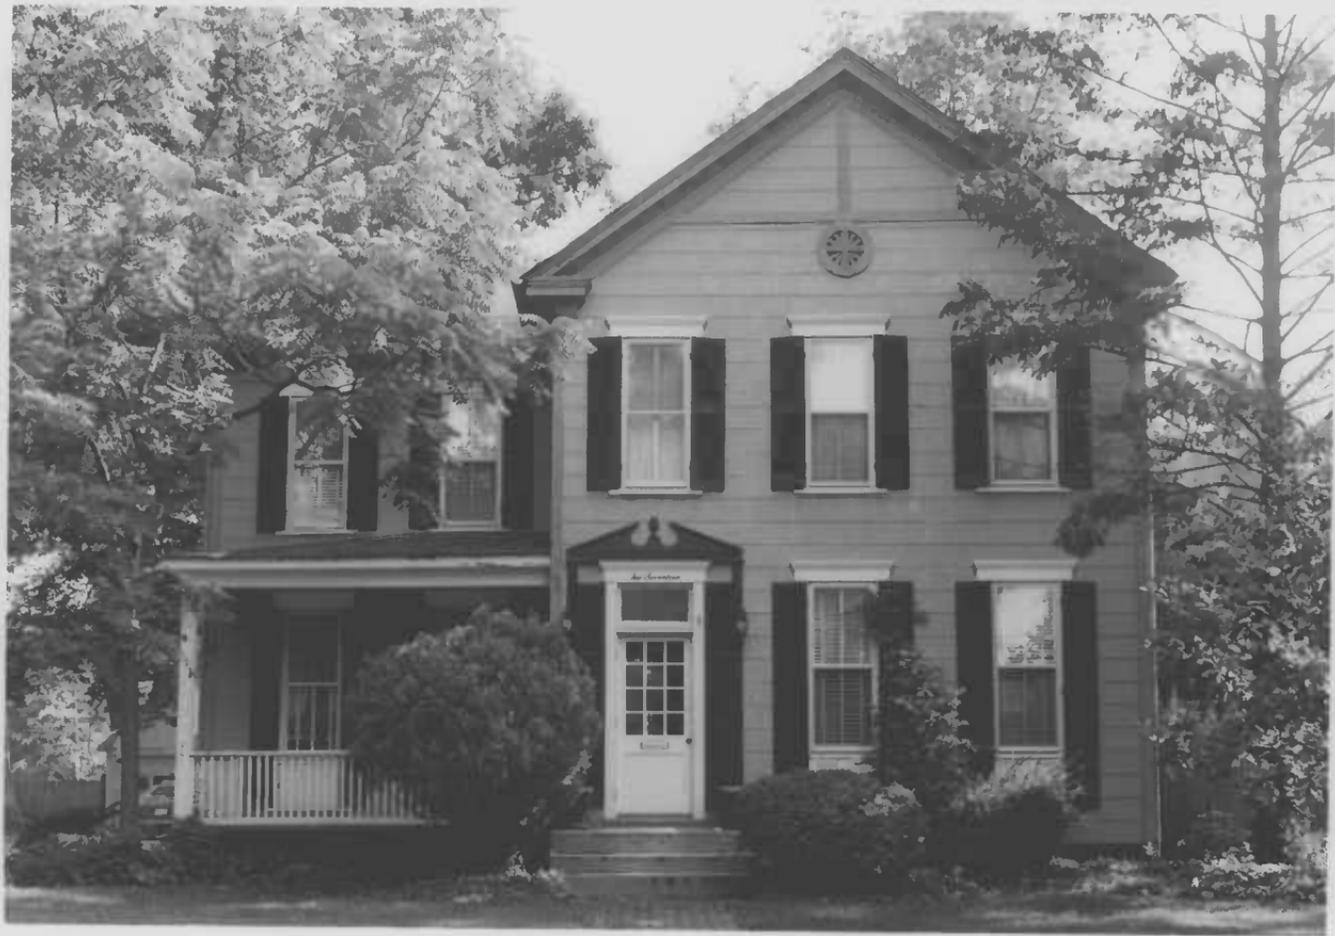
0695-12-1

The projecting three-bay, front gable south facade has an open pediment with return gable eaves. An ornate circular attic vent is located below the cross section of decorative vertical and horizontal framed design in the pediment. The second-story fenestration consists of single 2-over-2 double hung sash windows with moulded lintels flanked by wooden louvered shutters. The first bay of the first floor has an exterior 12-light wooden door with stained-glass transoms above. A broken pediment with decorative acorn finial, full-length louvered shutters, and moulding surrounds highlight the doorway. The front door is reached by a concrete stoop with three stairs; these are not original to the house. The second and third first floor bays have wooden inset panels below the 2-over-2 windows; louvered shutters extend the full length of the window and panel combination.

217 W. Montgomery Ave.
Rockville
So. Facade 6/85
#1872
Miz6/10/44

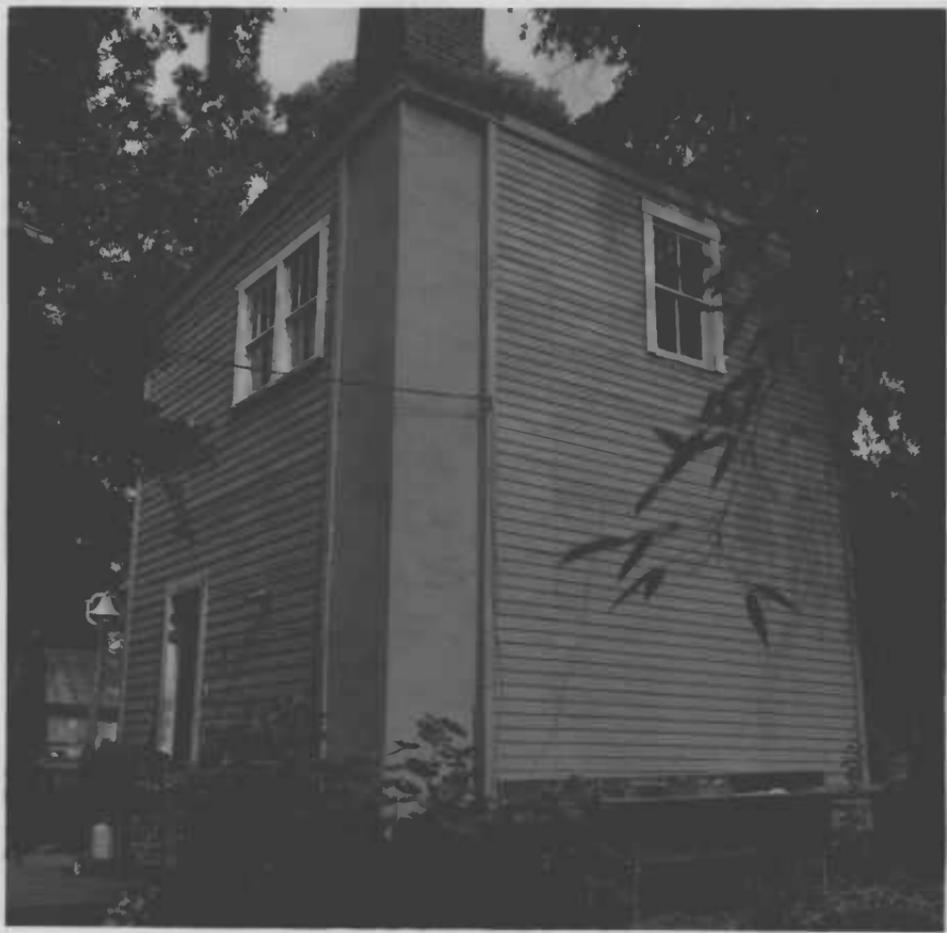
0885-16-5

The small two story two-bay by two-bay rear building has a large corner brick chimney and hearth. It is sheathed in 5" German siding with corner boards at the edges. It sits on a brick foundation.

The asymmetrical entrance facing the main building is raised and is reached by two steps. The door is a wooden cross-buck with diamond-shaped lights. There are nine 2-over-2 double hung sash window except for one 6-over-6 double hung sash on the second floor west facade. All doors and window are surrounded by moulded wood lintels. The roof has a protruding west eave and an almost flat asphalt-shingled roof. This building may have originally been a kitchen; it is now Mrs. King's studio.

M: 26/10/44
Outbuilding - 217 W. Montgomery Ave.
Rockville
8-85
