Site: M:26/10/55

The Conklin House

411 West Montgomery Avenue

Maryland Historical Trust State Historic Sites Inventory Form

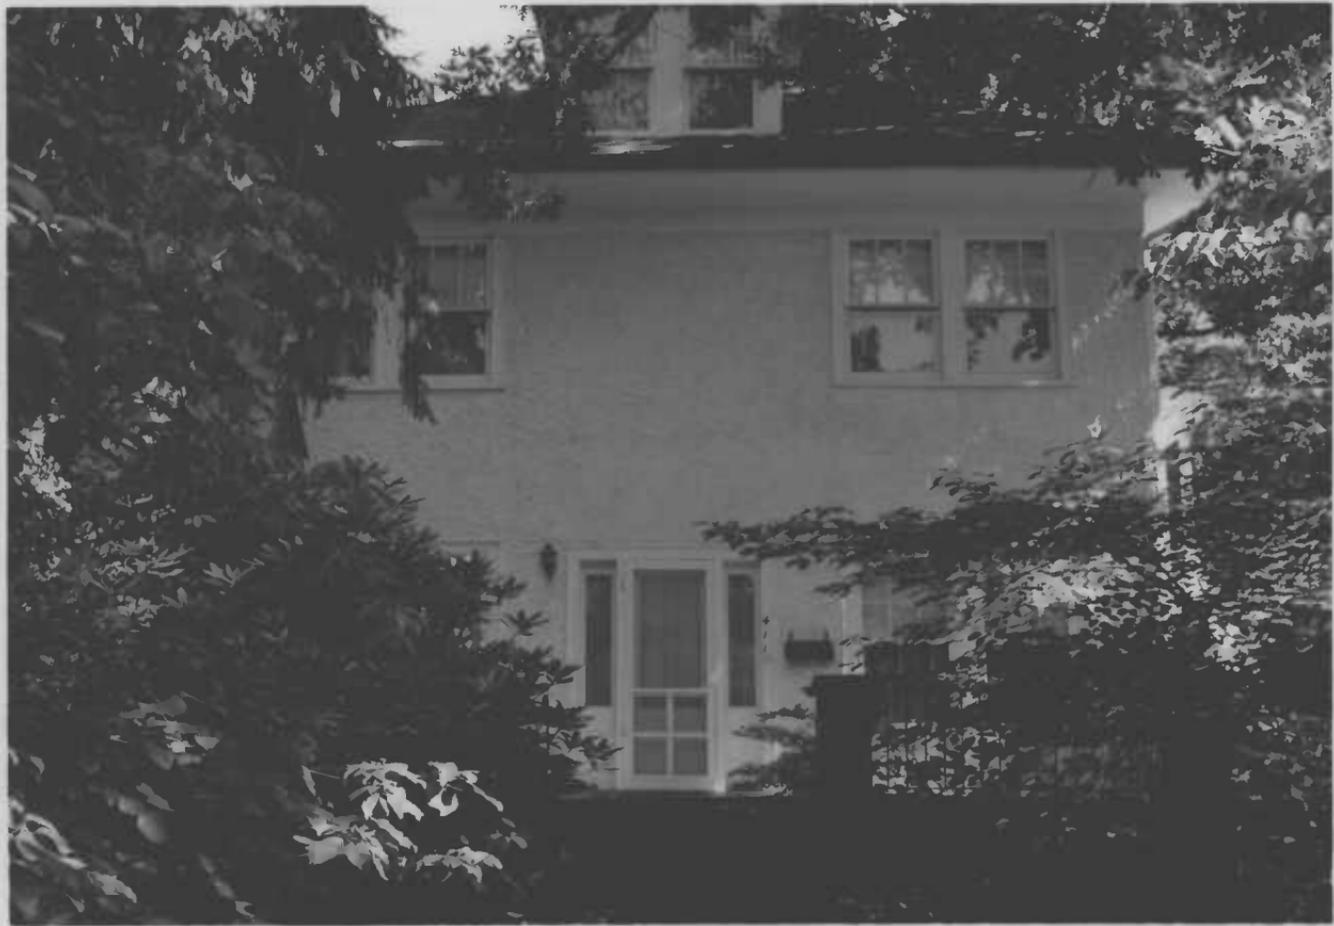
m: 26/10/55
Conklin House
411 W. Montgomery Ave
Rockville S facade
8-85

The front facade is asymmetrically arranged, with paired windows on each corner on both stories. A central exterior door containing a large window and having flanking sidelights serves as the principal entryway. Paired windows also are located in the dormer. An uncovered porch with cement foundation and capped cement piers connected with an iron balustrade stretches across the full facade.
