Site: M:26/11/12

Dawson Store/Burbanks

18,20 West Montgomery Avenue

State Historic Sites Inventory Form

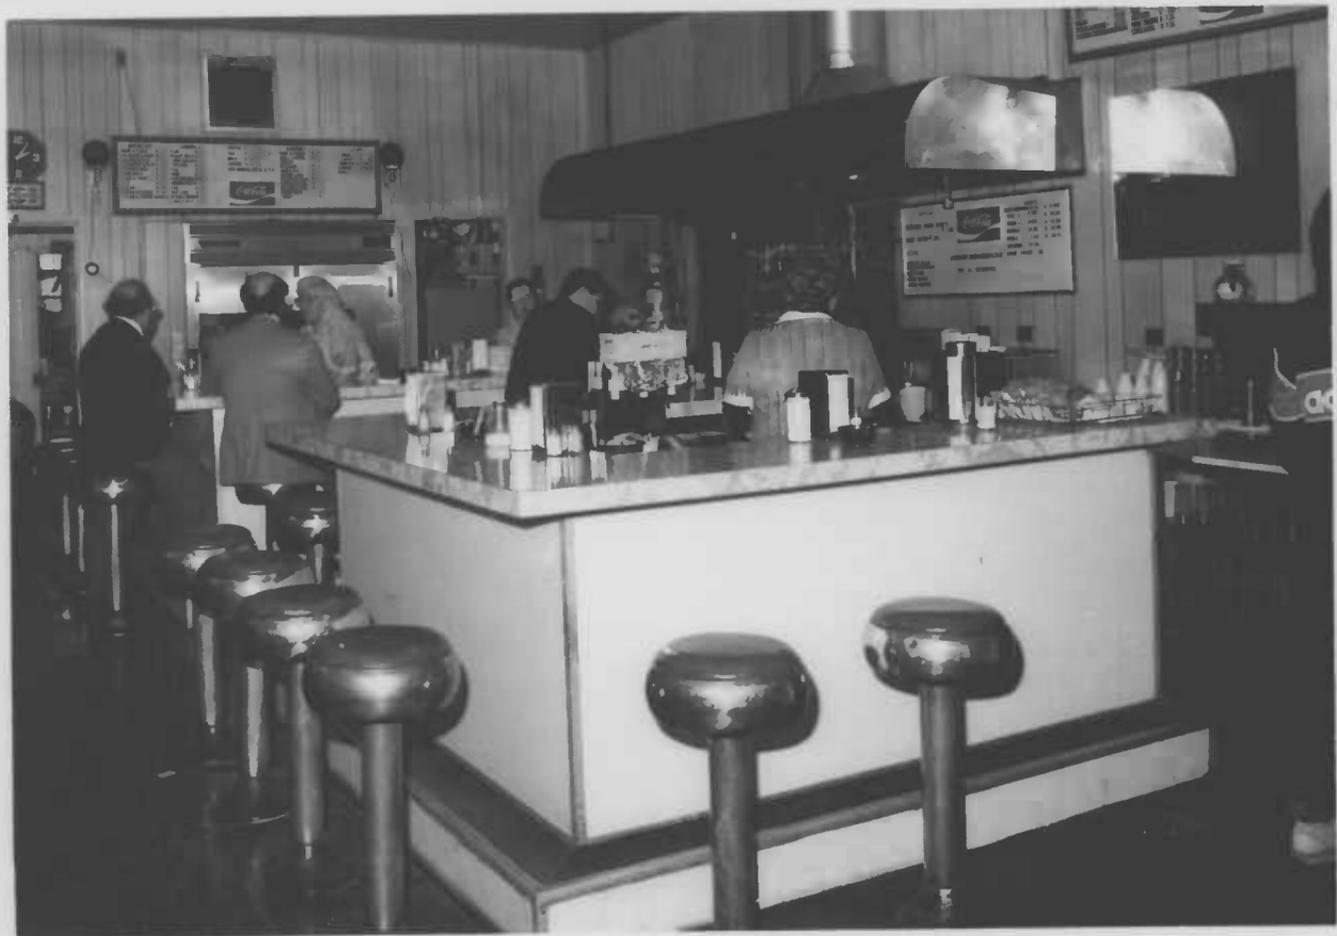
04860601

The interiors of both stores have been altered with paneling and updated materials. The western side or "Burbanks," however, still contains its early luncheonette counter and stools.

M: 26/11/12
18-20 W. Montg. Ave.
Rockville
interior
5-86
