Clarence W. Johnson House

403 North Van Buren Street, Rockville

Maryland Historical Trust State Historic Sites Inventory Form

Survey No. M: 26/16/15

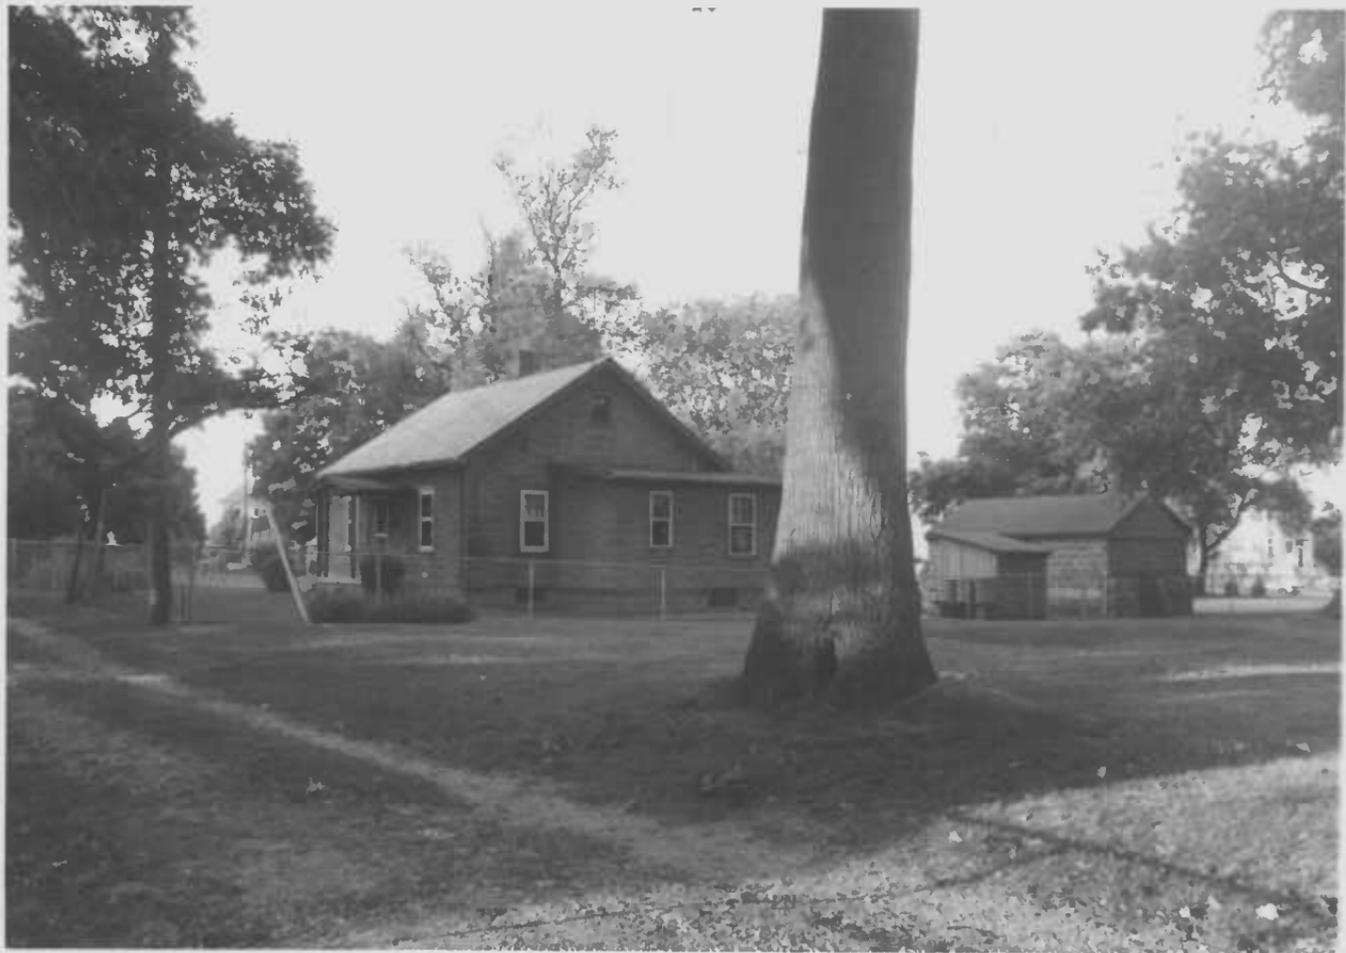
Clarence Johnson House

This 1-1/2 story rectangular three-bay by two-bay house has central doors front and rear covered by wide porches. There is a central plain brick chimney on the composition-shingled side-gabled roof. The exterior is clad with buff asphalt brick shingles. The windows are 6/6 with plain surrounds and aluminum storm windows. The foundation is beveled block.

The three-bay west (front) facade has one window in the north bay, one in the south bay, and a central wood exterior door, paneled with a large (2/3 height) single glass light. The wide front-gabled portico is supported by square corner posts and rests on a concrete stoop accessed by one concrete step.
