**National Register of Historic Places
Inventory—Nomination Form**

historic Dawson Farm (preferred)

and/or common "Rocky Glen"

street & number 1070 and 1080 Copperstone Court n/a not for publication

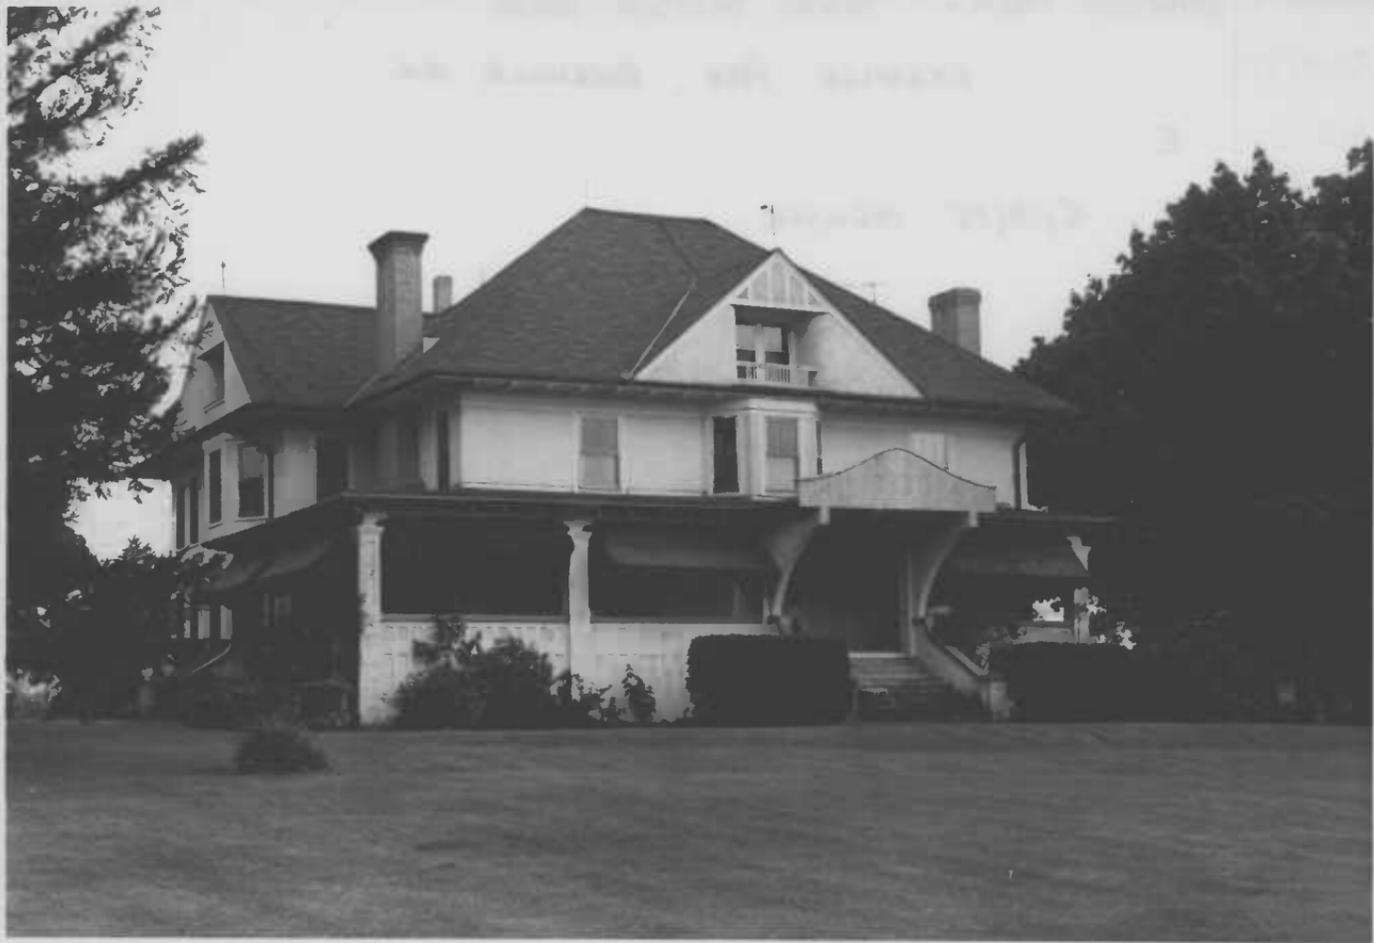
M: 26-19

NAME DAWSON FARM- HENRY DAWSON HOUSE

FACADE E

1912 farmhouse. This four bay by seven bay, 2½ story T-shaped house sits on a hill at a considerable distance from Rockville Pike facing northeast.

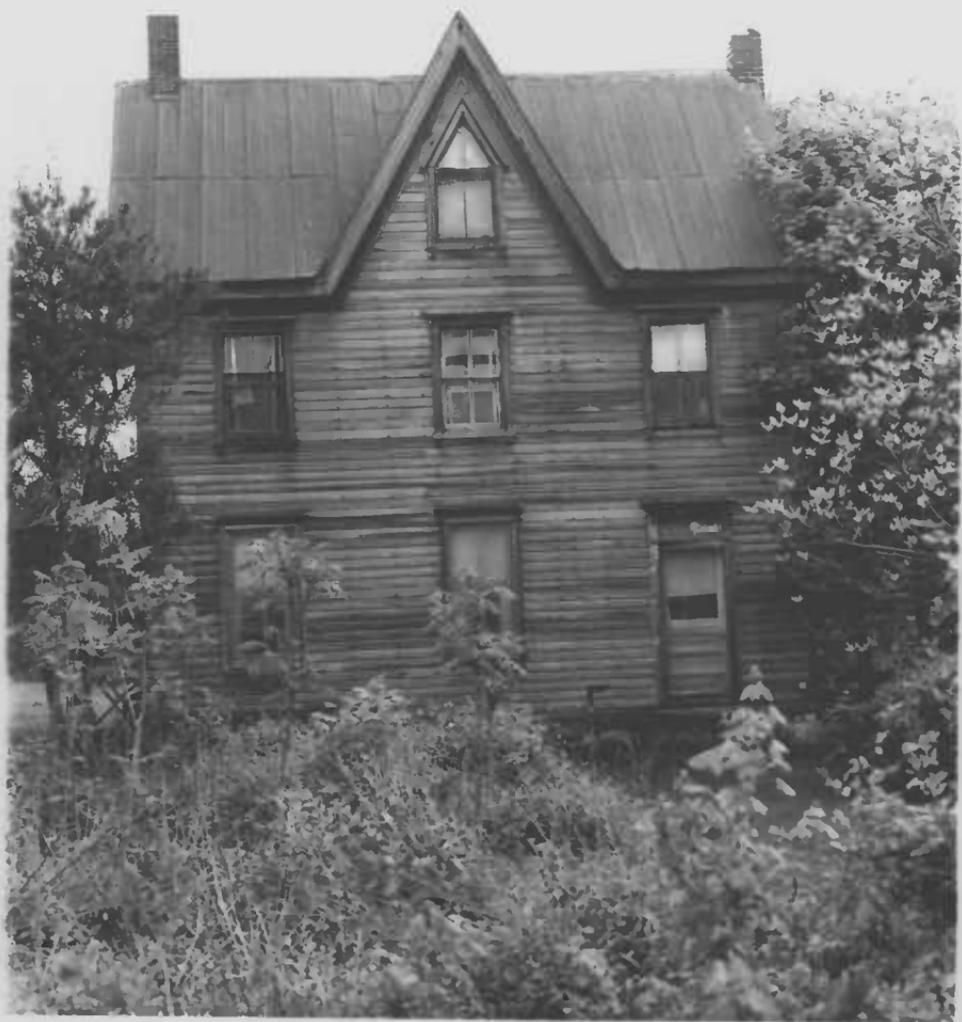
M: 26-19

NAME DAWSON FARM - LAWRENCE DAWSON HOUSE

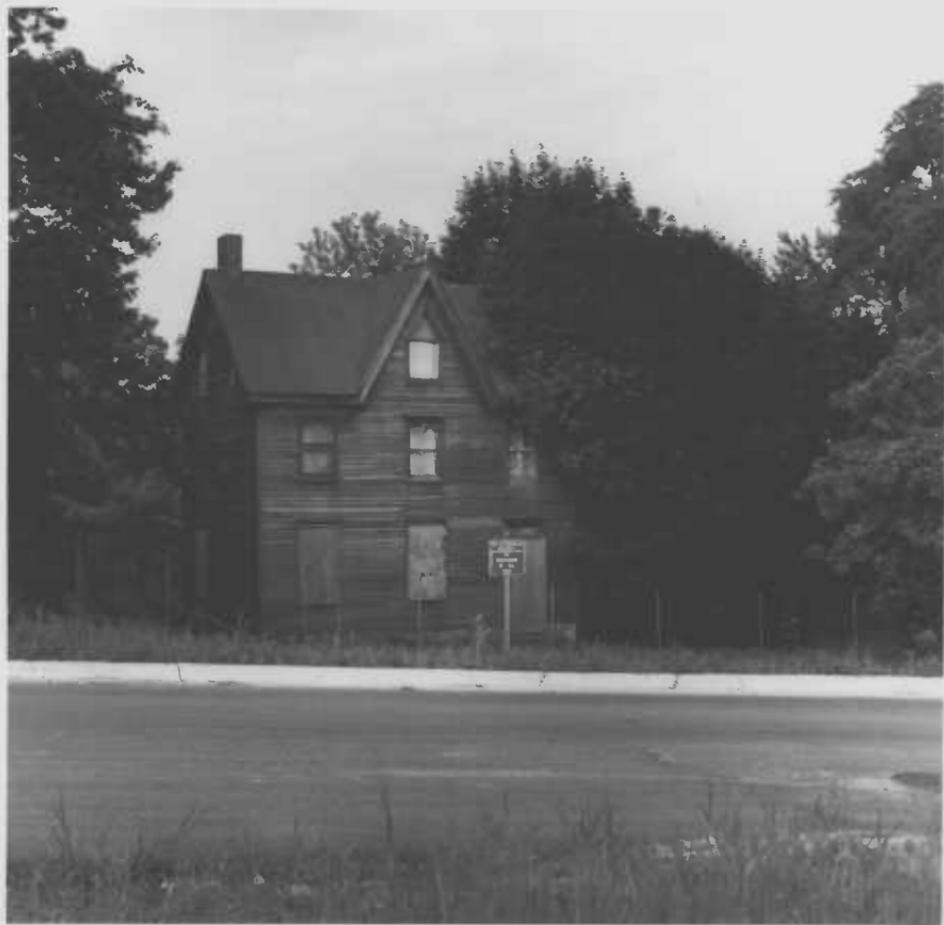
#1 of 9

Dawson Farm
Montgomery County, Maryland
August 1982
Photo: ViCom Photographers
Neg: MD Historical Trust, Annapolis, MD
1874 Dawson farmhouse, east (front) facade
1/9

#1 1874 Dawson farmhouse,
East (front) facade

The 1874 Dawson farmhouse is a vernacular farmhouse reflecting the influence of the Gothic Revival style. It is a 2½ story rectangular frame building, 3 bays wide and 2 bays deep. The steeply pitched "A" roof features a steep pointed center gable. There is an original narrow, interior brick flue in the south gable wall. Decorative exterior features include a transom over the front door, dentiled box cornice, and German siding on the front (east) facade). There is a fieldstone foundation. The original wood shingle roof was later covered with metal; The metal has recently been replaced with wood shingle. All windows are 2-over-2 double hung sash; shutters were removed long ago.

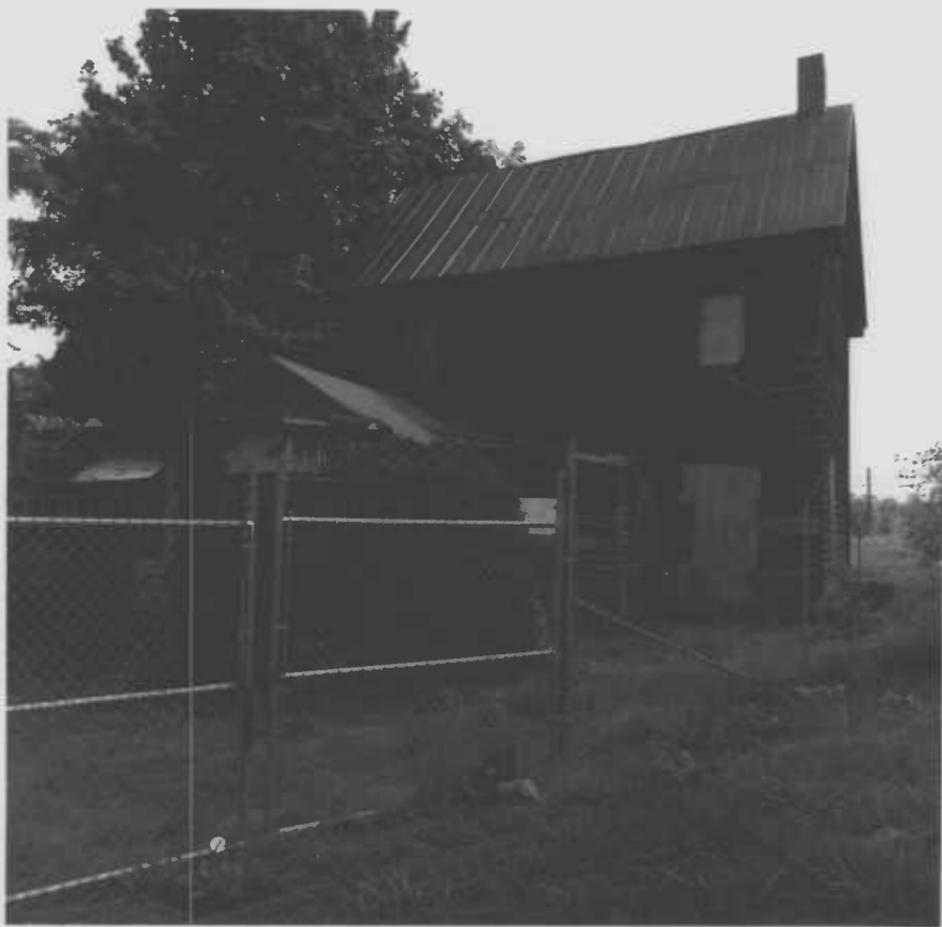
~~#2 of 9~~

West facade (rear)

In the 1930s, the earlier 1852 section to the west of the 1874 addition was demolished. A one-story, two part addition was constructed in the late 1940s; it contained a kitchen and small bath. In 1983, these unsightly appendages were removed and a 1½ story replacement was constructed to the west of the main block. The compatible, shed-roofed addition is set in slightly to distinguish it from the 1874 block. It has two shed-roofed dormers and double multi-paned doors on the west facade, and a door on the south facade. The plain clapboard and the two-over-two double hung windows duplicate those in the 1874 block.

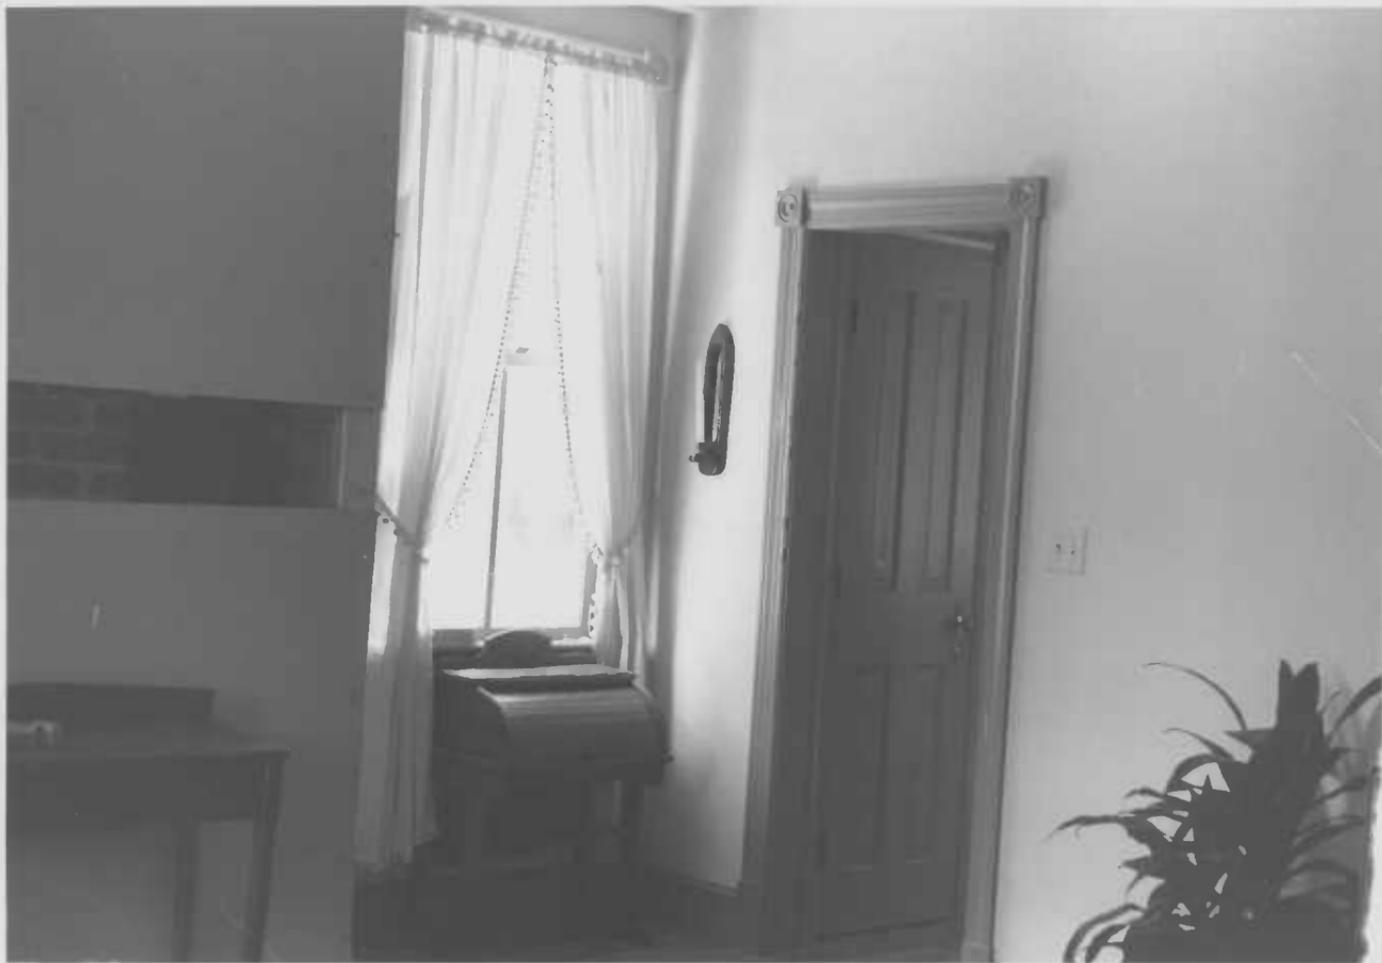
Dawson Farm M: 26-19

1874 hse 1080 Cooperstone Ct
Rockville
