NATIONAL REGISTER OF HISTORIC PLACES INVENTORY -- NOMINATION FORM

Corby Estate

10701 Rockville Pike (at Strathmore Ave.)

INVENTORY FORM FOR STATE HISTORIC SITES SURVEY

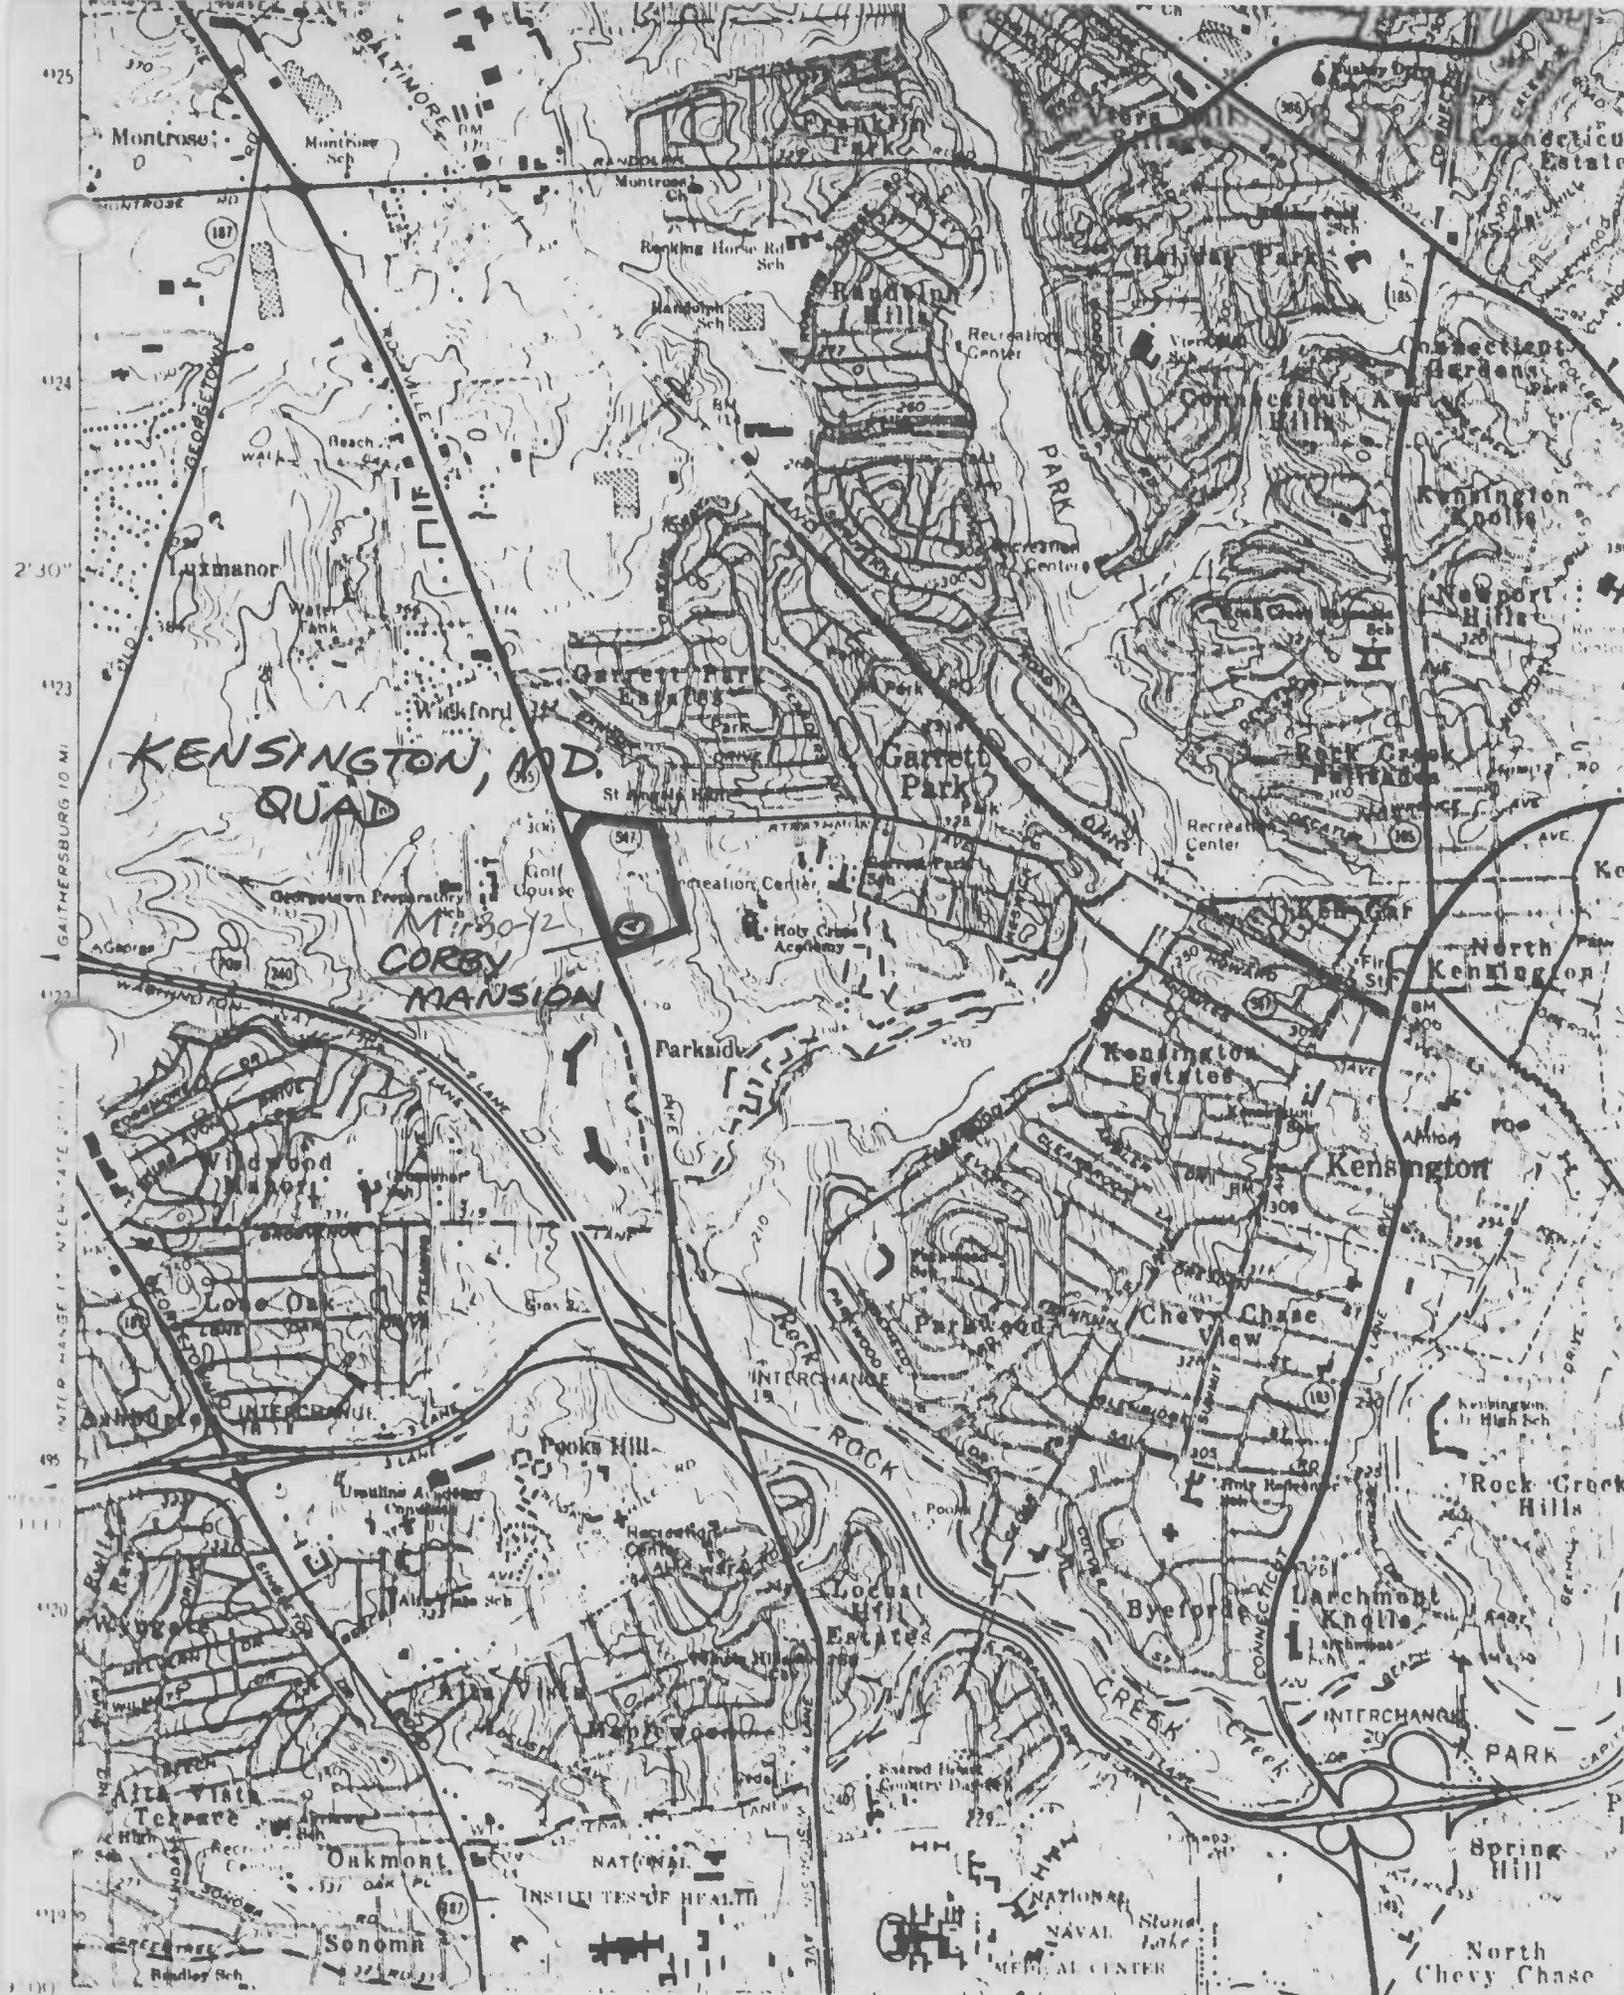
M:30-12
CORBY
MANSION

KENSINGTON, MD.
QUAD

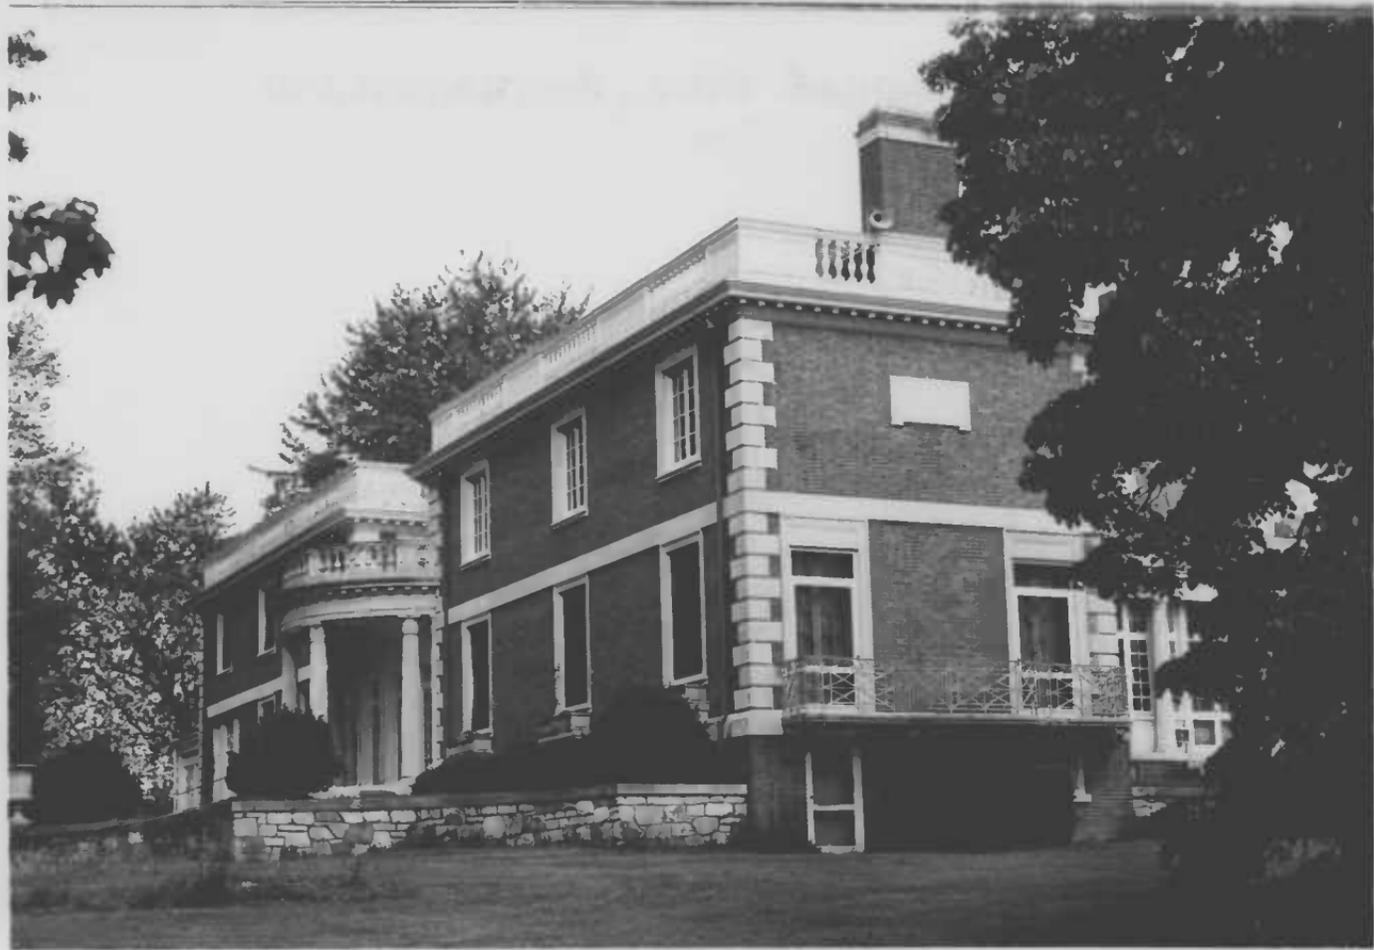
CORBY ESTATE

FACADE

NW

This is a huge, opulent brick building, built to resemble a magnificent Georgian mansion. The house is built in the shape of a T, with the leg of the T extending south from the central entrance of the building. This central entrance is located in the (north) main facade, and is accented by a columned, flat-roofed, stone portico, that features an ornate balustrade on the roof. This one-story entrance is flanked on either side by two-story, three-bay blocks of identical design. Each block has a hip roof covered with slate shingles. Large chimney stacks project from within the end walls. Carved stone balustrades surround the entire roofline of each block. The molded cornices have dentil rows. The brick walls are laid in Flemish bond, and have white marble quoins at each corner. The white marble trim also appears in the water-table, window frames and sills, and a wide belt course between the first and second stories.

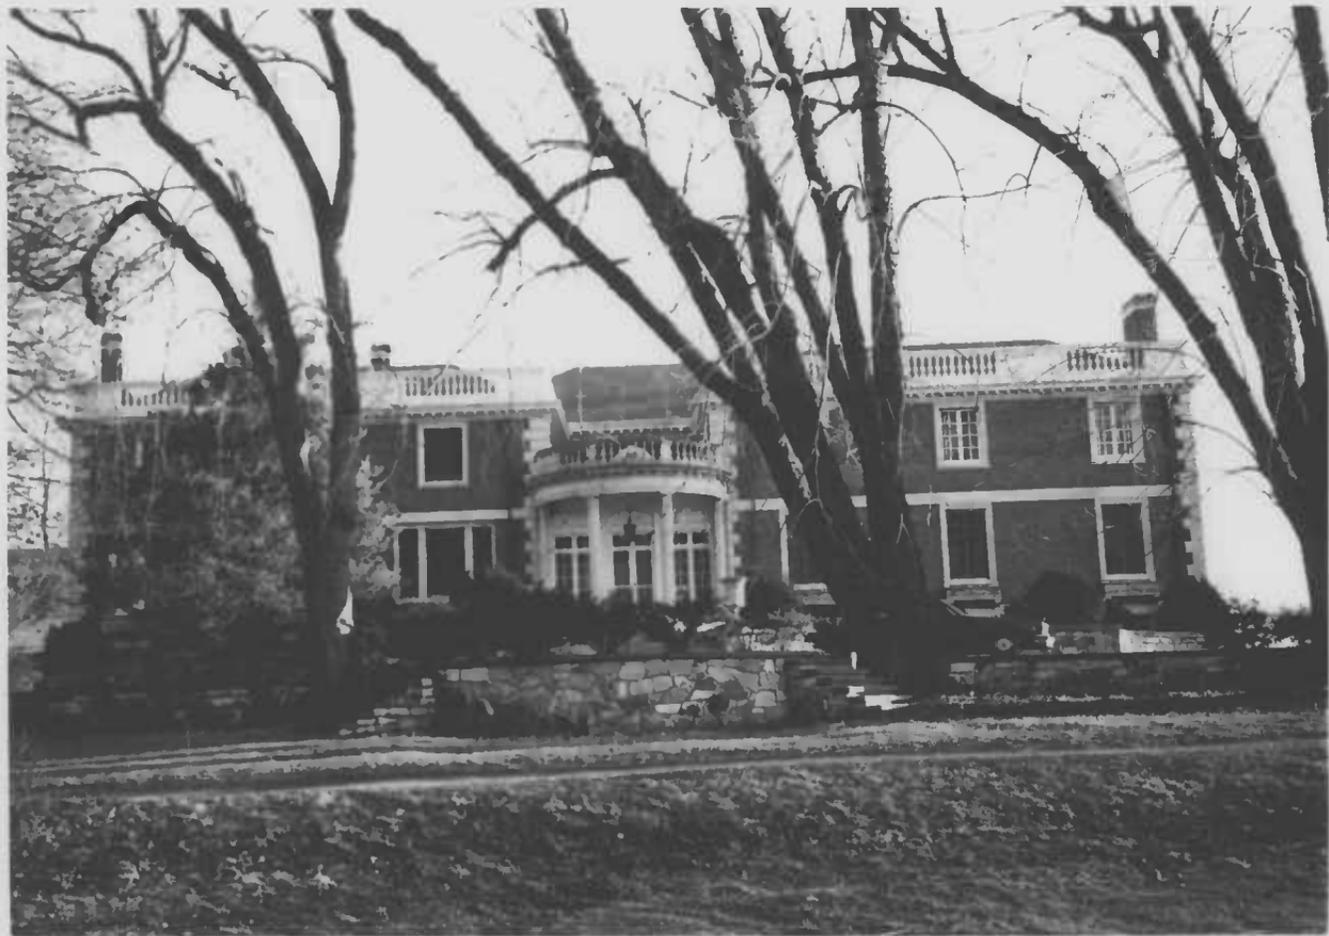
front facade

The Charles Corby Mansion is located on the east side of U.S. Route 355, Rockville Pike, five miles north of the Maryland-Washington, D.C. line in Montgomery County, Maryland. It is a Colonial Revival house dating from the early twentieth century designed in the shape of a T with the leg of the T extending south from the central entrance of the building terminating in the garden facade. The principal (northern) entrance is accented by a semicircular stone portico with fluted Doric columns and a flat roof featuring an ornate balustrade. This one story entrance is flanked on either side by identical two-story blocks of three bays, each having a hip roof covered with slate shingles. Large stone-capped chimney stacks project from within the end walls, and carved wooden balustrades surround the entire roofline of each block. The garden (southern) entrance is emphasized by a central two-story Ionic portico having a slate deck and a pediment with richly carved modillions. This two-story, three-bay central pavillion has a hip roof of slate shingles and two interior chimneys projecting above the west wall and one stone-capped chimney on the east. There is a molded cornice with dentils surrounding the entire house. The brick walls are laid in Flemish bond and have white marble quoins at each corner. White marble trim also appears in the water table, window frames and sills, and a wide belt course between the first and second stories. A wrought iron balcony projects from the end wall of the west block and from the second story in the south portico. In each angle of the T is a one-story unit with parapet walls on four sides surrounded by fluted Doric pilasters.

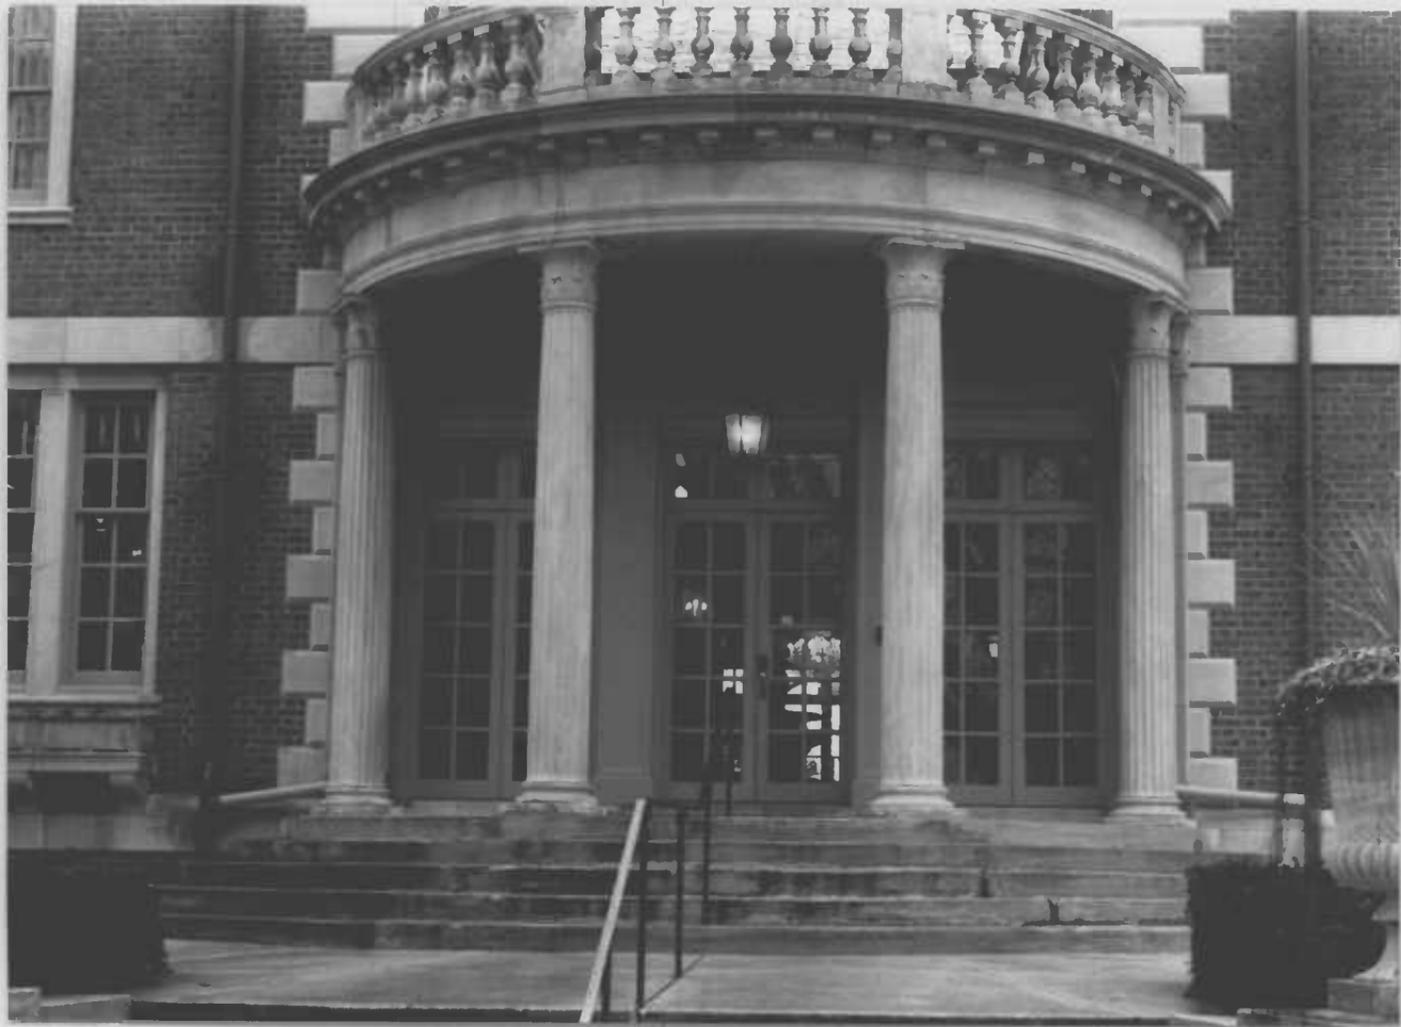
No. 30-13

(Cover, East)

Front Portico
Strathmore Hall
Montgomery City.
