PRINCE GEORGE'S COUNTY  
HISTORIC SITE SUMMARY SHEET

Building Name: St. Thomas Church Rectory

Location: 10108 Croom Road, Upper Marlboro MD 20772

# Maryland Historical Trust State Historic Sites Inventory Form

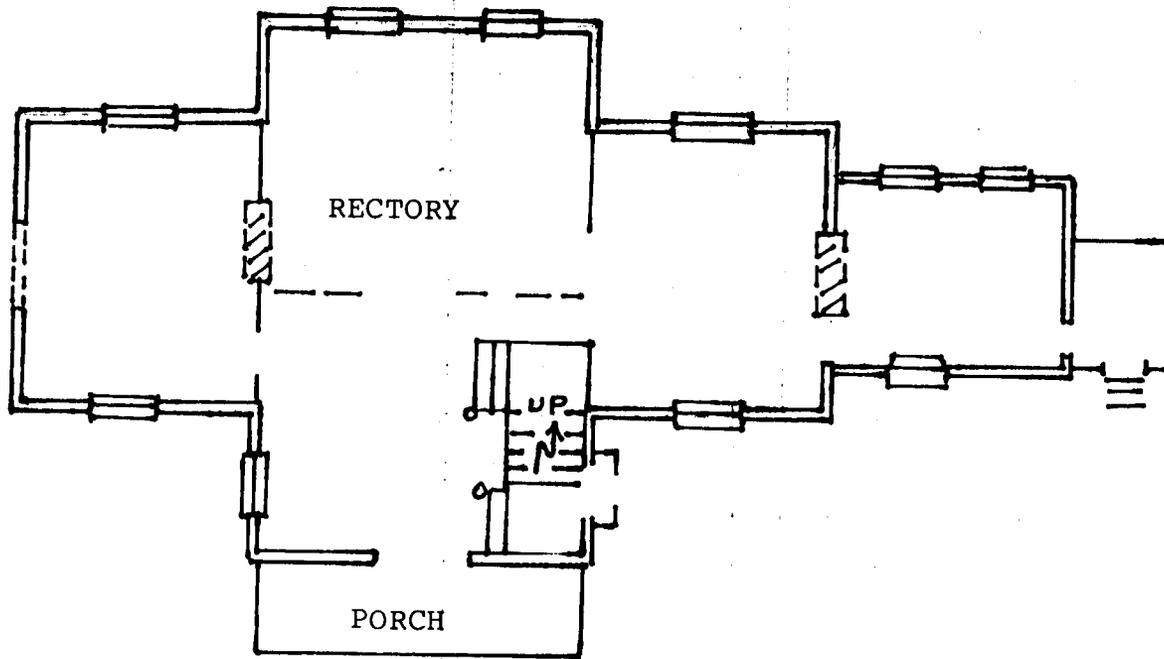
ST THOMAS' RECTORY

The unpaved drive ends in a circle (enclosing a small garden space) just south of the house. Fronting on this circle is a small front-gabled garage structure with vertical siding. Just south of the house, there are several cedars on the west, and a holly and several more cedars on the east. There are woods along the perimeter of the property to east, west and south, and a horse paddock to the north.

An old logging road splits off from the drive approximately 50 yards west of the house, and leads north to a turn-of-the-century tenant house (Sexton's House) and a modern stable building; a large and ancient oak marks the intersection of the logging road with the drive.

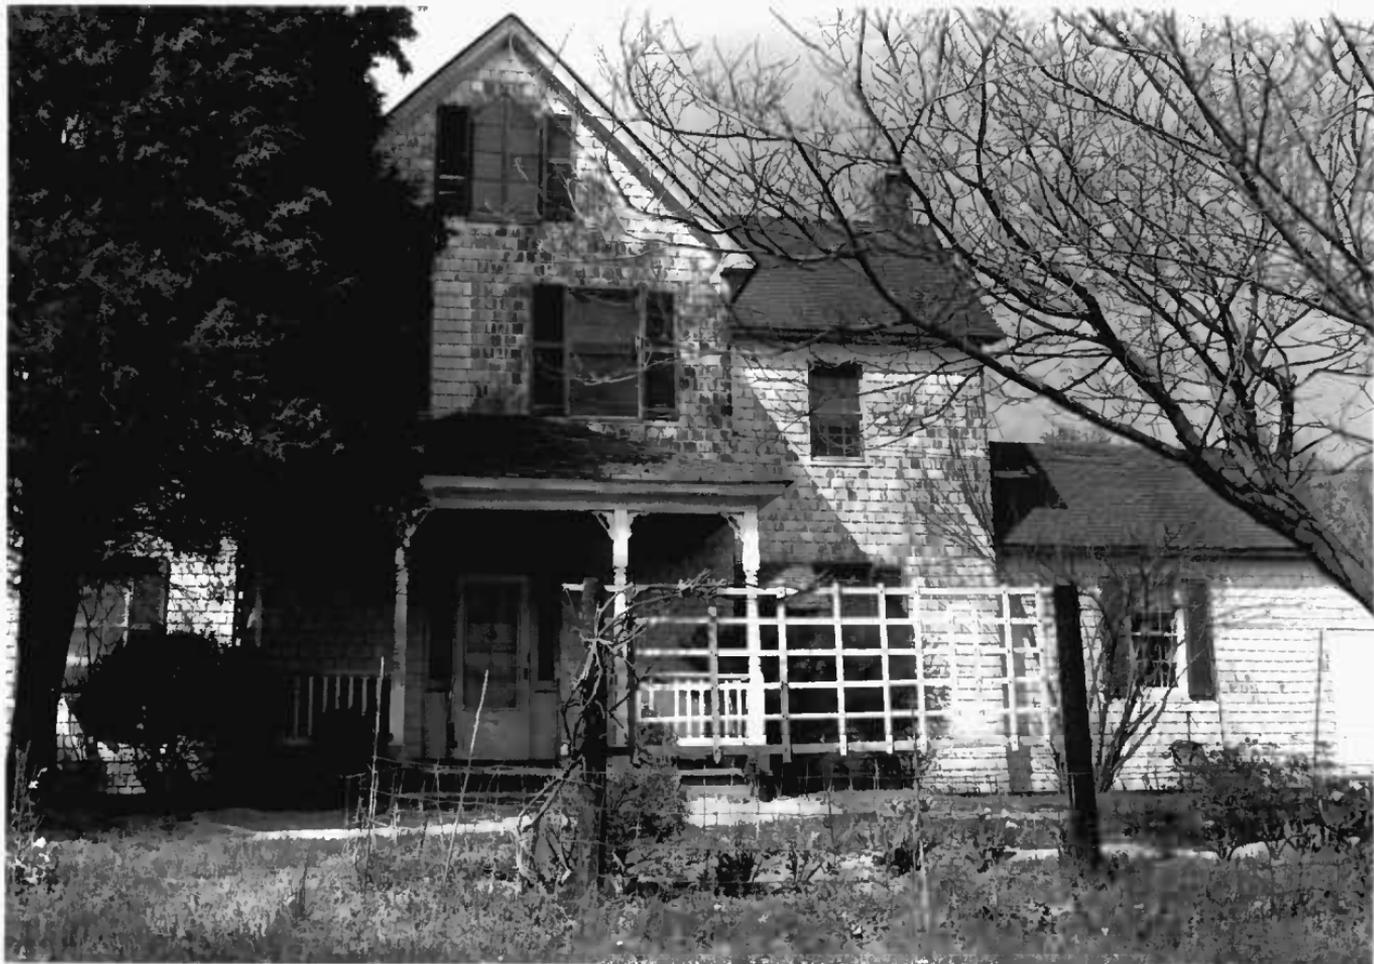
P.G. #86A-8

St. Thomas' Rectory  
Prince George's County, MD.  
Susan G. Pearl  
April 1985  
South elevation  
Neg: Md. Hist. Trust, Annapolis, MD.

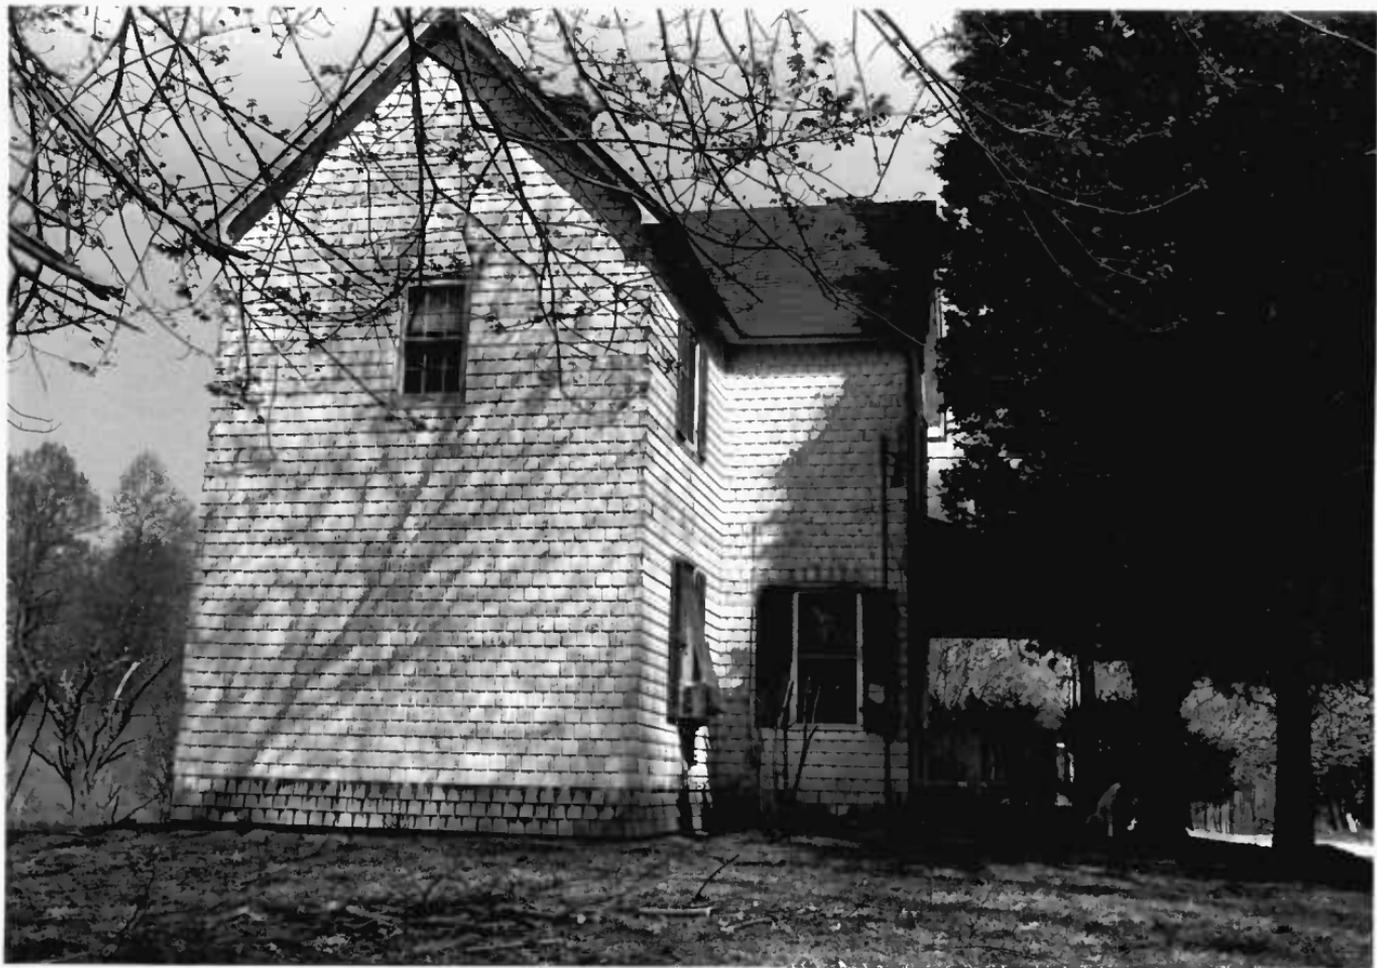
P.G. #86A-8

St. Thomas' Rectory  
Prince George's County, MD.  
Susan G. Pearl  
April 1985  
West elevation  
Neg: Md. Hist. Trust, Annapolis, MD.

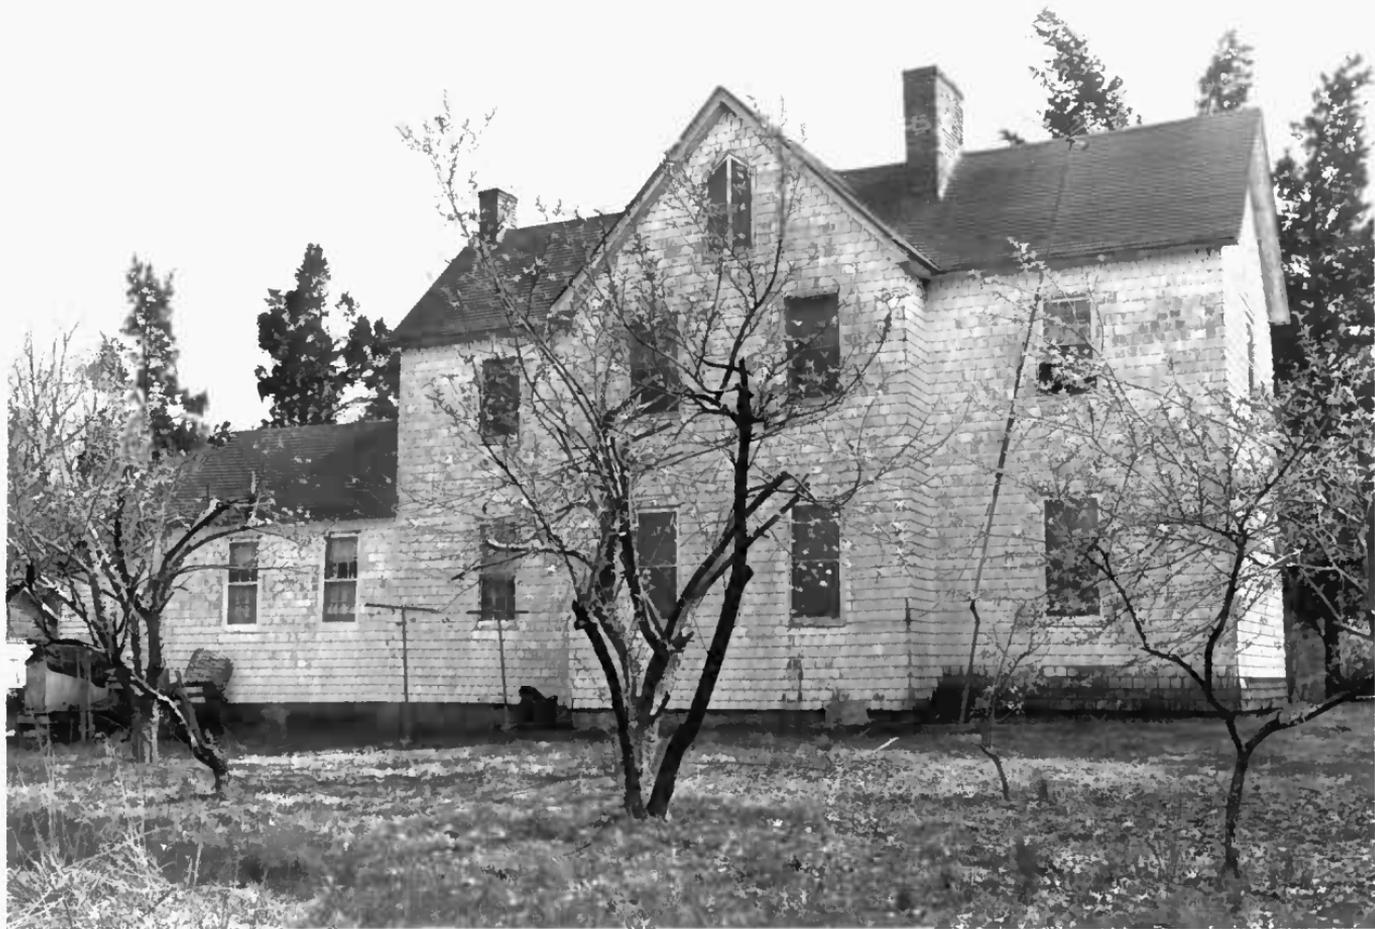
P.G. #86A-8

St. Thomas' Rectory  
Prince George's County, MD.  
Susan G. Pearl  
April 1985  
North elevation  
Neg: Md. Hist. Trust, Annapolis, MD.
