S-32
Millwood
Mt. Vernon vicinity
private

Maryland Historical Trust State Historic Sites Inventory Form

Survey No. S-32

and/or common Millwood

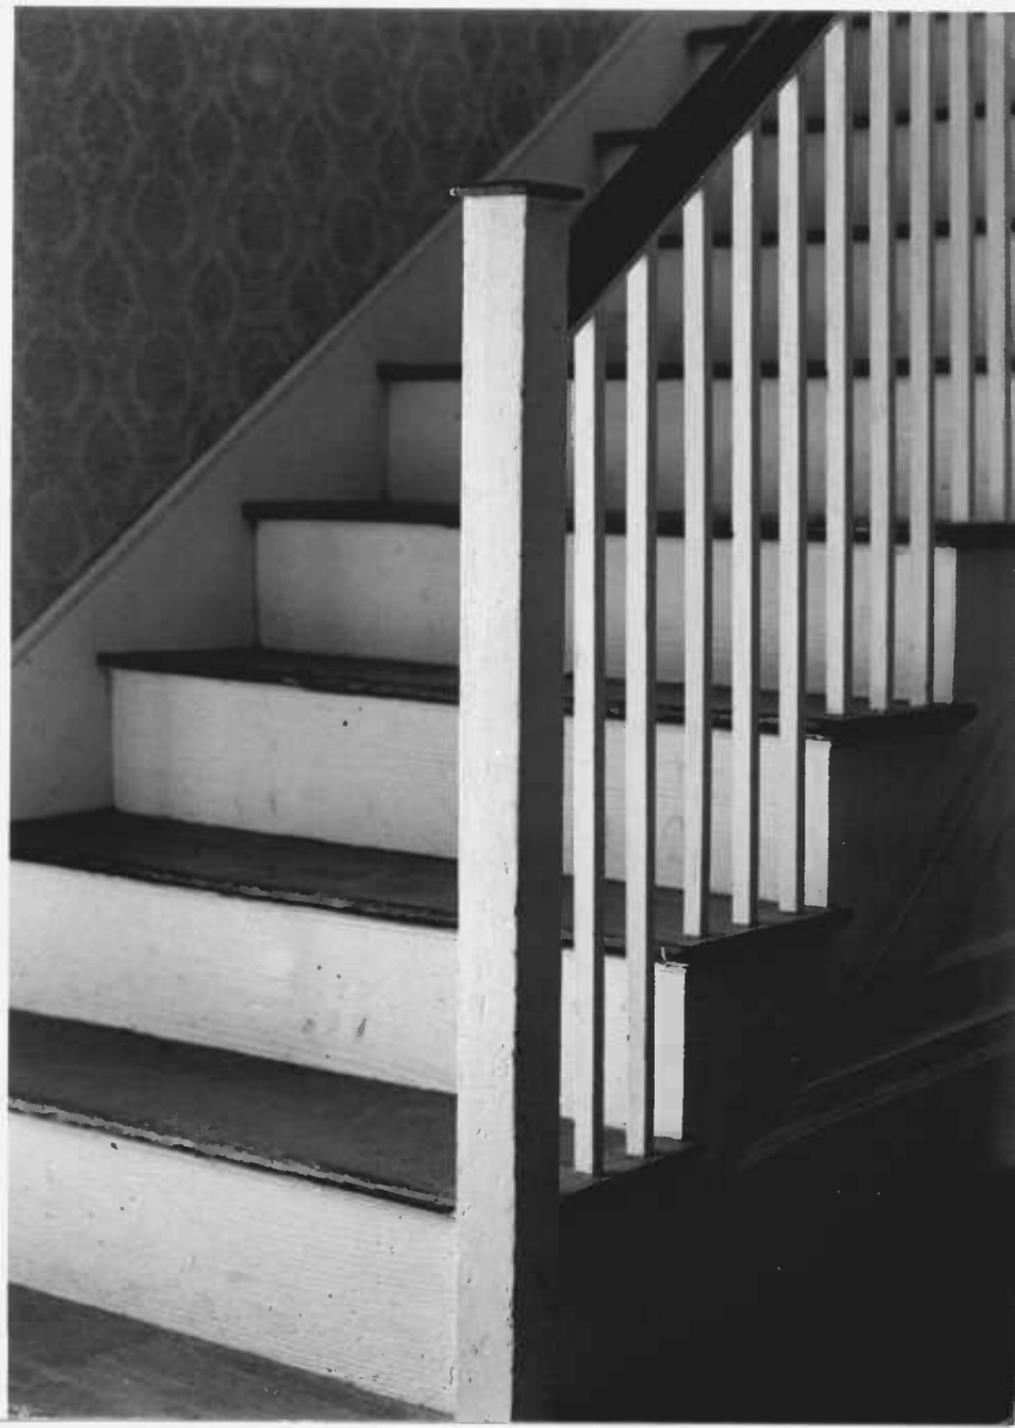
Newel Post

The interior has not been significantly altered. The transverse hall contains the principal dog-leg stair that rises in the southwest corner. A square newel post and rectangular balusters support a circular profile handrail. The stringer is undecorated, but the area below the stringer consists of flat panels. A paneled door closet opens into the space under the stair. On the east and west side walls it is clear the beaded baseboard has been patched to cover old door openings. In addition to baseboard moldings, the passage walls are trimmed with early nineteenth-century chair rail. The north wall of the passage is pierced by two six-panel doors framed by period surrounds. Some of the panels have been replaced with glass.

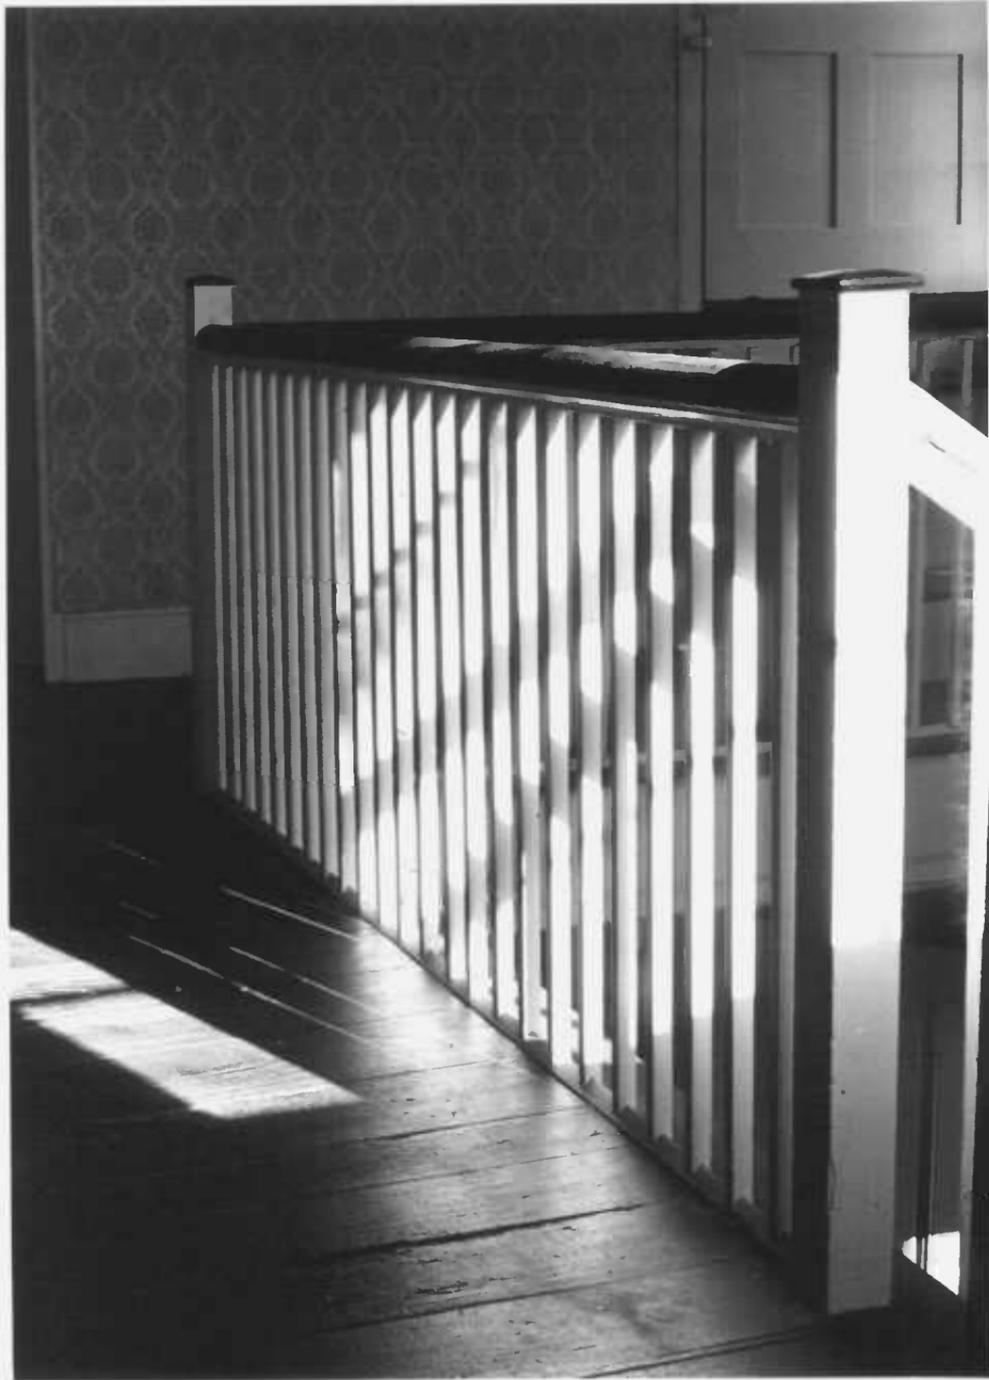
Millwood S-32
Mt. Vernon vicinity, Somerset Co., Md.
Second Floor Stair
3/86, Paul Touart, Photographer
Neg./Md. Historical Trust

The second floor of the main house is divided into three rooms that open from a second floor balcony. The handrail continues around the second floor to enclose the stair well. Fixed into the southeast corner of the second floor passage is an enclosed attic stair. The short flight of stairs rises behind a flush six-panel door. Flush six-panel doors also open into the other three rooms, which are finished in a straightforward manner without unusual details.

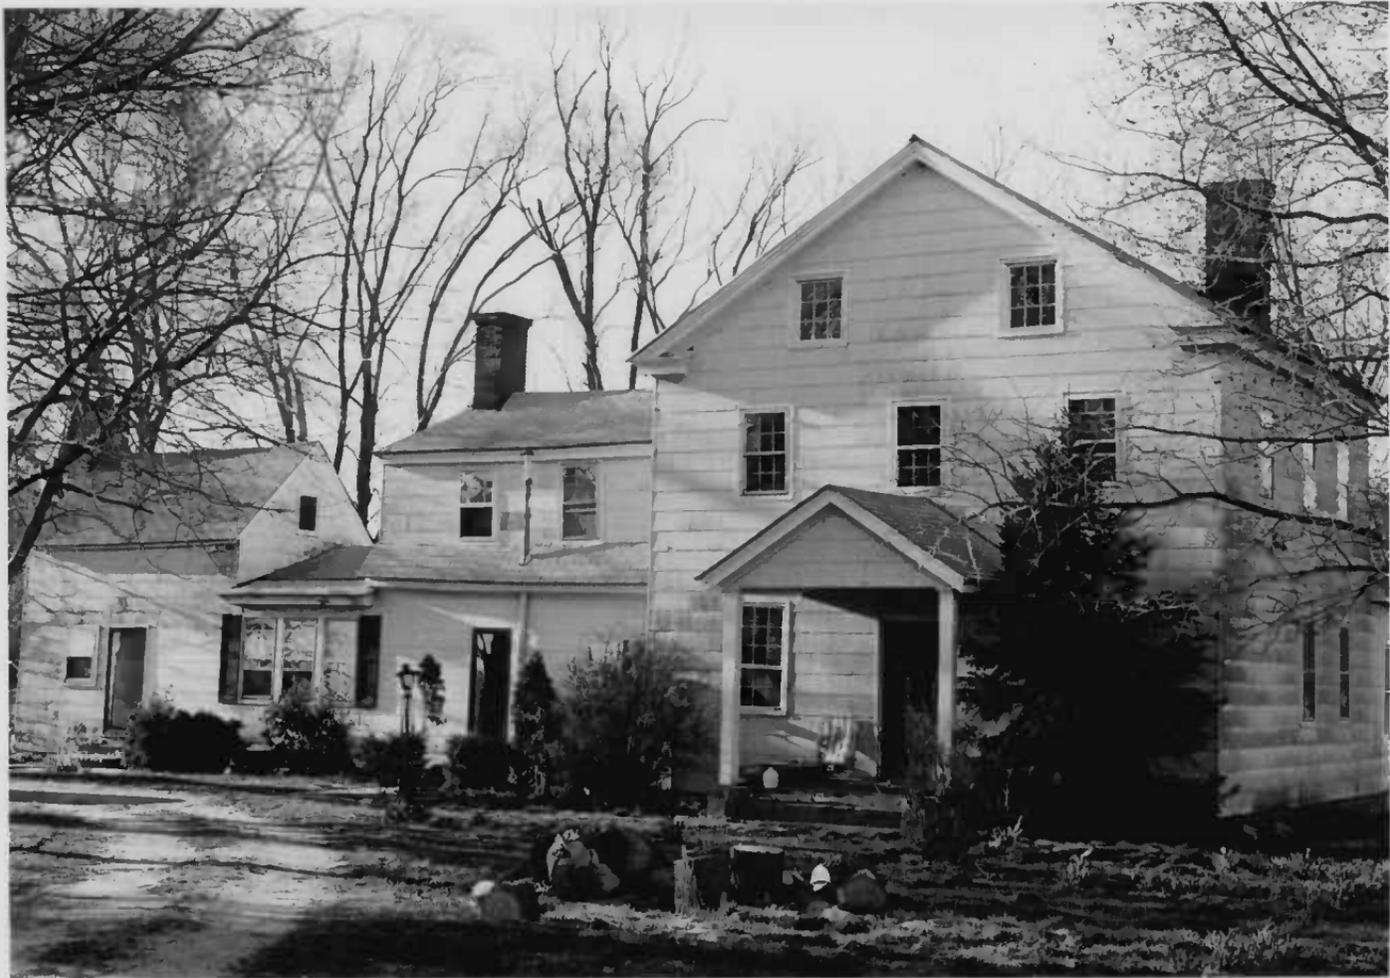
South Elevation

The main house, erected around 1815-1830, is a two-story, three-bay, transverse hall dwelling with a symmetrical elevation. A center four-panel door is flanked by nine-over-six sash windows, and the entrance is covered by a simple gabled stoop. Lighting the second floor are three six-over-six sash windows, and the attic is lighted by a pair of nine pane lights. The shutters have been removed from their hinges. The eave to the roof is slightly extended and finished at the base with short returns.

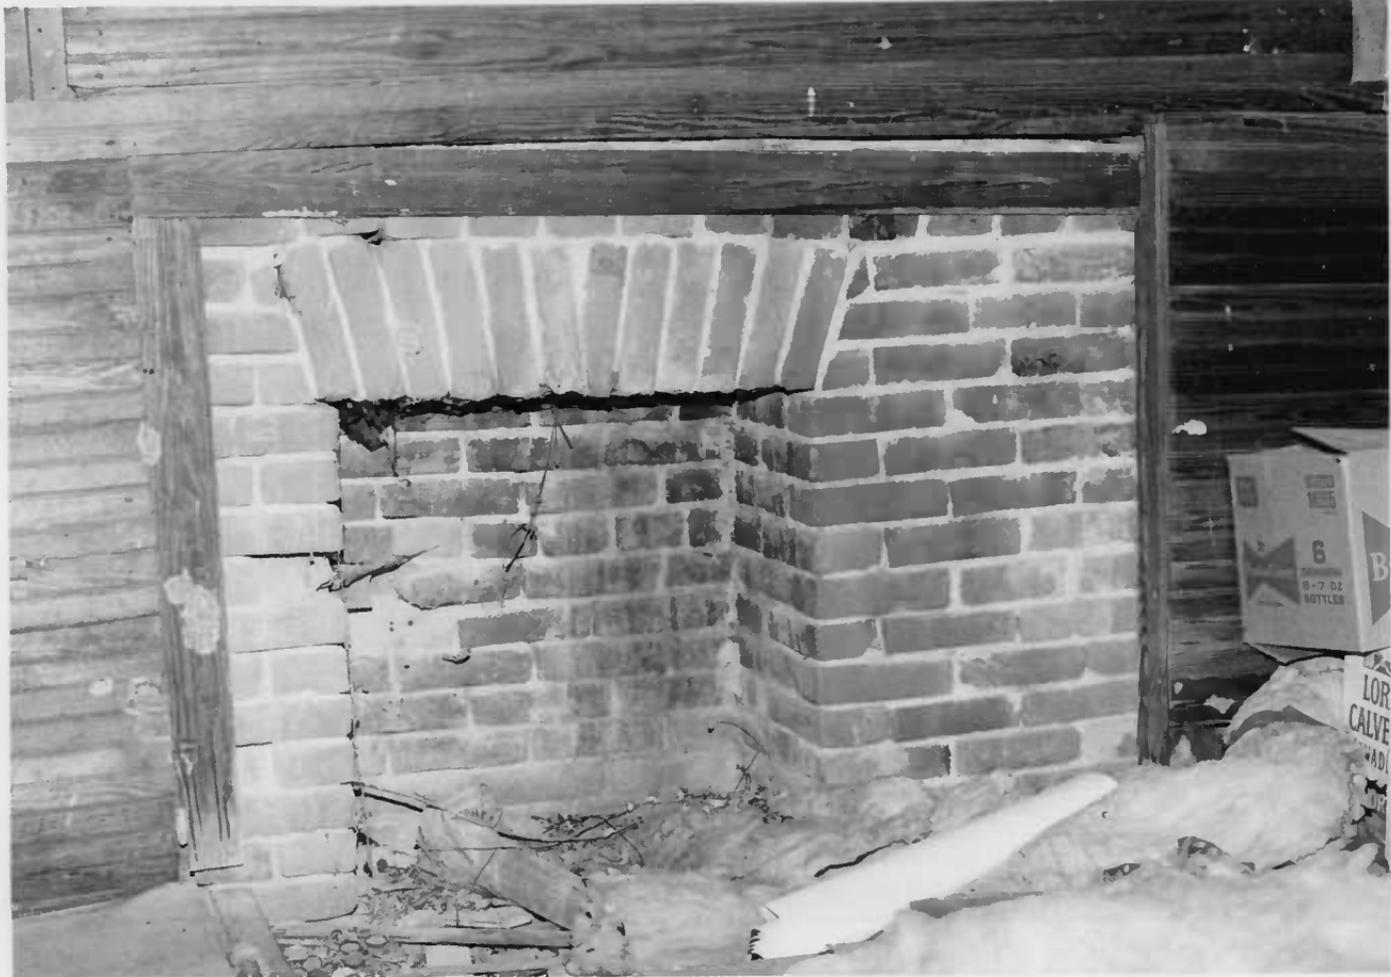
Loft Hearth

The interior of the hyphen or current kitchen has been completely reworked for modern kitchen service. The old kitchen, on the other hand, has not been altered aside from a layer of wallboard. The hearth has been covered up on the first floor. An access door in the ceiling permits entrance into the second floor loft where the walls and ceiling have been sheathed with narrow beaded boards. A small hearth is located on the west wall. Access into the space over the hyphen is gained through an open space in the east wall of the loft. Beaded weatherboards remain on the covered-over section of the old kitchen.
