S-36
Cherry Grove
Princess Anne vicinity
private

Maryland Historical Trust State Historic Sites Inventory Form

Survey No. S-36

Cherry Grove Description

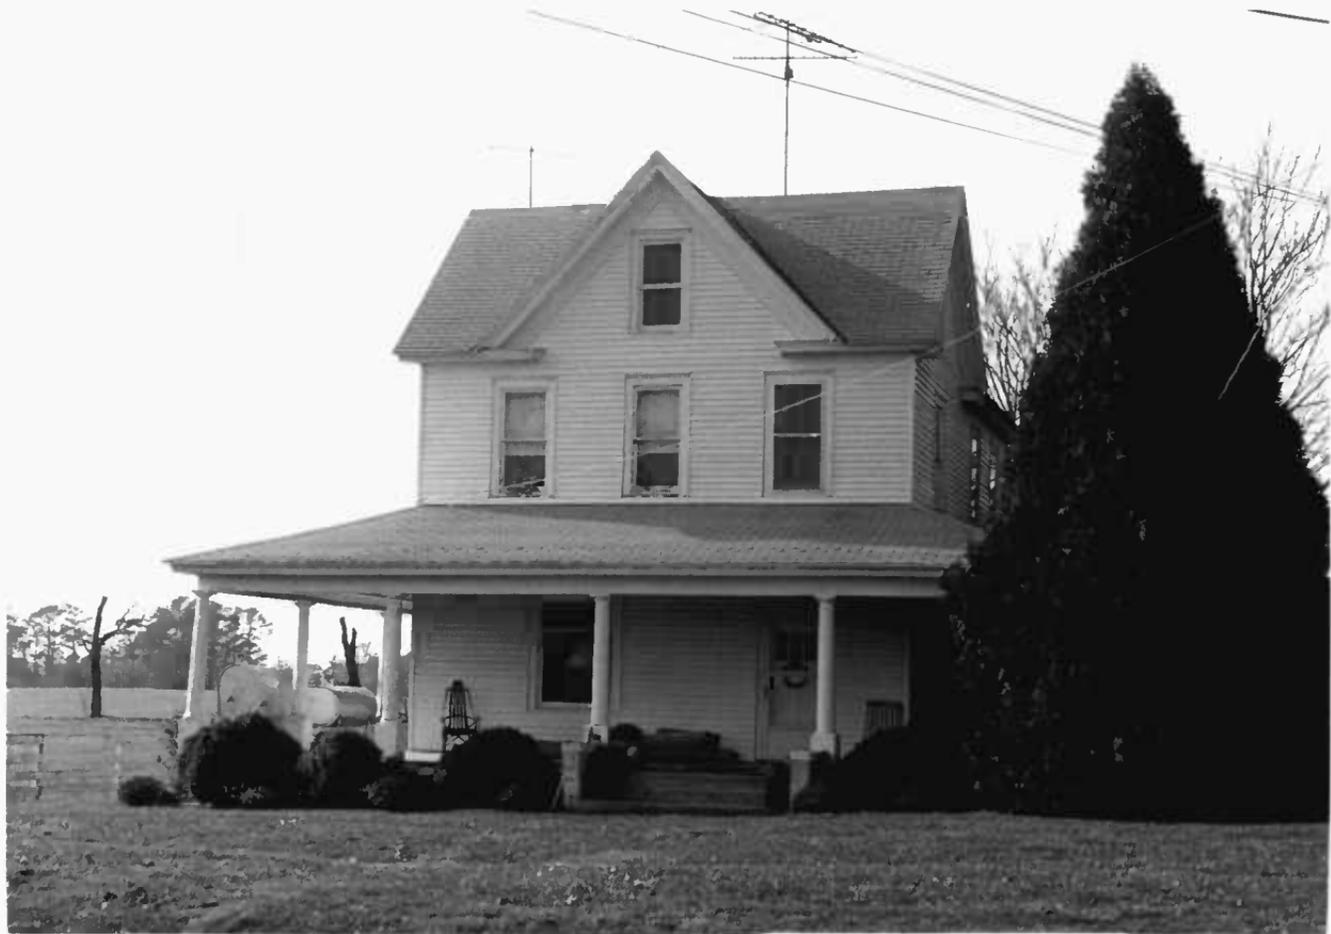
Cherry Grove S-36
Princess Anne vicinity, Somerset Co.
East Elevation
11/85, Paul Touart, Photographer
Neg/Md. Historical Trust

The east gable end of the middle section is fully covered by the current front part of the house, added around the turn of the century. The two-story, three-bay by one-room addition faces east with gable oriented on a north/south axis. The east elevation is an asymmetrical facade with two openings on the first floor and three on the second floor. A partially glazed door is located in the north bay, and a large window fills the south bay. The second floor is lighted by three evenly spaced single pane sash windows, and the cross gable is pierced by an identical sash window. Each gable end is lighted by a single pane sash window on each floor. The three sides of the front block are covered by a single-story Tuscan columned front porch. A trap door in the porch floor provides access to the partially excavated cellar.

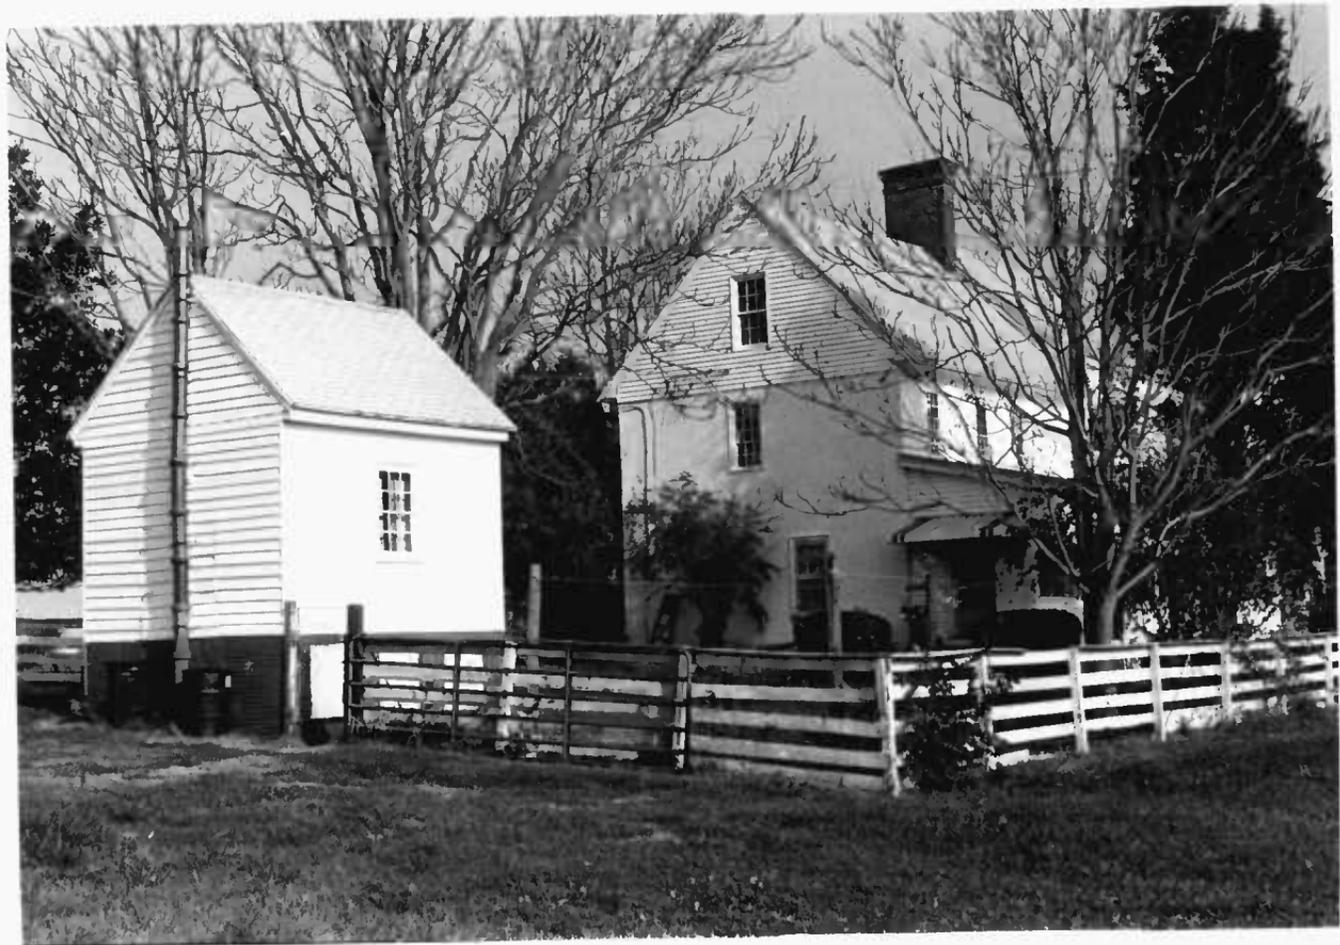
Cherry Grove S-36
Princess Anne vicinity, Somerset County
Southwest Elevation
11/85, Paul Touart, Photographer
Neg/Md. Historical Trust

The west end of the brick house has been altered with the reworking of the gable end. For some reason the brick gable end was taken down to the plate level and replaced with a stud wall. The brick wall is pierced at ground level by a bulkhead cellar entrance, while single nine over six sash windows light the first and second floor. The frame gable end is marked by a single six over six sash window.

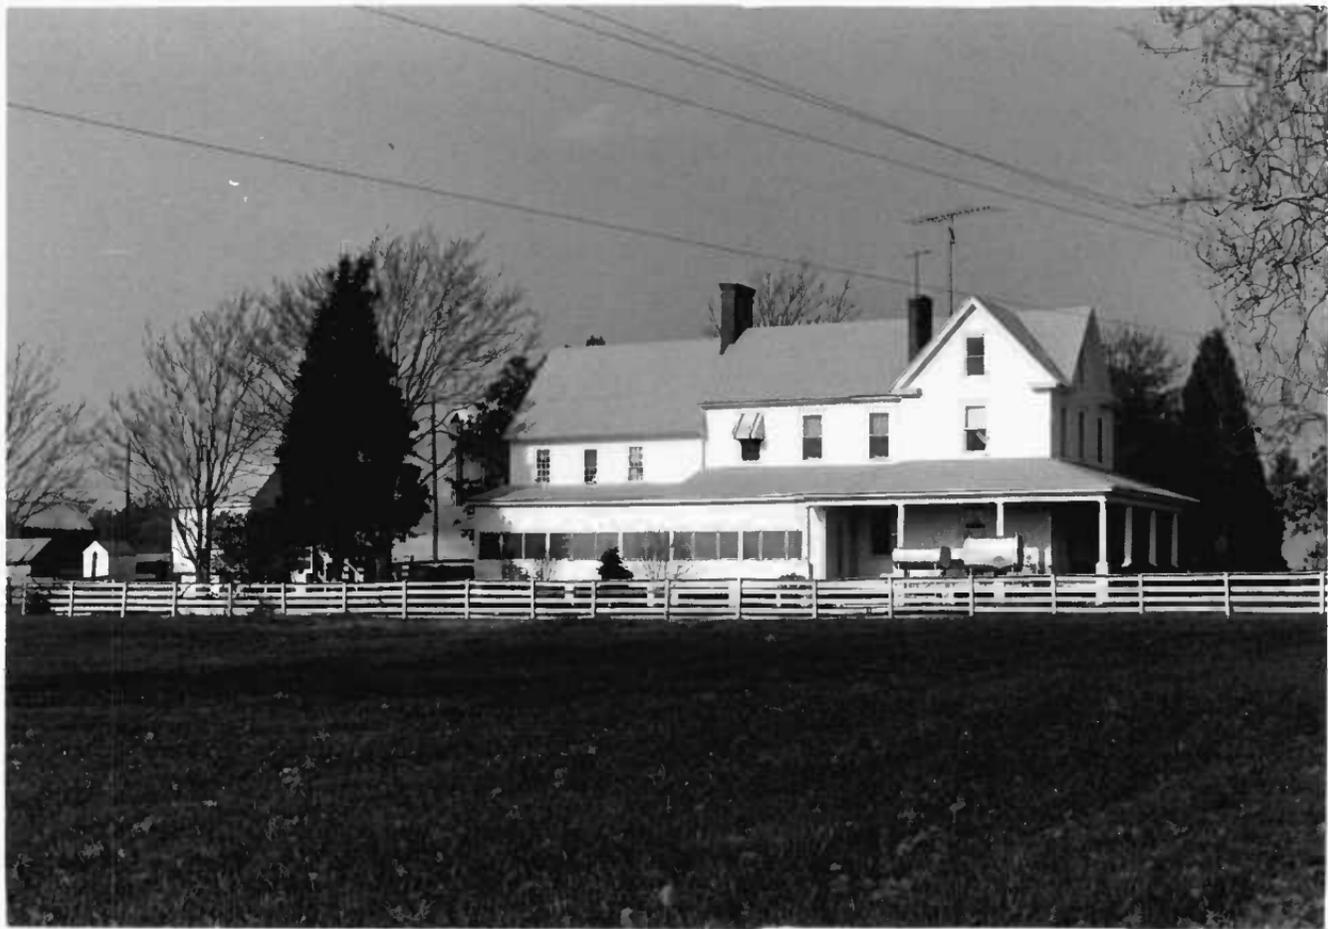
Cherry Grove S-36
Princess Anne vicinity, Somerset Co.
South Elevation
11/85, Paul Touart, Photographer
Neg/Md. Historical Trust

The south elevation is an asymmetrical three-bay facade with a center entrance and flanking nine over six sash windows. The west window has been bricked up, but the east first floor window survives with its wide mid-eighteenth-century muntins. A single-story shed roofed porch covers the first floor. The second floor is unevenly divided into three bays which are filled with nine over six sash windows.

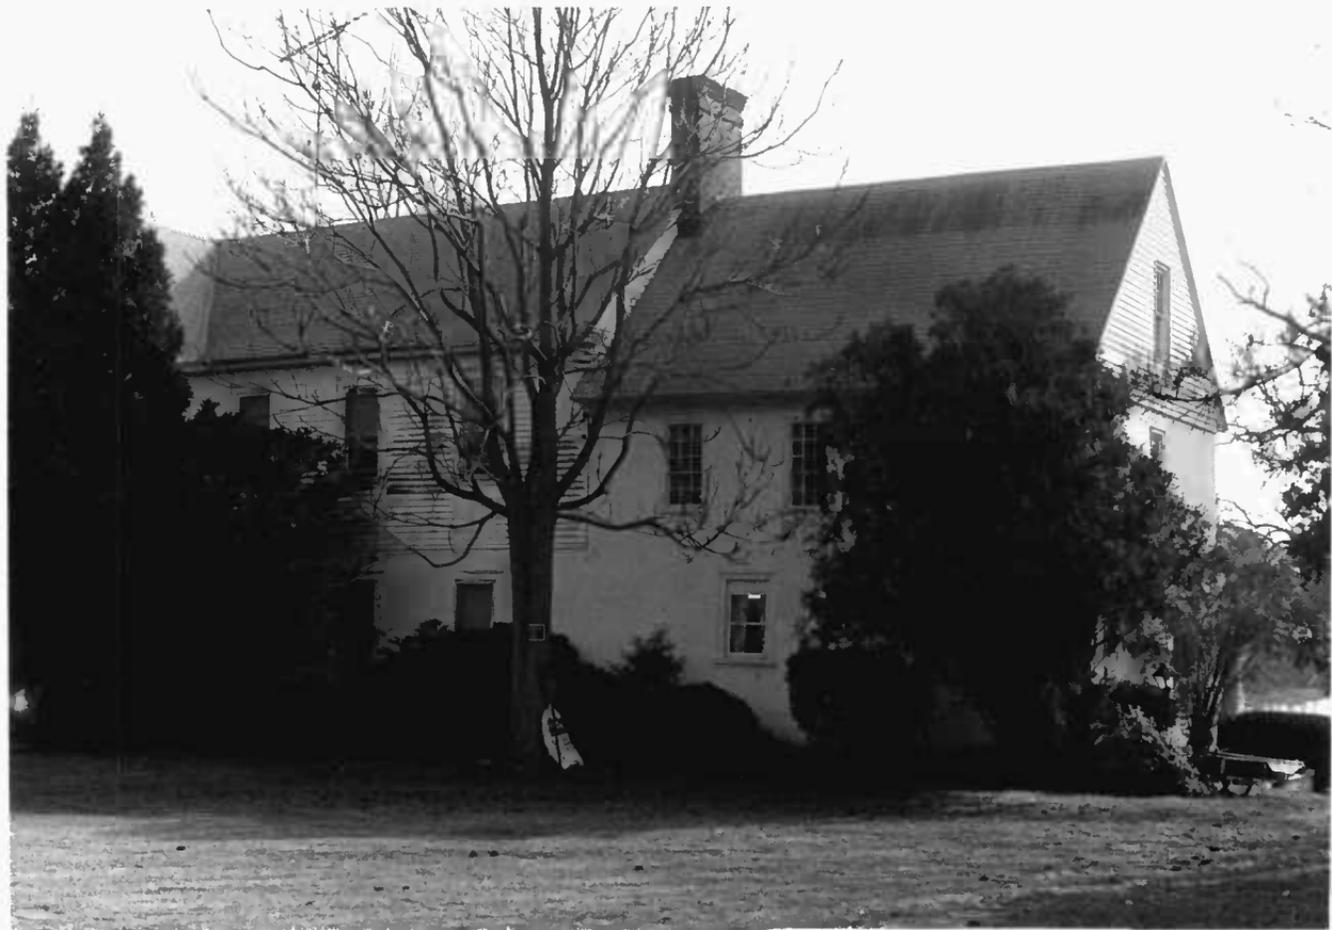
Supported by an excavated brick foundation, the stuccoed eighteenth-century brick house is covered by a steeply pitched asphalt shingle roof. One of the distinctive exterior features is the pair of plastered cove cornices which finish the eaves. A large interior end brick chimney rises from the east end of the brick house.

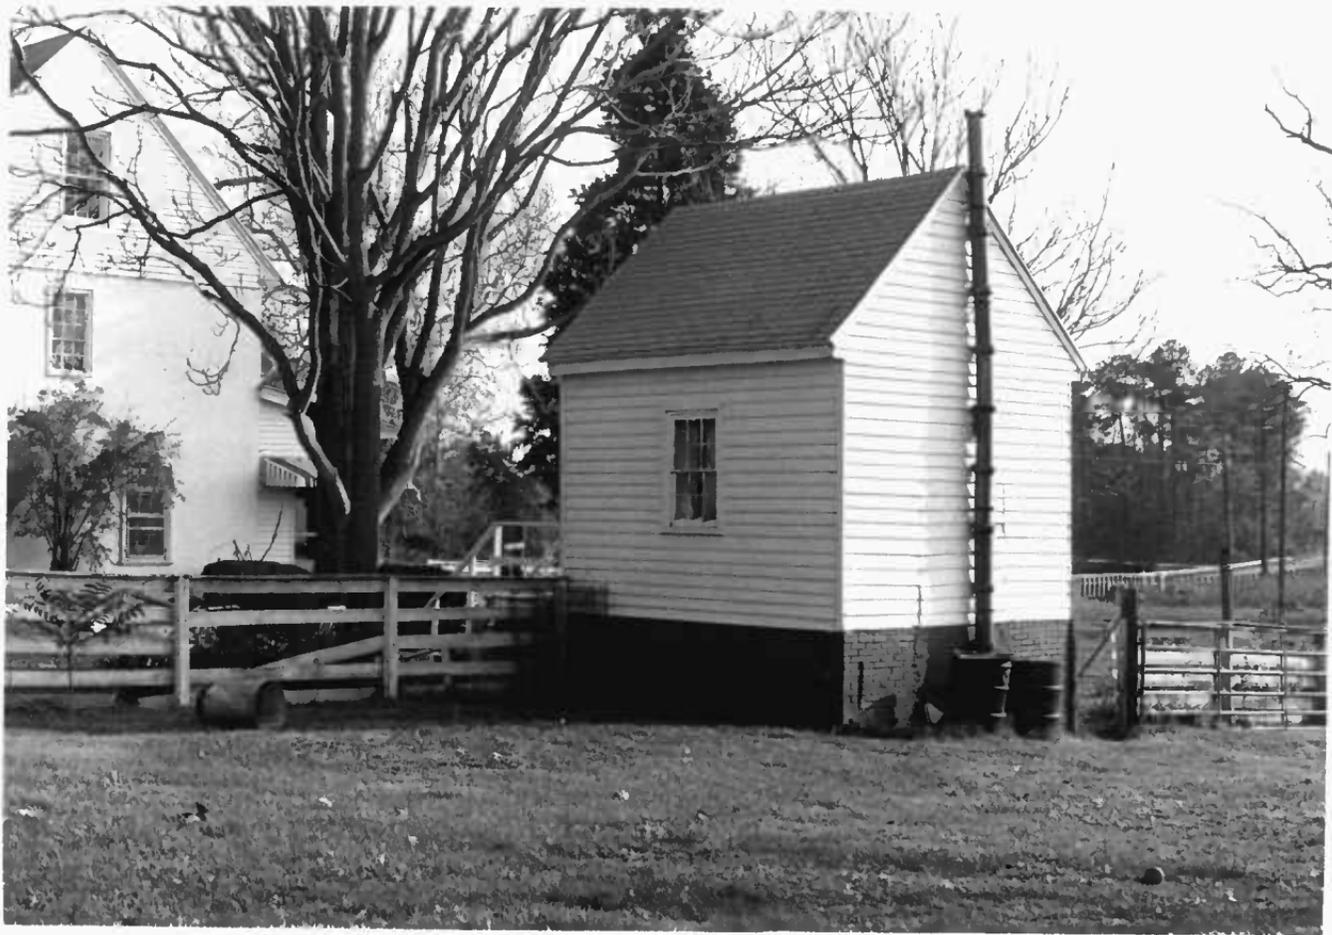
Cherry Grove S-36
Princess Anne vicinity, Somerset Co.
Doctor's Office-Northwest
11/85, Paul Touart, Photographer
Neg/Md. Historical Trust

The doctor's office stands directly west of the house, and it is supported by a raised common bond brick foundation with a partially excavated cellar. Flush panel double doors pierce the east and south walls. The one-room frame structure is sheathed with beaded weatherboards, and the steeply pitched roof is covered with asphaltingles.

over six sash window, and the west end has a terra cotta stove stack. A patch in the weatherboards indicates the former location of the exterior brick chimney.

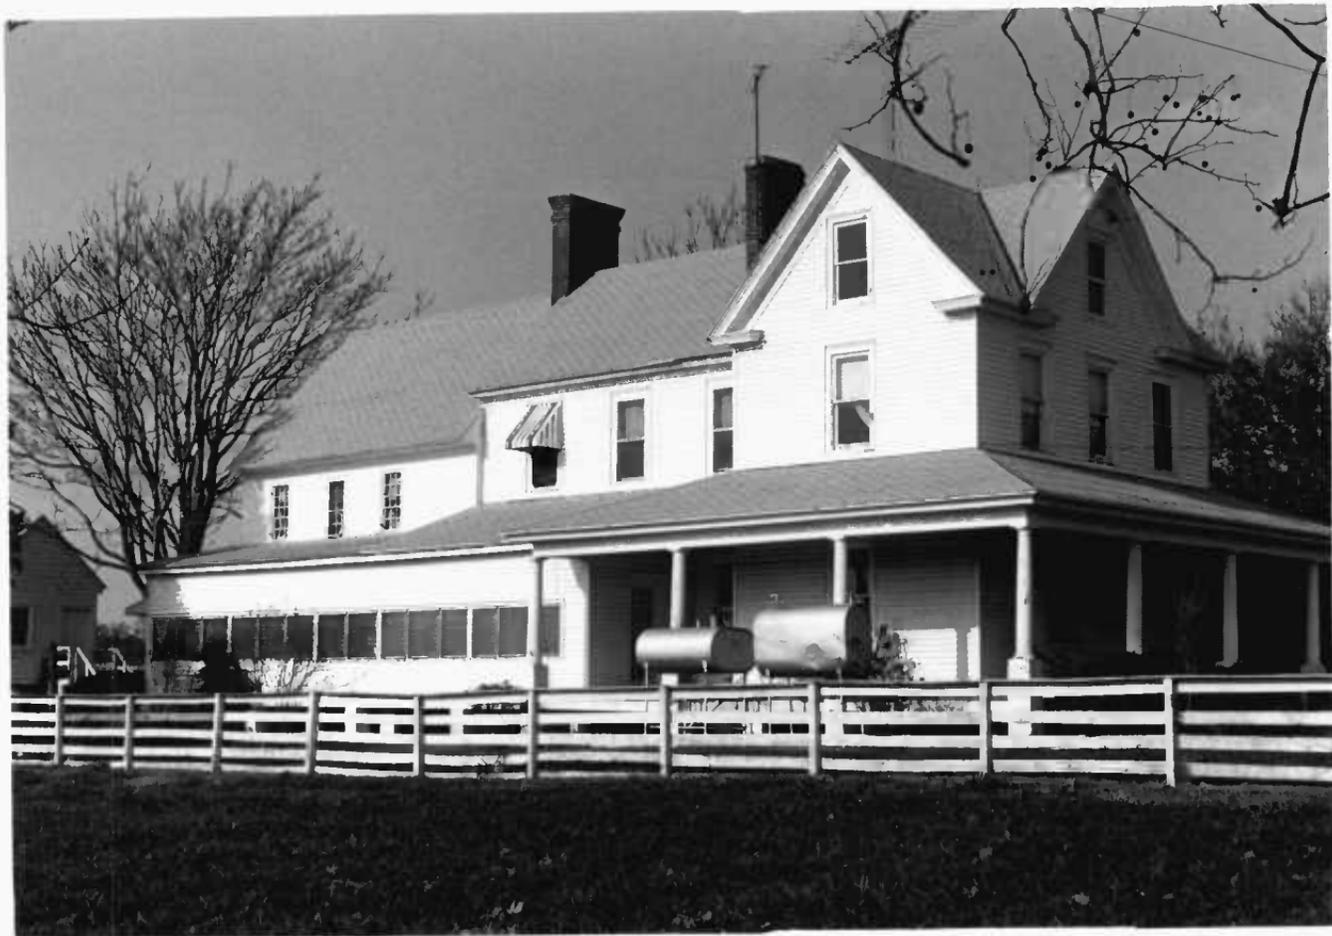
Cherry Grove S36
Princess Anne vicinity, Somerset County
South Elevation
11/85, Paul Touart, Photographer
Neg/Md. Historical Trust

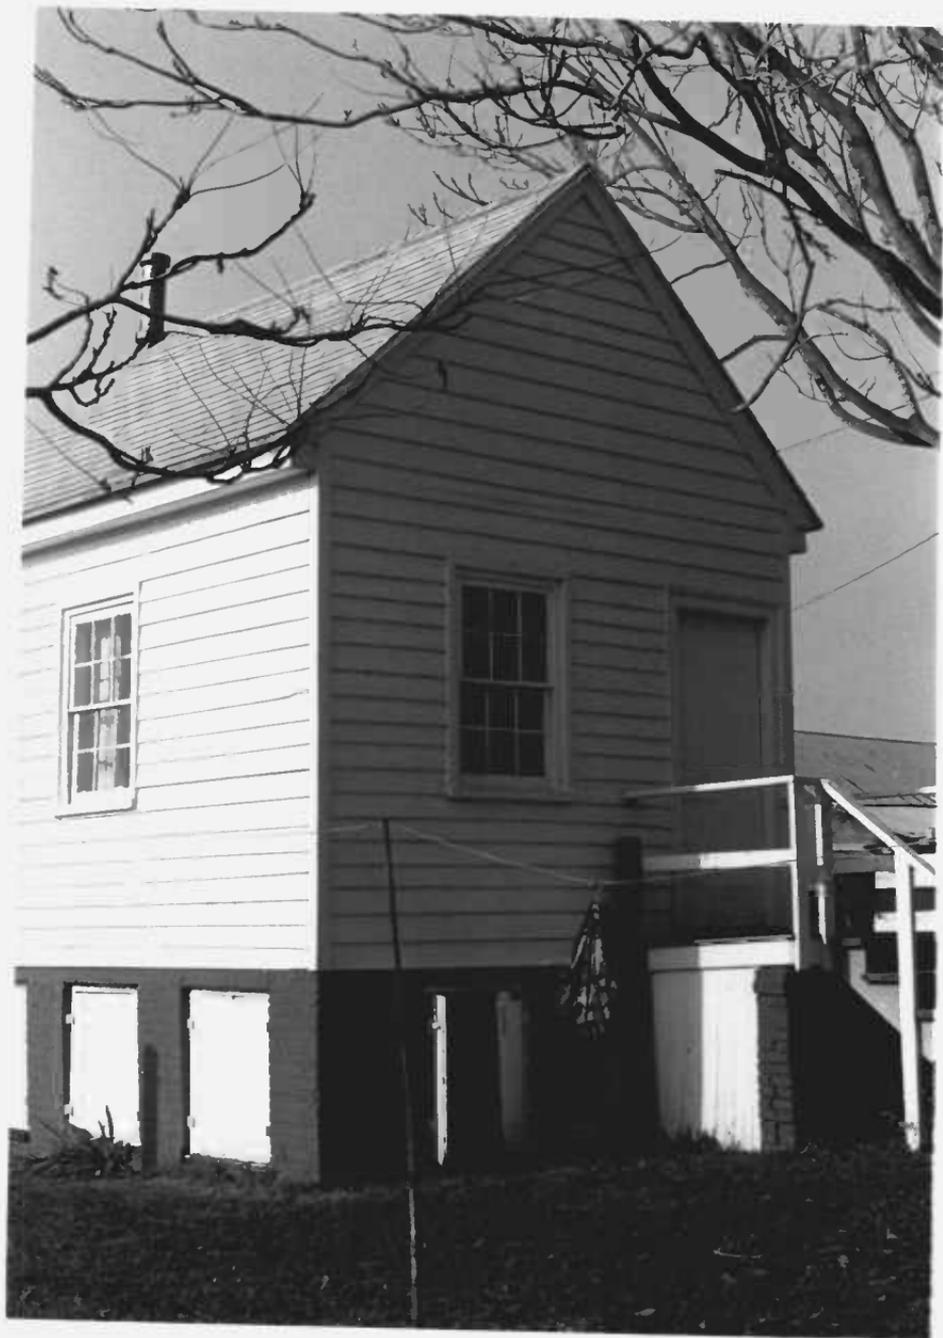
Cherry Grove S-36
Princess Anne vicinity, Somerset Co.
Doctor's office
11/85, Paul Touart, Photographer
Neg/Md. Historical Trust

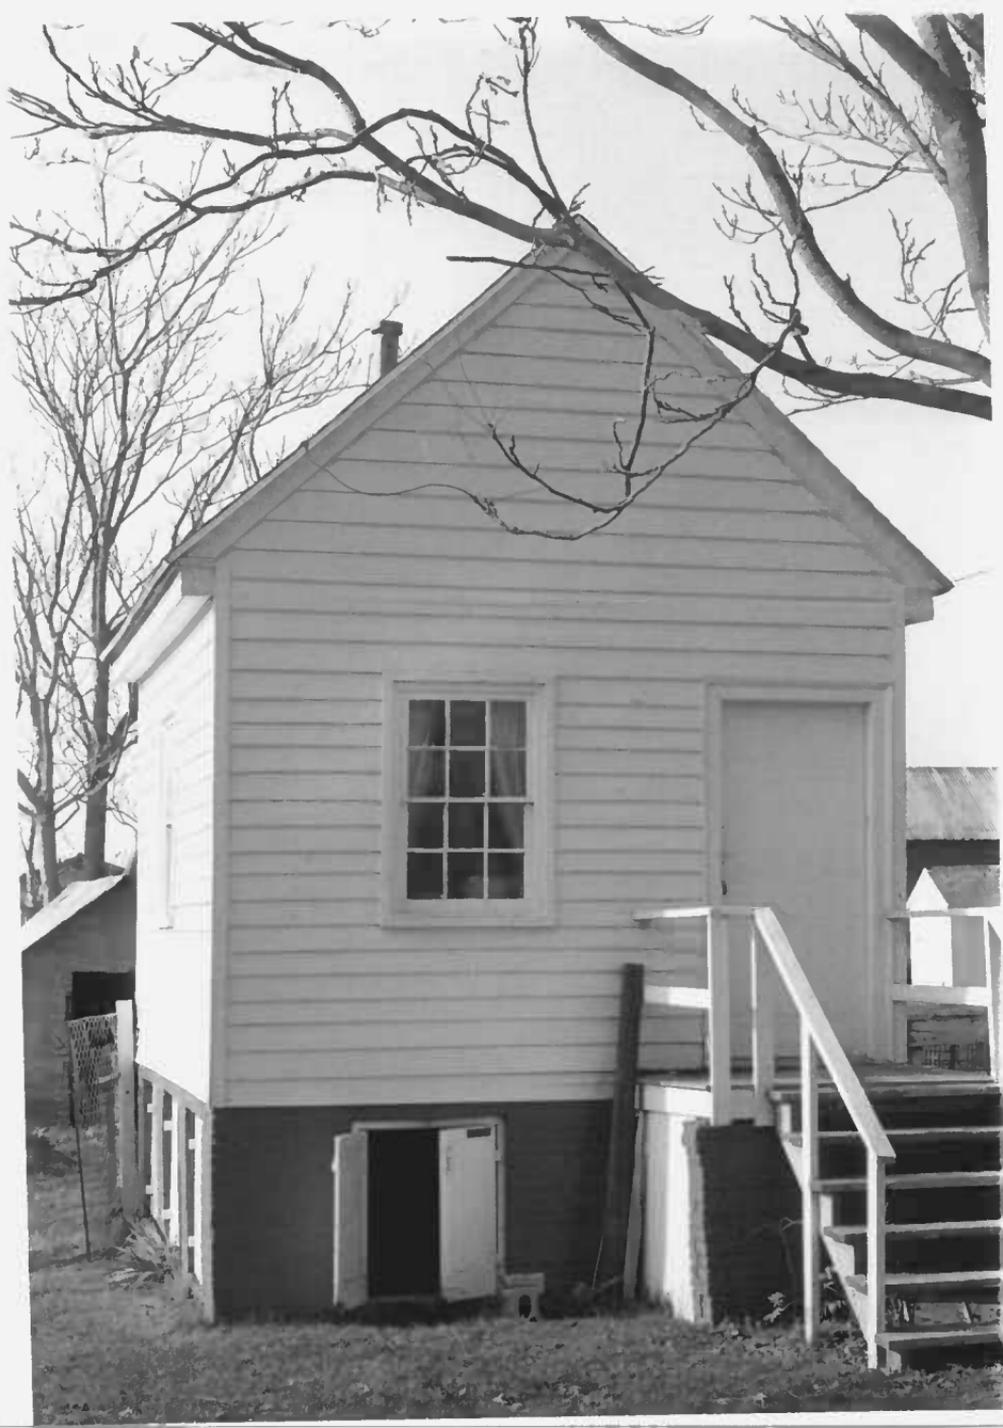
Cherry Grove Farm S-36
Princess Anne vicinity, Somerset Co., MD.
Southeast elevation of Doctor's office
3/86, Paul Touart, Photographer
Neg./MD. Hist. Trust

The east (main) facade is a gable front elevation with a flush six-panel door in the right bay and an adjacent six over six sash window. The flush gable end is finished with a beaded bargeboard. Both the north and south sides are marked by a single six
