S-121
Phoenix Methodist Episcopal Church
Cash Corner vicinity
public worship

Maryland Historical Trust State Historic Sites Inventory Form

Survey No. S-121

historic Phoenix Methodist Episcopal Church

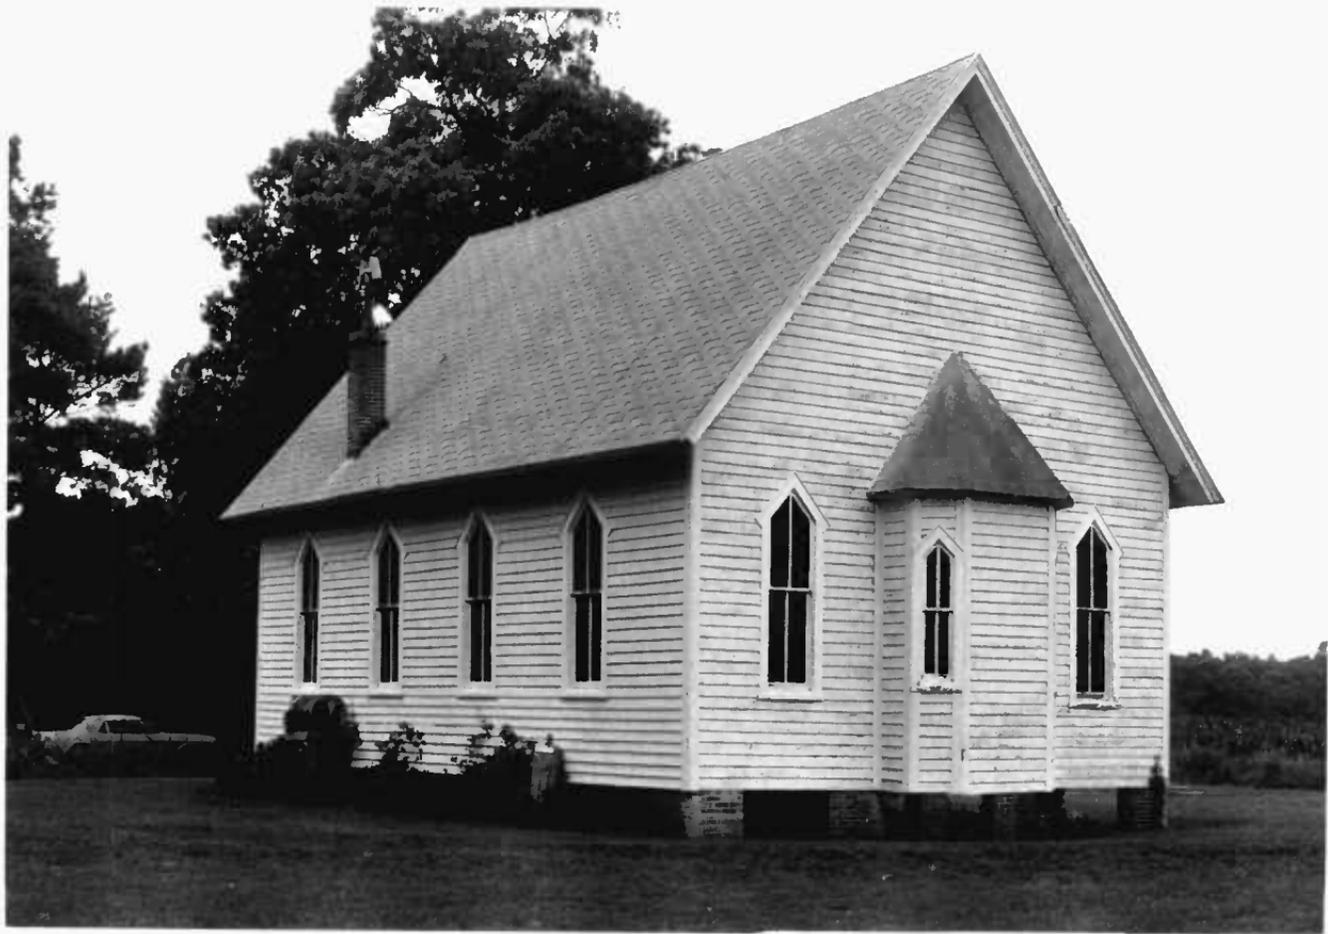
Phoenix Church
Near Parsonville, Somerset County
North Elevation
7/85 Photographer - Paul Touart
Neg/Maryland Historical Trust

The north gable end has a single-story three-sided apse lighted by two colored glass pointed arch sash windows.

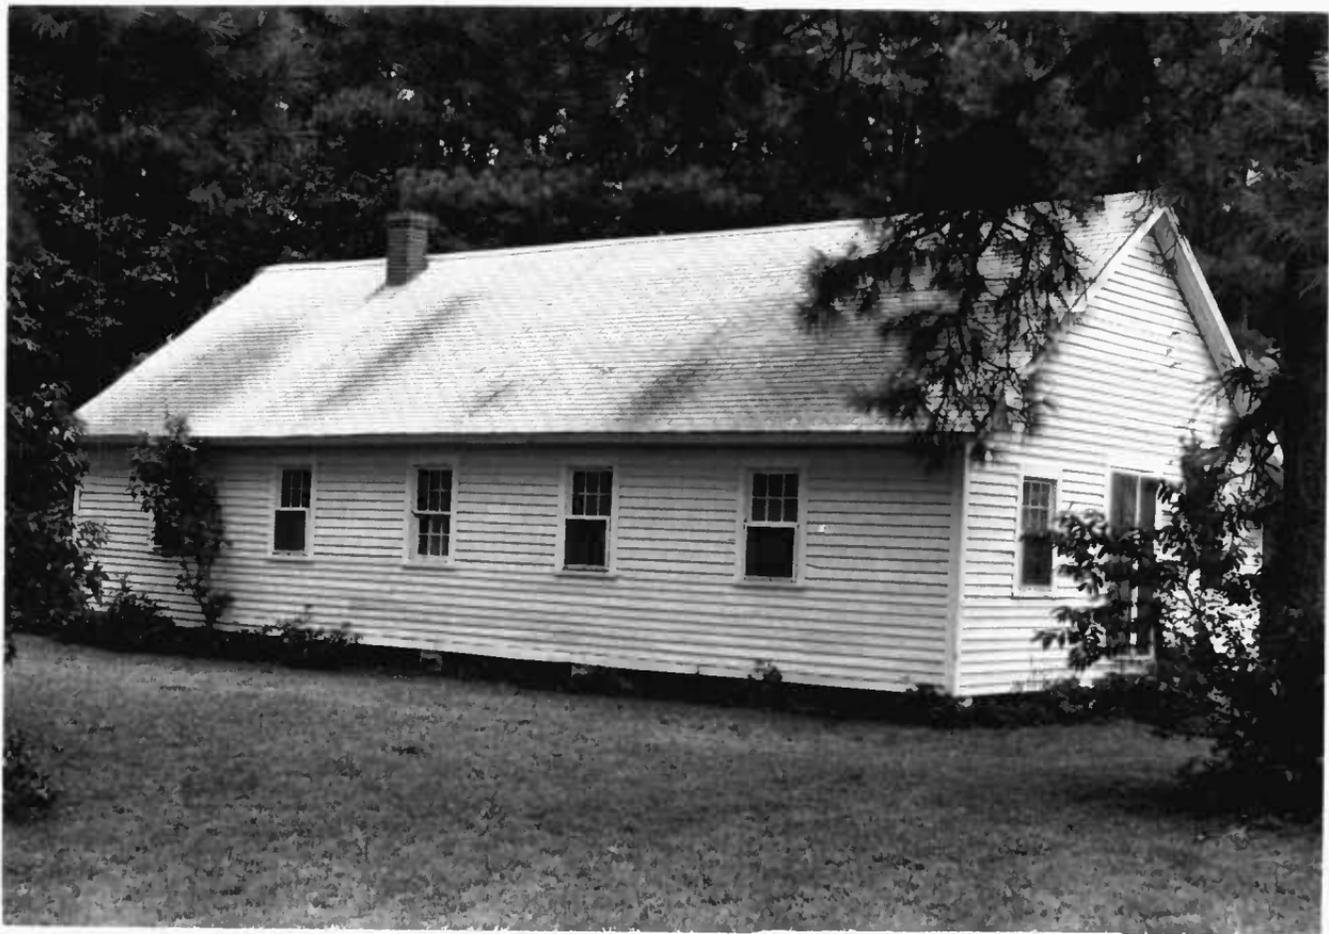
Church Hall - Northwest

Standing east of the church is a single-story three-bay by three-bay frame church hall with a gable-front entrance and six over one sash windows. The structure is sheathed with narrow weatherboards and covered by a medium sloped asphalt shingle roof.

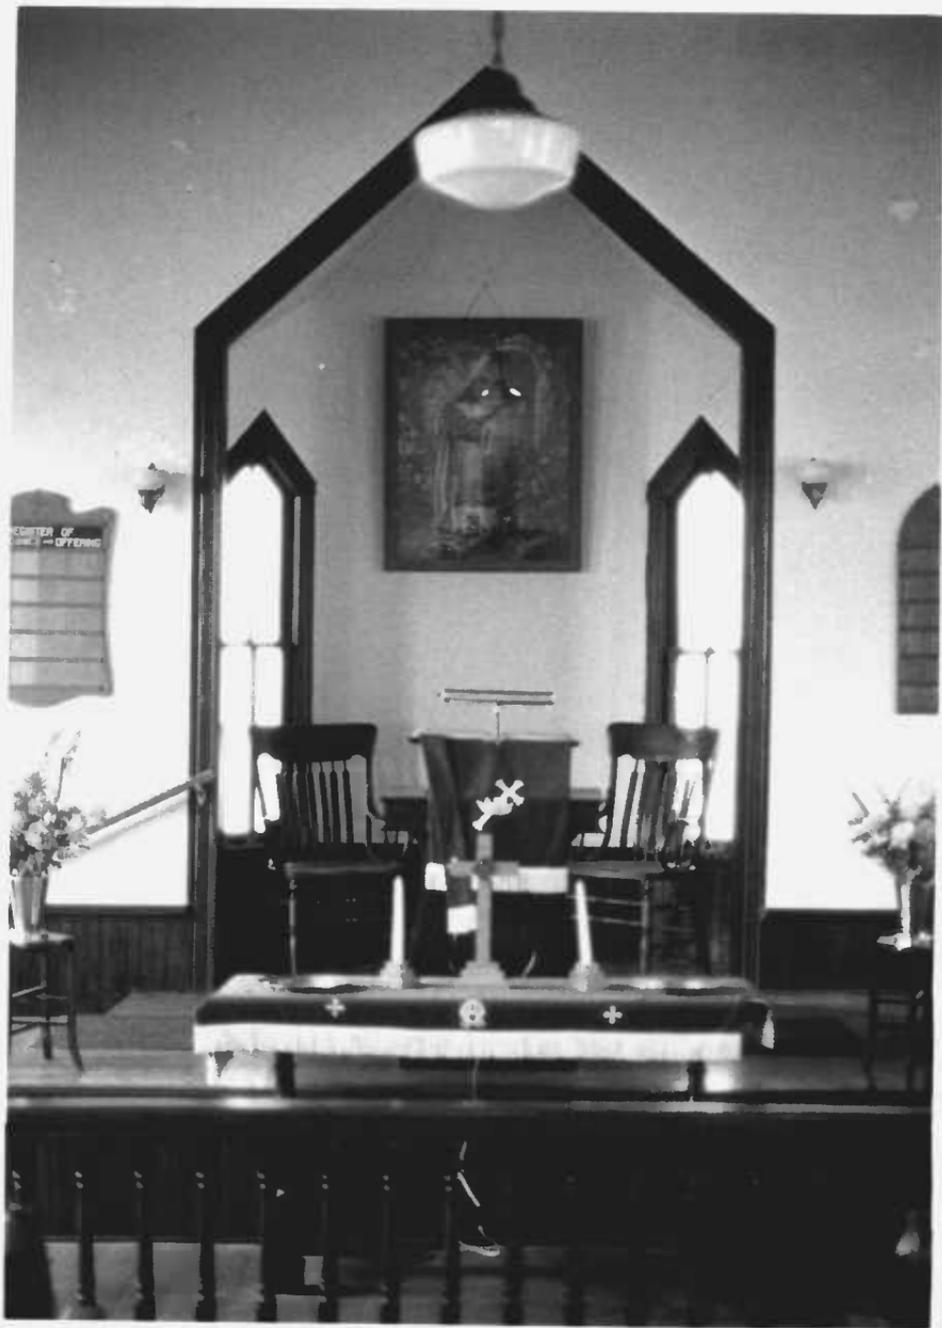
Phoenix Methodist Epis. Church S-121
Parsonville vicinity, Somerset County
Sanctuary
8/85, Paul Touart, Photographer
Neg./Md. Historical Trust

The one-room church interior has a high beaded board ceiling and milkglass chandeliers. The raised altar is divided from the sanctuary by a turned baluster railing, and the small apse is lighted by lavender glass windows. Victorian period choir chairs and sanctuary pews complete the significant interior furnishings.

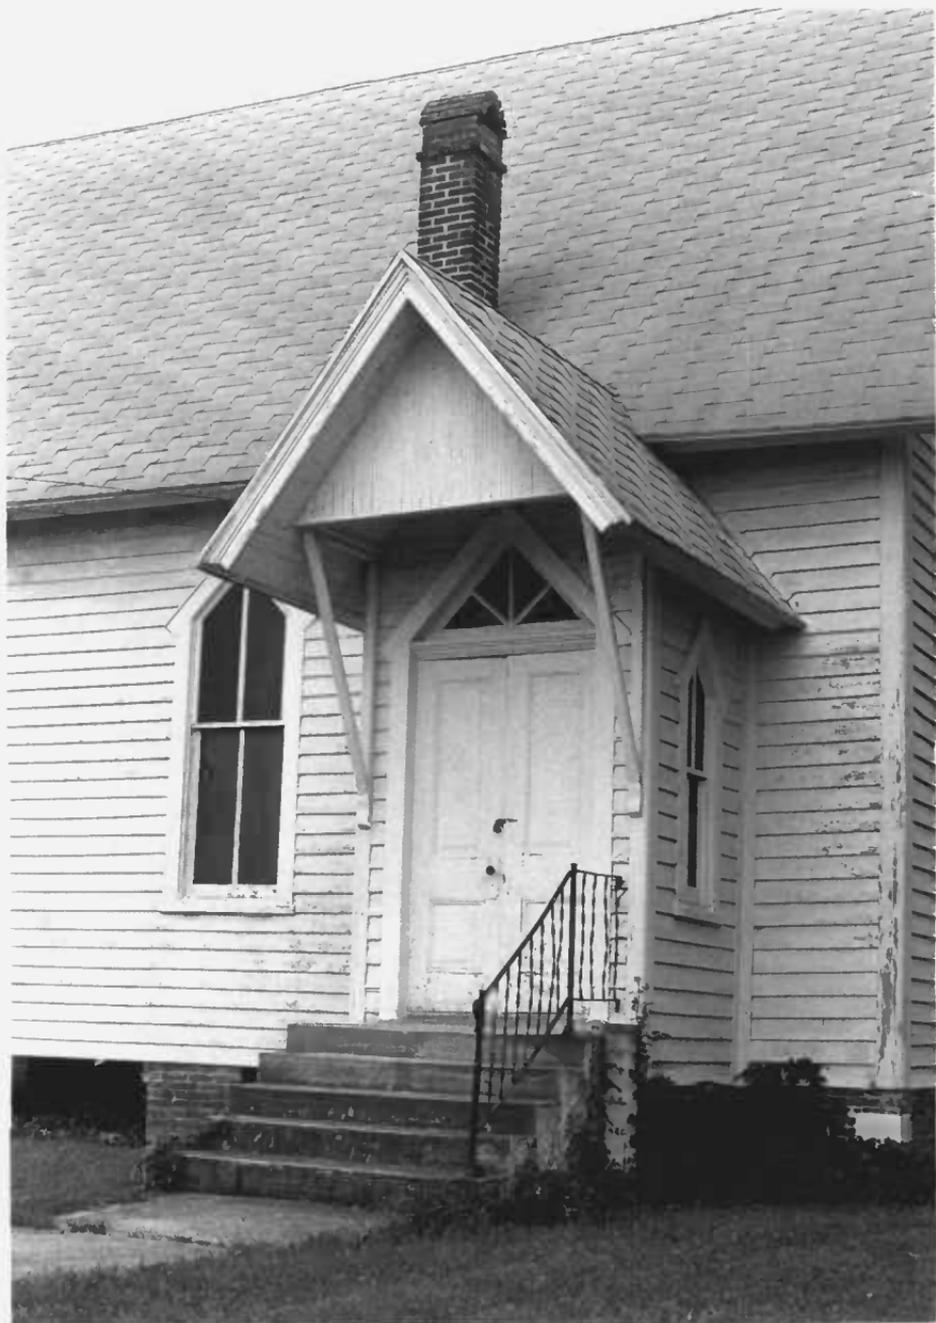
Phoenix Methodist Epis. Church S-121
Parsonville vicinity, Somerset County
West Entrance
8/85, Paul Touart, Photographer
Neg./Md. Historical Trust

The west (main) facade is a four-bay elevation with a gabled entrance in the southernmost bay. A double door entrance is topped by a pointed arch transom filled with colored glass. The gabled entrance roof is extended and supported by stick brackets. A small lancet window marks each side of the entrance vestibule. The adjacent three bays are filled with pointed arch sash windows with colored glass. The marble datestone is located in the lower south corner and is inscribed, "Phoenix M.E. Church, 1897". Rising from the roof is a narrow brick stove stack.

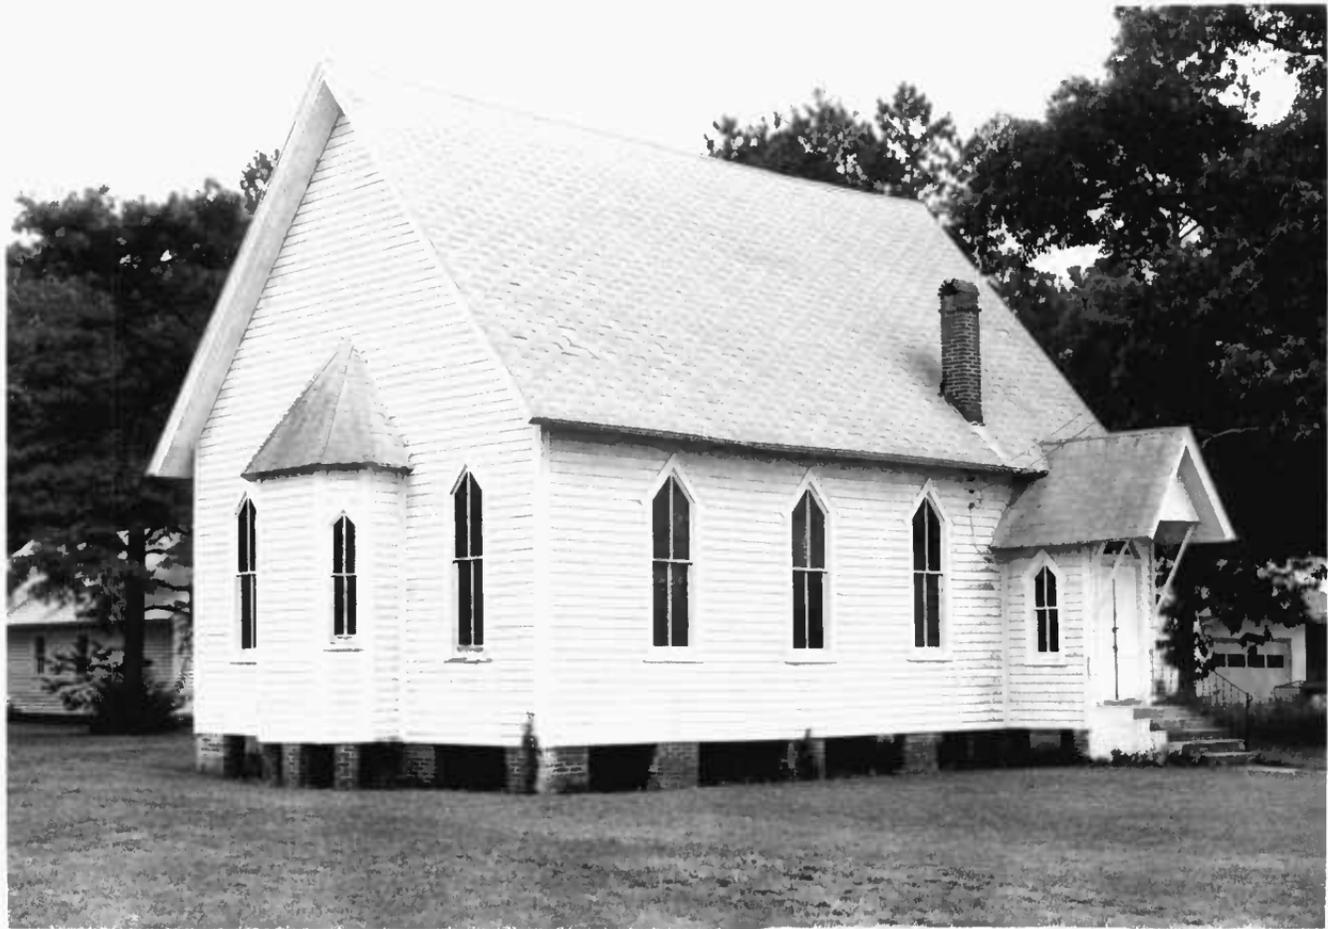
Phoenix Church
Near Parsonville, Somerset County
Northwest Elevation
7/85 Photographer - Paul Touart
Neg/Maryland Historical Trust

Dated to 1897, the weatherboarded frame structure is supported by a brick pier foundation and is covered by steeply pitched asphalt shingle roof. The eaves are extended and the soffits are sloped.
