S-203
Campoe Farm
Near Westover
Private

c. 1860-1870

Maryland Historical Trust State Historic Sites Inventory Form

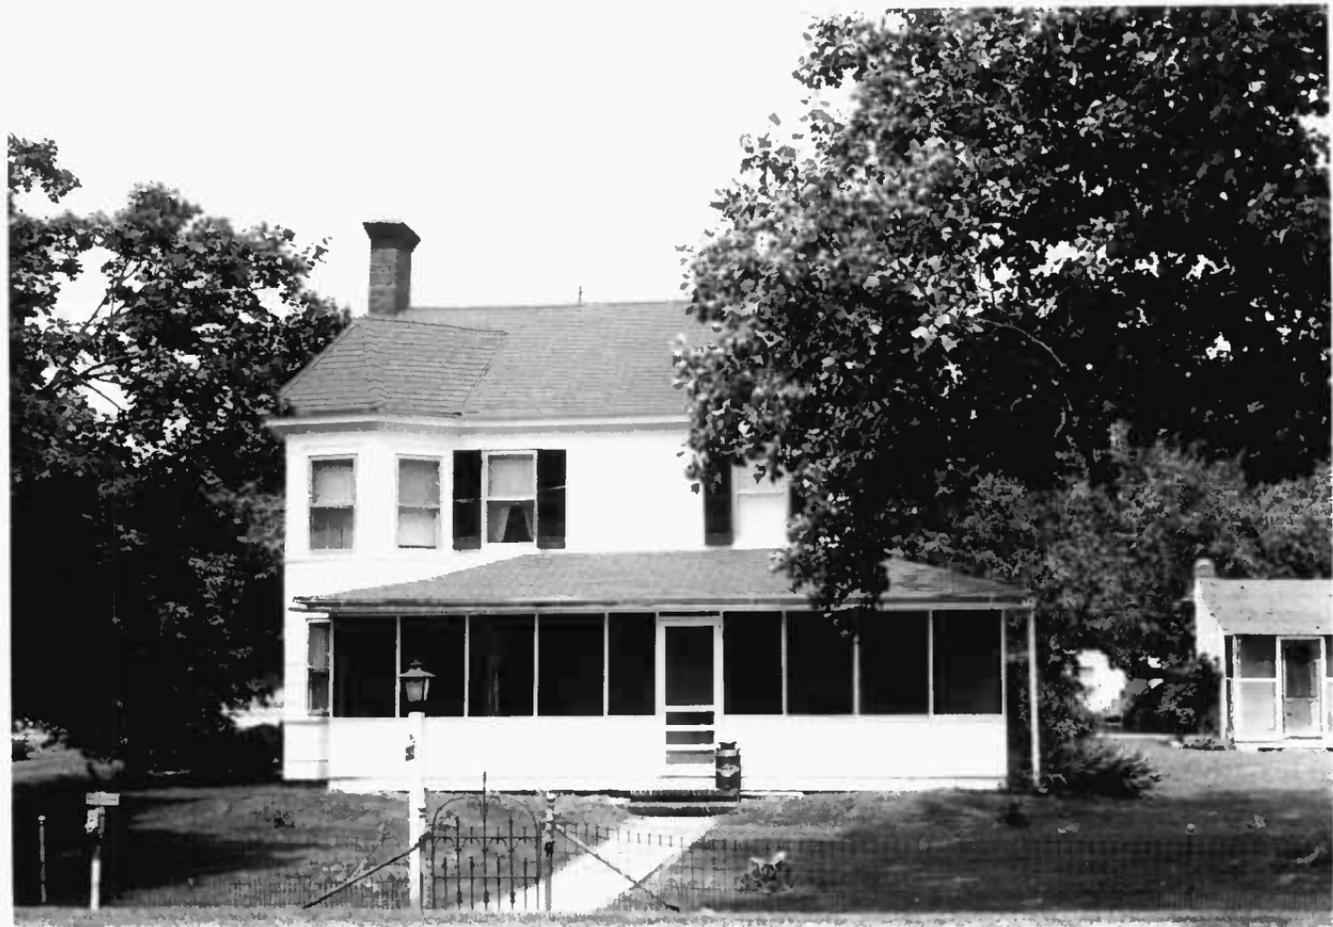
S-203

The south (main) elevation is two bays across with an entrance in the right (or east) bay. The front door is partially glazed. Single-pane sash windows light the first and second floors. According to the present owners, the corner two-story bay was attached after initial construction. The first floor is covered by a hip roof porch with chamfered posts.

Campoe Farm
South Elevation
Near Westover
5/84 Paul Touart
Neg./MD. Historical Trust

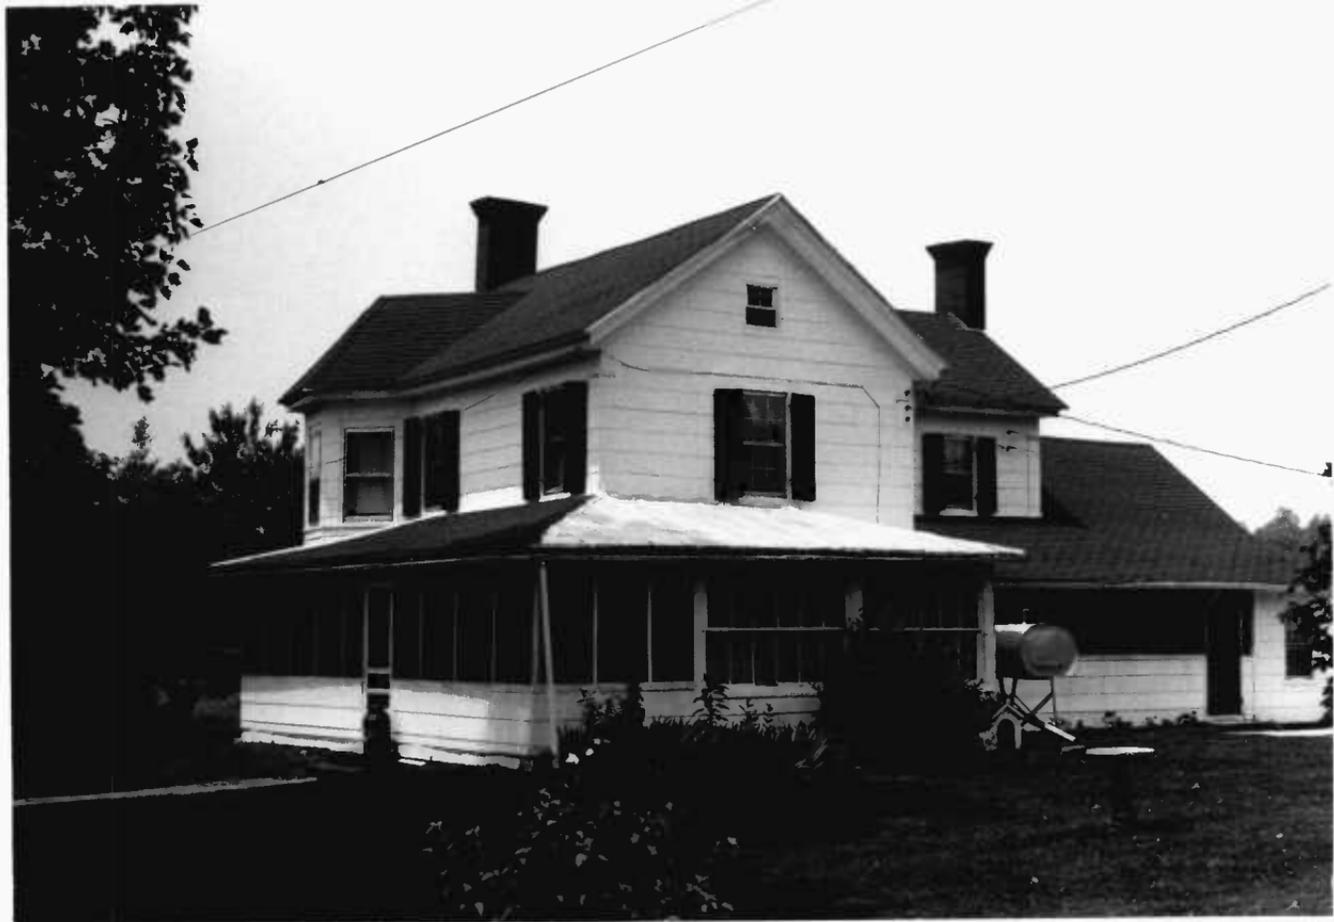
S-203

Campoe Farm
Southeast Elevation
Near Westover
6/84 Paul Touart
Neg./MD. Historical Trust
