S--211  
John Lewis Porter Farm  
Near Wellington  
Private

# Maryland Historical Trust State Historic Sites Inventory Form

historic John Lewis Porter Farm, "Porters Purchase"

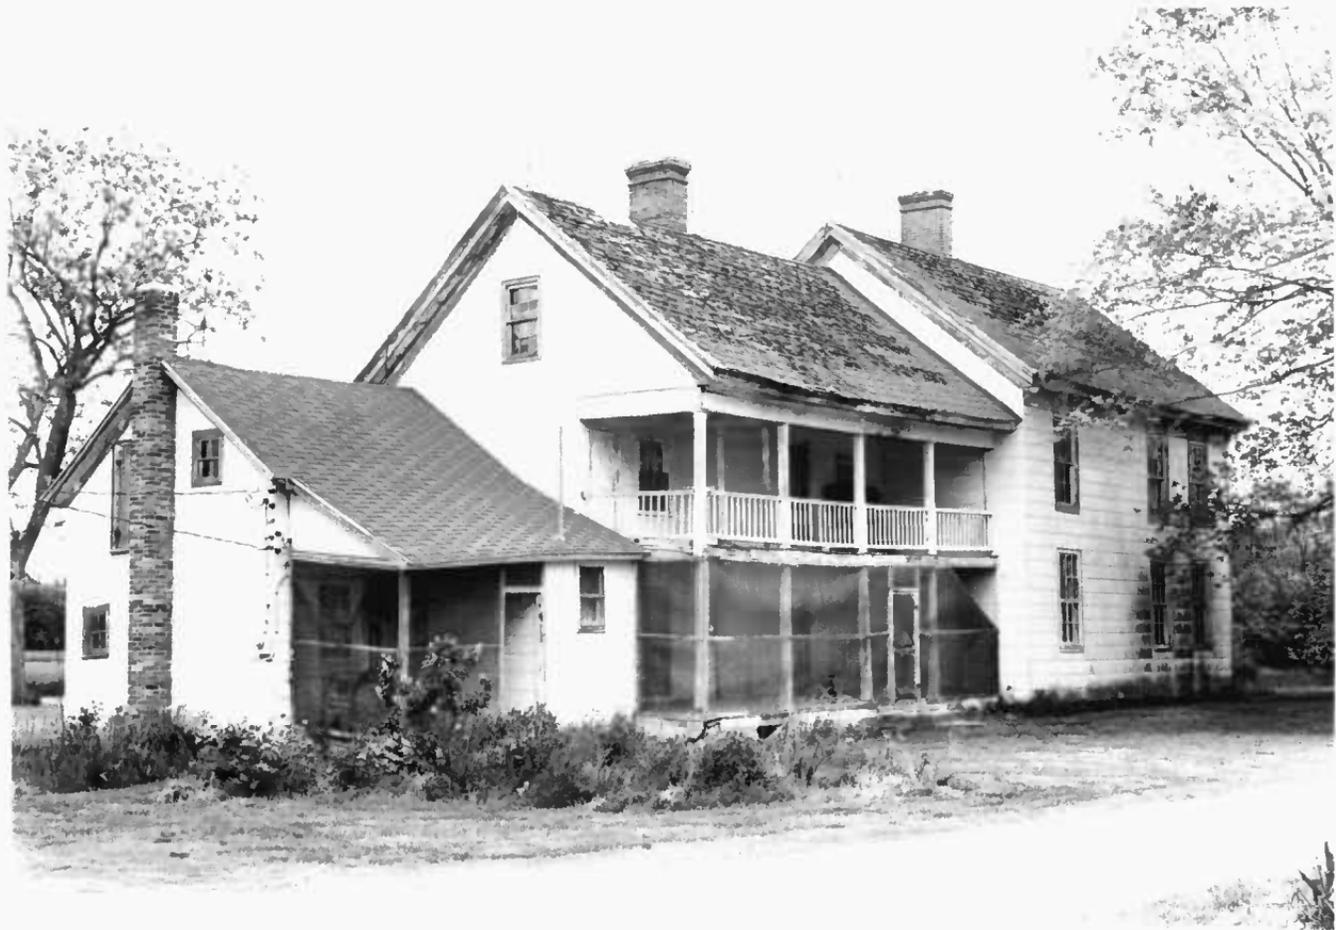
S-211

John Lewis Porter Farm  
Near Wellington, Somerset County  
Southwest Elevation  
5/84 Paul Touart  
Neg./ Maryland Historic Trust

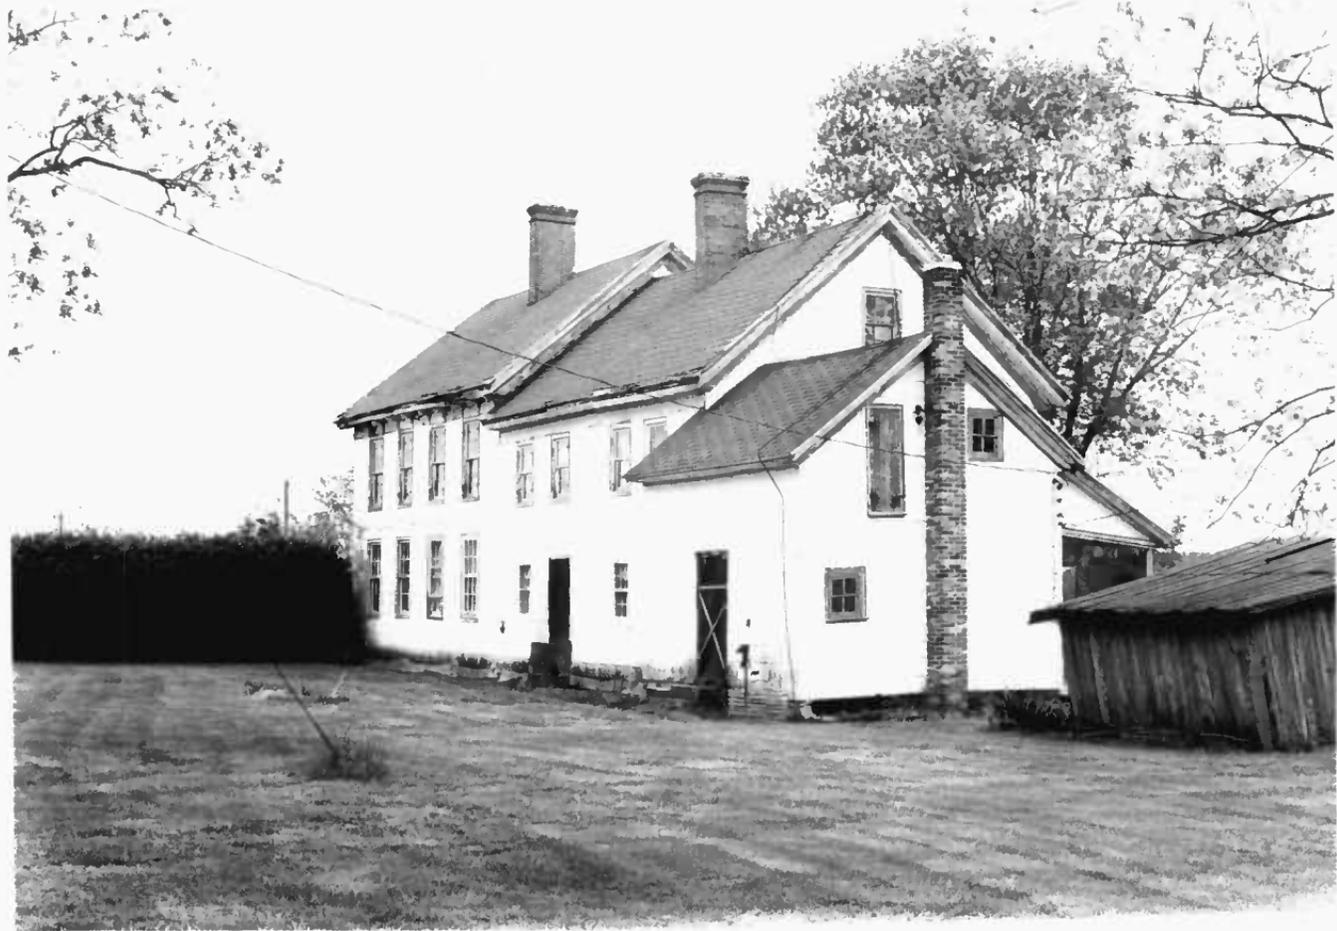
S-211

John Lewis Porter Farm  
Near Wellington, Somerset County  
Northwest Elevation  
5/84 Paul Touart  
Neg./ Maryland Historic Trust

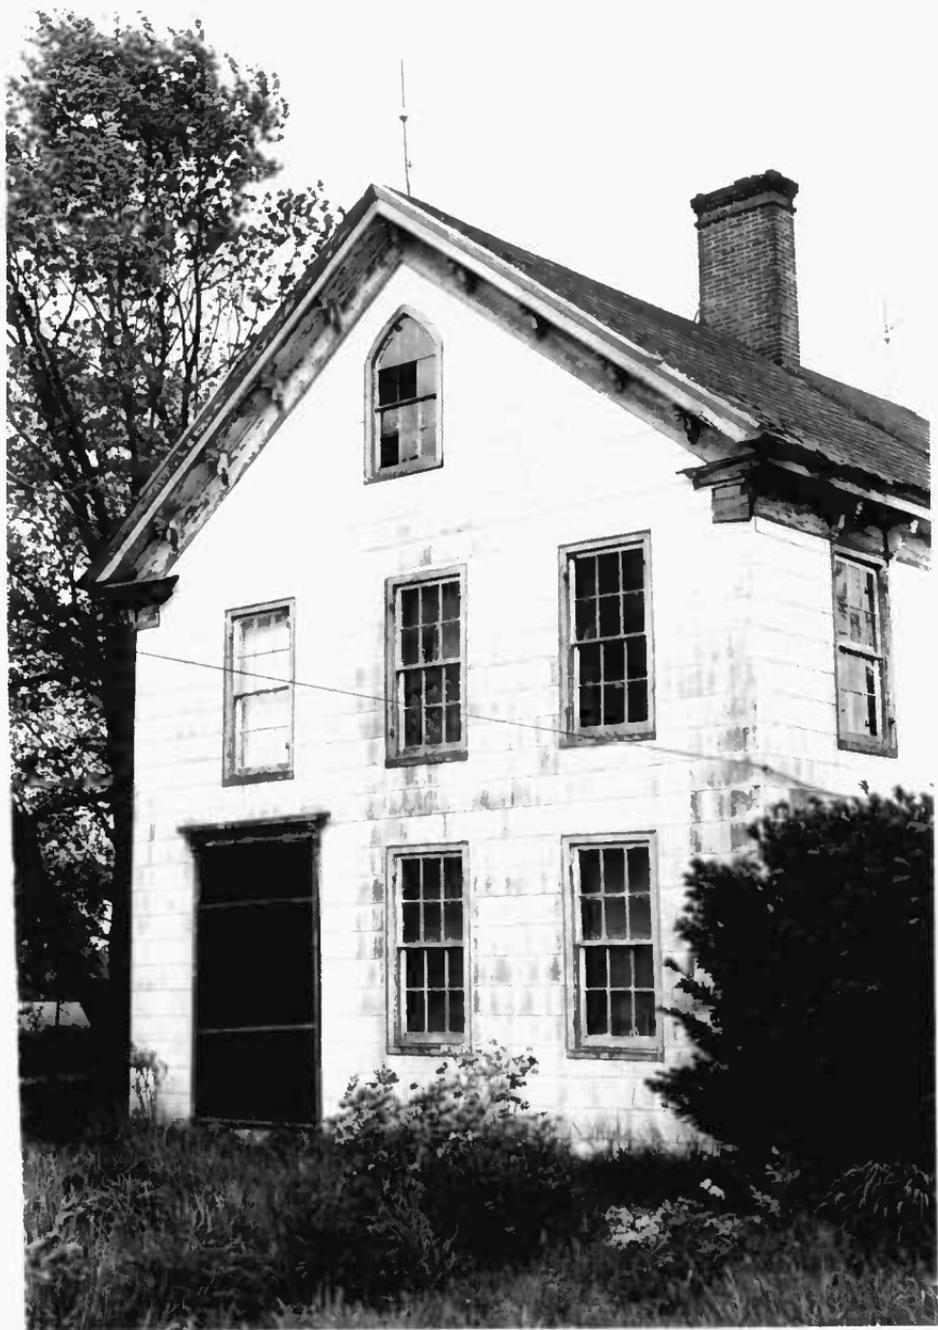
S-211

The east (main) facade is three bays across with a boarded-up entrance in the south bay and two adjacent 6/6 sash windows. A small entablature and pilasters frame the entrance. The second floor is lighted by three 6/6 sash window, and the gable end is pierced by a pointed arch 6/6 sash.

John Lewis Porter Farm  
Near Wellington, Somerset County  
East Elevation  
5/84 Paul Touart  
Neg./ Maryland Historic Trust
