S-271  
Alfred Tull House  
Tulls Corner  
private

c. 1880

# Maryland Historical Trust State Historic Sites Inventory Form

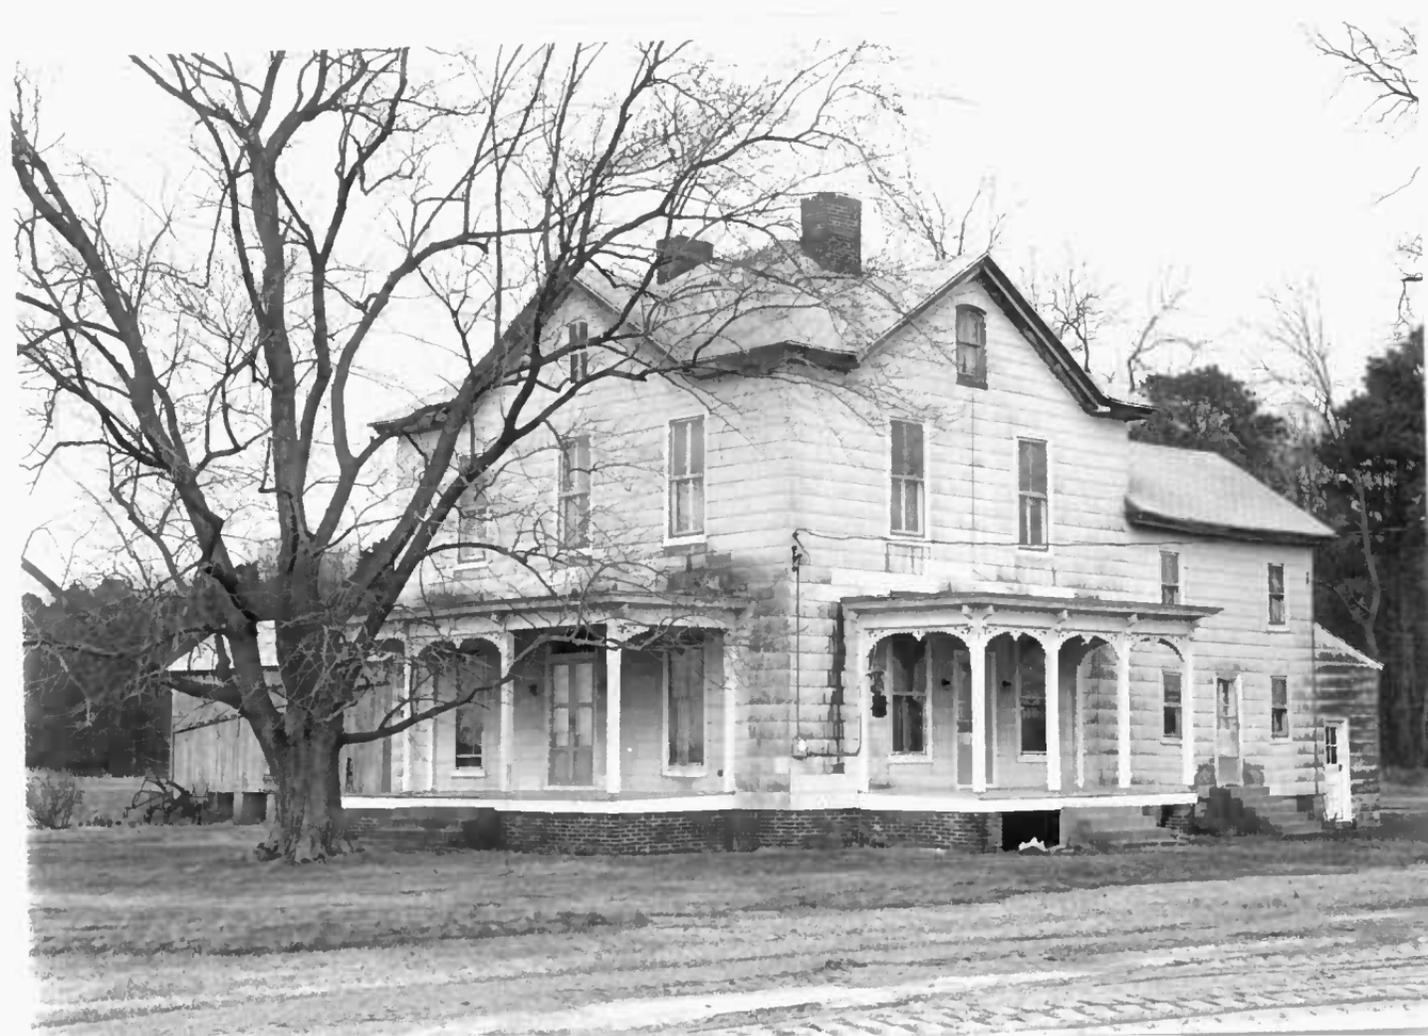
Southwest Elevation

The west (main) elevation is a symmetrical three-bay facade with a center heavily molded double door topped by a two-light transom. The first and second floors are lighted by two over two sash windows, and the front gable is pierced by a two over two sash with a slightly arched header. The first floor is covered by a flat-roofed porch supported by chamfered posts and decorated with sawwork and brackets. A pair of brick chimneys rises from the central portion of the house while flanking the stair hall.

The south elevation is a two-bay facade with a side entrance squeezed between the two first floor windows. The second floor and attic are lighted by identical windows, and the same Victorian porch stretches across the first floor.

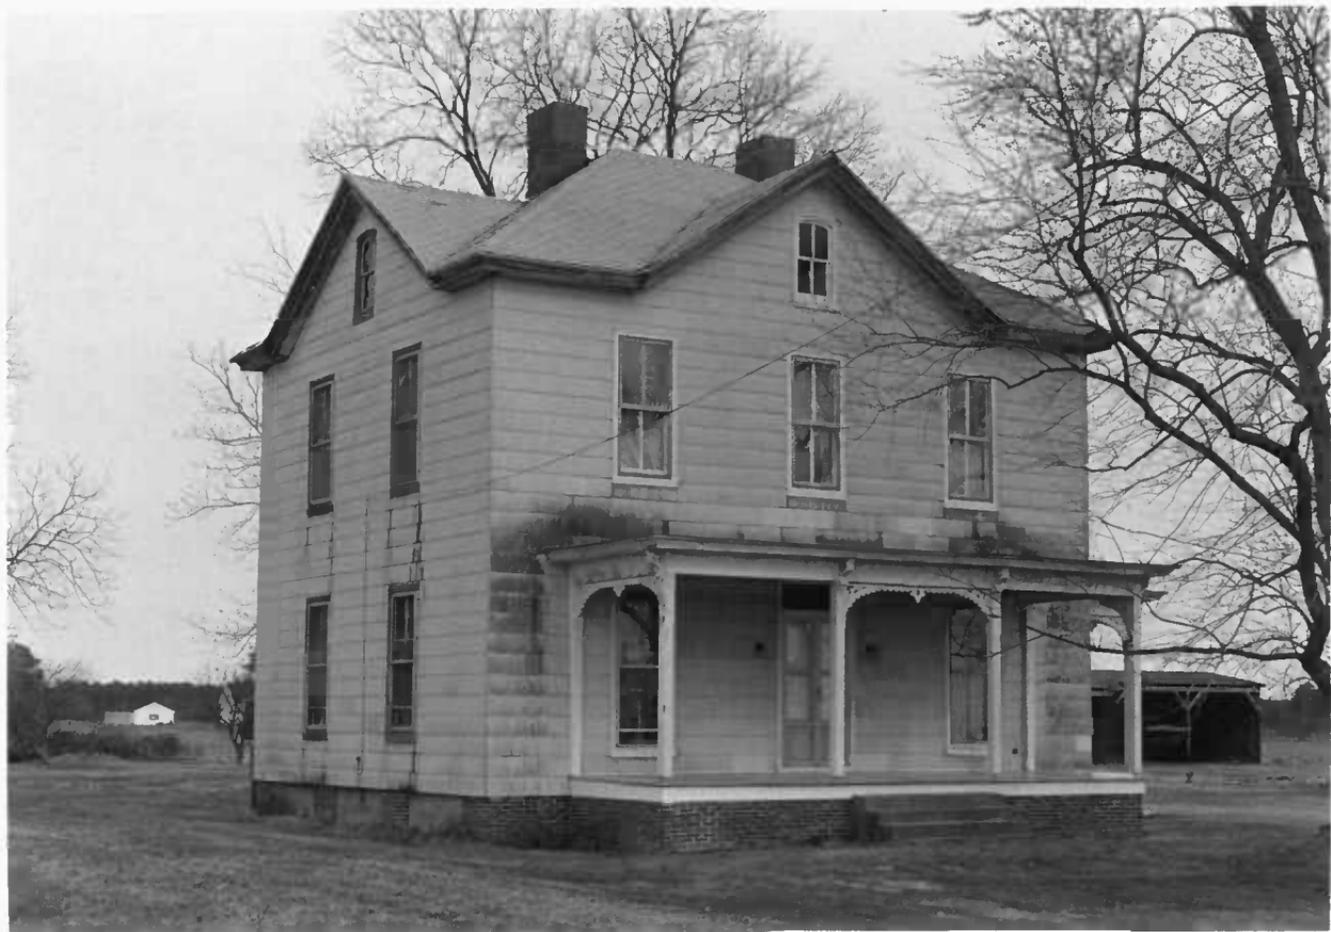
Northwest Elevation

The north end of the main house has two 2/2 sash windows on each floor and a single 2/2 attic light with an arched header.
