S-272
School No. 4
Shelltown vicinity
private

Maryland Historical Trust State Historic Sites Inventory Form

Survey No. S-272

historic School No. 4

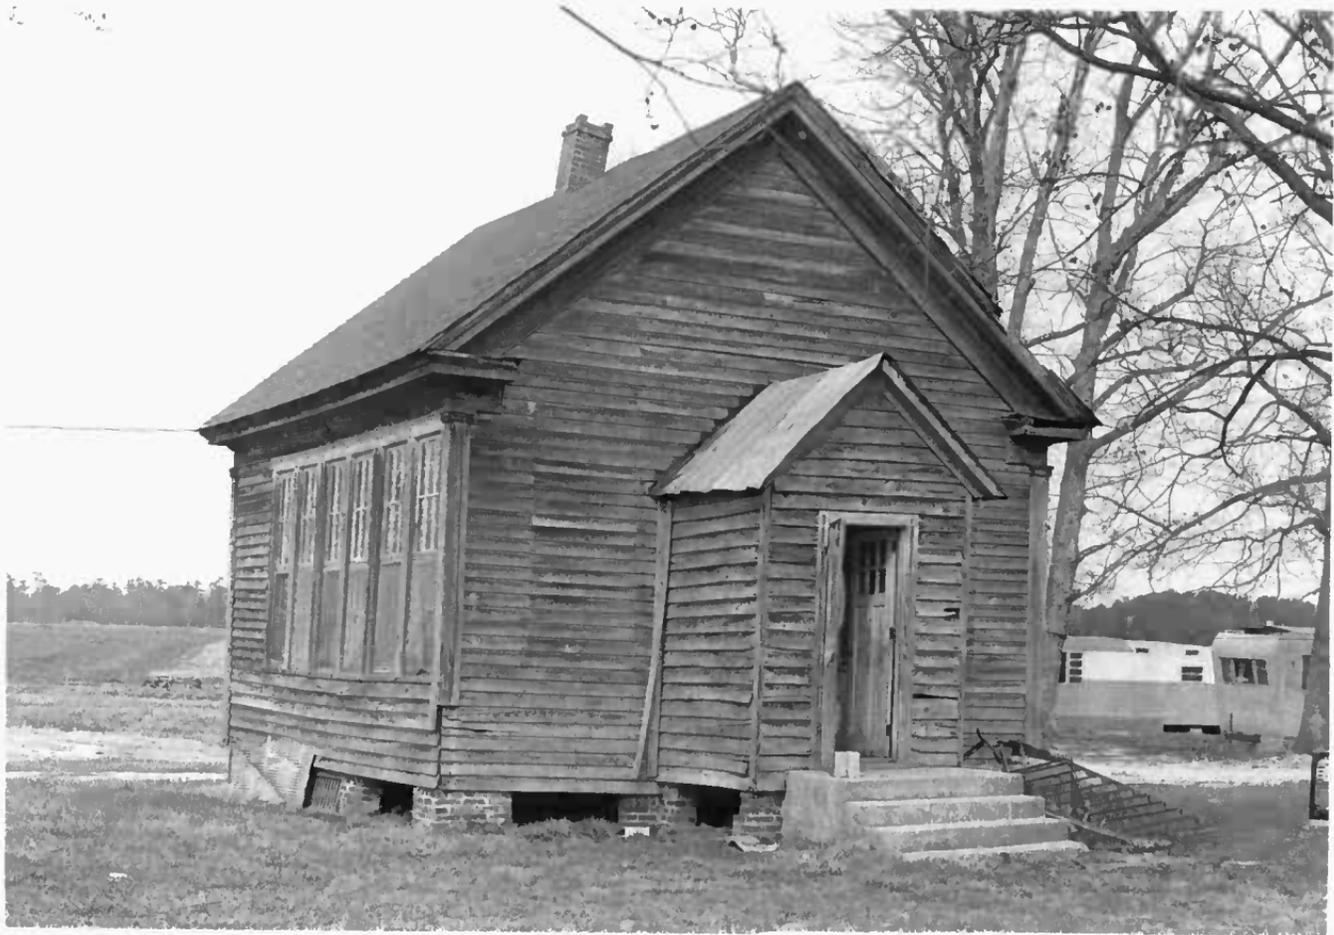
South Elevation

The southeast (main) facade is marked by an enclosed gabled entry. Corner pilasters frame the elevation.

The southwest (side) elevation is distinguished by a series of six off-center 6/6 sash windows installed at a slightly later date to add more light inside.

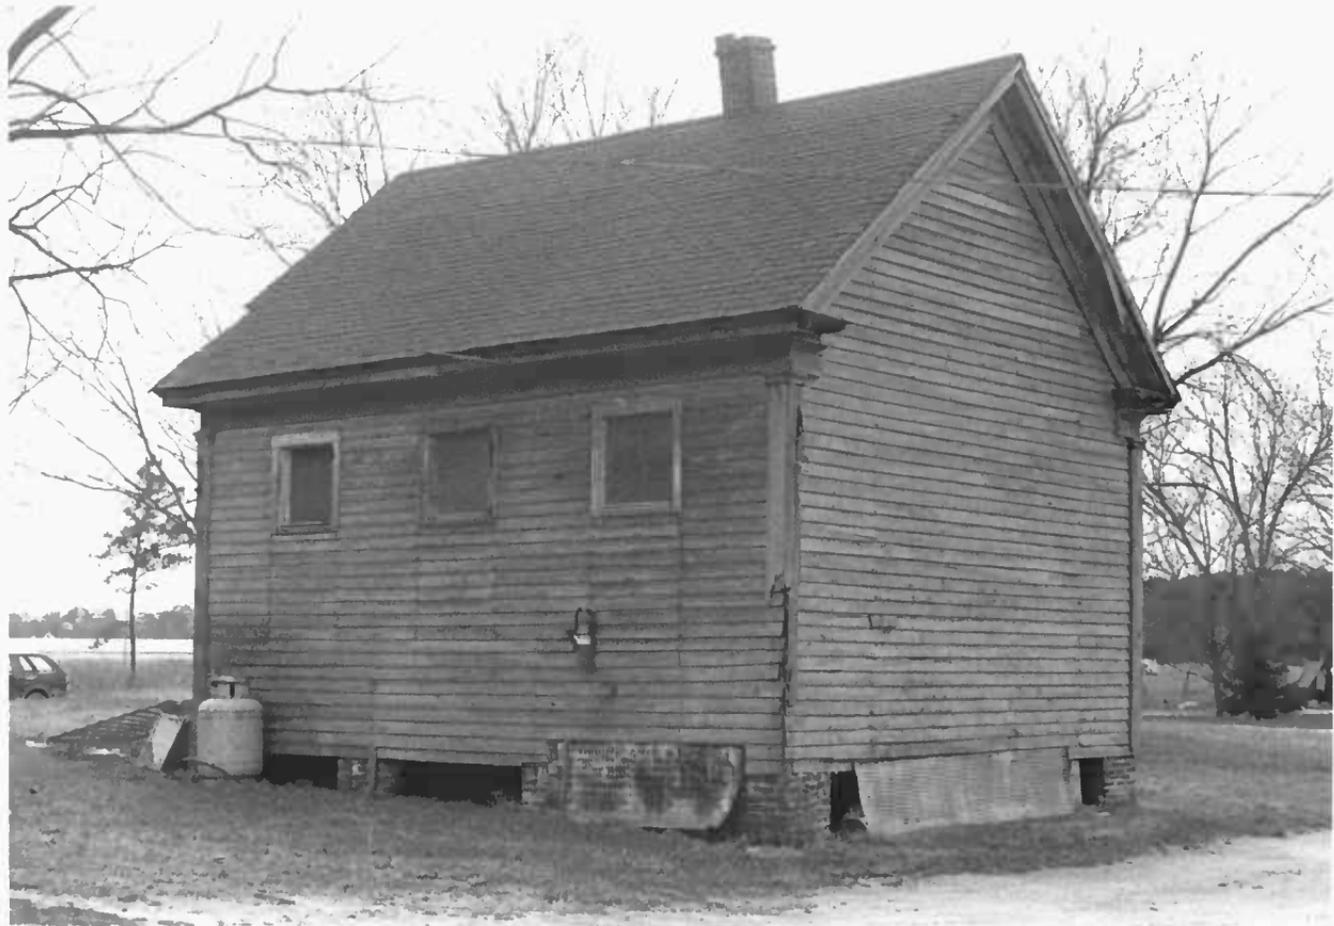
Northeast Elevation

Finally, the northeast (side) has three window openings that have been reduced in size from large size 6/6 sash to small square windows. A narrow brick stack rises from the center portion of the structure.
