WA-I-271

Cearfoss Vicinity

INVENTORY FORM FOR STATE HISTORIC SITES SURVEY

Castle Plains Farm

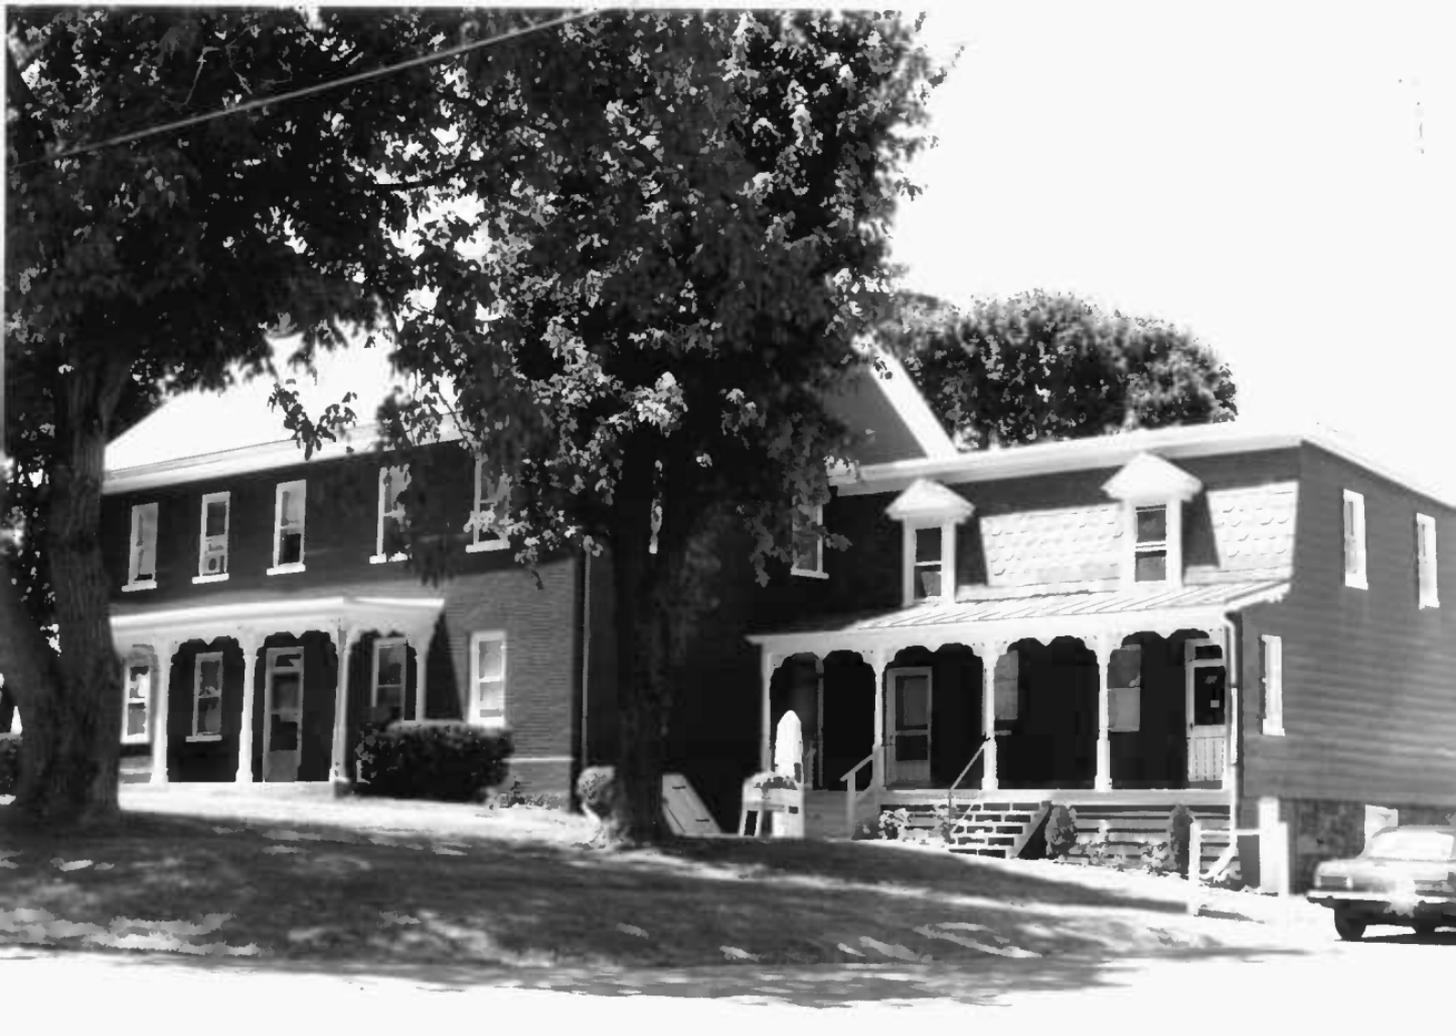
From east

Flemish bonding is displayed at the front or east elevation and the two end walls as well. The rear or west wall has American or common bonding with three courses of stretchers between header rows. A water table of quarter round bricks is present at all four walls, seven courses above the foundation. High flat arches of brick are present above the windows and doors. The entire surface of the structure has been painted red.

The main entrance is located in the center bay of the front elevation. The door is framed similarly to the windows and includes a narrow transom. The central three bays of the front wall at the first story are sheltered with a flat roofed porch supported by heavy chamfered square posts with Victorian brackets. A similar porch with turned posts and a shed roof extends across the front elevation of the wing.

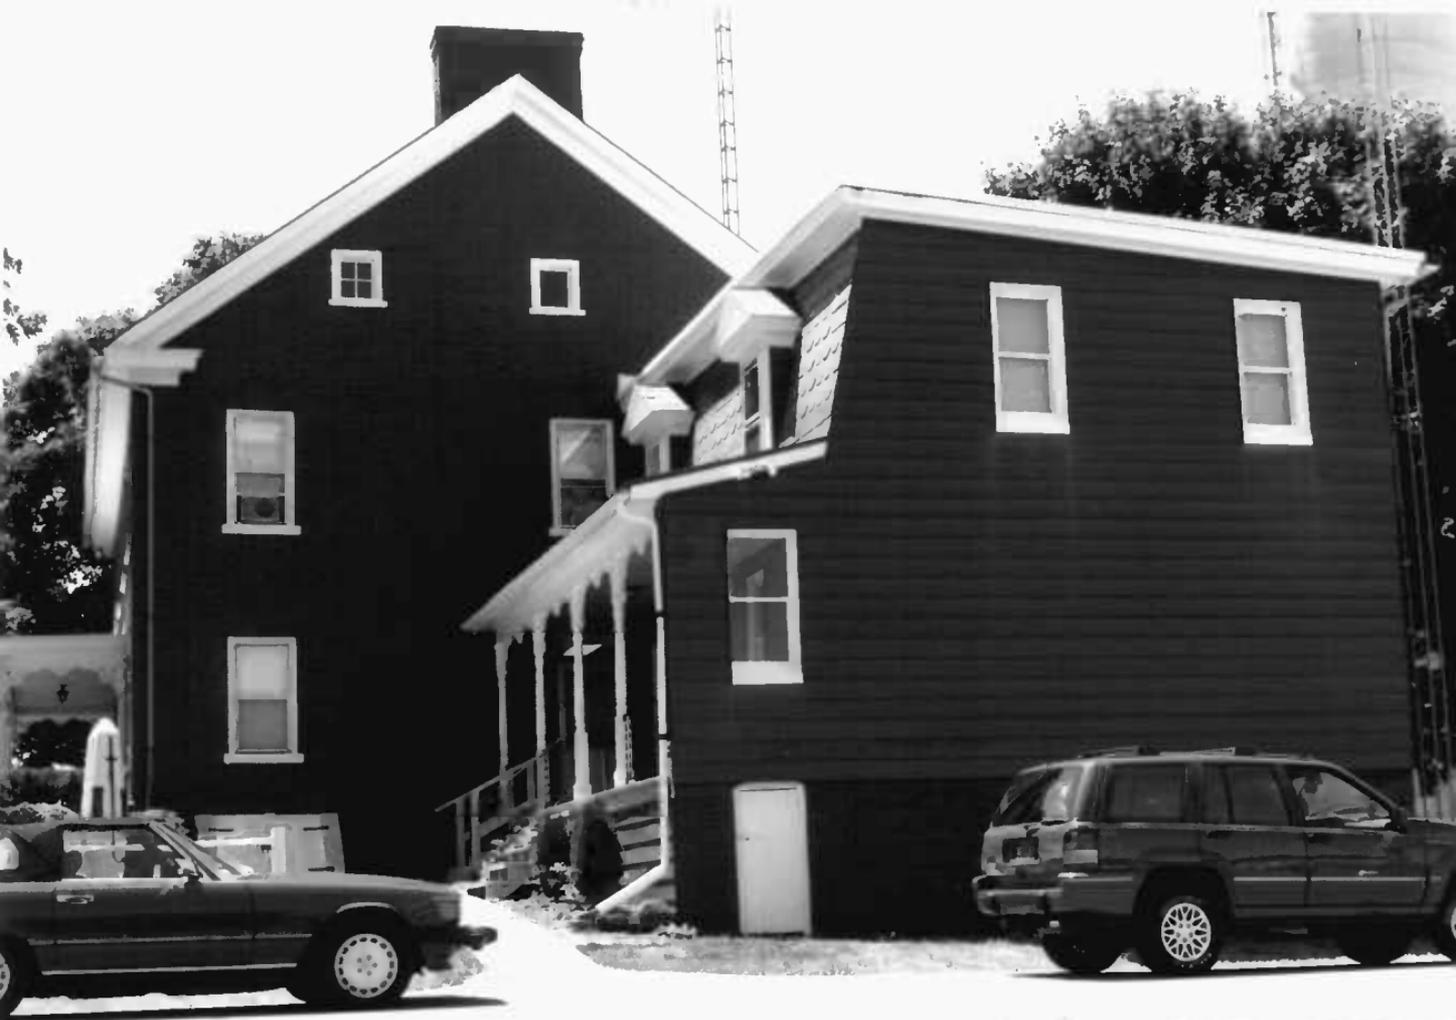
The house rests on fairly level ground parallel to the road and faces east. The structure is a two story, five bay brick dwelling on low fieldstone foundations. Attached to its north end wall is a stone, brick and frame two story shed roofed addition. A one story enclosed porch has been added to the rear of the main section.

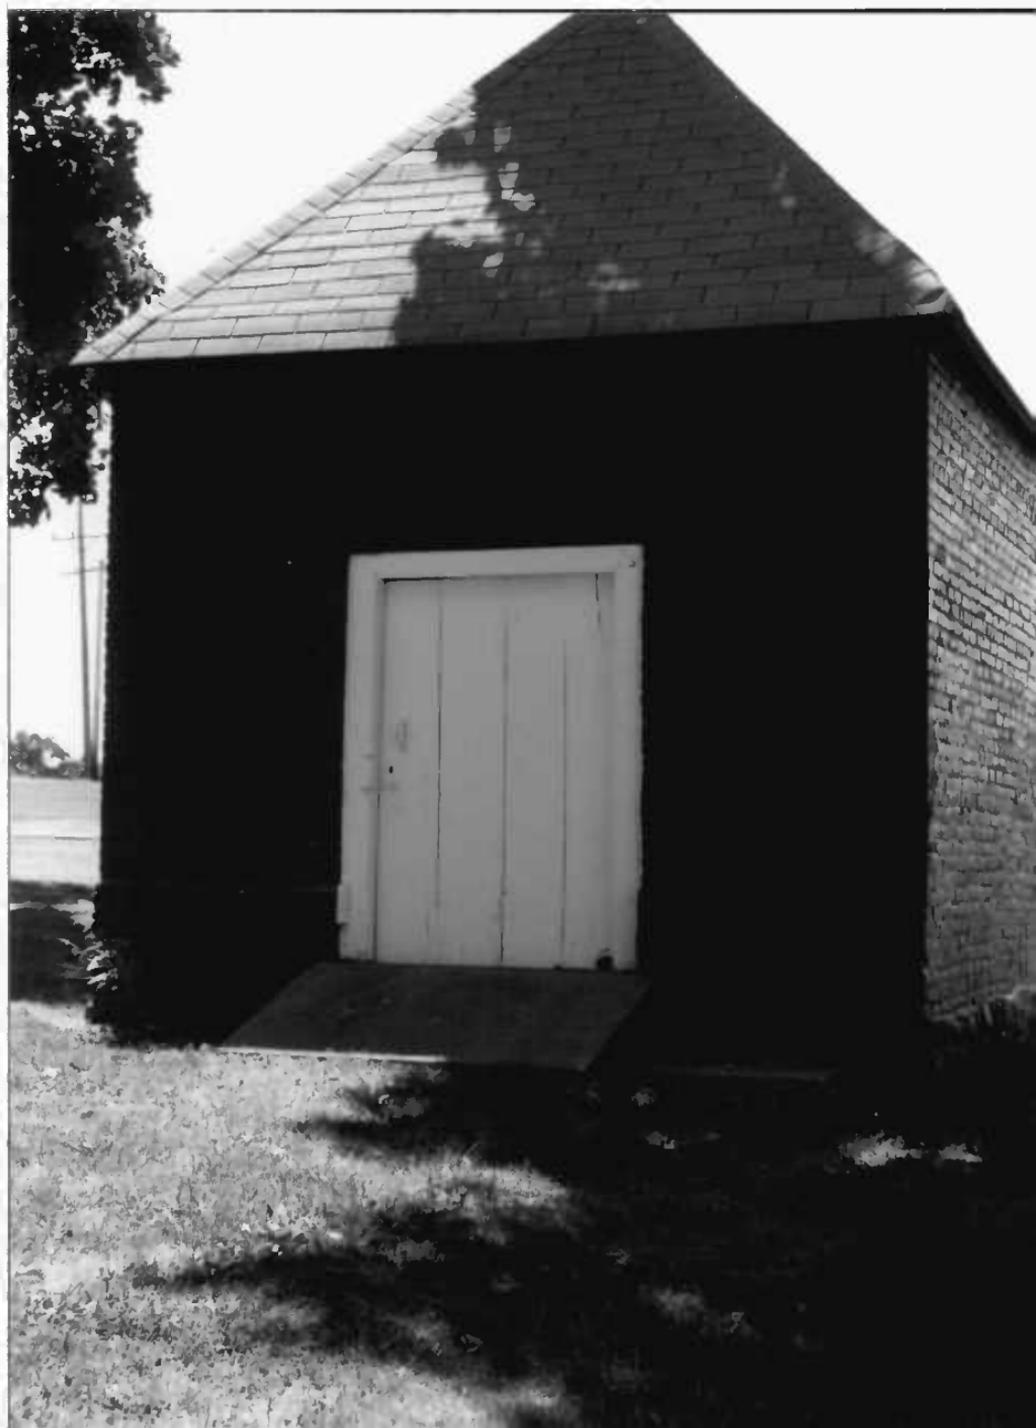
Just southwest of the dwelling is a square brick smoke house resting on low fieldstone foundations. It is constructed in common bond with three courses of stretchers between header rows. The hipped roof is sheathed with asphalt shingles like those used on the house.

Smoke House on south side
of house from north
