MARYLAND HISTORICAL TRUST
NR-ELIGIBILITY REVIEW FORM

Property Name: Brumbaugh-Kendle-Grove Farmst Inventory Number: WA-I-480

Maryland Inventory of Historic Properties Form

historic Brumbaugh-Kendle-Grove Farmstead
 other Luther Grove Farm

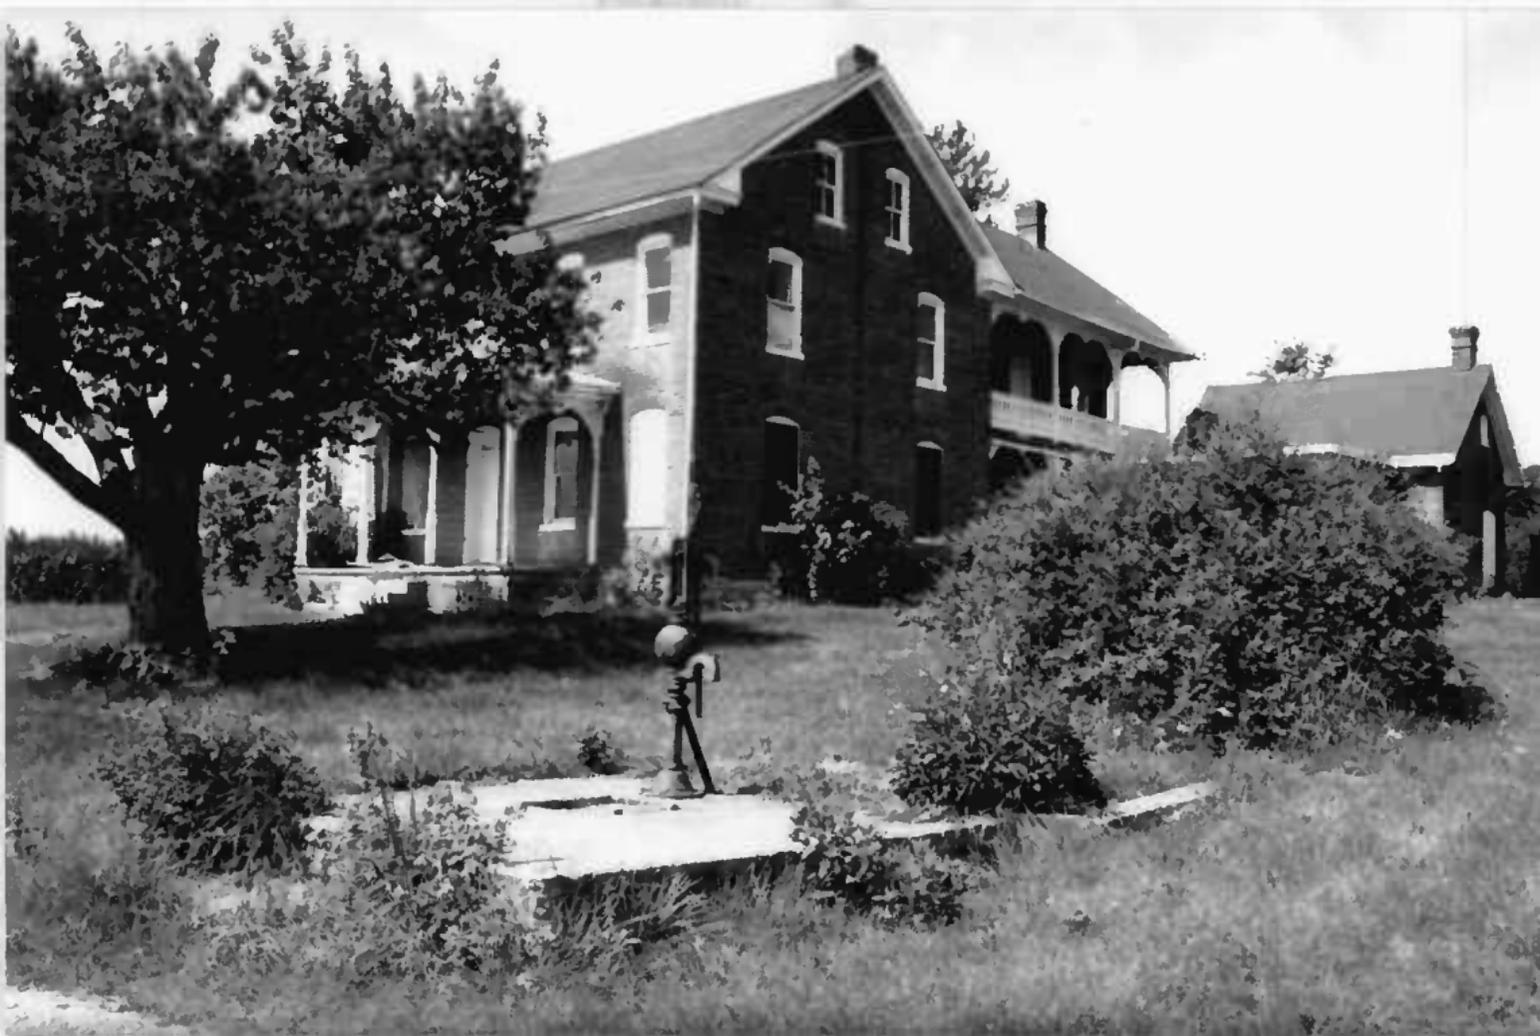
1 of 41

Farmhouse - looking SW

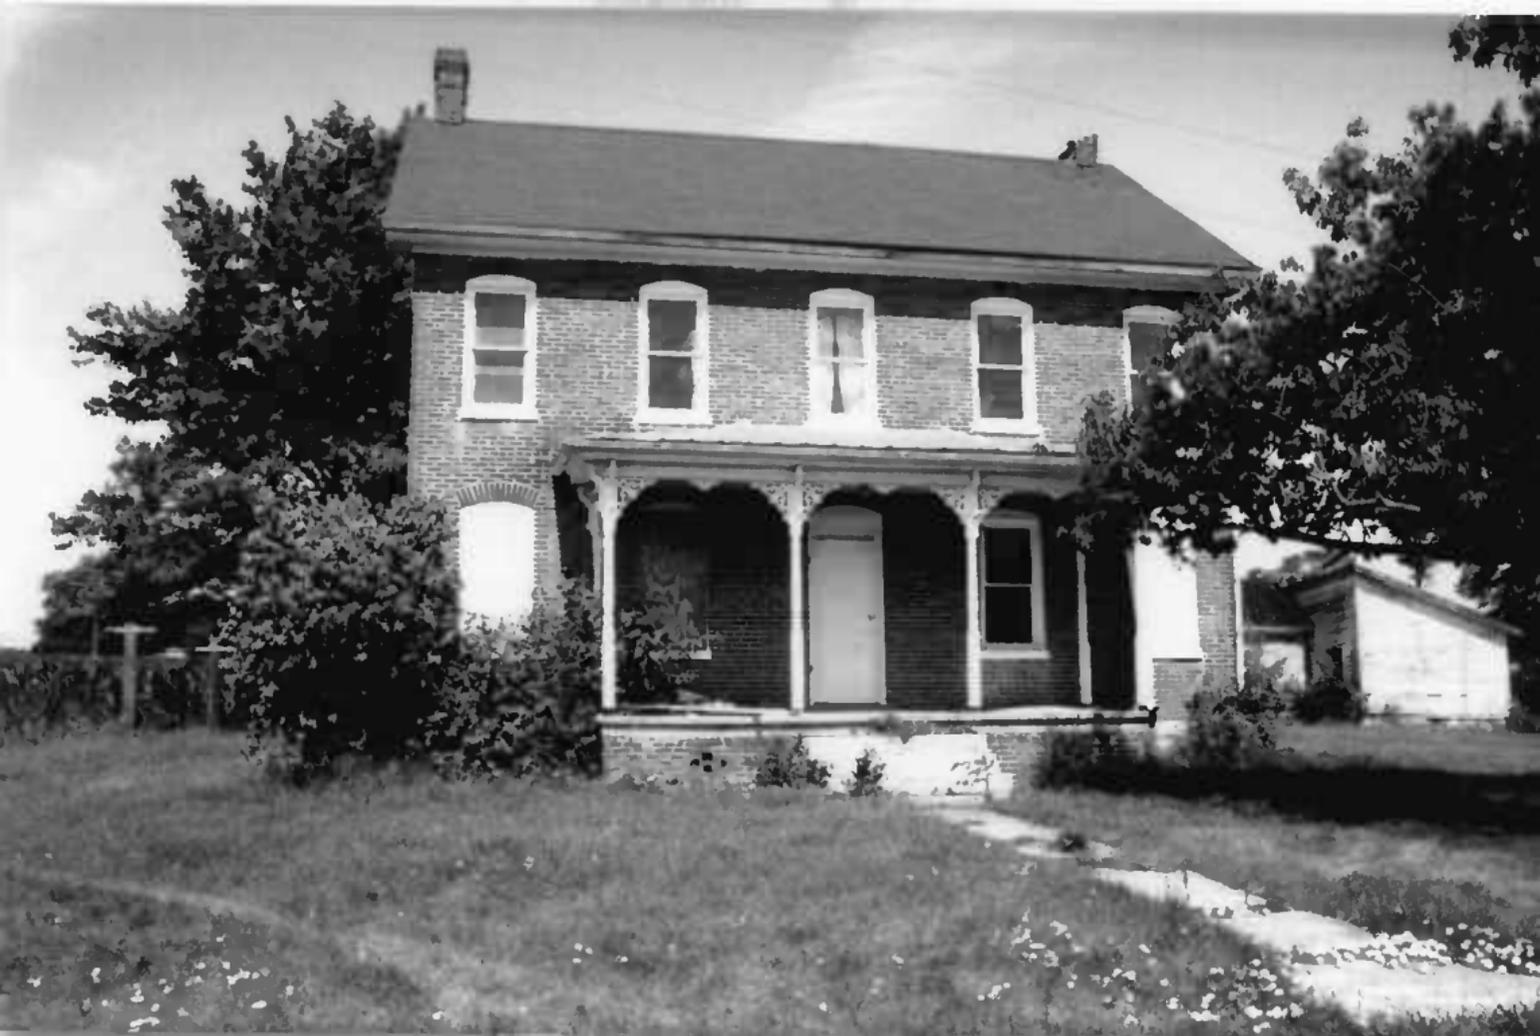
2 of 41

Farmhouse - looking W

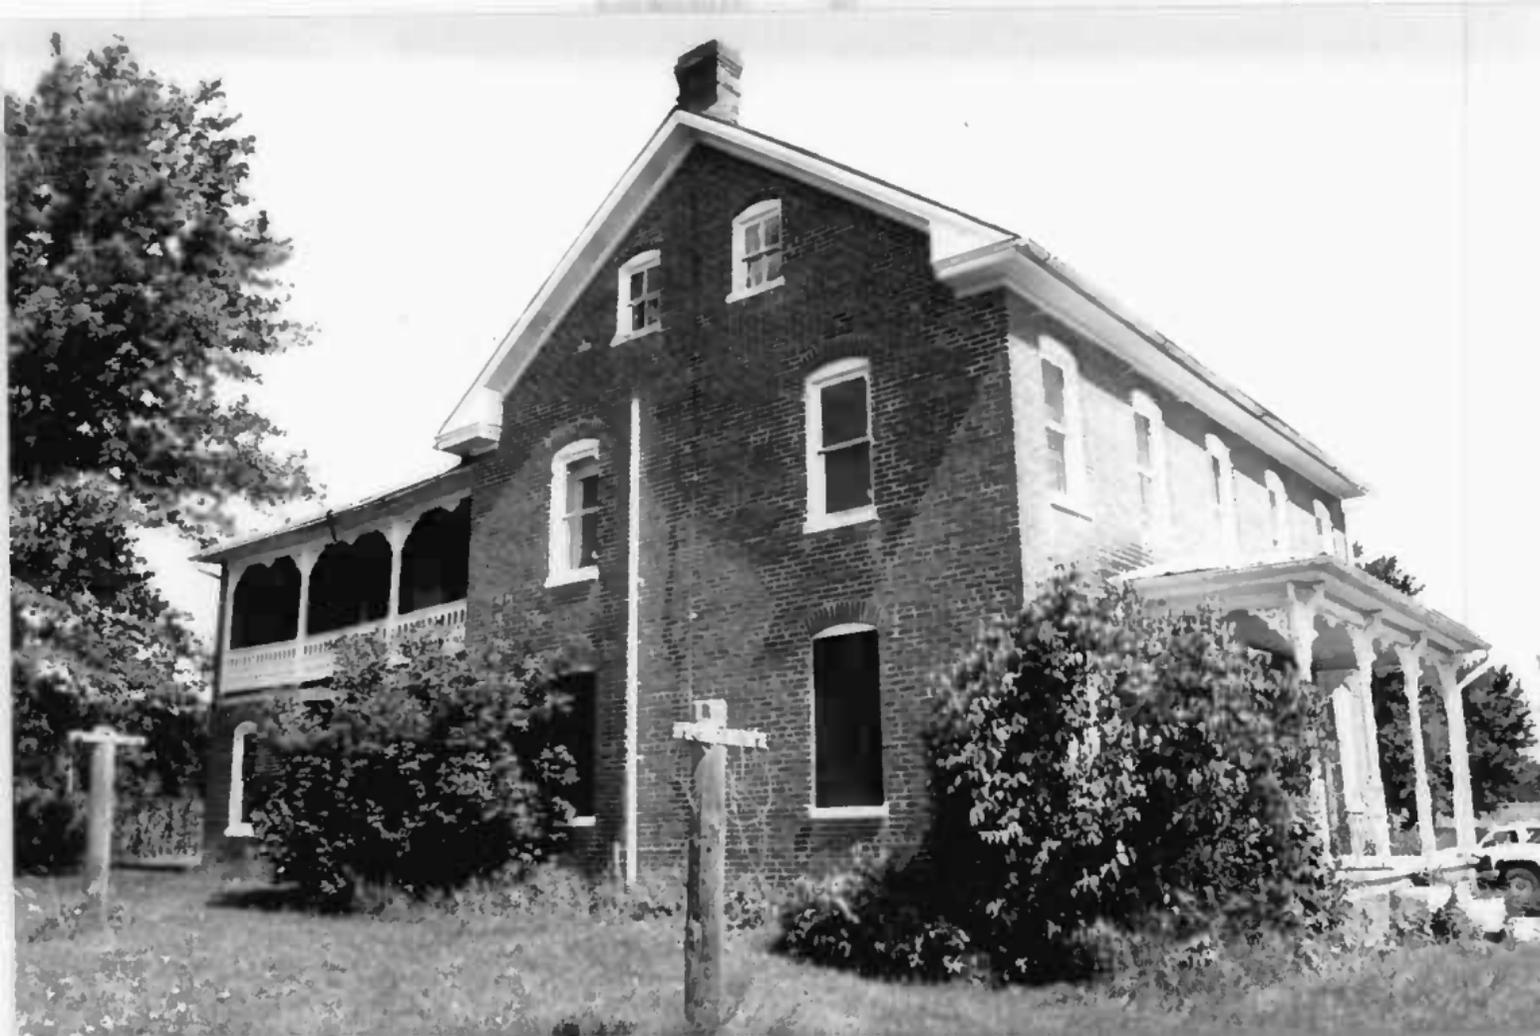
3 of 41

Farmhouse - looking NW

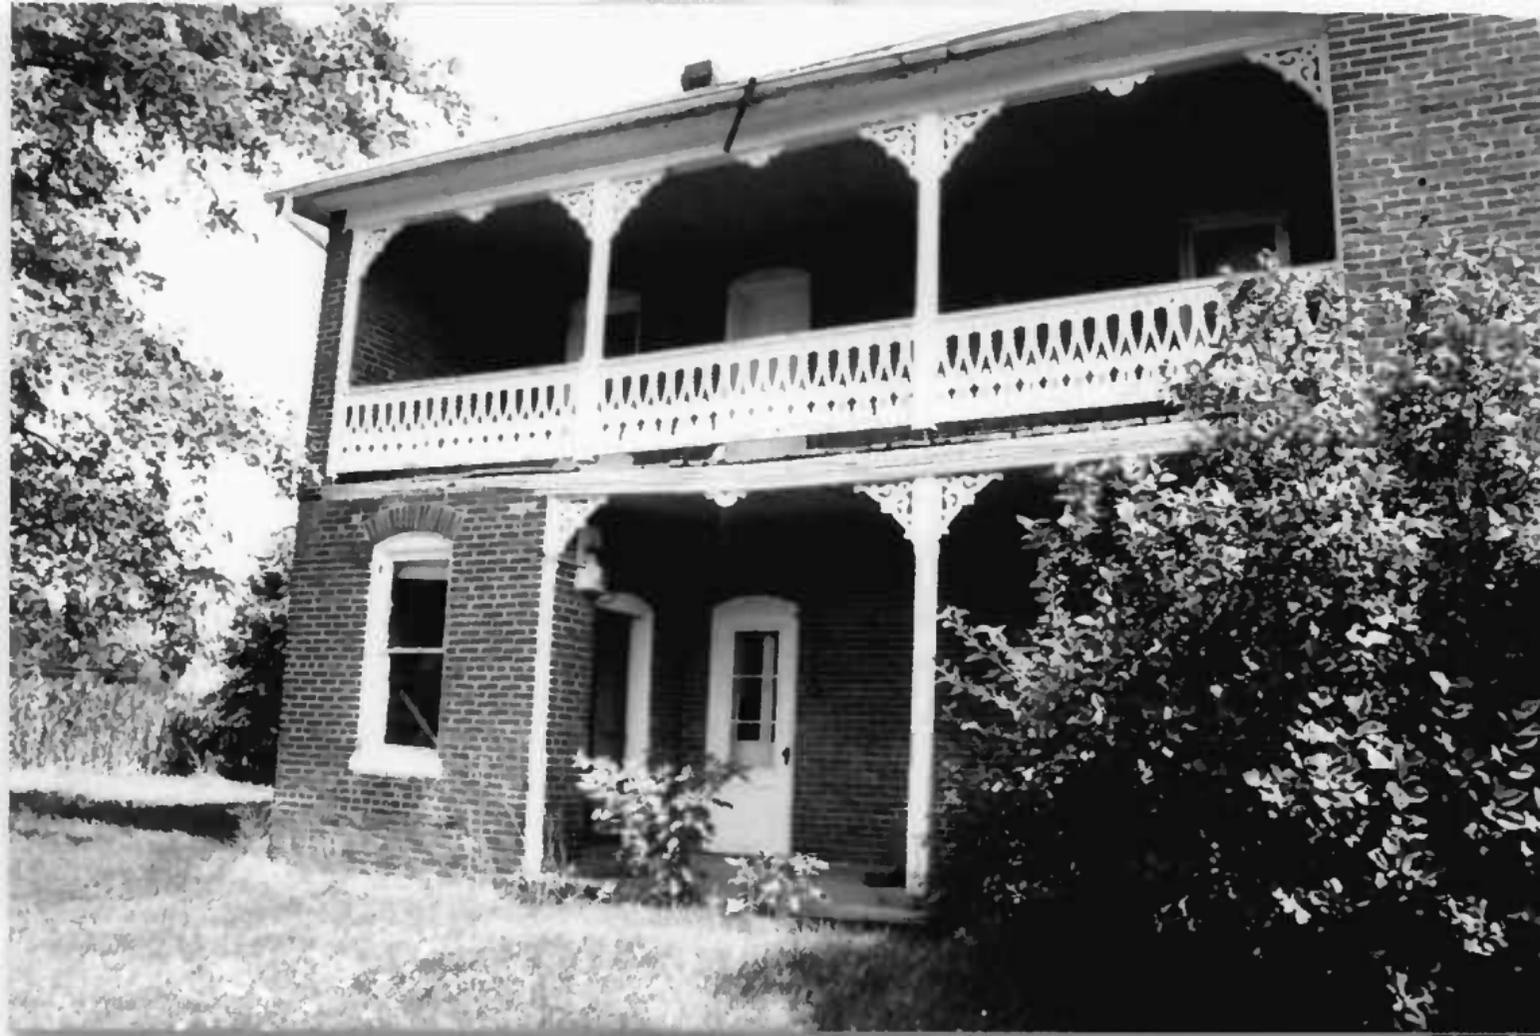
4 of 41

Farmhouse - looking NW

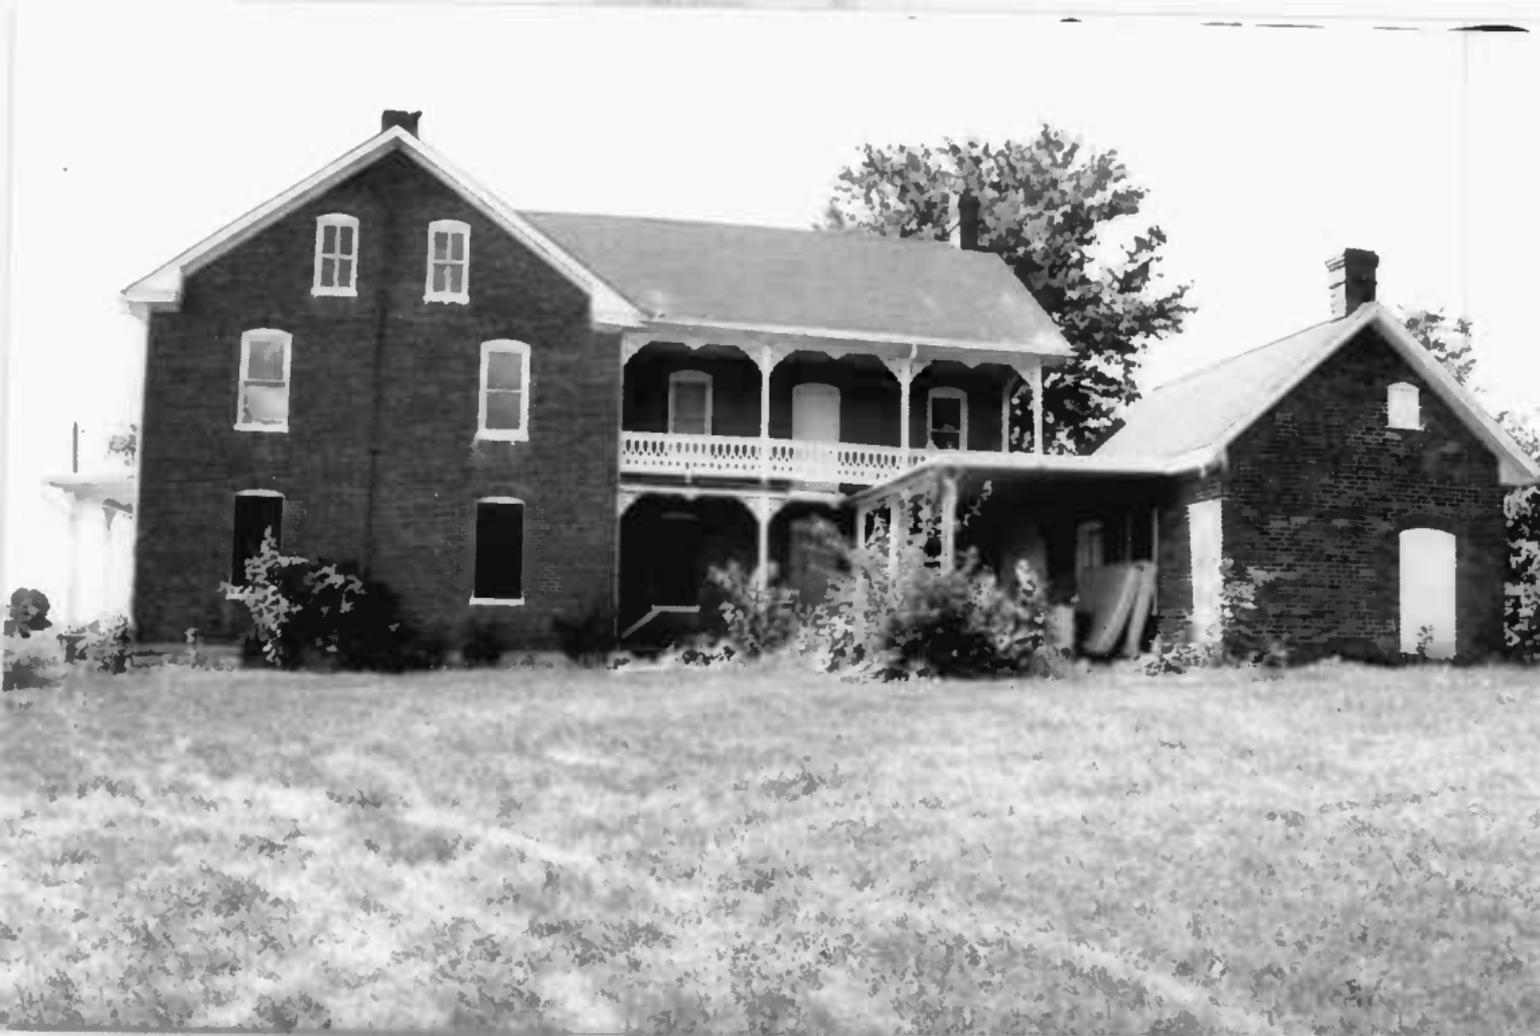
6 of 41

Farmhouse - looking S

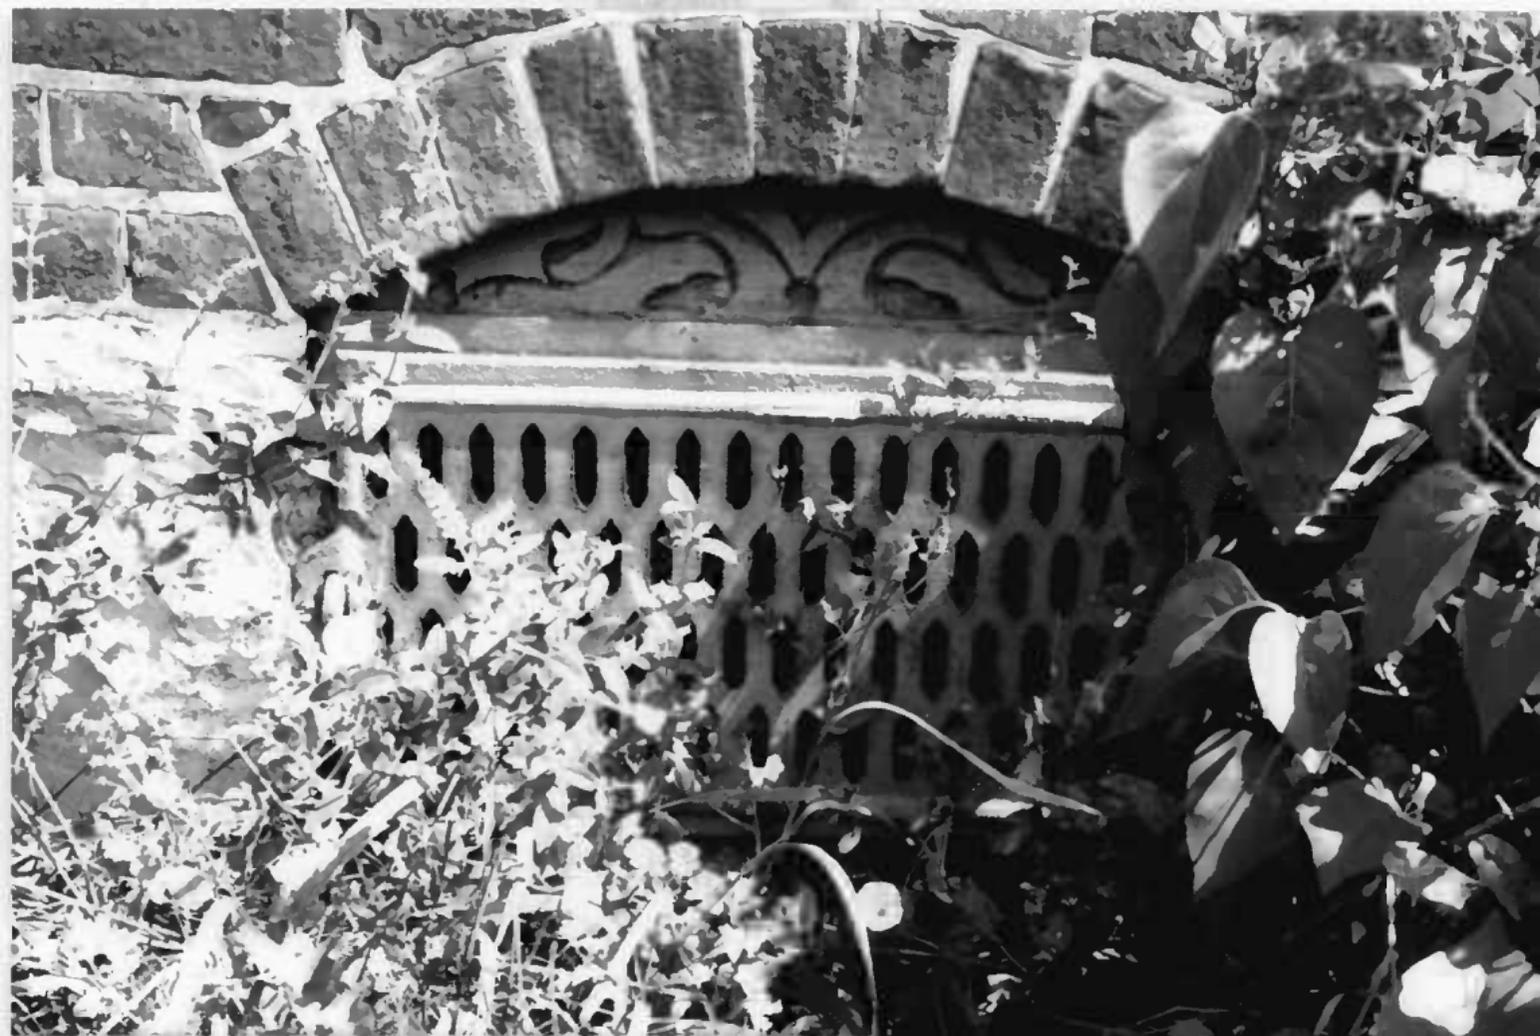
Farmhouse - foundation ventilator, looking N
7 of 41

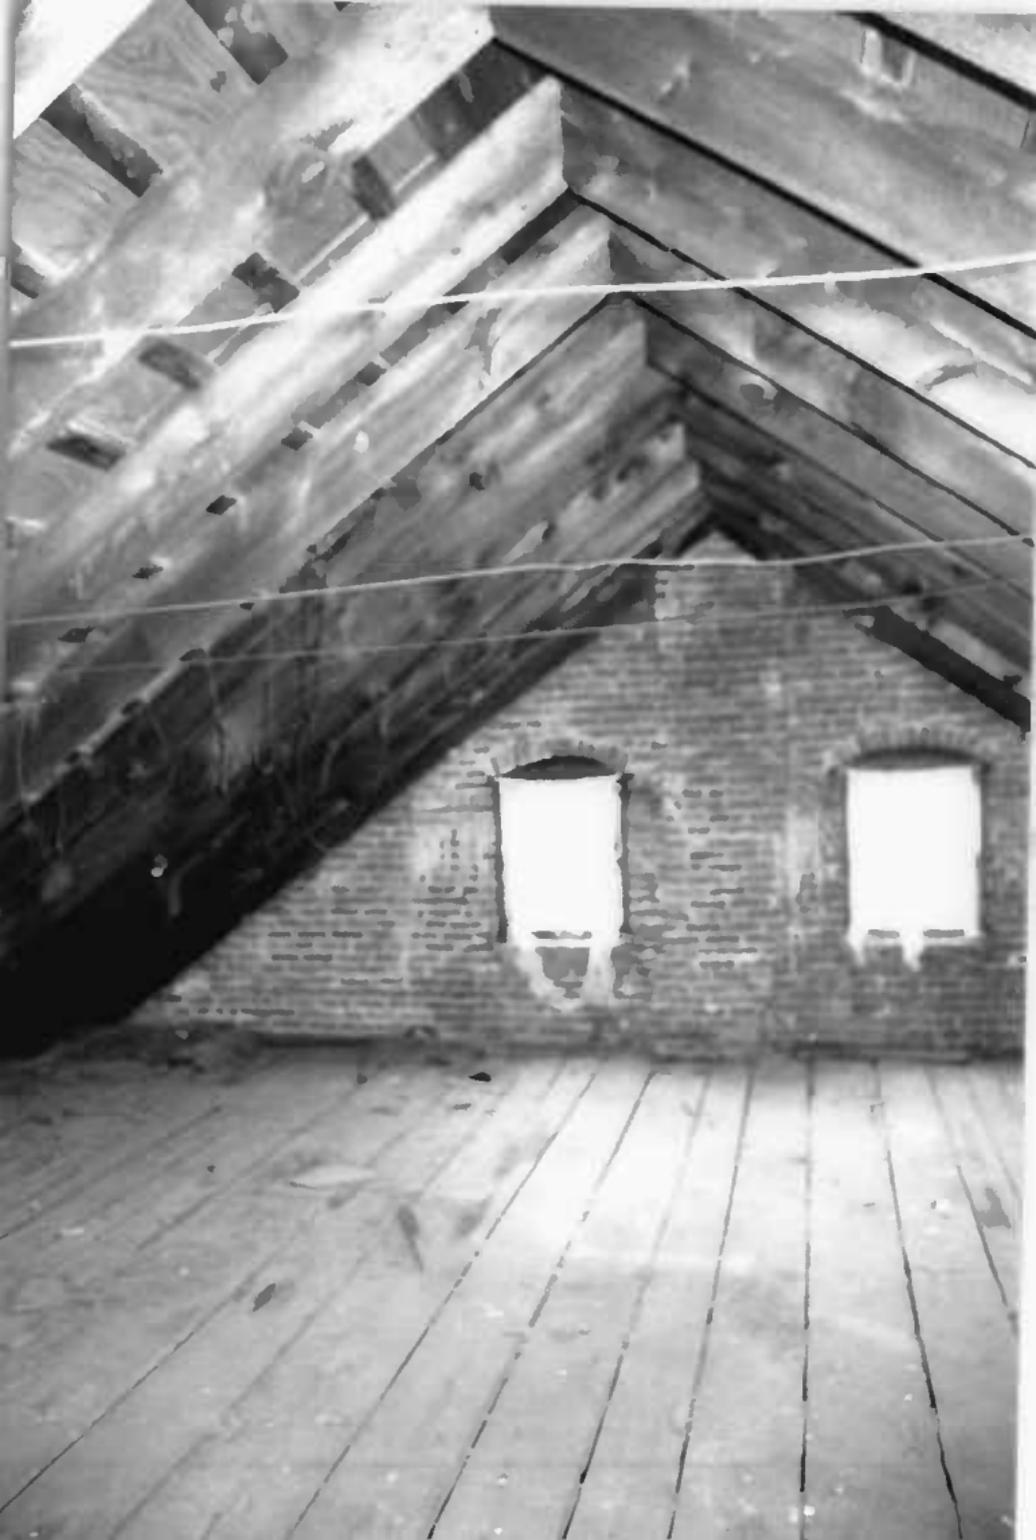
8 of 41

A boxed stairwell to an attic that extends above the front block and the ell is walled with plaster. The roofs over both blocks were raised at the same time. They are supported by circular-sawn common rafters butted and nailed together at the ridge and topped by strip sheathing. These closely spaced strips likely once supported roofing other than the current asphalt shingles, which are nailed to later-added plywood sheathing.

Farmhouse 2 - front black attic, looking S

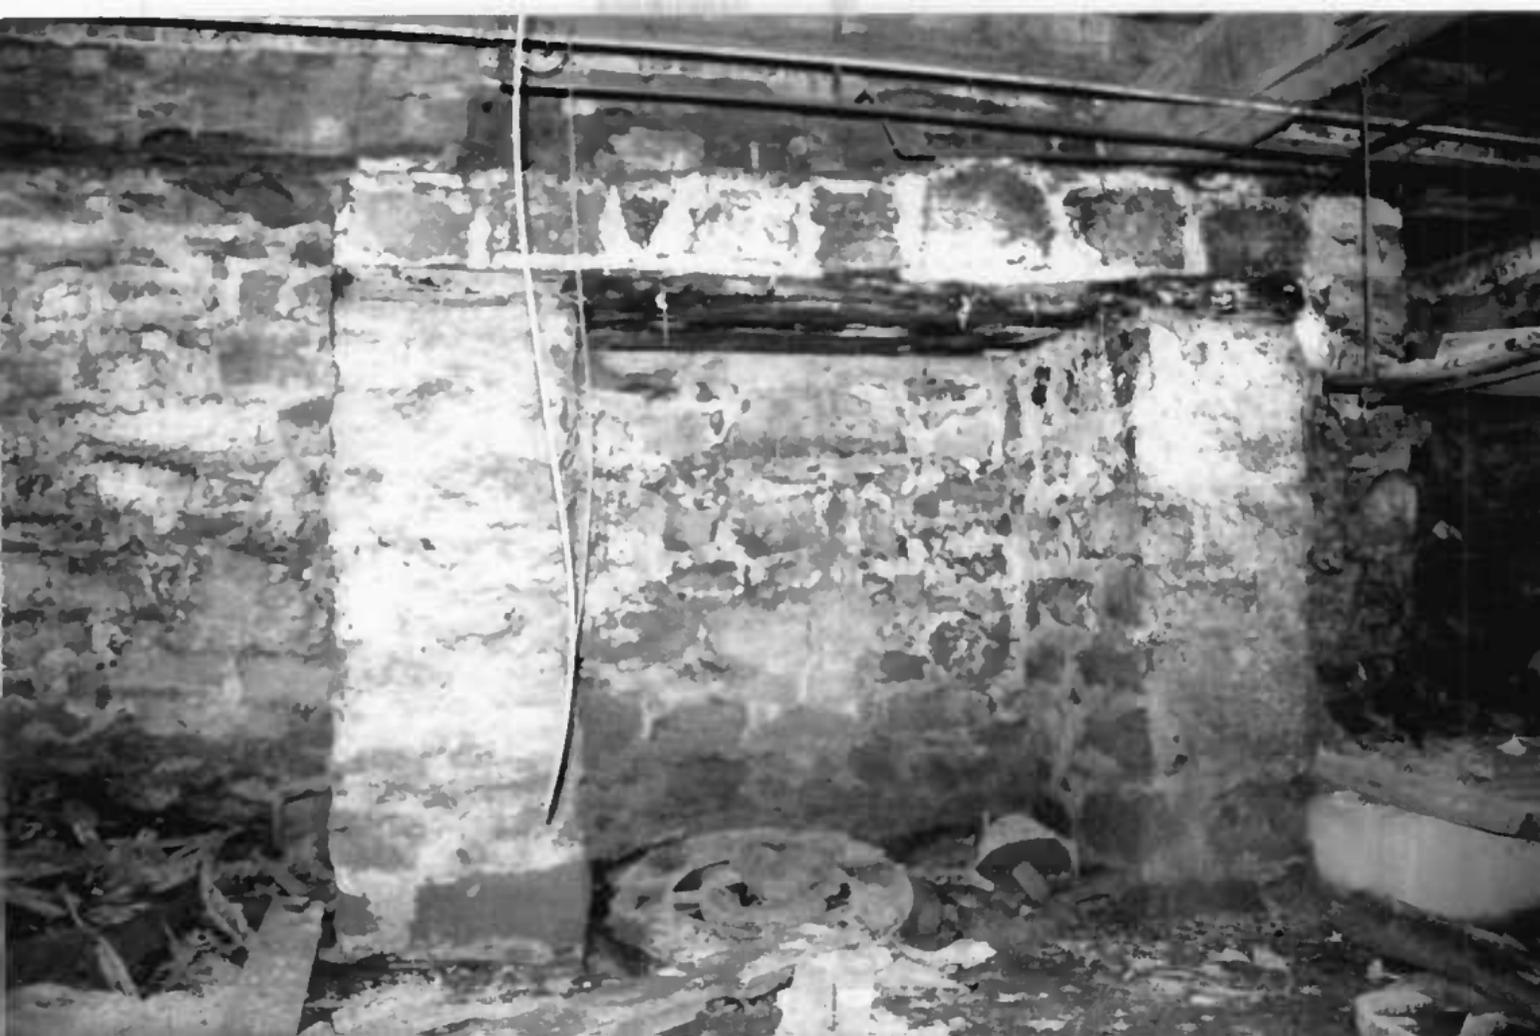
17 of 41

The basement, which runs beneath both blocks, is reached from the kitchen. The walls of its stair are plastered. Only in the basement is the early date of the house site apparent. Beneath the rear ell is a brick-floored room topped by large, hand-hewn beams. The stone walls of a large fireplace project from the north side wall of the room. Beams topped by stone cover the former opening of the hearth. The basement room beneath the southern portion of the front block has limestone walls also topped by large, hand-hewn beams. The room beneath the northern portion of the block, however, has smaller, more regular, machine-sawn joists and beams. The association of the basement with an earlier house on the site is cloudy. The brick-floored room beneath the ell probably predates the current house. Perhaps it was the cellar of the “more than 100 years” old log house that Samuel M. Kendle tore down in 1895 before building the current house. Perhaps the rough-hewn joists and beams that underpin the southern portion of the front block were part of the foundation, or salvaged from, that earlier house. Only the members beneath the northern portion of the front block appear to be contemporary with the aboveground portions of the residence.

Farmhouse - fireplace in basement beneath ell, looking N

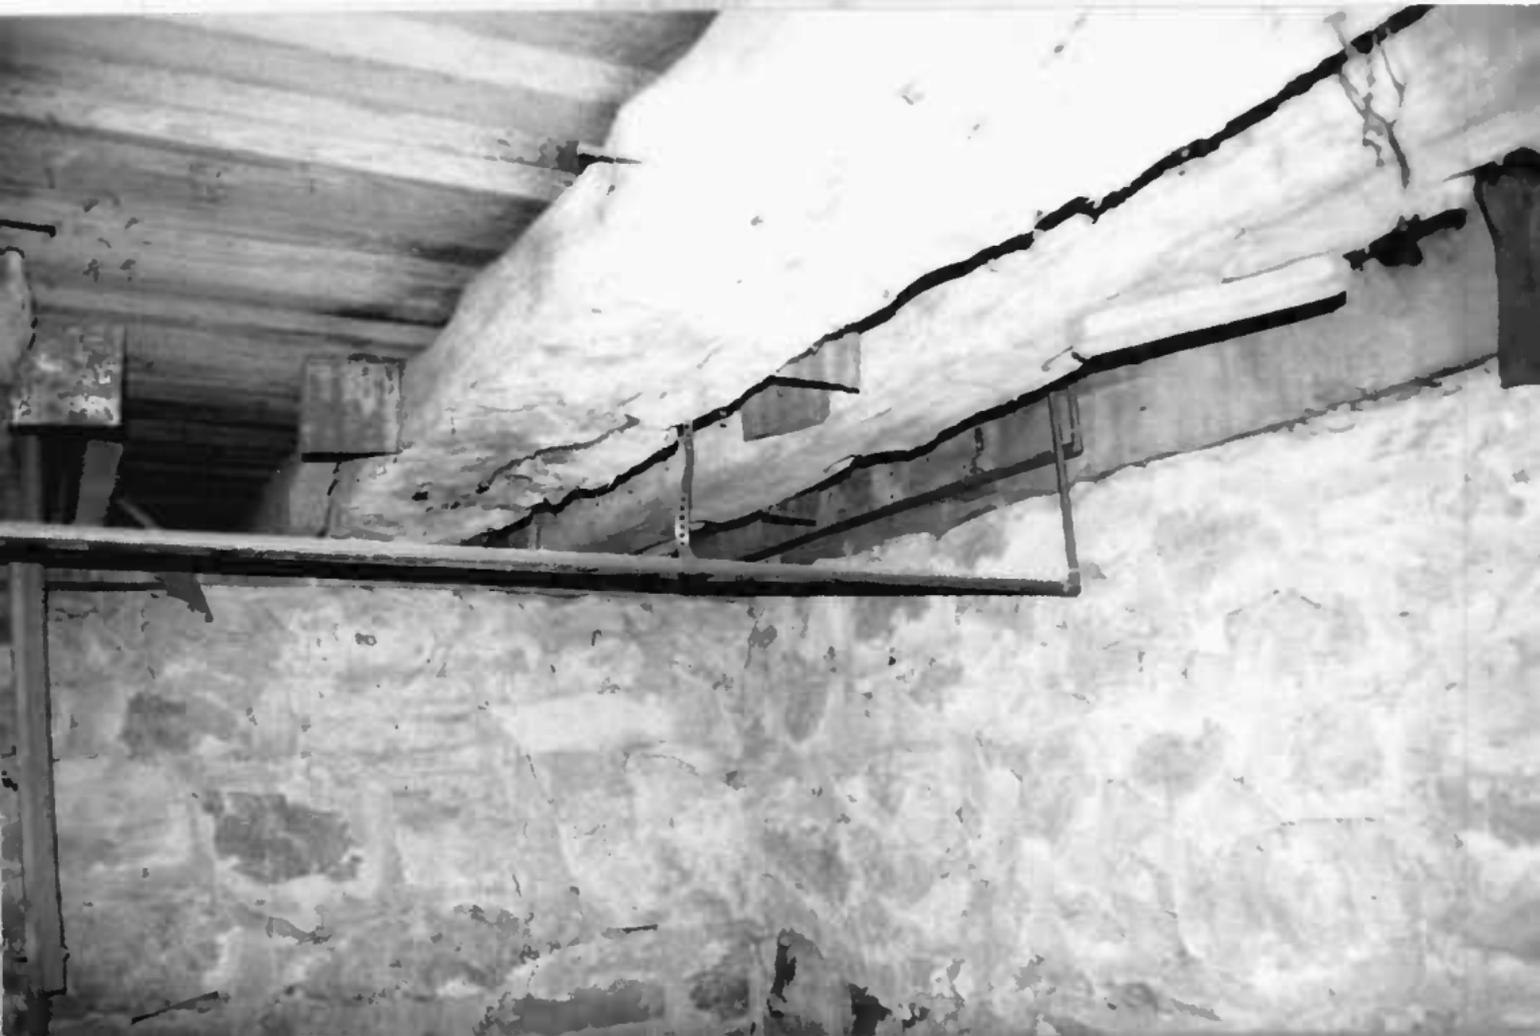
10 of 41

Farmhouse - basement beneath southern half of
front block

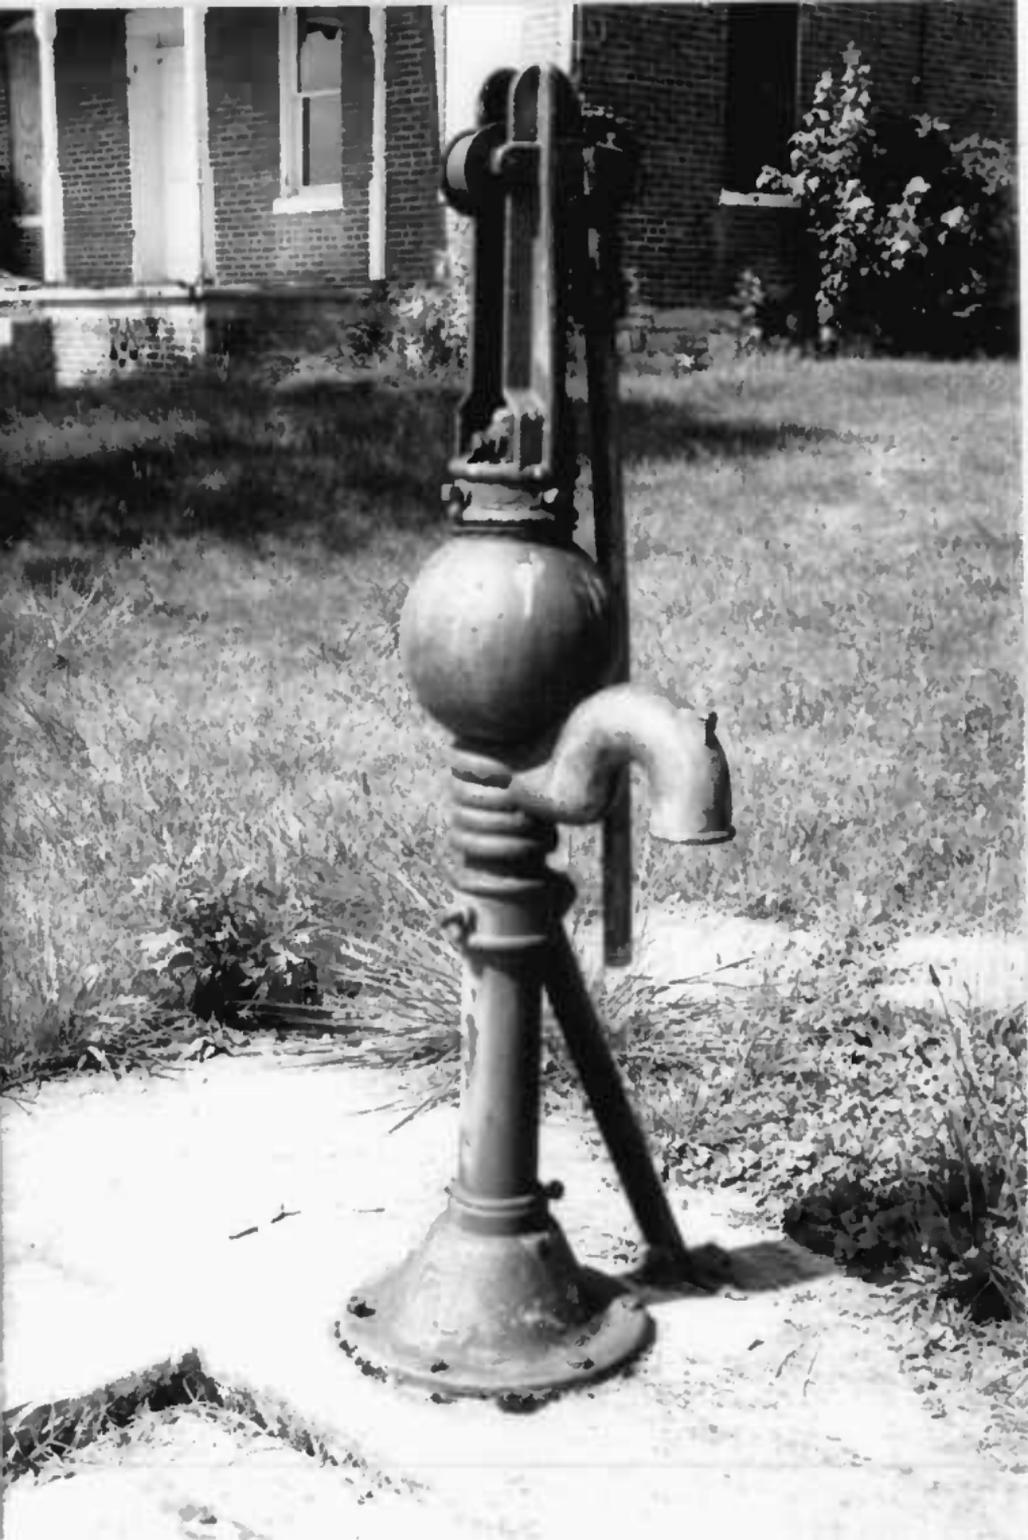
19 of 41

A bulbous iron well pump survives to the house's southeast, at the edge of the front yard near the limestone-gravel drive. It is set on a large concrete pad that seals the well. Any house or structure that once covered the well and pump is now gone. The pump—an object—is in fair to good condition.

Well pump - looking SW

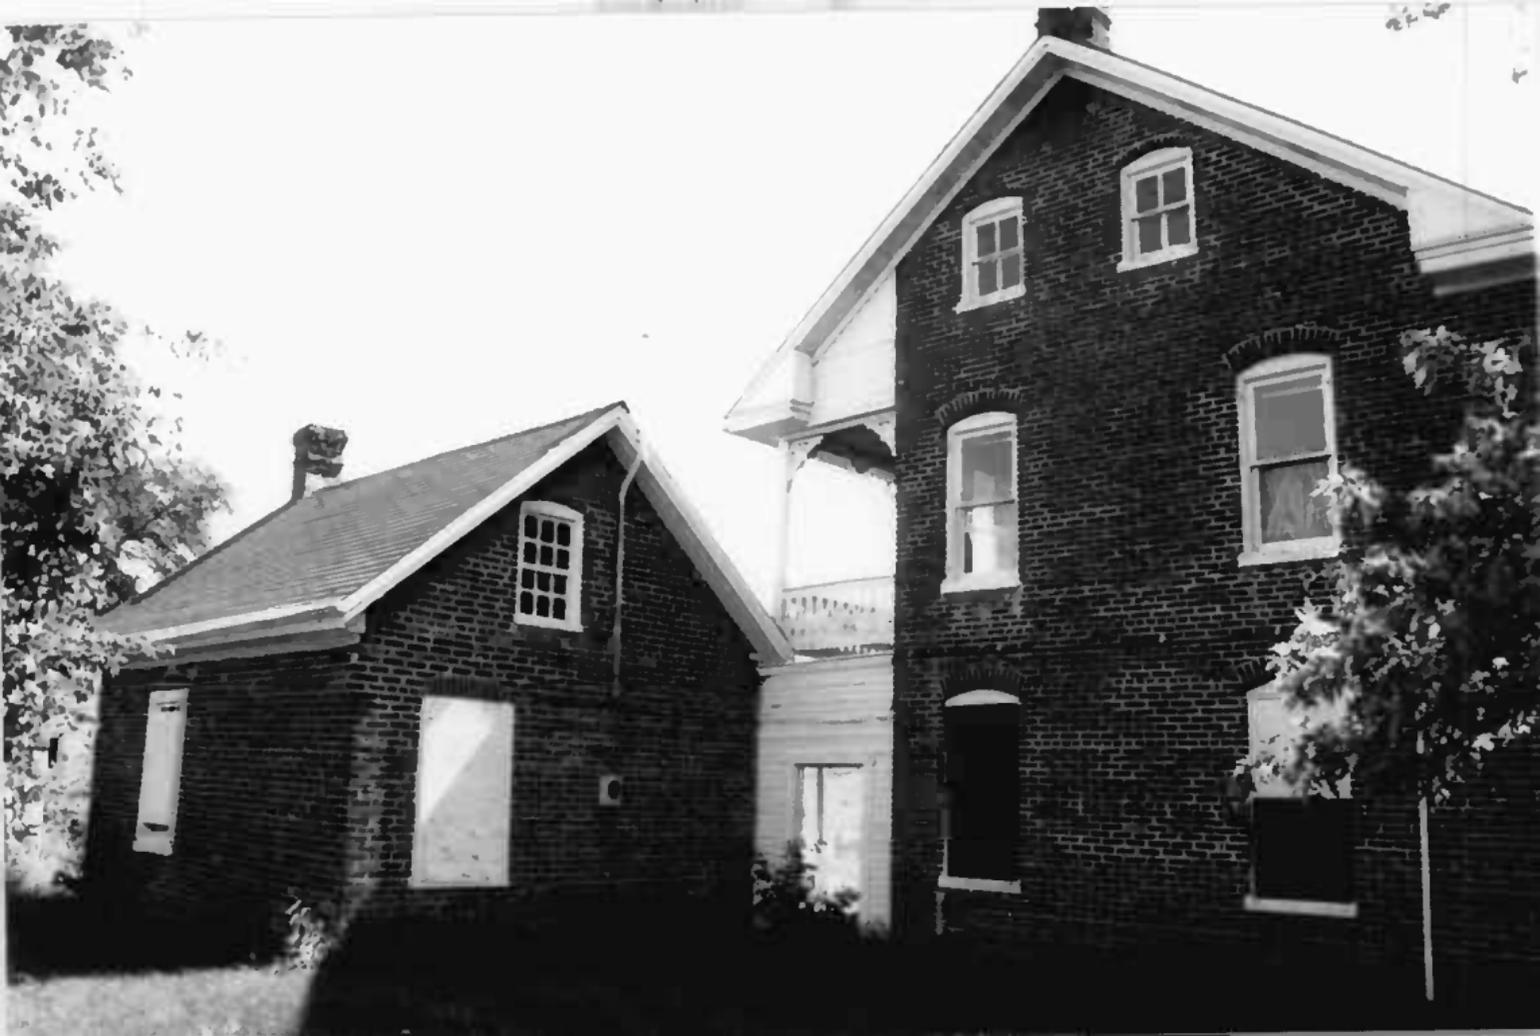
20 of 41

Off the northwest corner of the farmhouse’s northern porch stands a brick washhouse. Its bricks, laid in seven-over-one bond, and segmental arches indicate that it was built at the same time as the house. A brick enclosure that once held two large kettles, which is served by the corbeled chimney stack that rises from the north gable end, suggests that the building served as a washhouse. Some of the radiators removed from the house are now stored in the building. The building is vacant and in fair to good condition.

Washhouse at left, rear elevation of farmhouse
at right - looking NE

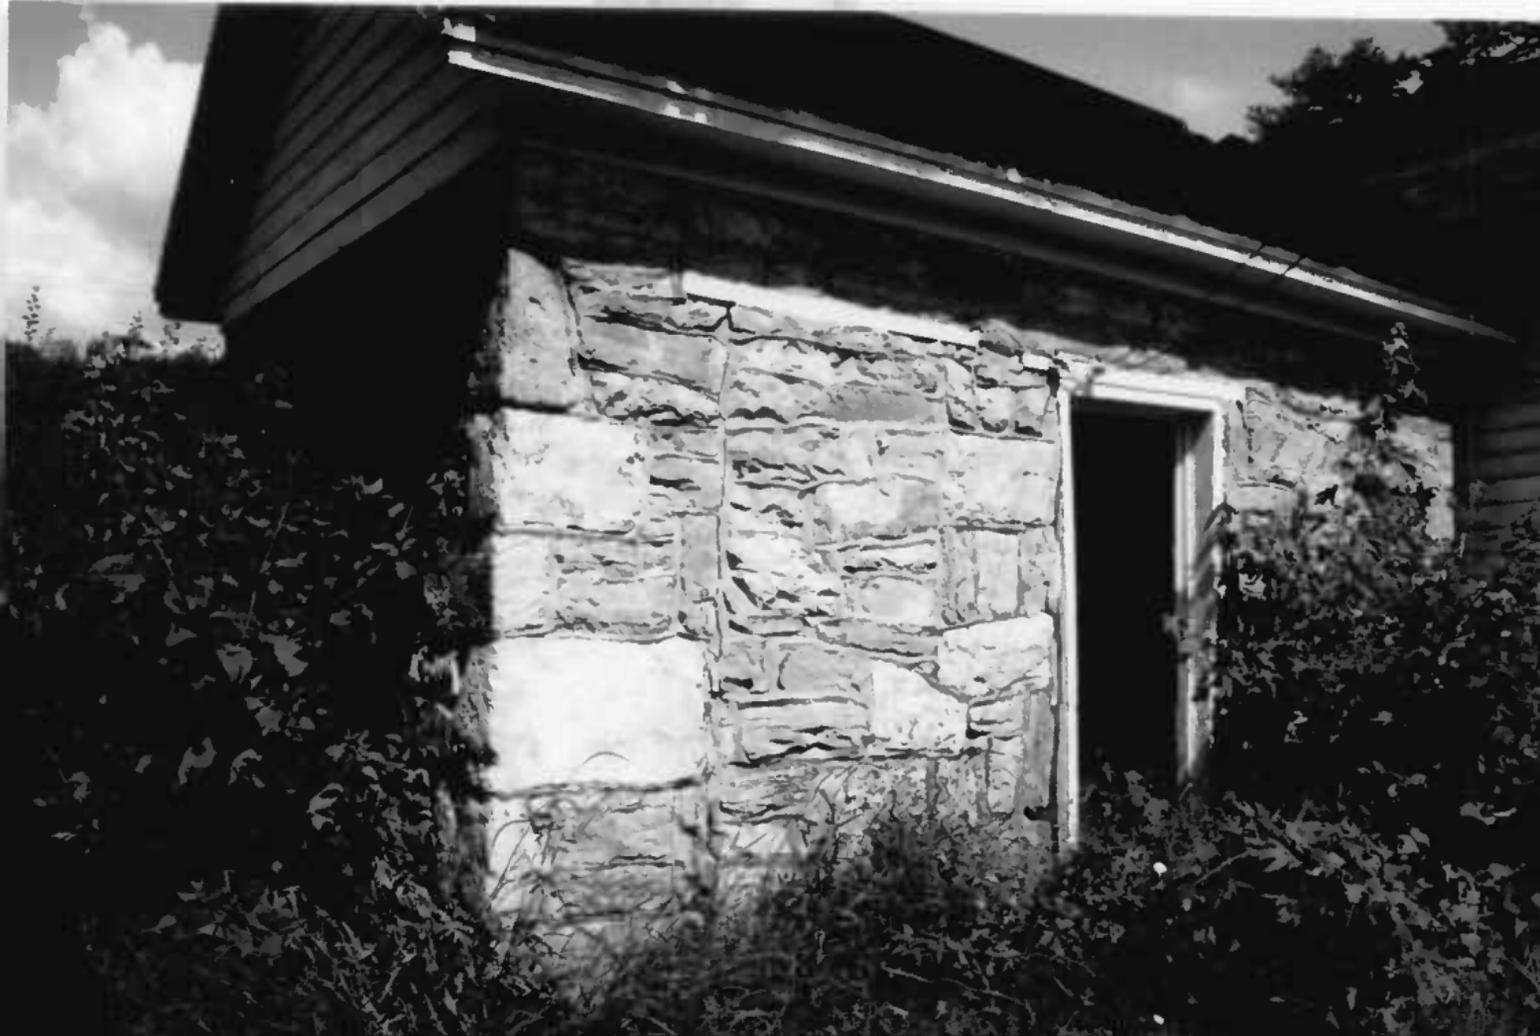
21 of 41

Just north of the washhouse is a gable-end building with a door set in its long east elevation. It is built of limestone blocks punctuated with large limestone quoins similar to those of the foundation of the brick barn. This building, last used to hold chickens, may have been erected as a smokehouse. With the barn, it is likely the oldest building on the farmstead, probably dating from the 1860s or 1870s. The building is vacant and in fair to good condition.

Smokehouse - looking NW

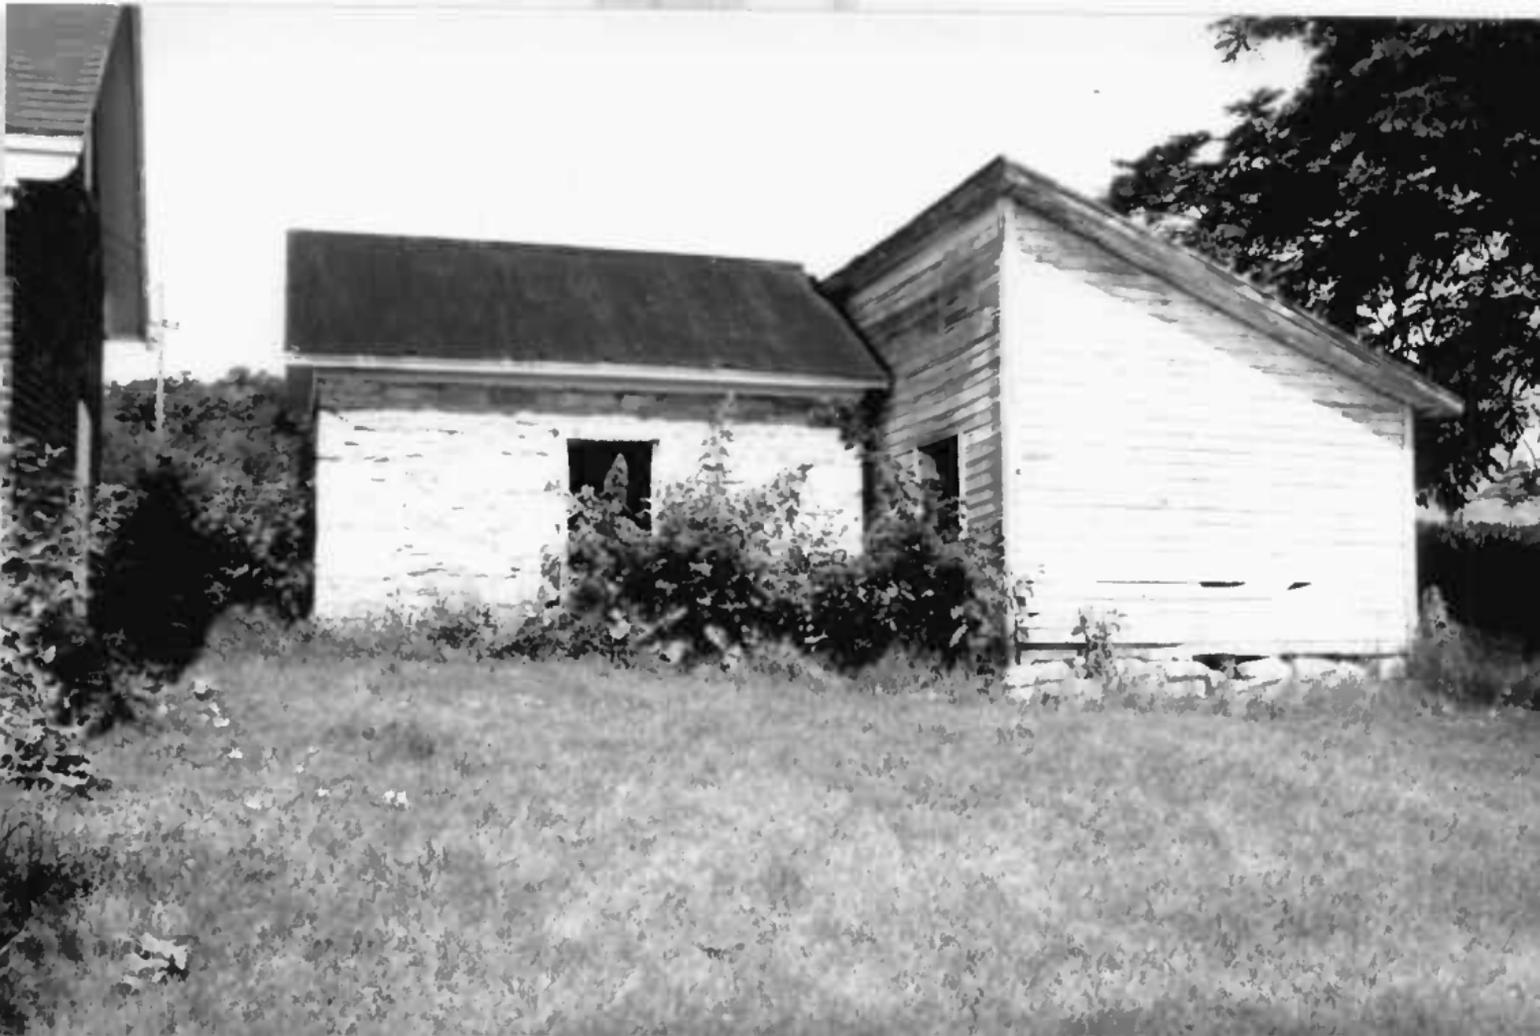
22 of 41

This weatherboarded, shed-roofed, frame building probably dates from the early twentieth century. It is set on a stone foundation perpendicular to the smokehouse, the north end of which it abuts. It last functioned as a chicken house. The structure is vacant and in fair to good condition.

Smokehouse at left, chicken house at right -
looking NW
