MARYLAND HISTORICAL TRUST
NR-ELIGIBILITY REVIEW FORM

Property Name: Brumbaugh-Kendle-Grove Farmst Inventory Number: WA-I-480

Maryland Inventory of Historic Properties Form

historic Brumbaugh-Kendle-Grove Farmstead
 other Luther Grove Farm

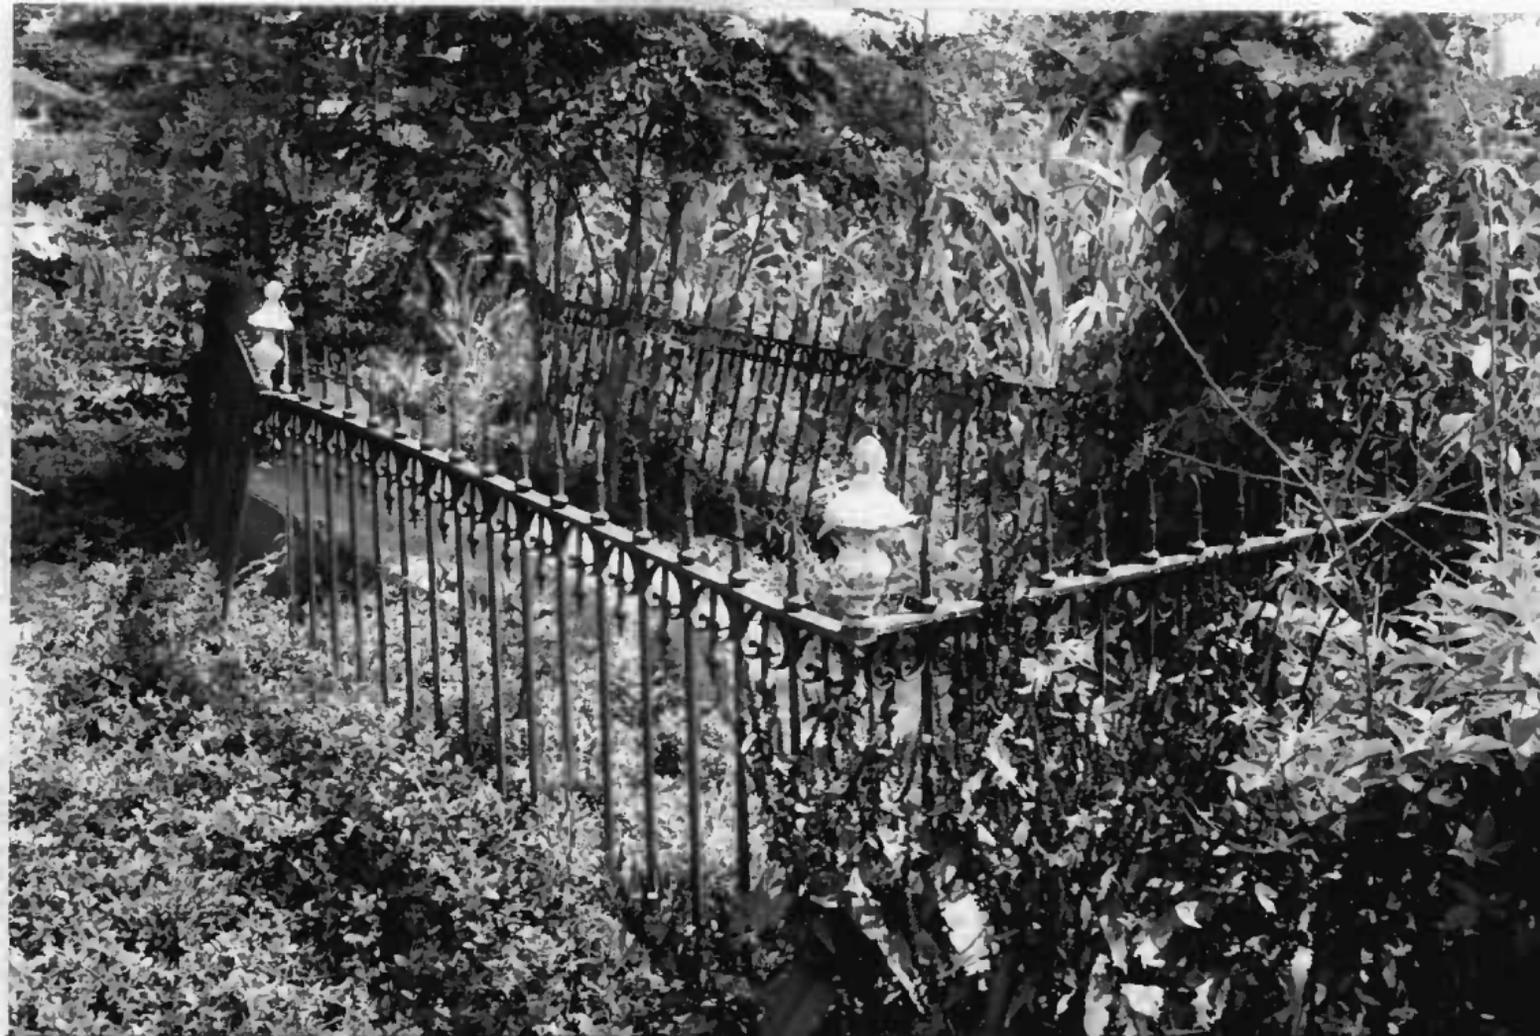
23 of 41

In a cornfield to the west of the house and the east of US 11 is the small Brumbaugh family cemetery. Local cemetery recorder Samuel W. Piper identified ten burials in the burying ground in the 1930s, most with limited information on their markers (Morrow and Piper 1994:32). These were the graves of H. Brumbaugh (d.1854), J. Brumbaugh, M. Brumbaugh, Henry C. Brumbaugh, Henry C. Brumbaugh (d.1862, seven years old), Andrew Brumbaugh (d.1859, 49 years old), Alice Brumbaugh (d.1852, one year of age), U. Brumbaugh, E. Brumbaugh, and an unidentified E.M. At present, the cemetery includes only three markers—labeled J. B., M. B., and . B.—and one modern plaque. The plaque identifies the two legible markers as those of Johann Jacob Brumbaugh (1728-1799) and Mary Elizabeth Angle Brumbaugh (1740-1806). The three markers and the plaque are set in a thick rectangular concrete slab that is enframed by a sagging, decorative, cast-iron fence. The visible tops of the stone markers are plain. Those of Jacob and Mary have segmental arches. That of the unidentified Brumbaugh is rectangular.

Cemetery - looking NE

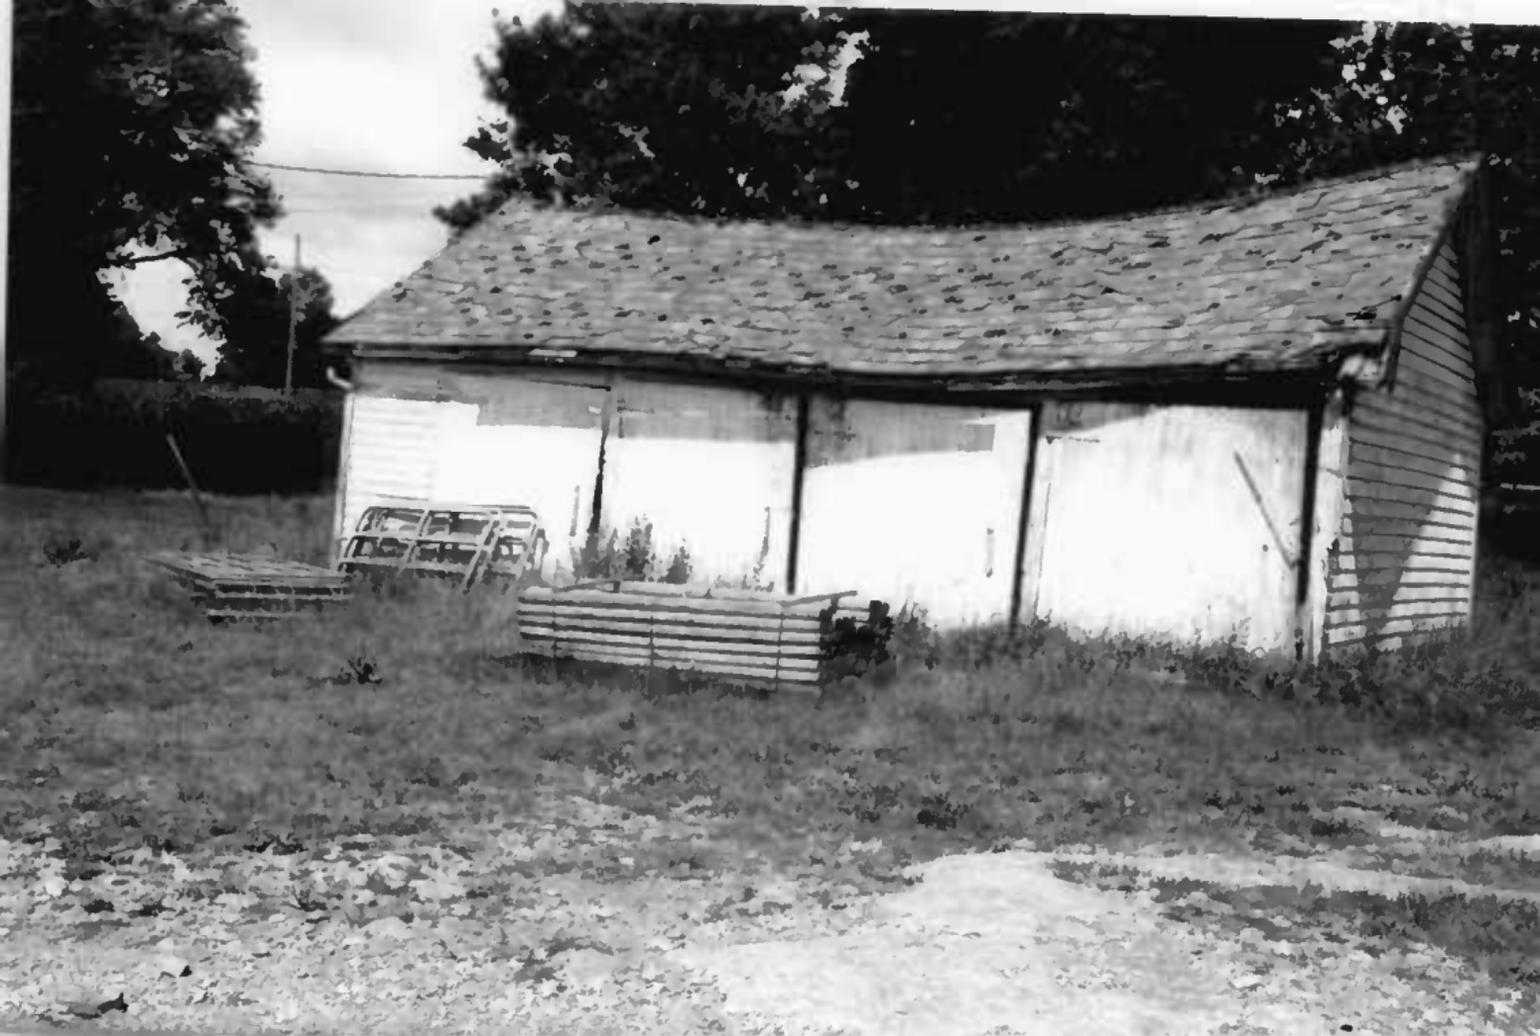
25 of 41

A long garage or tractor shed, probably constructed in the early twentieth century, stands north of the house, just to the south of the chicken house/corn crib and barn. It is a frame, weatherboarded, gable-end structure with a long wall of doors. Mossy slate shingles cling to its sagging roof. The building is vacant and in fair to good condition.

Garage - looking SW

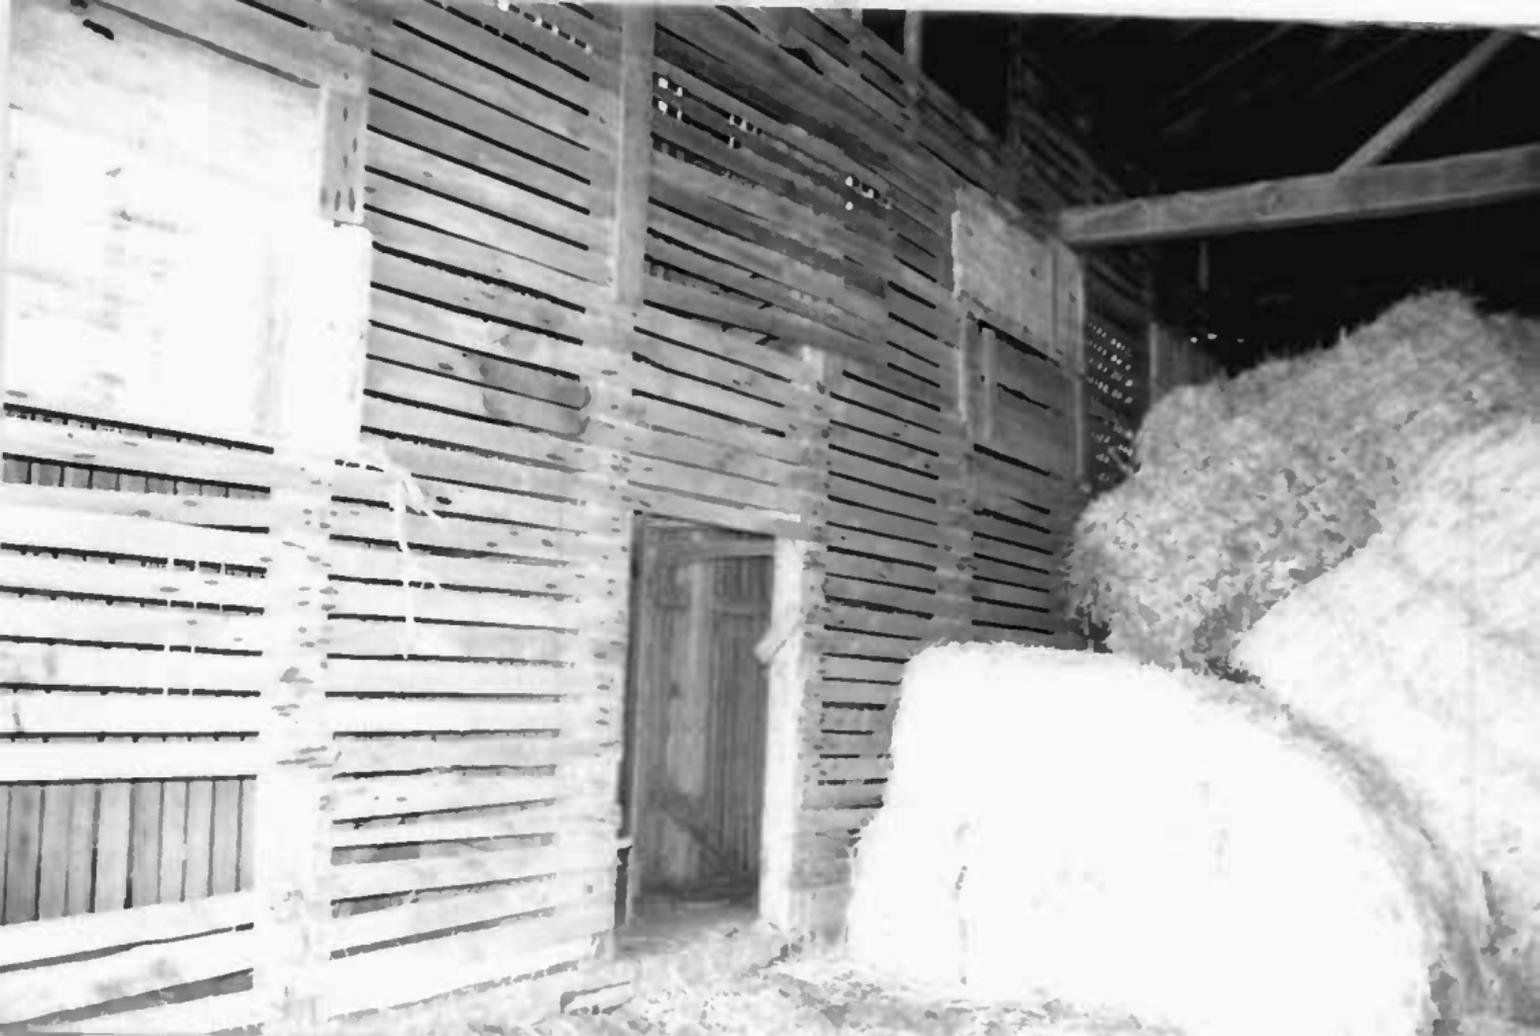
28 of 41

A multi-use agricultural building probably dating from the early twentieth century is affixed to the south end of the barn. At the building's south end, beneath a shed roof, is a long chicken house with a separate shop or office at its east front. Running along the northern length of the chicken house is a long, tall, corn crib. The crib is located beneath a tall, hipped roof that extends up over a wide passage for holding wagons and equipment. This passage—closed by wagon doors at the west and open at the east—separates the chicken house/corn crib from the brick barn. The multi-use building is flush with the barn at the west. An overhang pulls it flush with the forebay of the barn at the east. The building is of frame sided with vertical boards and horizontal weatherboards. Its roof is metal. The chicken house, shop or office, and corn crib are no longer in use. Hay is stored in the wagon shed. The building is in fair to good condition.

Corn crib/wagonhouse - looking SW

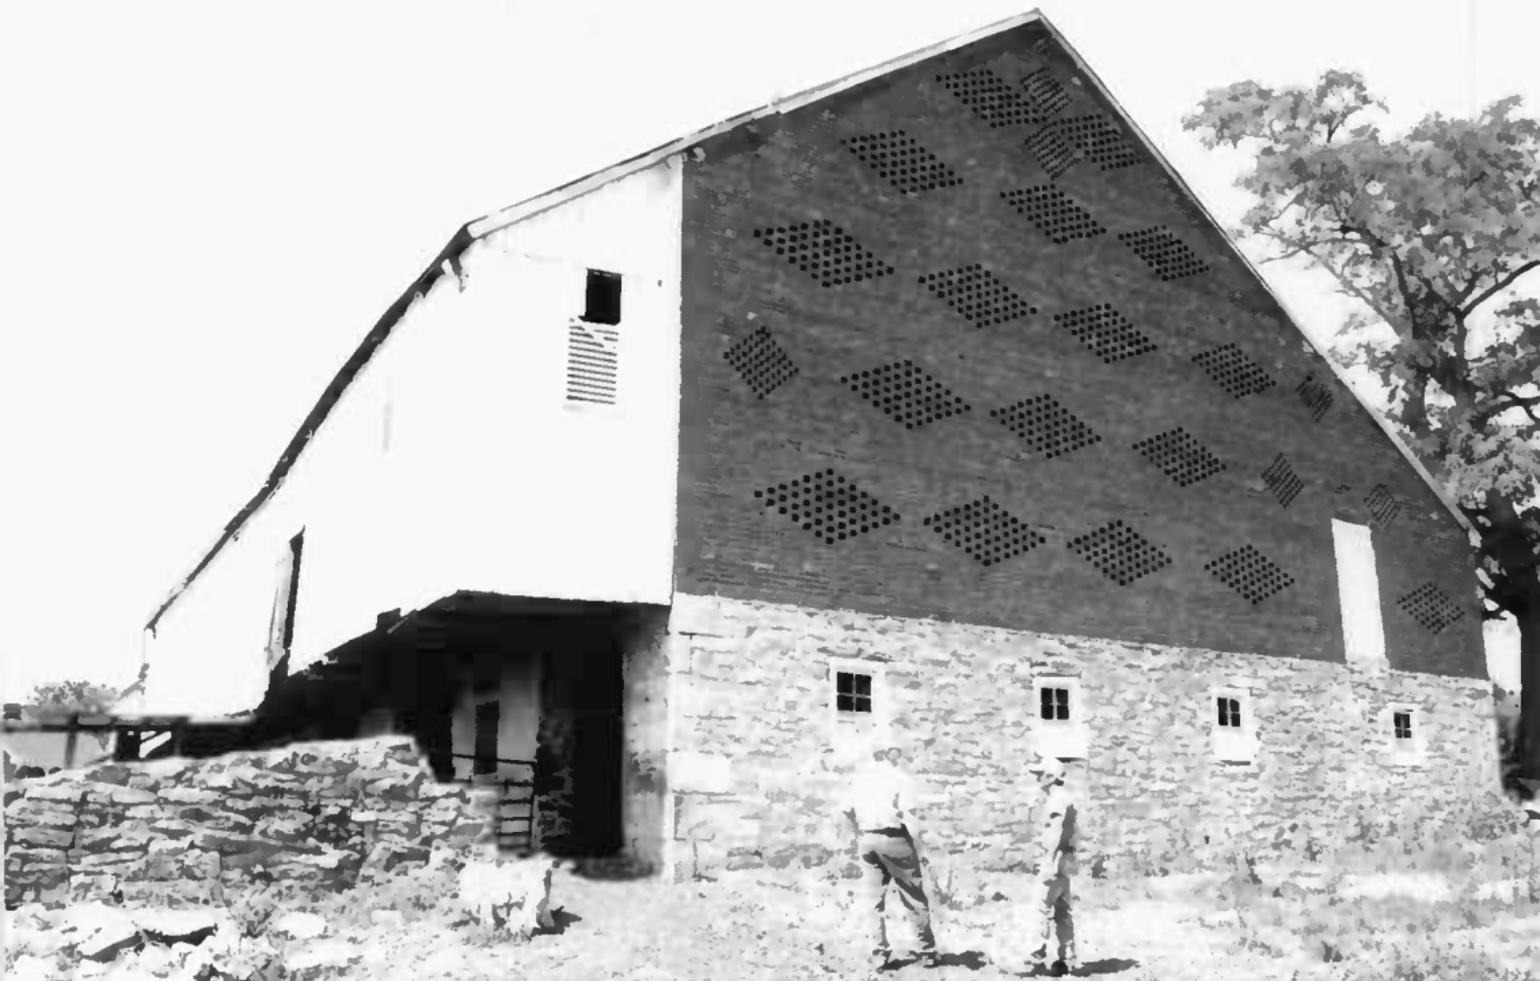
33 of 41

This handsomely finished building is likely the “large brick swisser *barn*” mentioned in the 1883 auction advertisement for the farmstead. The upper body of the barn is built of brick and frame beneath a gable-end roof. Its north and south gable ends are of brick-laid in seven-over-one common bond like the house—pierced with multiple diamond-shaped ventilators. Brick bays, also patterned with diamond ventilators, extend out from the upslope side of the barn, at its northern and southern corners. Set back from these brick bays are three frame bays served by large wagon doors. The interior of the barn is divided into wagon and threshing platforms and hay mows. The soaring loft above, topped in part by modern roof framing, was designed to hold hay as well. At the long east elevation of the barn, opposite the wagon doors, is a frame forebay cantilevered over a livestock yard. The lower level of the barn, which is at ground level at the east, is open beneath the main body of the barn and forebay. Its limestone walls are similar to those of the smokehouse. Limestone and later concrete walls partially enclose a livestock pen that extends out from (east of) the forebay. The barn is rented out to a farmer, who continues to store hay in its body and shelter cows at its lower level. The barn is an excellent example of the large, brick, Sweitzer barns with decorative ventilators found in north-central Maryland and south-central Pennsylvania (Noble 1984:30). The building, which has some twisted uprights and collapsing ventilators, is in fair to good condition.

URS Corp., 3109 Poplarwood Ct., Raleigh, NC
N elevation and forebay of barn-looking SW

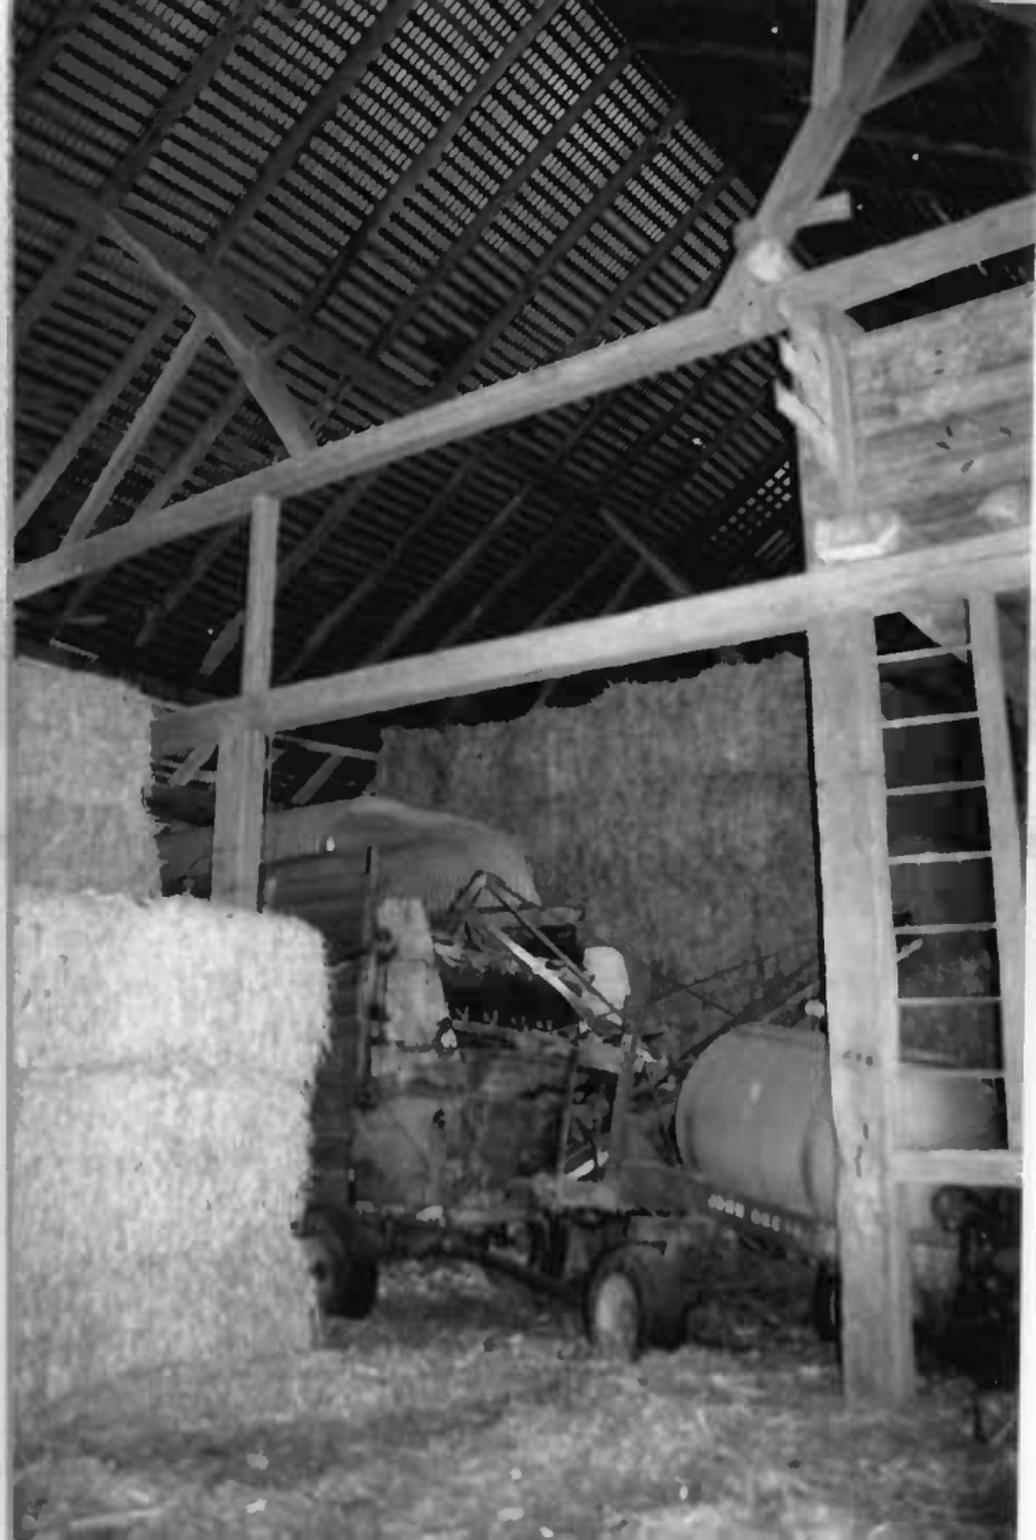
35 of 41

Barn interior, roof framing

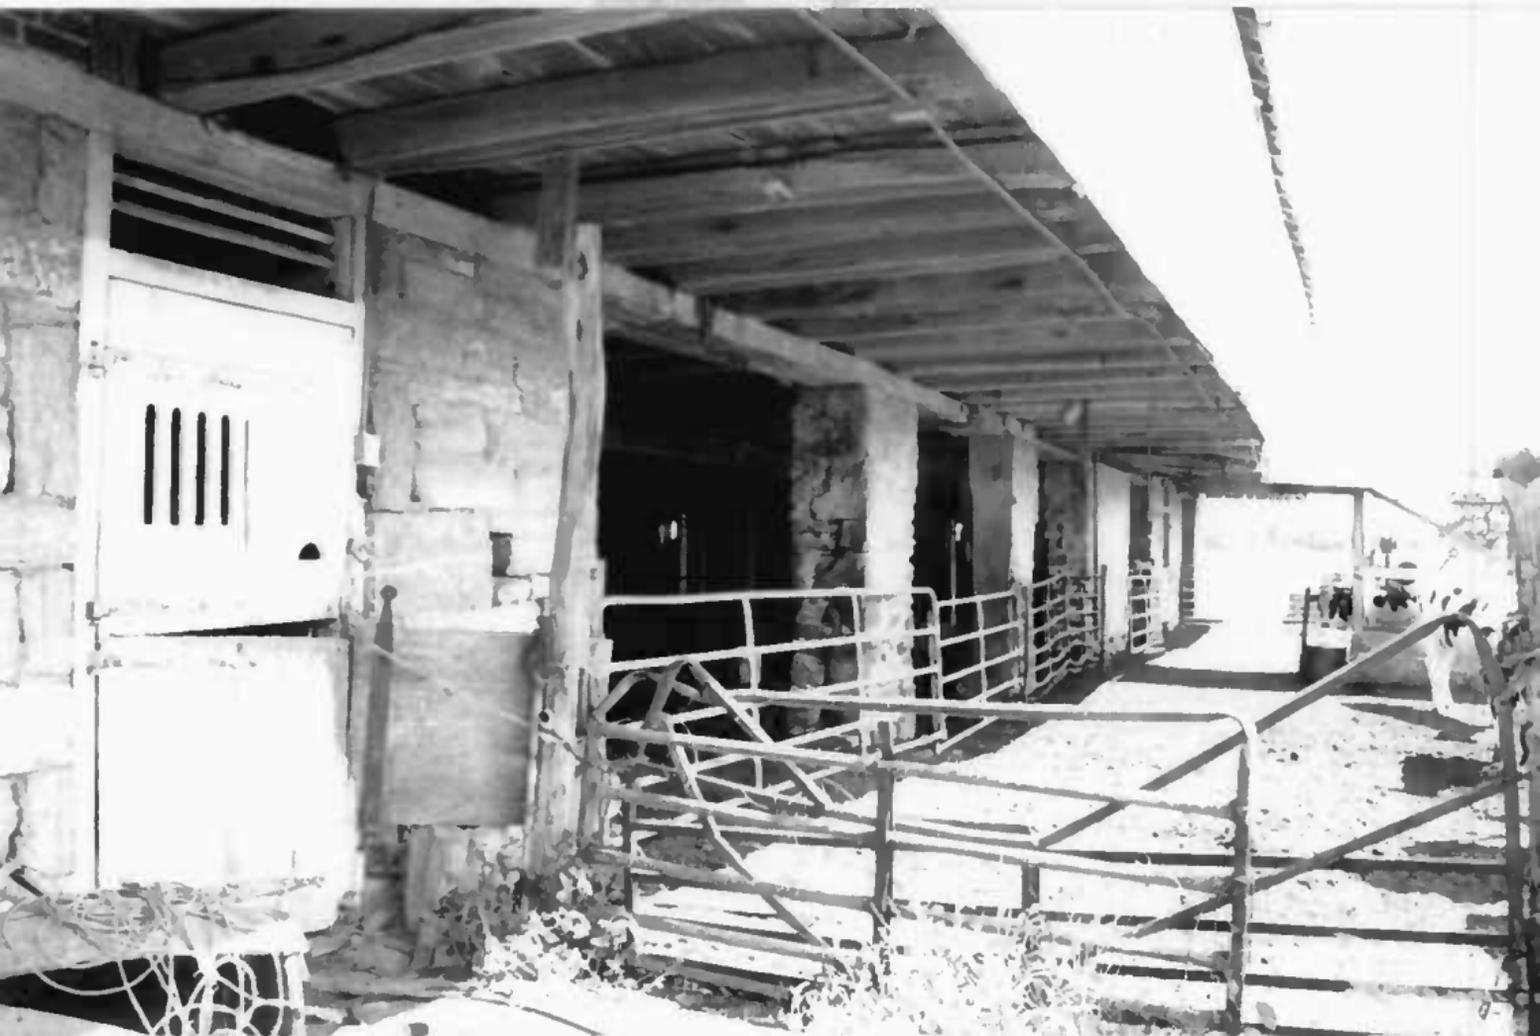
36 of 41

Barn forebay - looking N

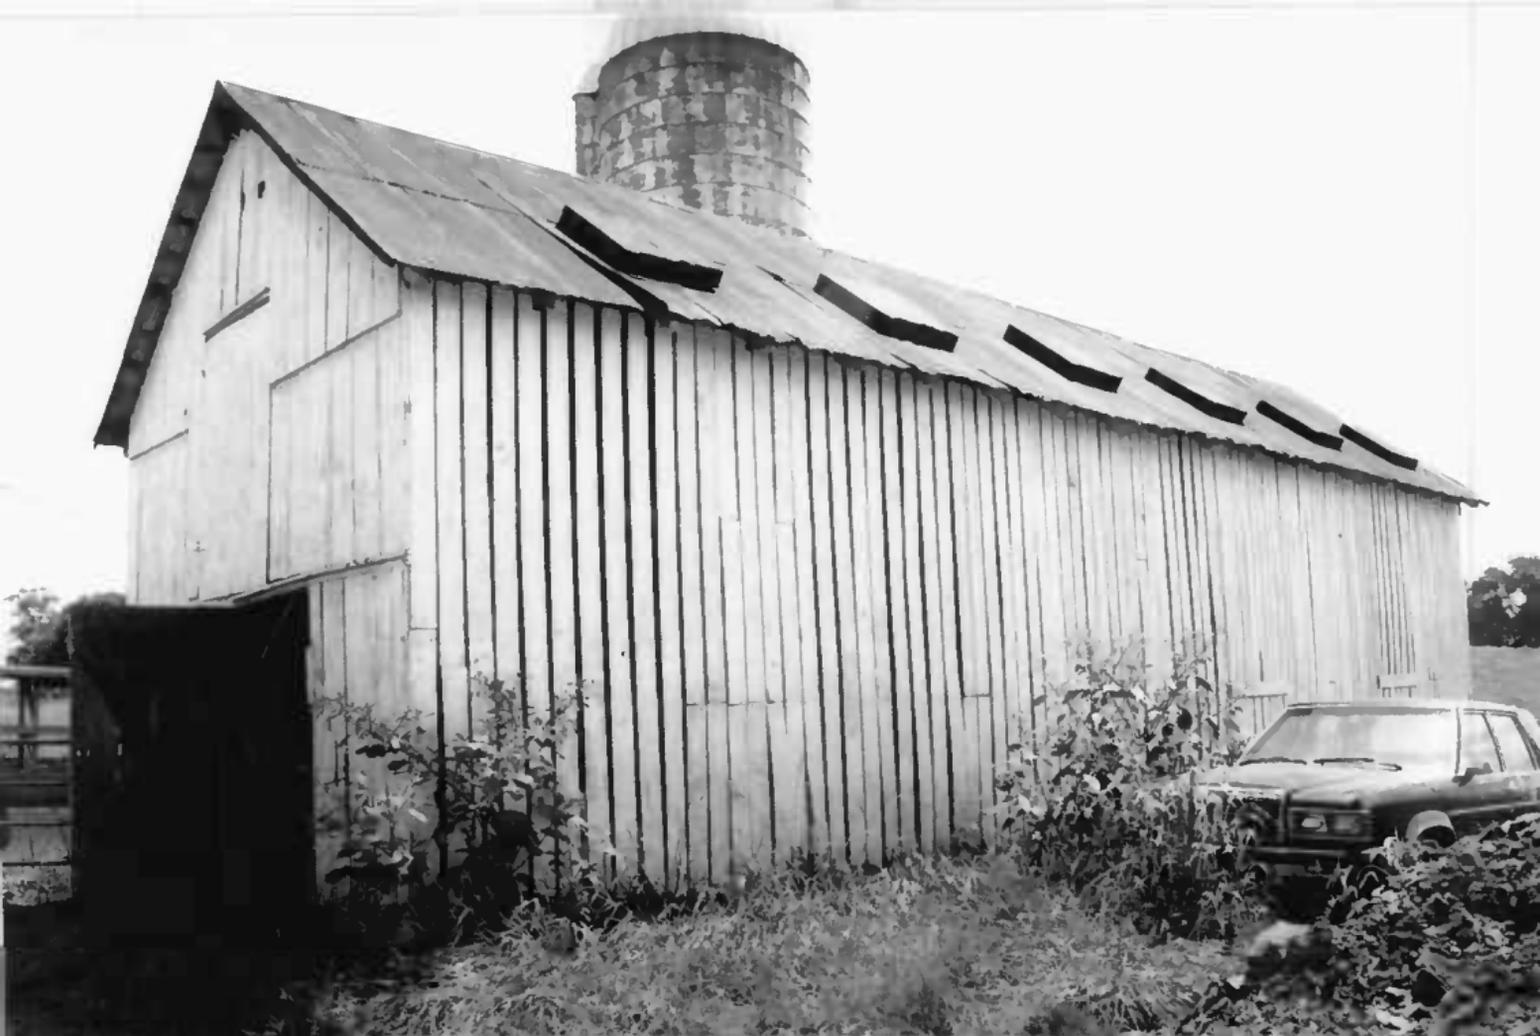
37 of 41

East of the wagonshed stands a long, rectangular, frame outbuilding that probably dates from the early twentieth century. Along its long north elevation, behind vertical slats, is a corn crib. Along its south elevation is a hog pen faced with tighter vertical boards. The building is of frame and topped by a seam-metal, gable-front roof. The structure is vacant and in fair to good condition.

Heq pen/corn crib - looking NE

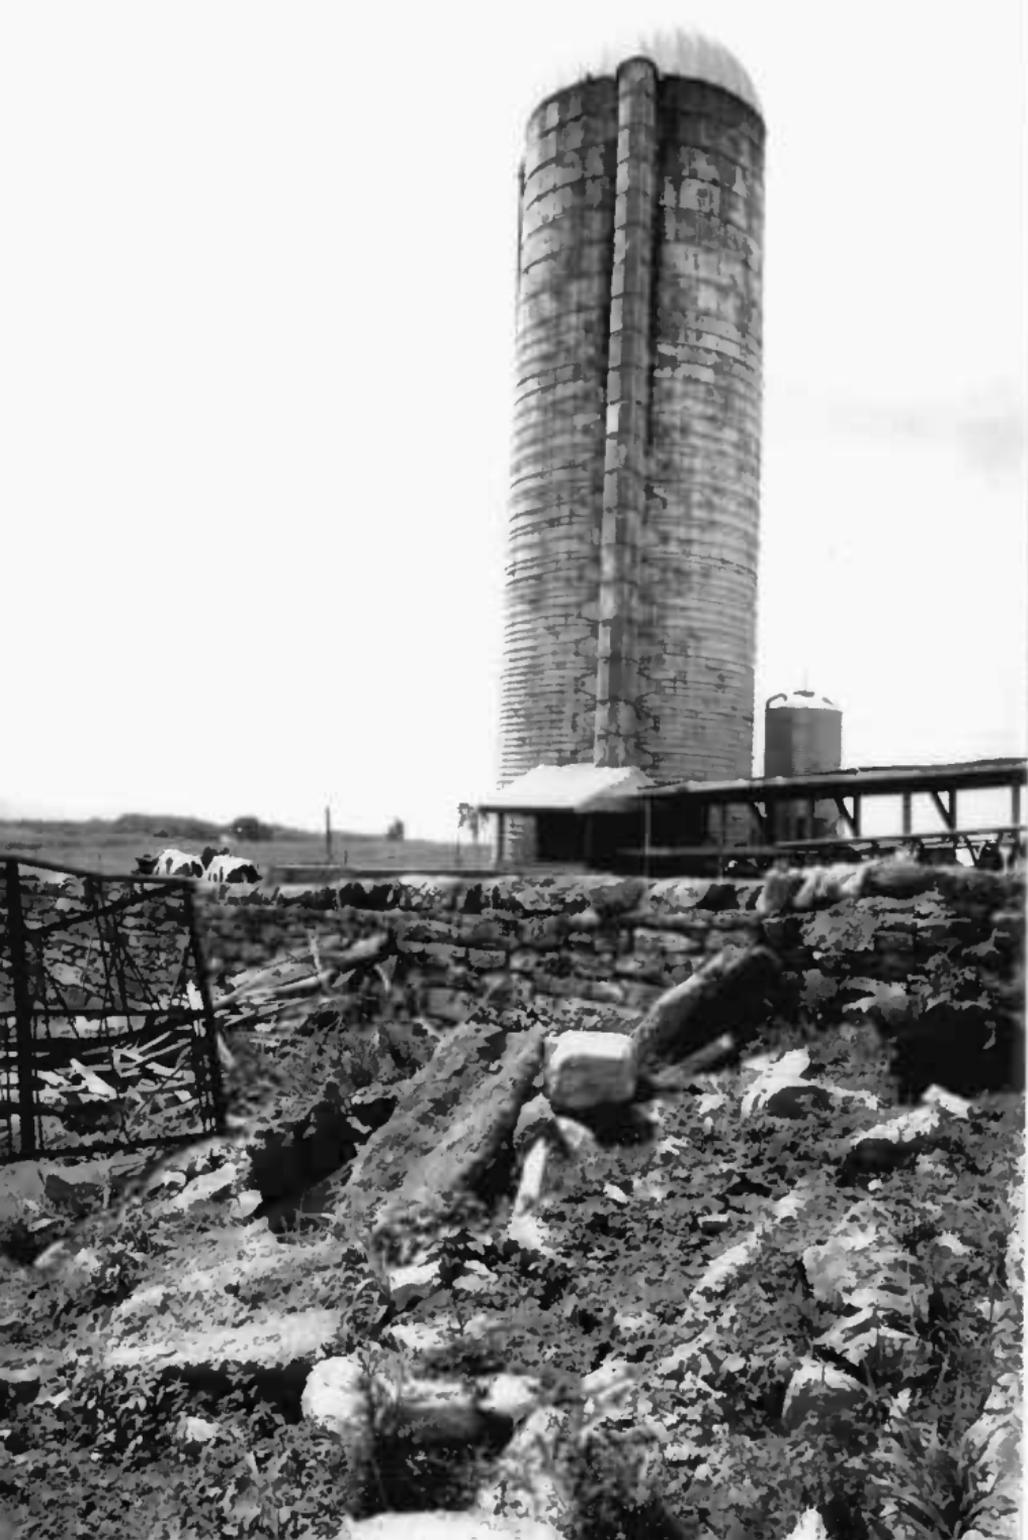
38 of 41

To the northeast of the hog pen/corn crib is a tall silo. Built of concrete and topped by a round metal roof, it is probably the most recently constructed of the farmstead's structures. The structure is in fair to good condition.

Livestock yard and silo - looking S
