WA-I-509 Brick House

Early-20th century

Hagerstown vicinity

Maryland Historical Trust State Historic Sites Inventory Form

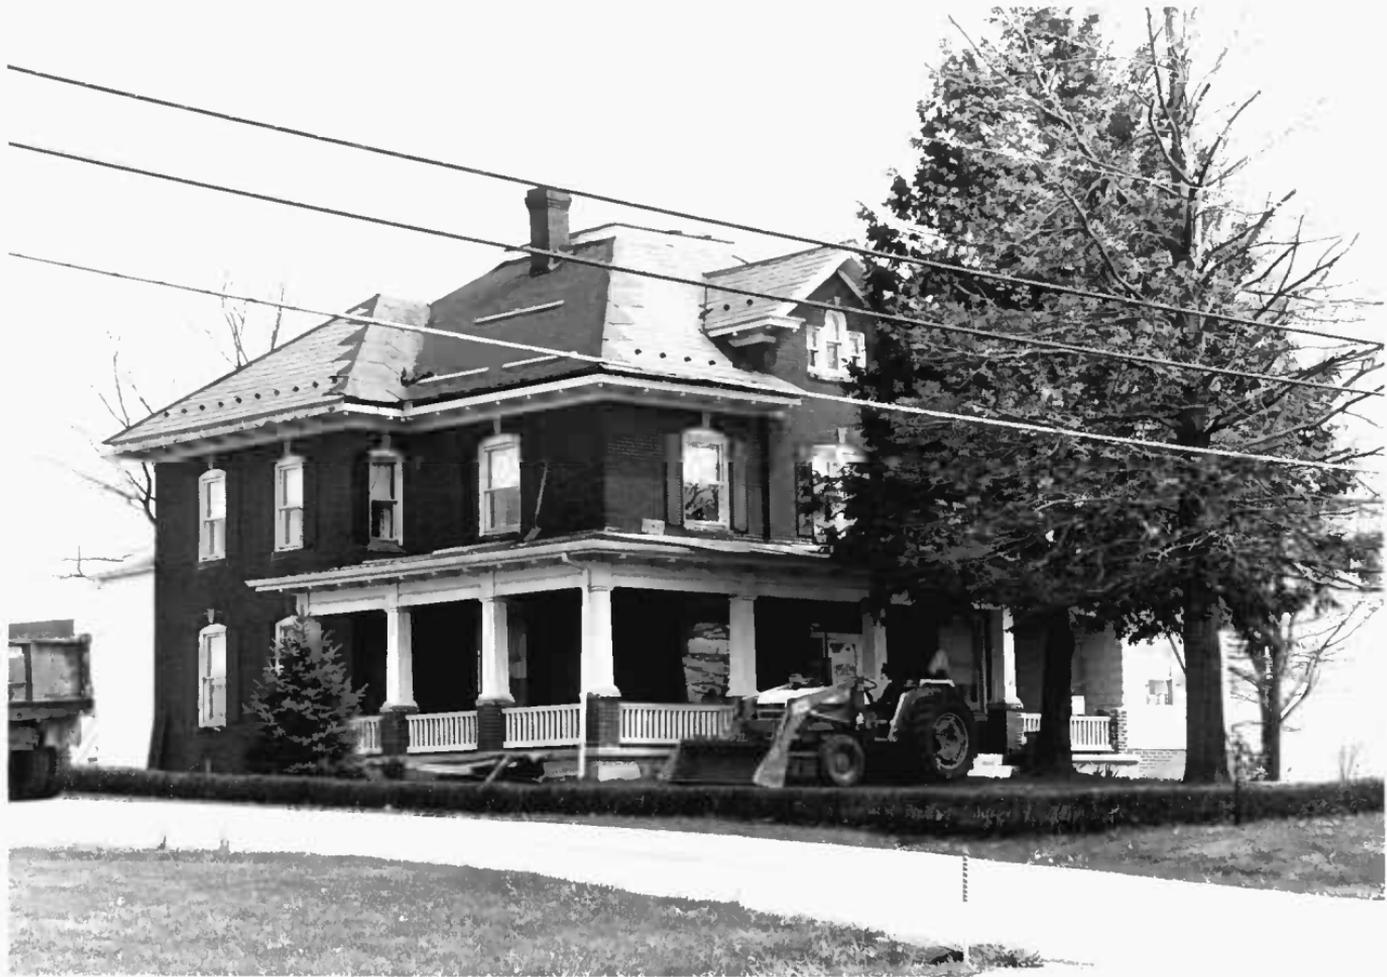
1. Brick House WA-I-509
2. Washington County, Maryland
3. Joe Getty
4. May 1983
5. Maryland Hist. Trust, Annapolis, Md.
6. North & West Elevations; camera facing southeast
7. 1/1
