WA-I-522 Foursquare House

Early 20th century

Hagerstown Vicinity

Maryland Historical Trust State Historic Sites Inventory Form

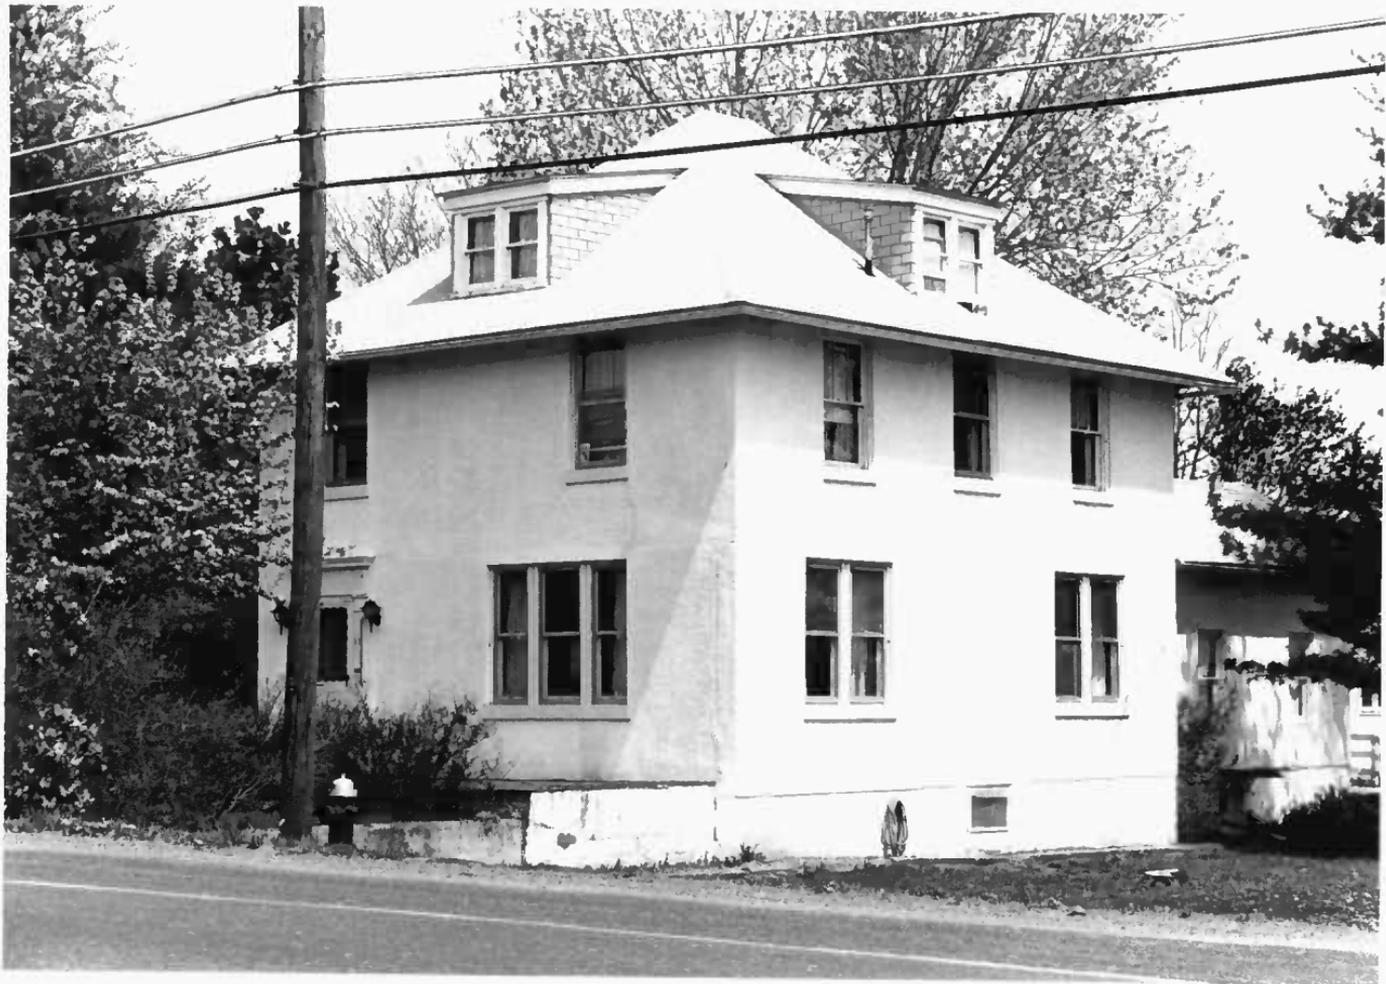
1. Foursquare House WA-I-502 522
2. Washington County, Maryland
3. Joe Getty
4. May 1983
5. Maryland Hist. Trust, Annapolis, Md.
6. West elevation; camera facing east
7. 1/1
