Survey # WA-I-675
Street Address 8 E. Poplar Street
Town, State Funkstown, Maryland 21734
private x, public ___

Survey # WA-I-675

MARYLAND COMPREHENSIVE PRESERVATION PLAN DATA

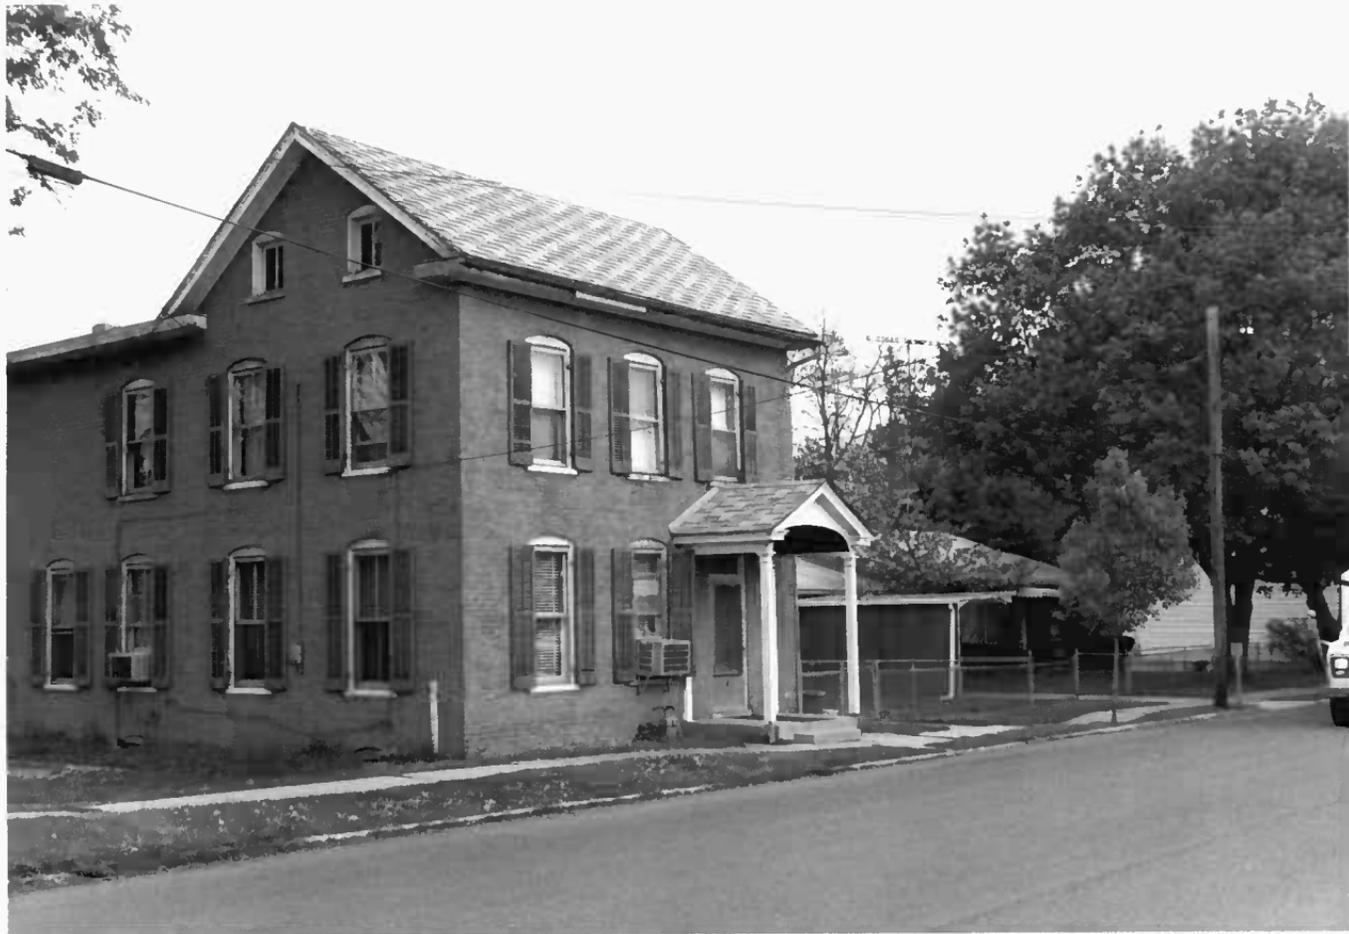
#150, (1 of 1)

This two story, three bay brick house is constructed entirely in common bond with segmental arches above the windows. There is a shed roof extension to the rear. Windows have either two over two or single pane sash. They have parts of louvered shutters with movable louvers. The main entrance is located in the east end bay of the front elevation. It is sheltered by a 1930s Colonial Revival entrance porch.
