ABSTRACT
WA-II-197
Dunrovin Farm
Hagerstown Vicinity
private

Mid 19th Century

INVENTORY FORM FOR STATE HISTORIC SITES SURVEY

Dunrovin Farm

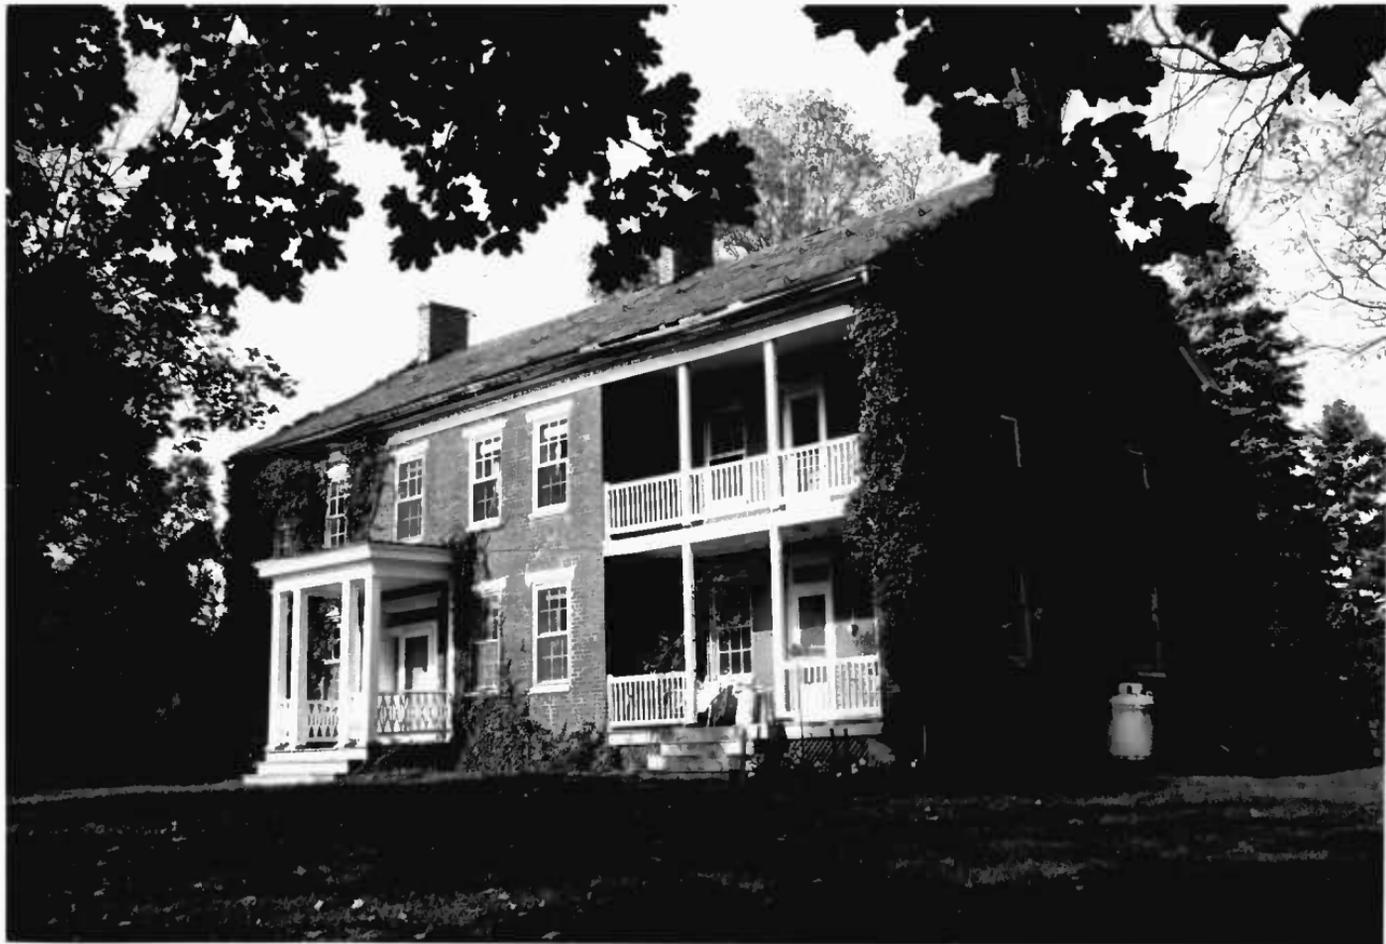
S-E

The house is a two story, eight bay brick structure resting on low fieldstone foundations. The three easternmost bays of the front elevation are within a double porch recessed several feet from the plane of the facade wall. The bricks forming the walls are laid in American or common bond at all elevations. Five rows of stretcher bricks are used between courses of headers. There is no decorative masonry associated with the brick construction. The end walls of the house are thoroughly covered with ivy.

The house appears to be in good condition, the barn in fair condition and the log house deteriorated. The farm contains 146.256 acres.

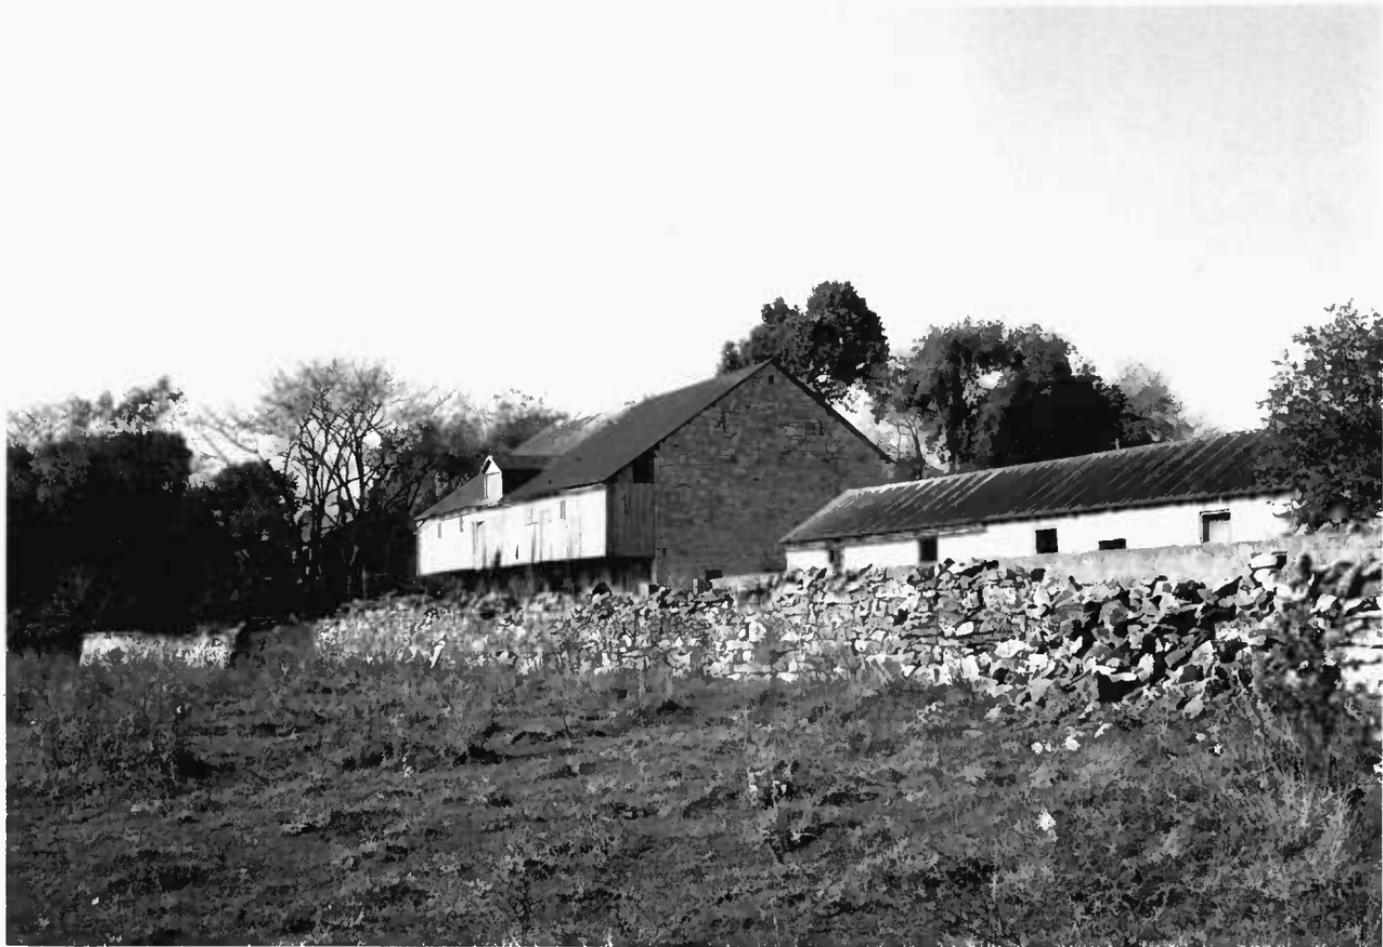
Bar SC

East of the house is a large stone bank barn with a frame forebay. It has the characteristic vertical ventilator slits in its end walls and a round opening high in its gables. The barn is said to date from the 18th century. East of the barn is a one story, two bay log cabin with exposed construction of hewn logs joined with inverted "V" notching at the corners.
