**WA-II-228**

**Ruins of Stone Farmstead**

INVENTORY FORM FOR STATE HISTORIC SITES SURVEY

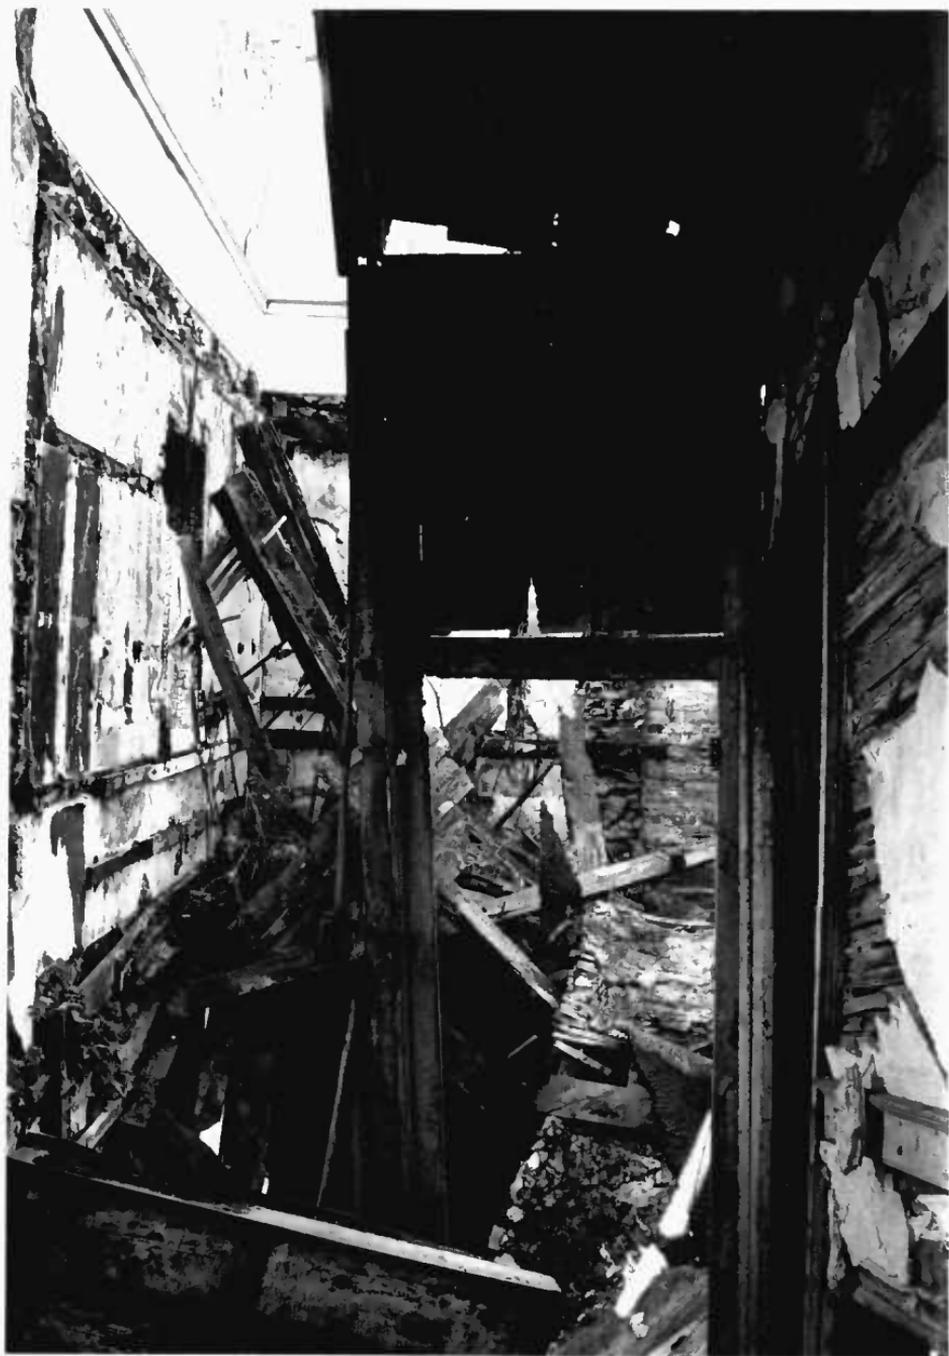
Lot II-228  
Interior View  
Nov. 1975

Found among the rubble at the interior of the house were door frames trimmed with ovolo molding and stone beaded board partitions. Early chair rail, plaster and lath remained. A set of stairs was located against the south wall of the house. Chimneys and fireplaces were of brick.
