WA-II-497      Frame House

# Maryland Historical Trust State Historic Sites Inventory Form

Survey No. WA-II-497

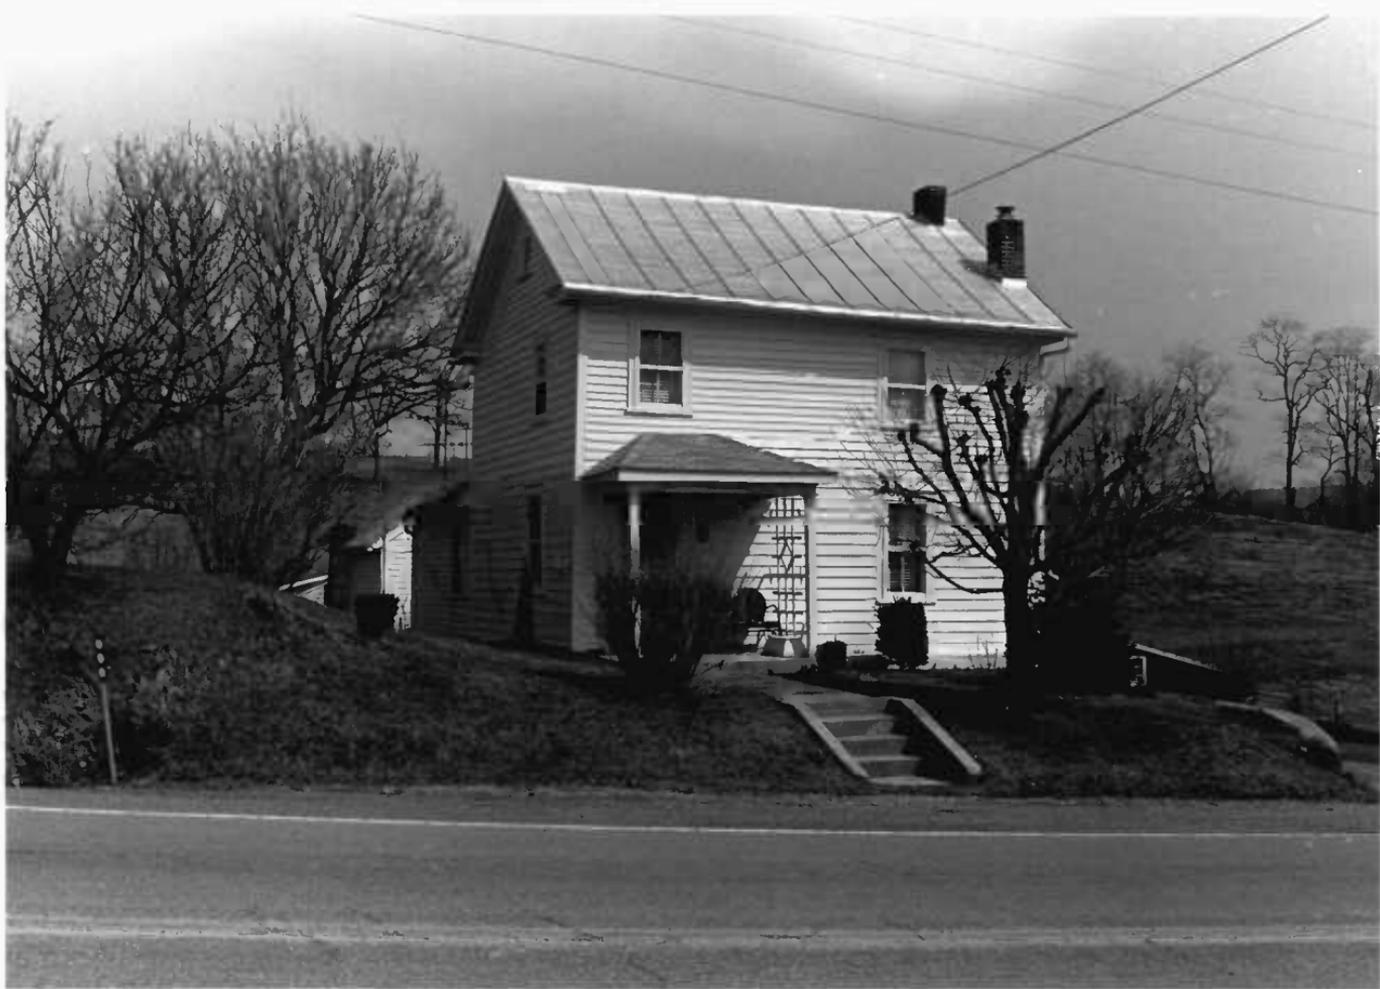
1. Frame House           WA-II-497
2. Washington County, Maryland
3. Joe Getty
4. May 1981
5. Maryland Hist. Trust, Annapolis, Md.
6. West & north elevations; camera facing  
southeast
7. 1/1
