Maryland Historical Trust
State Historic Sites Inventory Form

Magi No. WA-III-115

historic Sandy Hook Church

street & number north side of Sandy Hook Road, .2 mile east of Clark Road not for publication

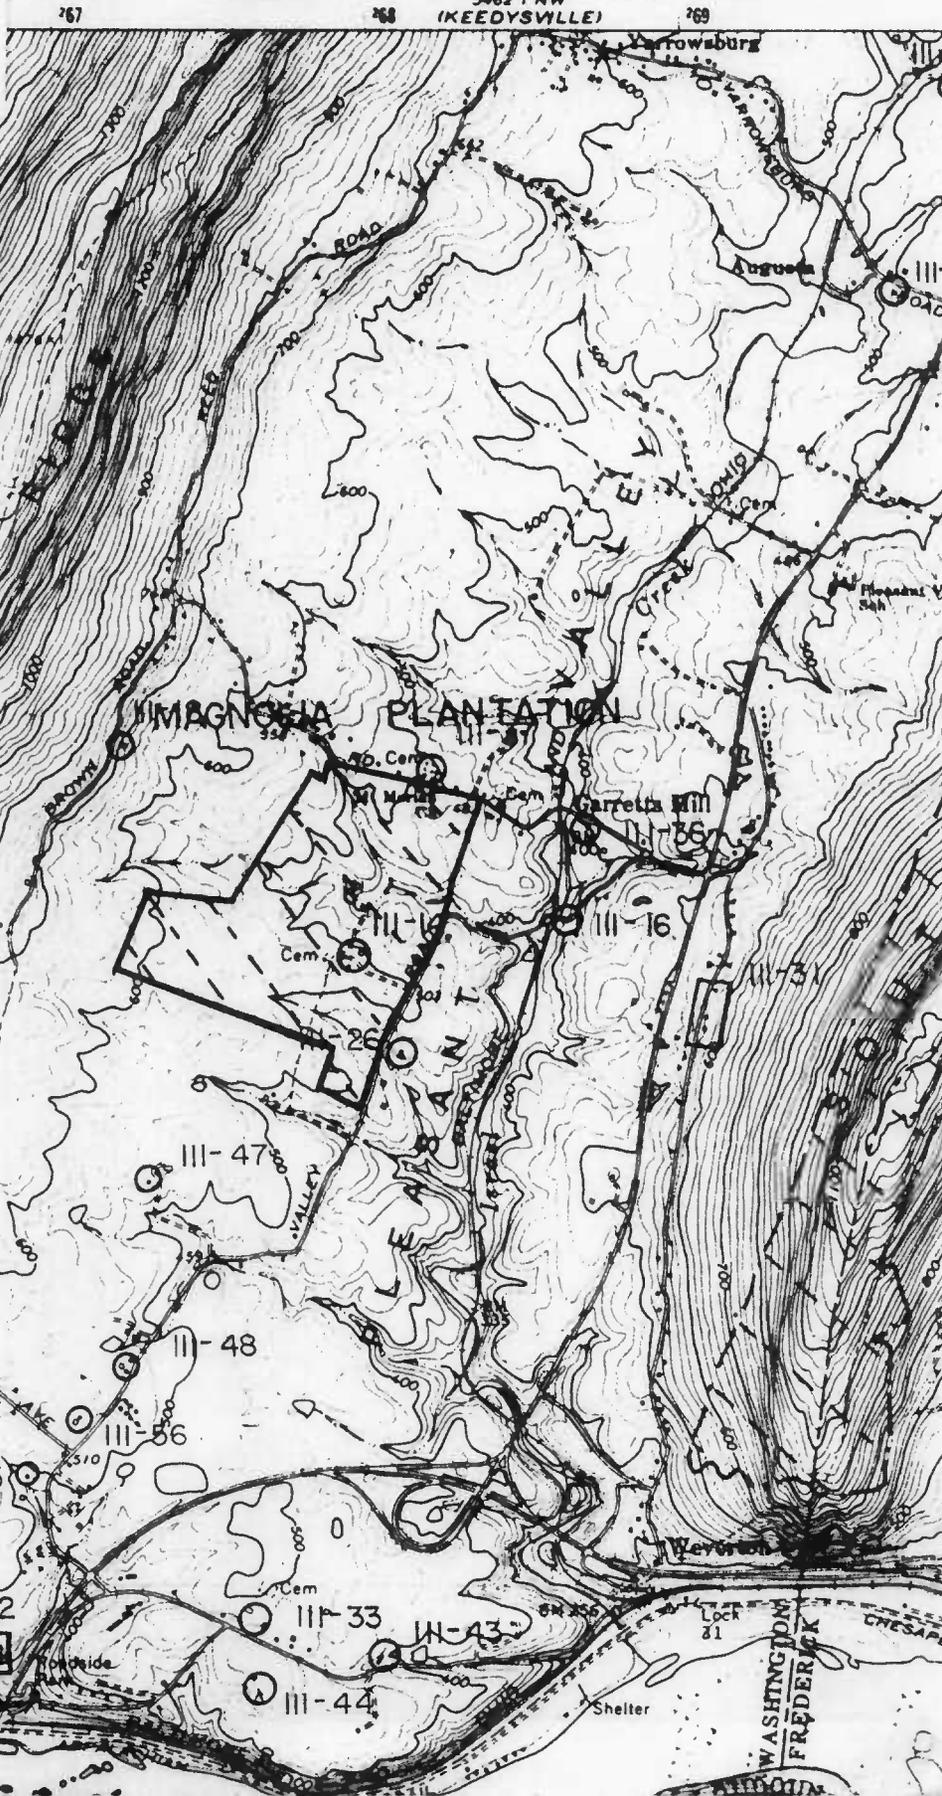
WA III-115

1. WA-III-072 ~~WA-III-115~~
2. Washington Co., Md.
3. Joe Getty
4. ~~April 1983~~ 7/82
5. Md. Hist. Trust, Annapolis, Md.
6. South elev. (camera facing north)
7. 1/1
