**MARYLAND HISTORICAL TRUST
DETERMINATION OF ELIGIBILITY FORM**

Property Name: Misty Meadows Farms Inventory Number: WA-IV-027
 Address: 14236 Misty Meadow Rd. City: Smithsburg Zip Code: 21783-1222
 County: Washington USGS Topographic Map: Smithsburg, MD-PA
 Owner: Misty Meadows Farms, Inc. Is the property being evaluated a district? yes
 Tax Parcel Number: 26 Tax Map Number: 27 Tax Account ID Number: 14-006583
 Project: Ringgold Wireless Facility Agency: FCC
 Site visit by MHT Staff: no yes Name: _____ Date: _____
 Is the property located within a historic district? yes no

**MARYLAND HISTORICAL TRUST
NR-ELIBILITY REVIEW FORM**

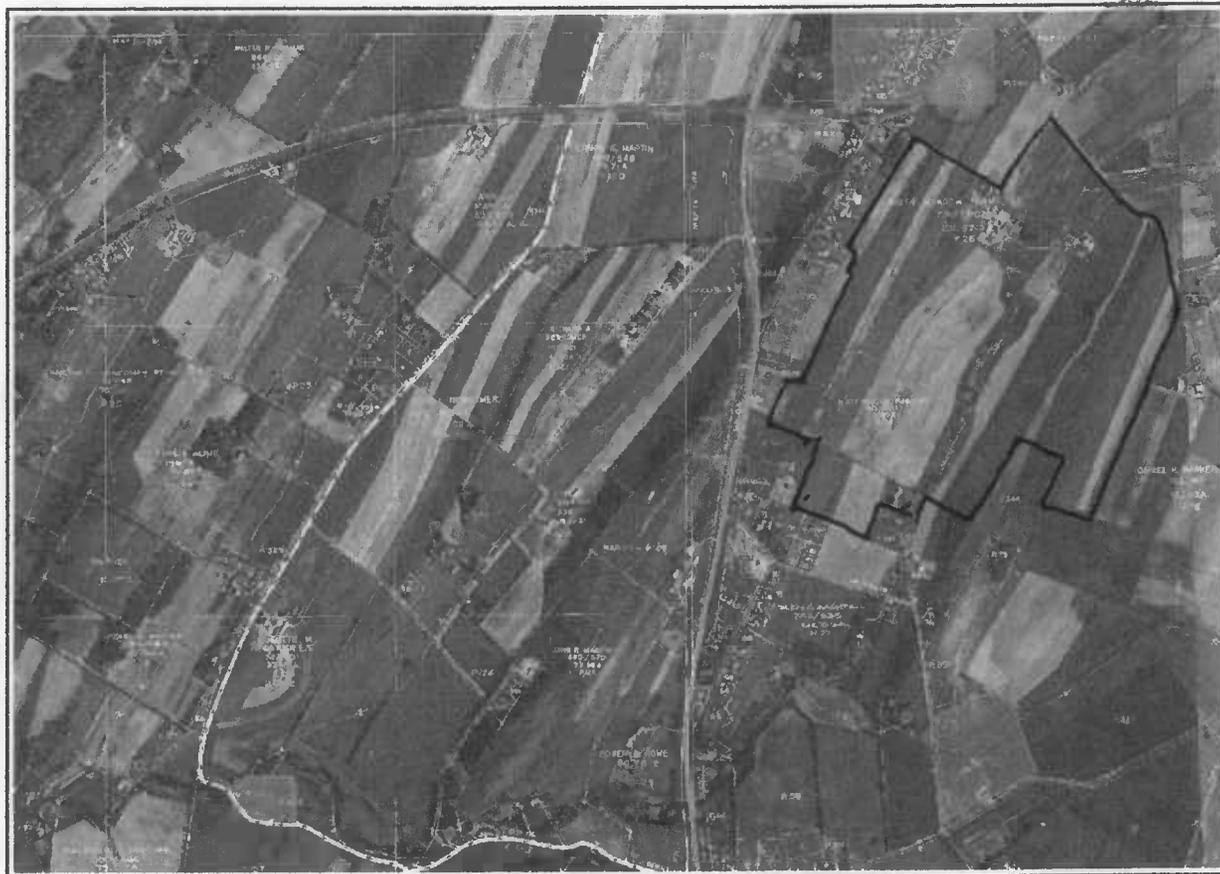
*Proposed NRHP Boundary
WA-IV-027 (tentative,
Rural Historic Landscape)*

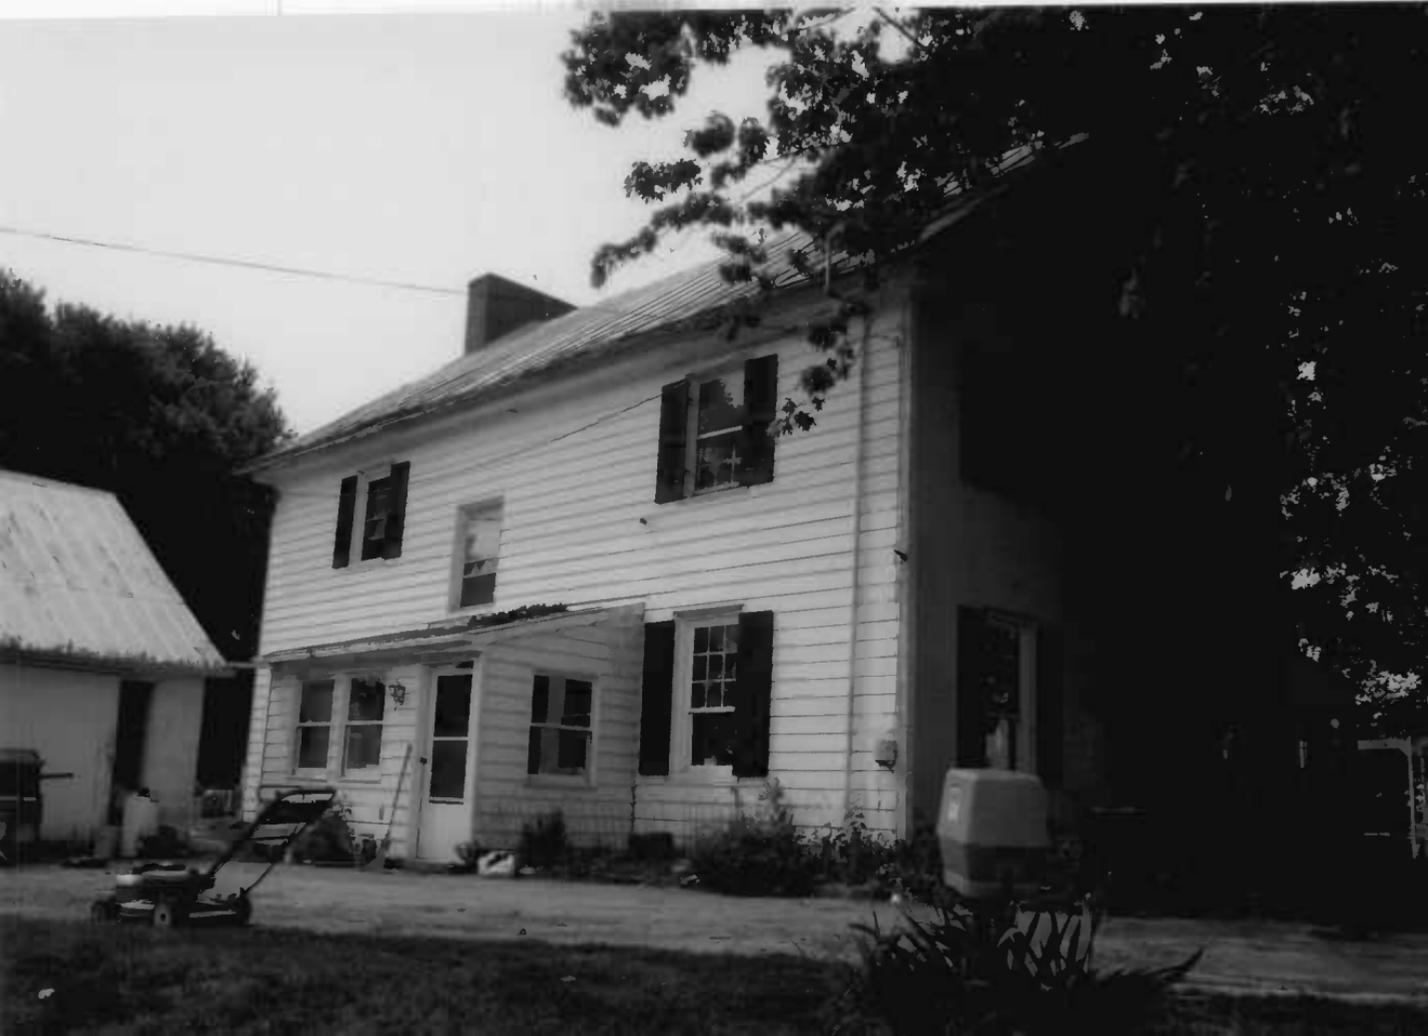
11/3

The house is a 2.5-story side gabled brick building. There is an enclosed shed roof entry porch on the east façade and an enclosed one-story shed roof porch on the west façade. The building is clad by aluminum siding on the east and west façade and stucco on the north and south. There are two brick interior gable end chimneys and the windows are 6/1 and 1/1 double-hung metal sash. There are louvered and paneled wood shutters on the first and second story windows. The roof is clad by standing seam metal and there are cornice returns. There is a fenced pool in the rear (west) of the house.

House: Front (North)
Facade. View to SW

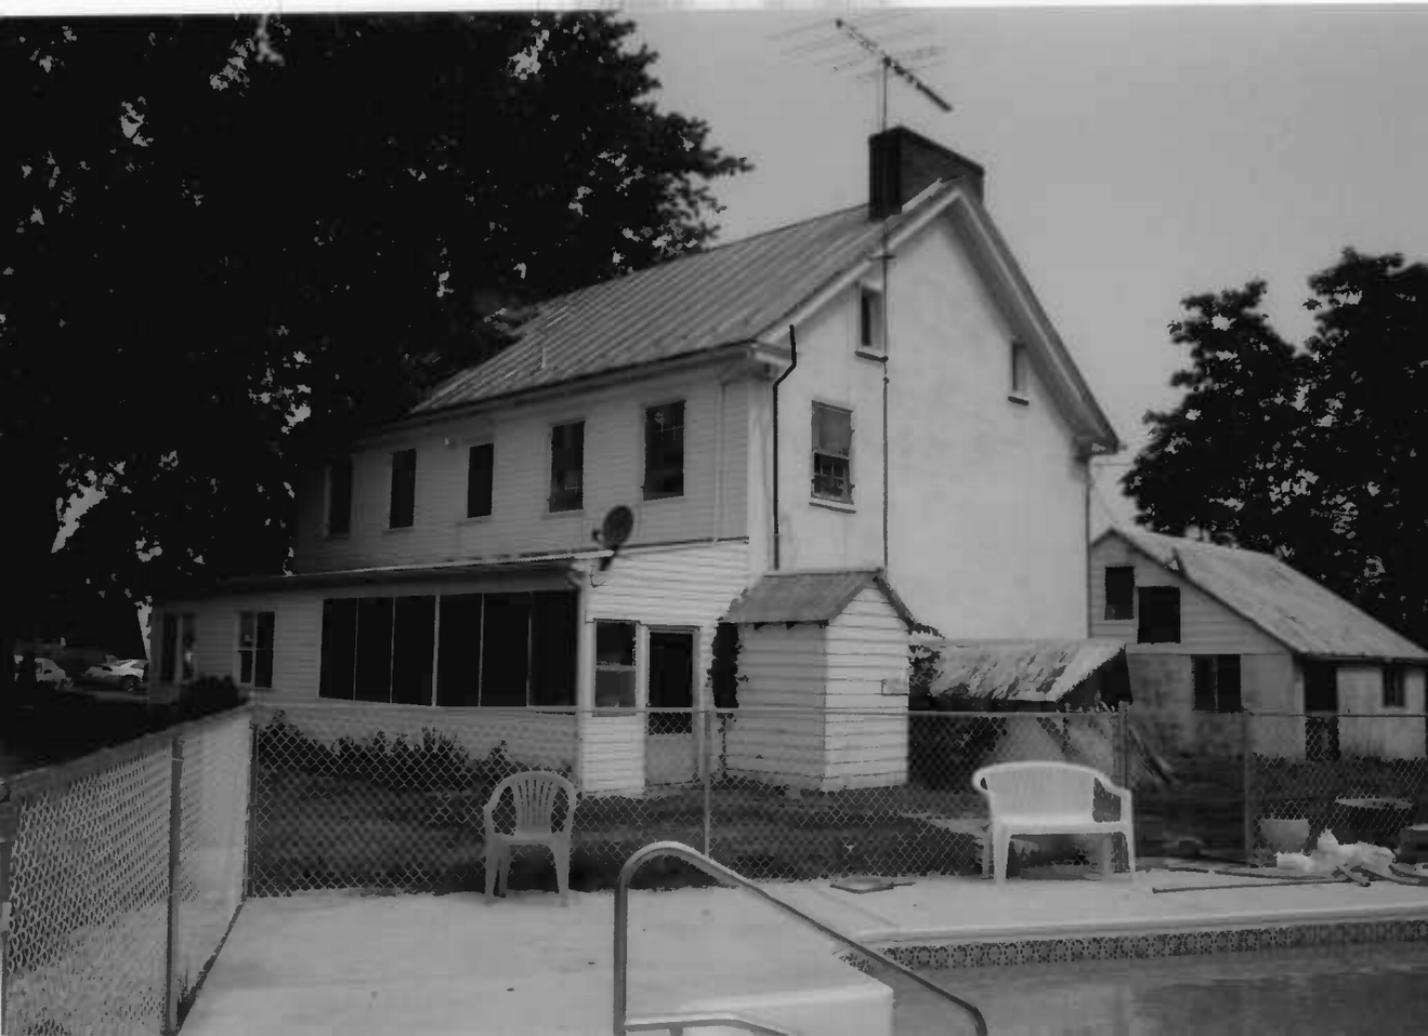
House: (near South)
Fugade & pool in back
Yard. View to North
2/3

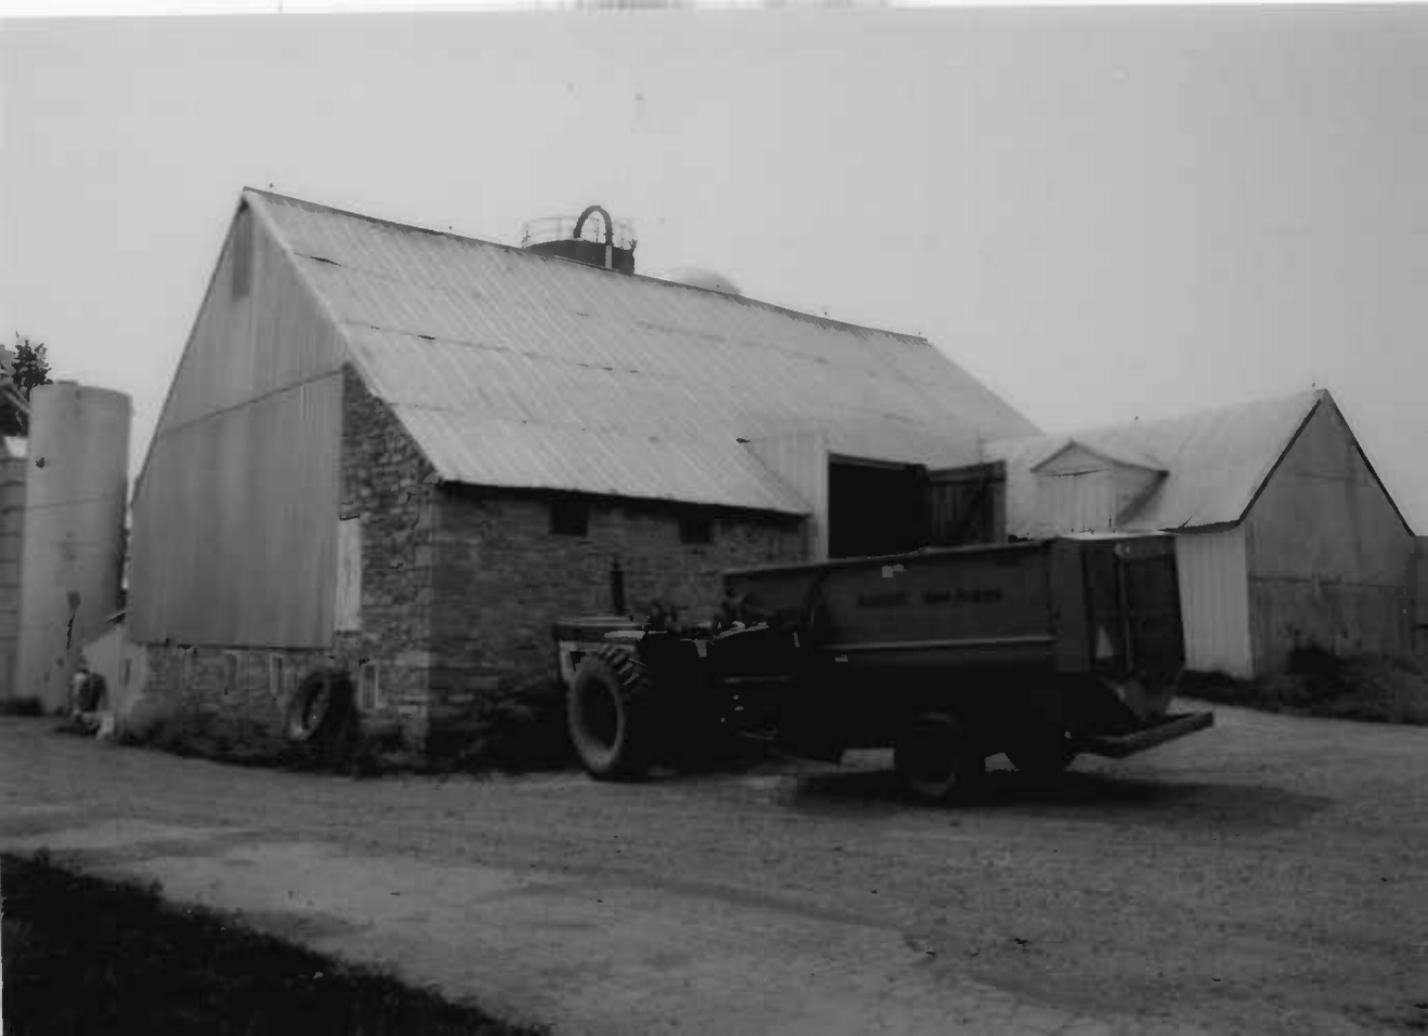
#3/3

The barn is located north of the house. It is a side gable bank barn constructed on a squared and coursed rubble foundation. The original wood siding has been replaced by corrugated metal and the roof is clad by standing seam metal. There are several silos, metal grain storage bins, and other outbuildings associated with the barn.

Barn view to SW.

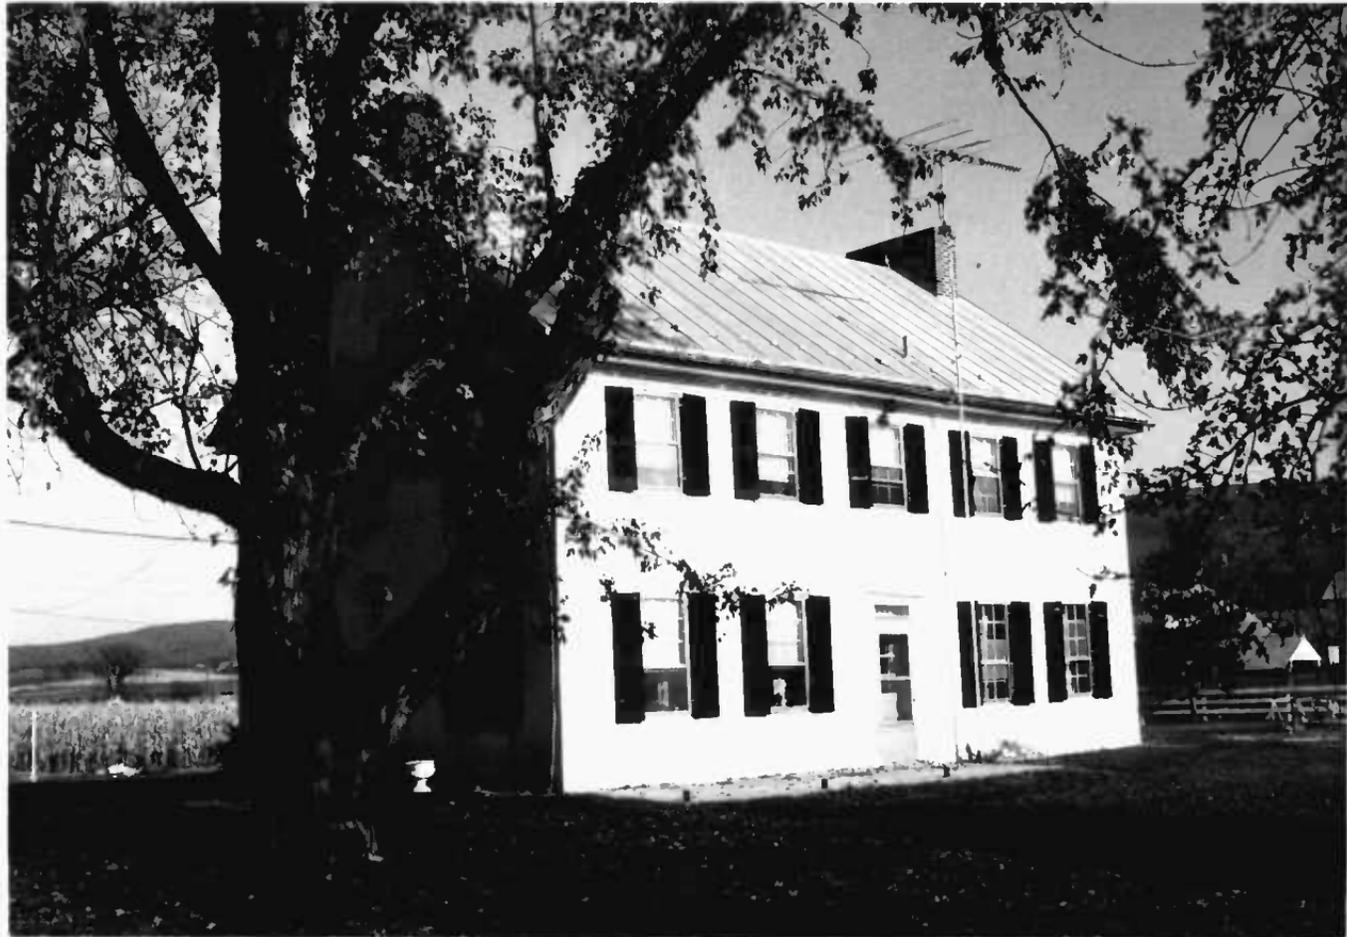
S.W

This two story, five bay farmhouse is sheathed with stucco and wooden siding. Beneath, it may be of brick or log construction. First story windows have nine over six pane sashes while those at the second story have six over six lights. Although most window frames are relatively narrow, the main central entrance has massive framing with mitered corners. A narrow transom is present above the door. Also present on the property is a large frame bank barn with stone graineries.
