Maryland Historical Trust
Maryland Inventory of Historic Properties Form
Intercounty Connector Project

historic Zadok Magruder Property

street & number 7227 & 7229 Muncaster Mill Road not for publicationcity, town Redland vicinity of congressional district

Survey No. M:22-20-1(PACS A8.6/A8.7)

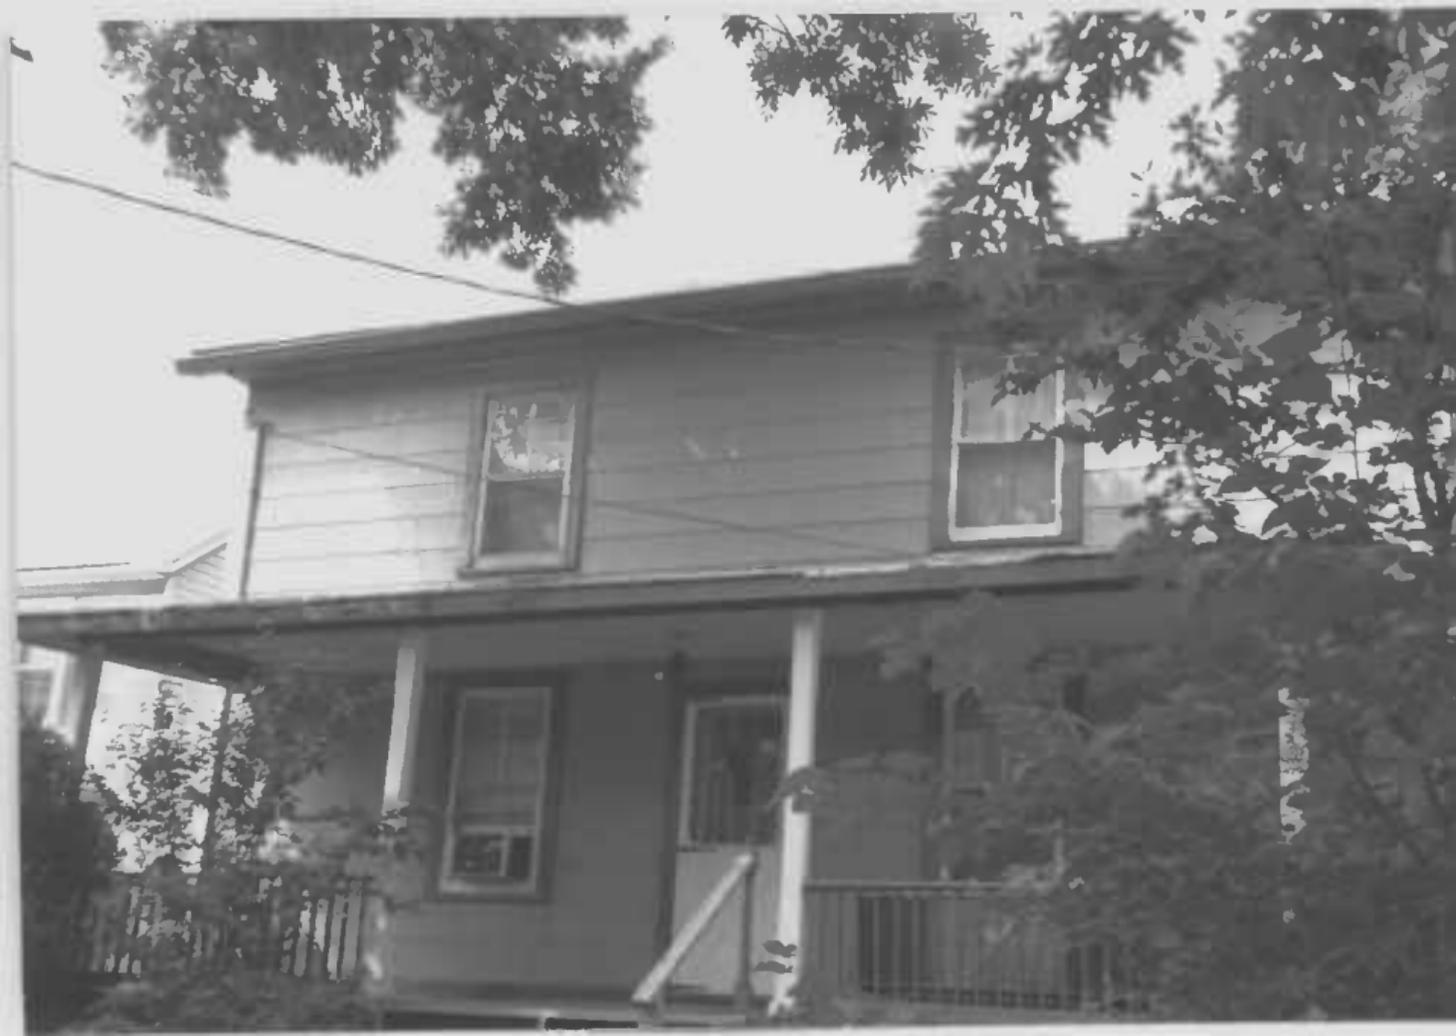
- 1 M.22-20-1
2. Zadok Magruder Property
- 3 Montgomery
4. Caroline Hall
5. July 1996
6. P. A. C. Spers and Company, 40 W. Chesapeake Ave, Suite 412, Towson MD 21204
7. 7777 Worcester Mill Rd, south elevation
8. 1 of 9

The first story of the front, or south facade has a central entrance with one, 2/2 double-hung window on each side. The second story has two, 2/2 double-hung windows.

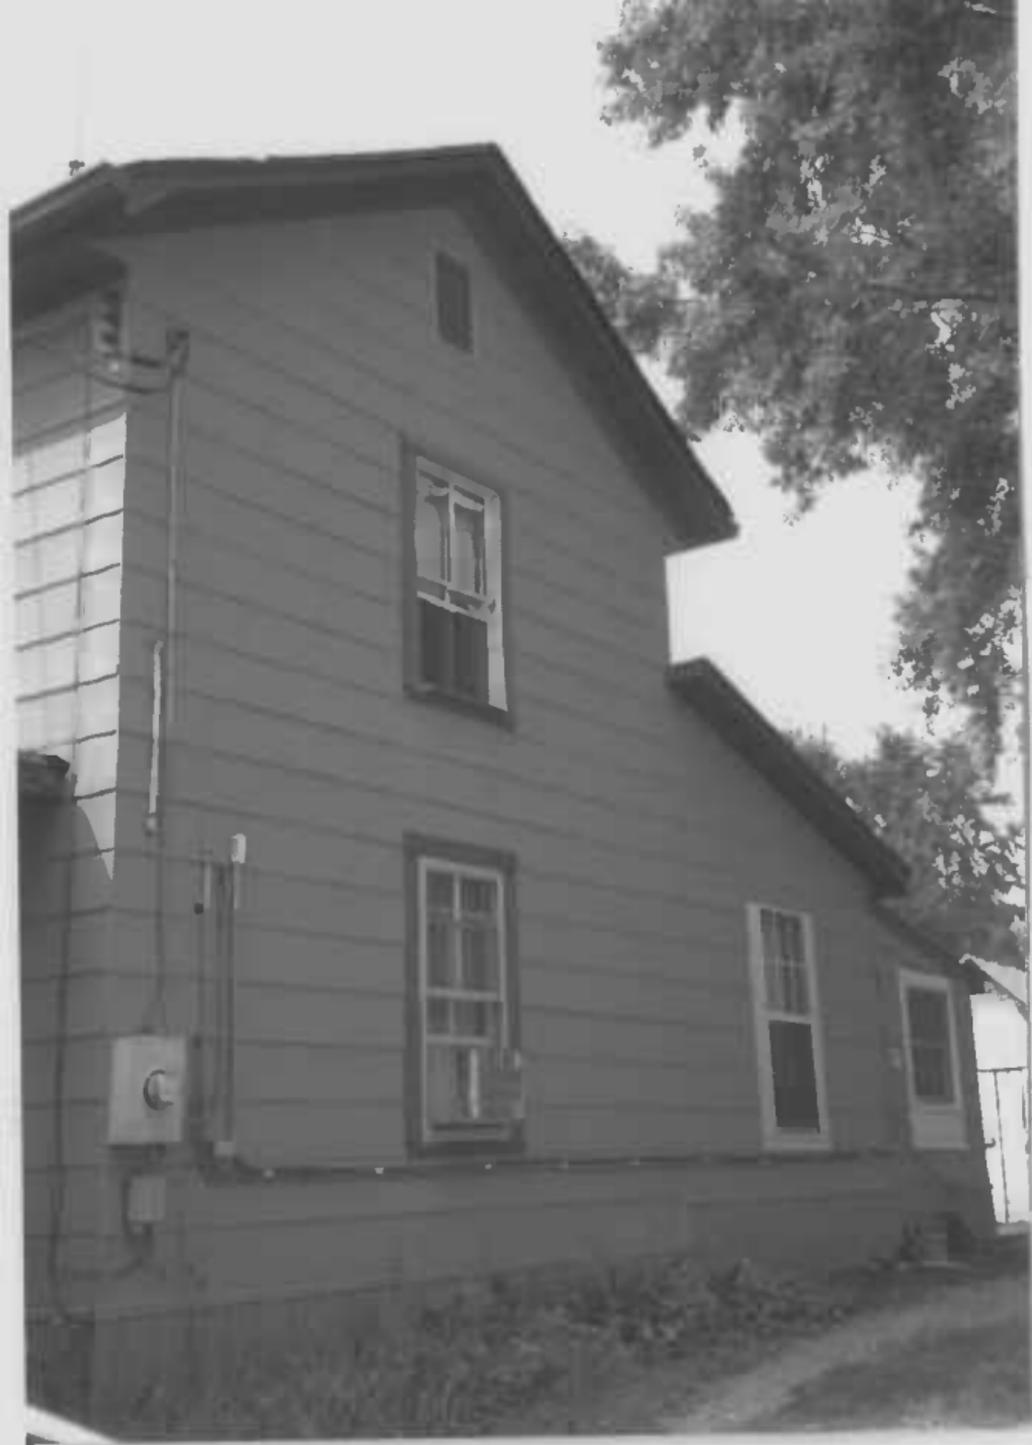
1. M. 22-20-1
2. Zadok Magruder Property
3. Montgomery
4. Caroline Hall
5. July 1996
6. P.A.C. Sporo & Company 40 W. Chesapeake
Ave, Suite 412, Towson MD 21204
7. 7227 Moncaster Mill Rd. east
elevation
8. 2 of 9

The east elevation has one, 2/2 double-hung window on both the first and second stories of the I-house. Both rear additions have one, 2/2 double-hung window on the east elevation.

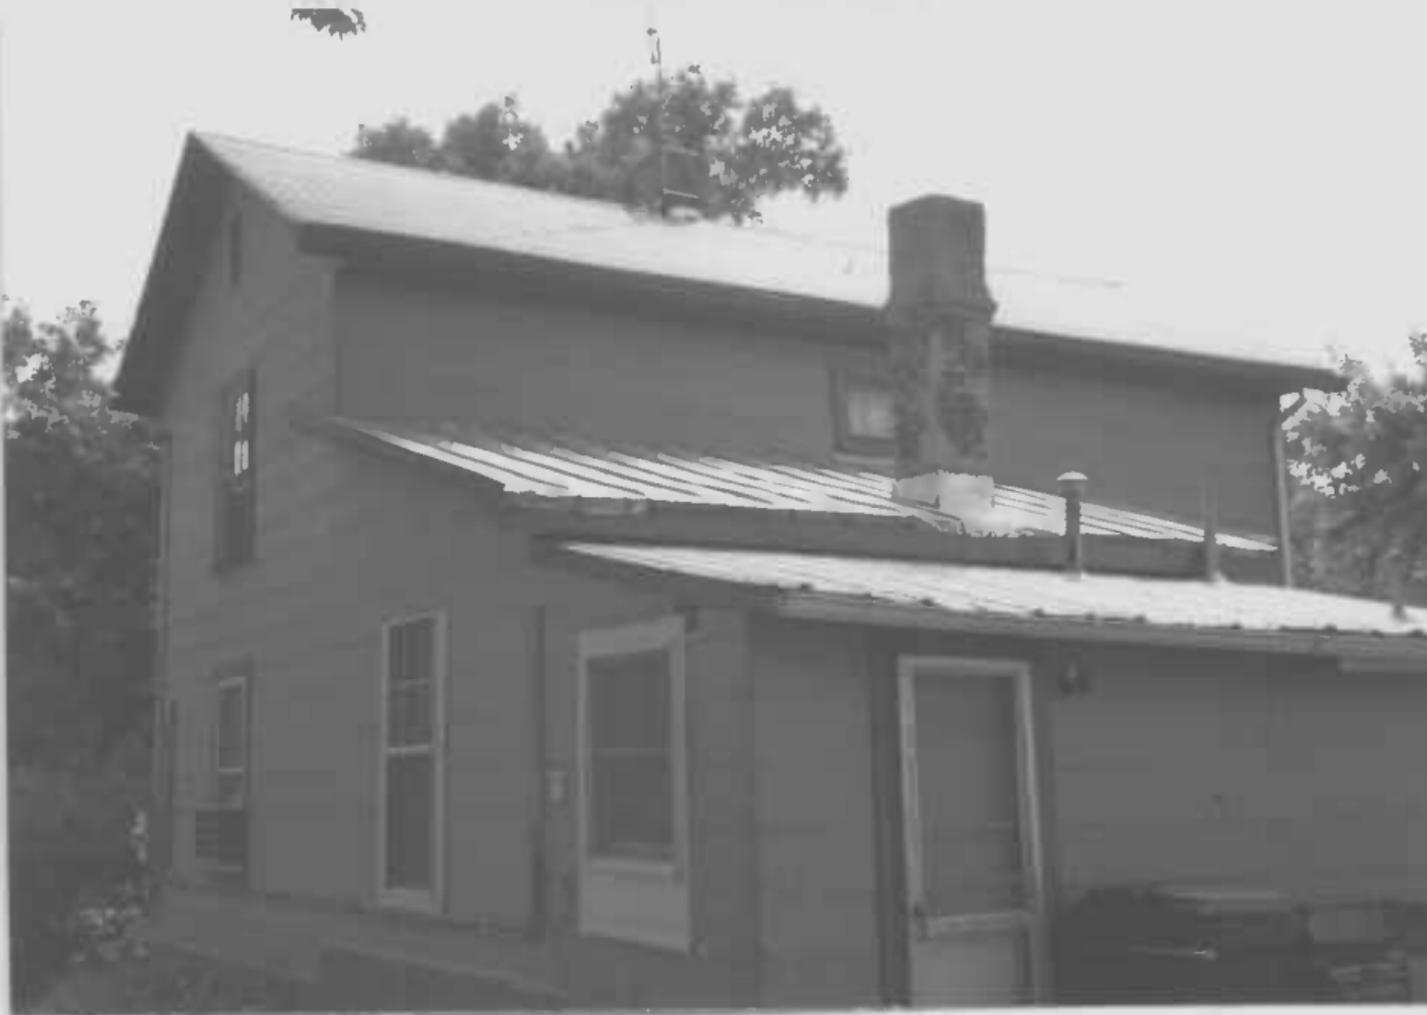
1. M 22-20-1
2. Zadok Maguder Property
3. Montgomery
4. Caroline Hall
5. July 1996
6. P.A.C. Spco & Company, 40 W. Chesapeake Ave, suite 412, Towson MD 21204
7. 7227 ~~East~~ Muncaster Mill Road
North elevation
8. 3 of 9

The rear, or north elevation has two additions; a 1-story shed roof addition which projects from the I-house, and a 1/2-story addition which projects from the 1-story addition. These two additions conceal the first story of the I-house. The 1/2-story addition has a wood door. Neither the 1-story addition, nor the second story of the I-house have any fenestration. At the eave of the I-house is a small, 1-light window.

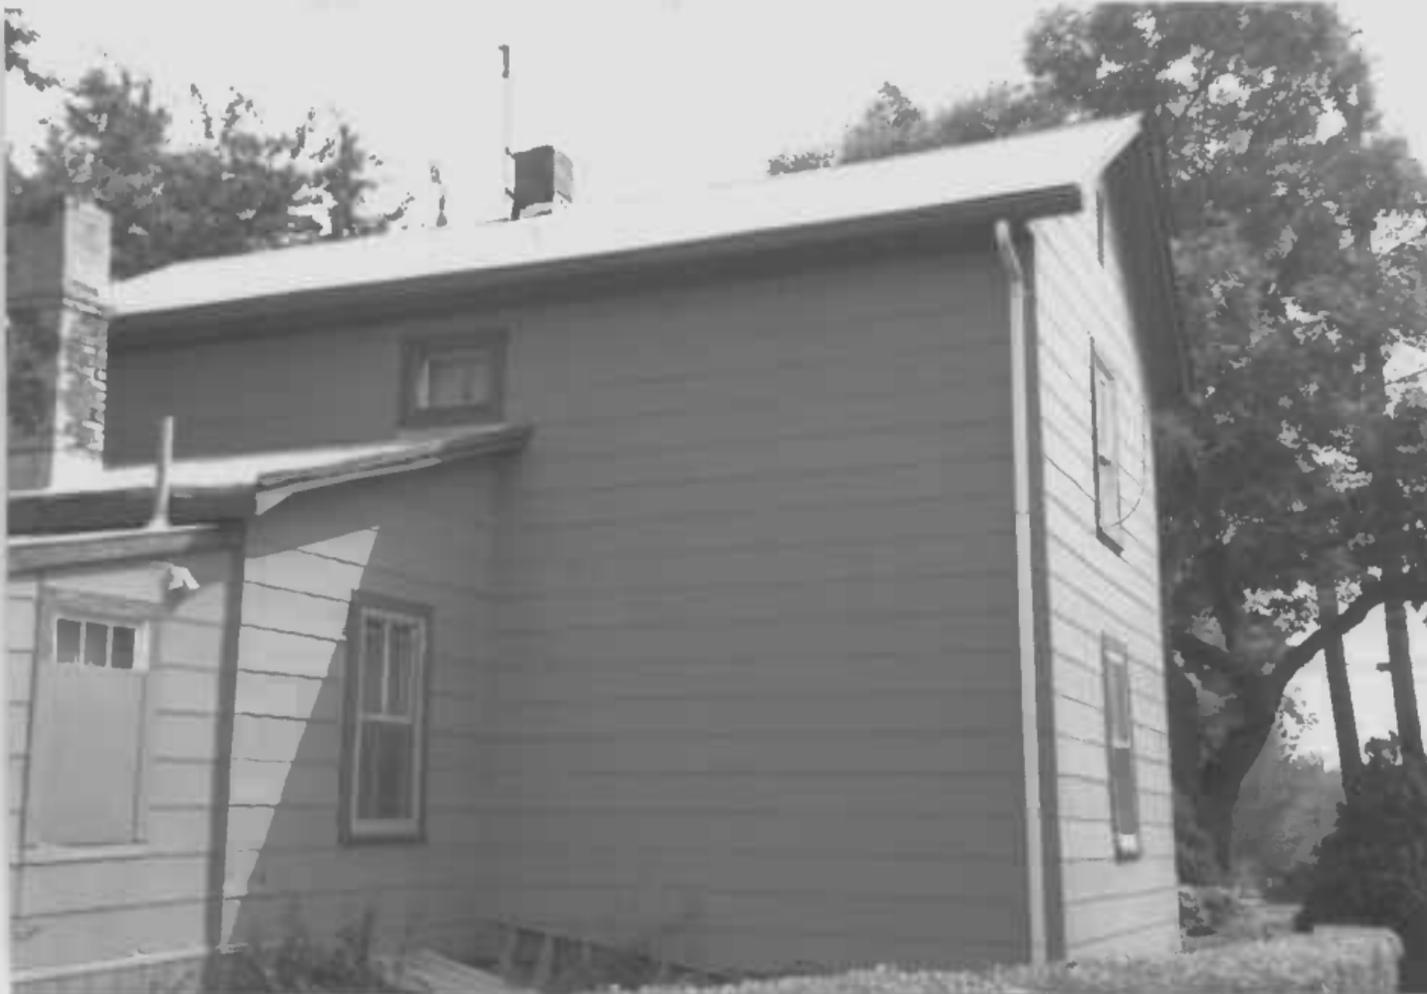
1. M: 22-20-1
2. Zadok Magruder Property
3. Montgomery
4. Caroline Hall
5. July 1996
6. P.A.C. Speco & Company, 40 W. Chesapeake
Ave., Suite 412, Towson MD 21204
7. 7227 Muncoaster Mill Rd
west elevation
8. 4 of 9

The west elevation of the I-house has one, 2/2 double-hung window on both the first and second stories. The west elevation of both rear additions has one, 2/2 double-hung window.

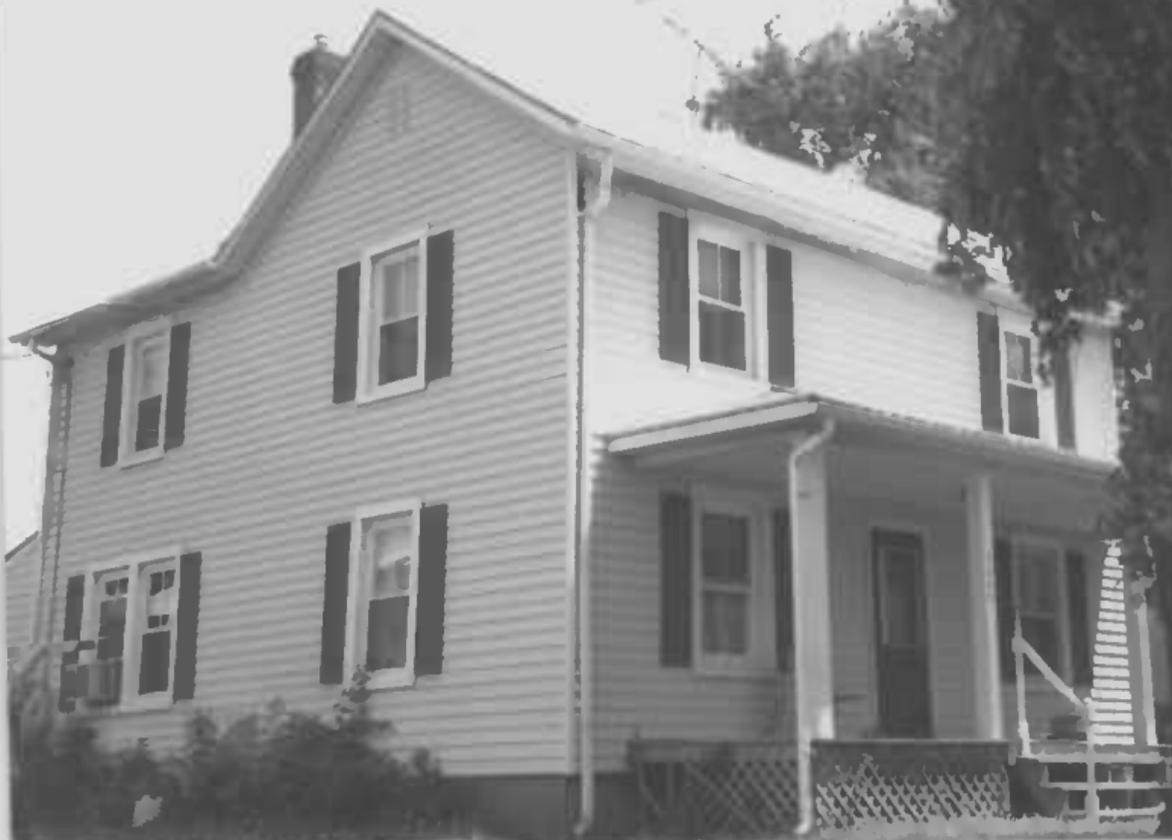
7. 7229 Muncaster Mill Rd.

The front, or south facade has a central entrance with one, 2/2 double-hung window on each side. The fenestration pattern on the front facade is symmetrical, with two, 2/2 double-hung windows on the second story, vertically aligned with the windows on the first story.

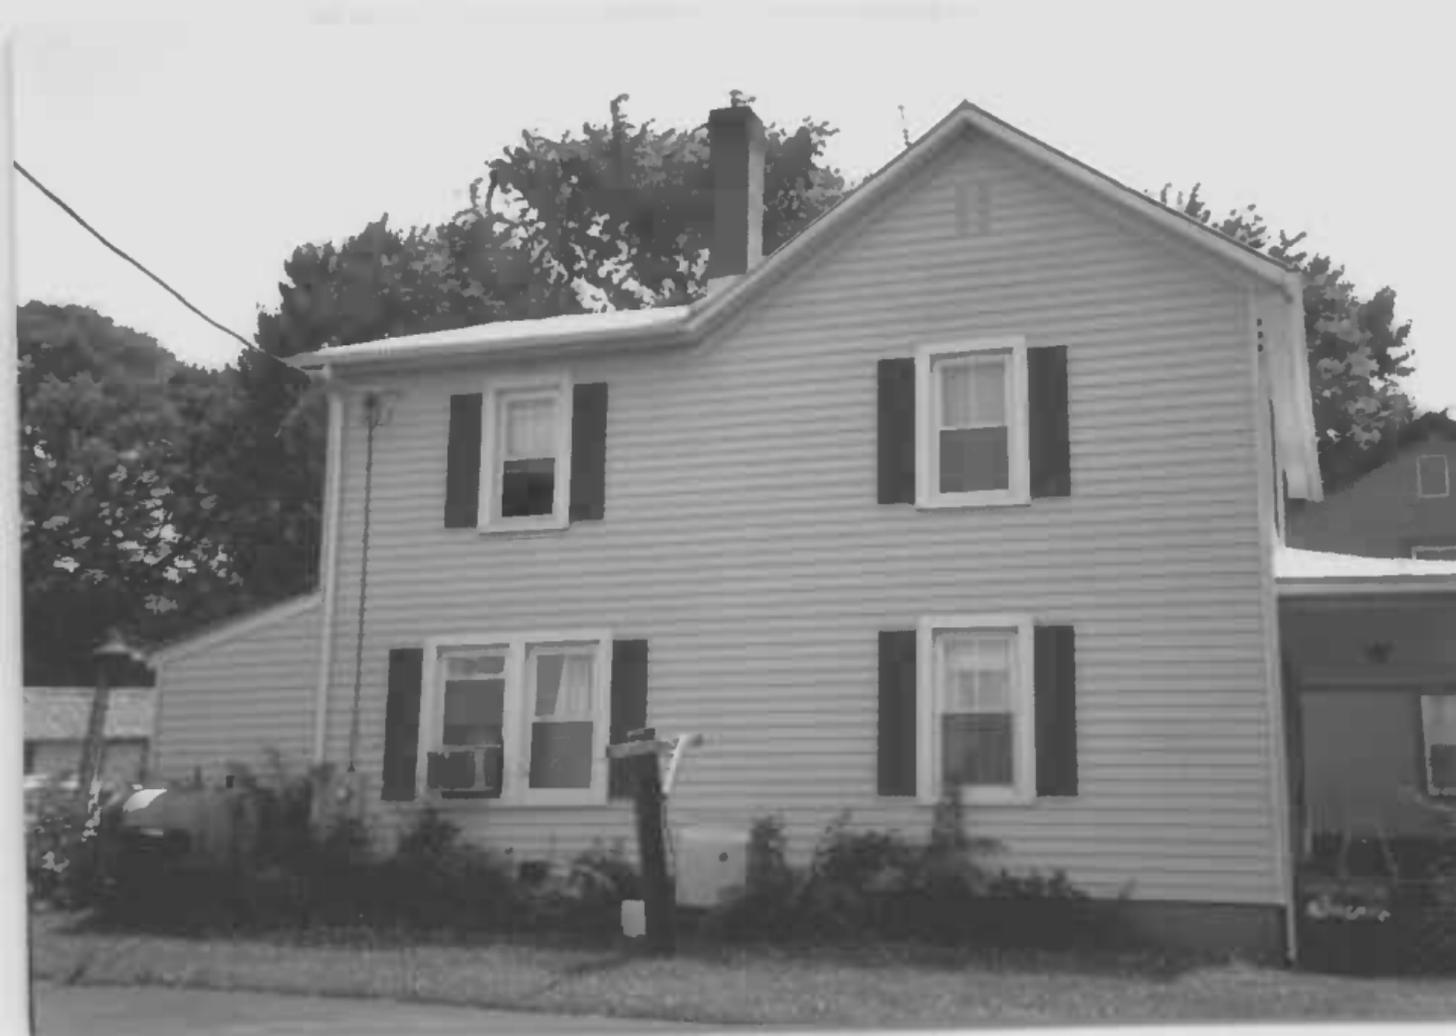
1. M 22-20-1
2. Zadok Magruder Property
3. Montgomery
4. Caroline Hall
5. July 1996
6. P.A.C. Spoor & Company, 40 W Chesapeake Ave, Suite 412, Towson MD 21204
7. 7229 Moncaster Mill Road
West elevation
8. 6 of 9

The west elevation has one, 2/2 double-hung window on both the first and second stories of the original I-house. The 2-story rear addition has a paired, 2/2 double-hung window on the first story, and one, 2/2 double-hung window on the second story. The 1-story rear addition has no fenestration.

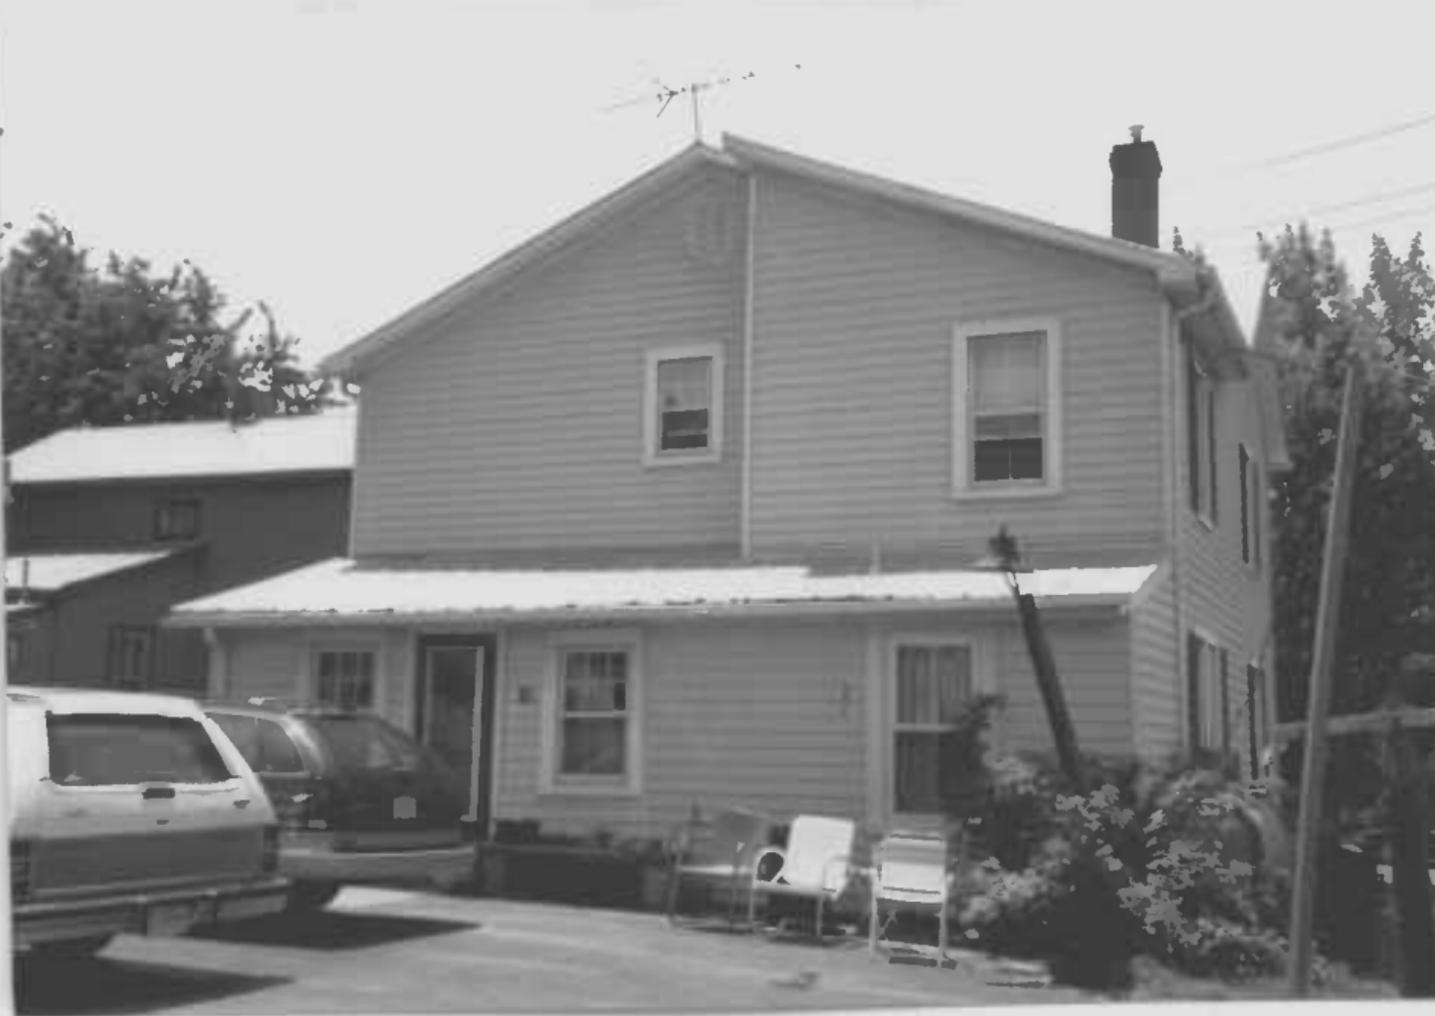
1. M. 22-20-1
 2. Zadok Magruder Property
 3. Montgomery
 4. Caroline Hall
 5. July 1996
 6. P.A.C. Sperry & Company, 40 W. Chesapeake Ave., Suite 412 Towson MD 21204
 7. 7229 Muncaster Mill Rd
 8. North elevation
- 7 of 9

The rear, or north elevation of the I-house is entirely concealed by the two rear additions. The first story of the 2-story addition is concealed by the 1-story rear addition. The north elevation of the 1-story addition has two, 6/6 double-hung windows, one 2/2 double-hung window, and a door. The north elevation of the 2-story addition has two, 2/2 double-hung windows on the second story.

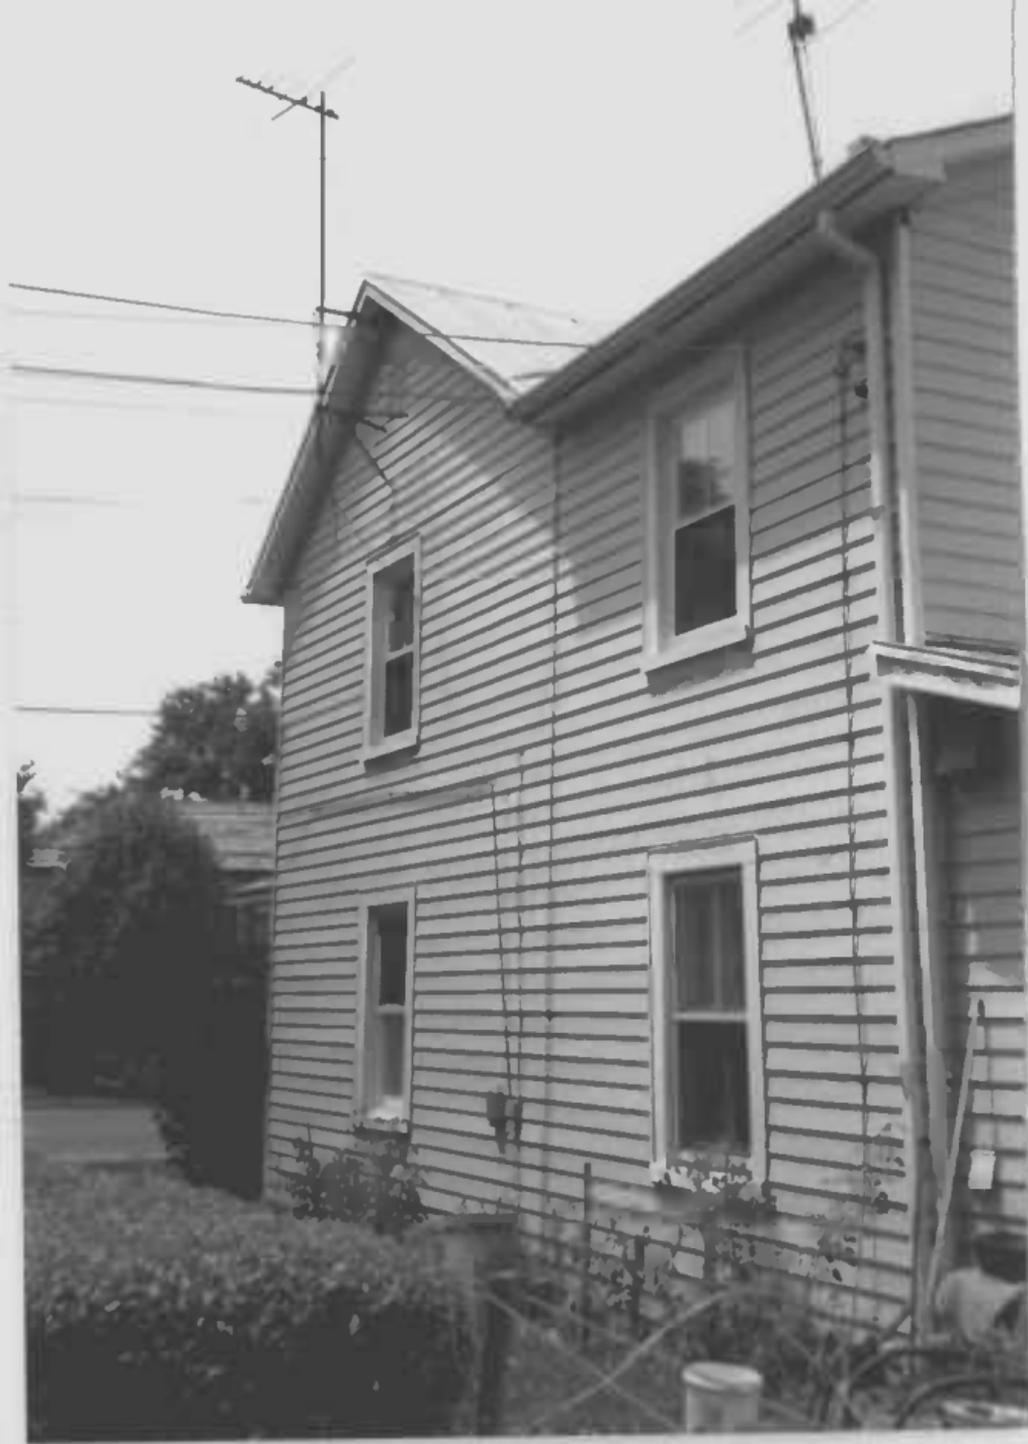
7. 7229 Moncaster Mill Rd
east elevation

The east elevation has one, 2/2 double-hung window on both the first and second stories of the I-house. The east elevation of the 2-story rear addition also has one, 2/2 double-hung window on both the first and second stories. The 1-story rear addition has no fenestration on the east elevation.

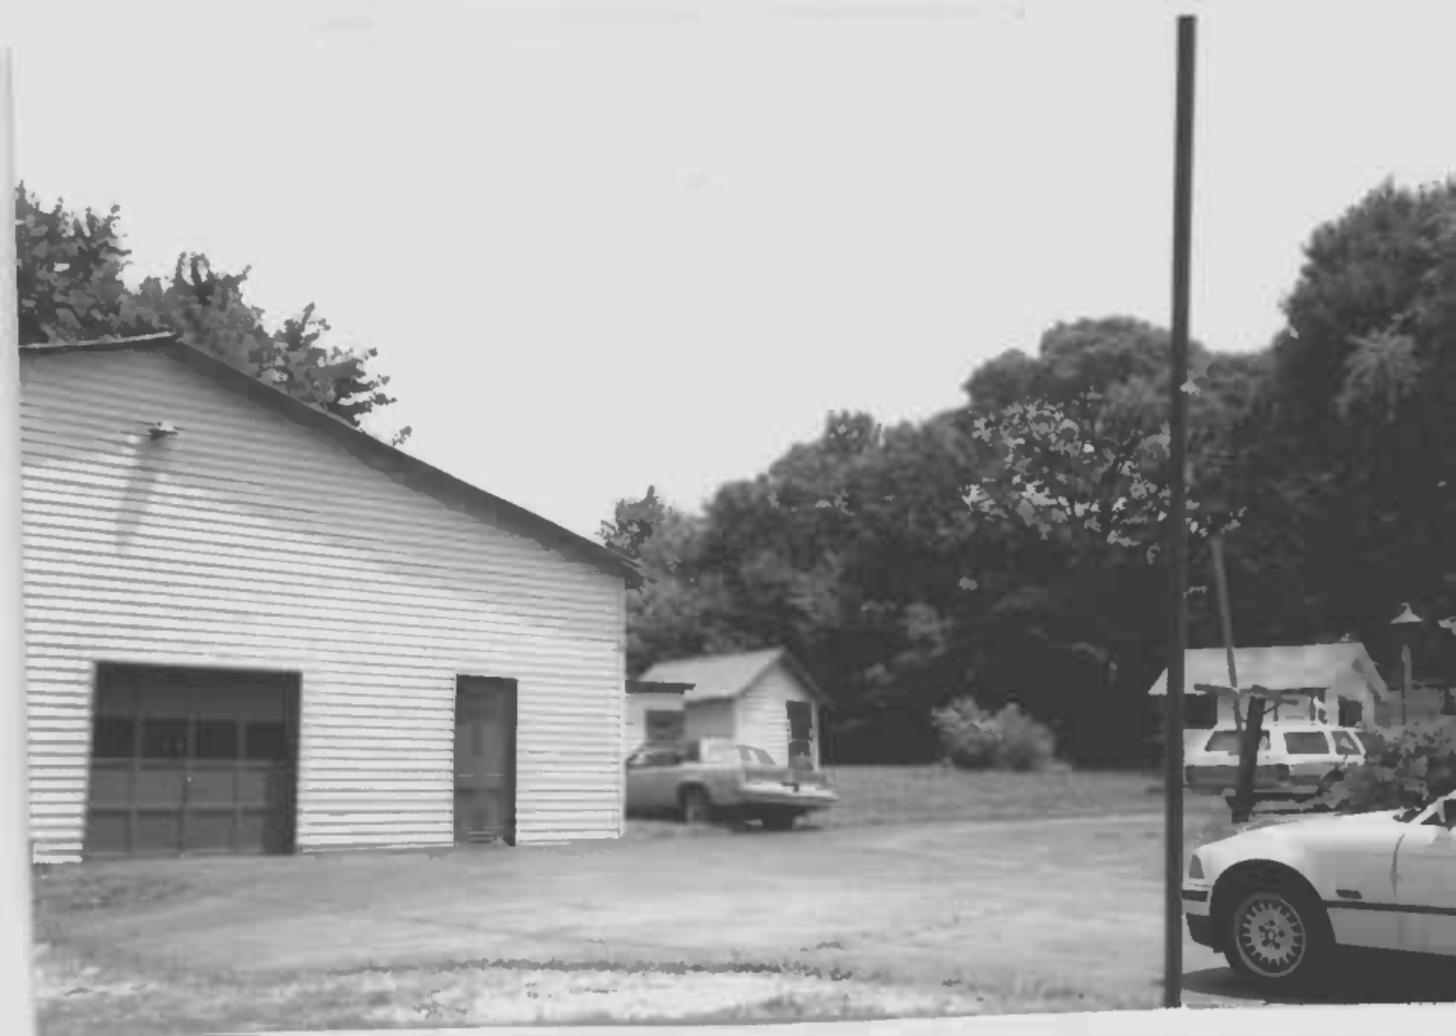
1. M-22-20-1
2. Zadok Maguder Property
3. Montgomery
4. Caroline Hall
5. July 1996
6. P. A. C. Speed & Company 40 W. Chesapeake
Ave, Suite 412 Towson MD 21284
7. 7229 Marcaster Mill Rd
outbuildings
8. 9 of 9

There are four outbuildings associated with this property. Three of the outbuildings are small, wood-frame sheds. Two of the sheds have front-gable roofs, while the third has a shed roof. The fourth outbuilding is a large, modern garage. The structure has a front-gable roof and is clad in vinyl siding. The outbuildings are located north of the house.
