Maryland Inventory of Historic Properties number: CAR-297

Name: #5017 / MD 404 Ab. over Fuchahoe Creek

MARYLAND INVENTORY OF HISTORIC BRIDGES
HISTORIC BRIDGE INVENTORY
MARYLAND STATE HIGHWAY ADMINISTRATION/
MARYLAND HISTORICAL TRUST

SHA Bridge No. 5017 Bridge name MD 404 Alternate over Tuckahoe Creek

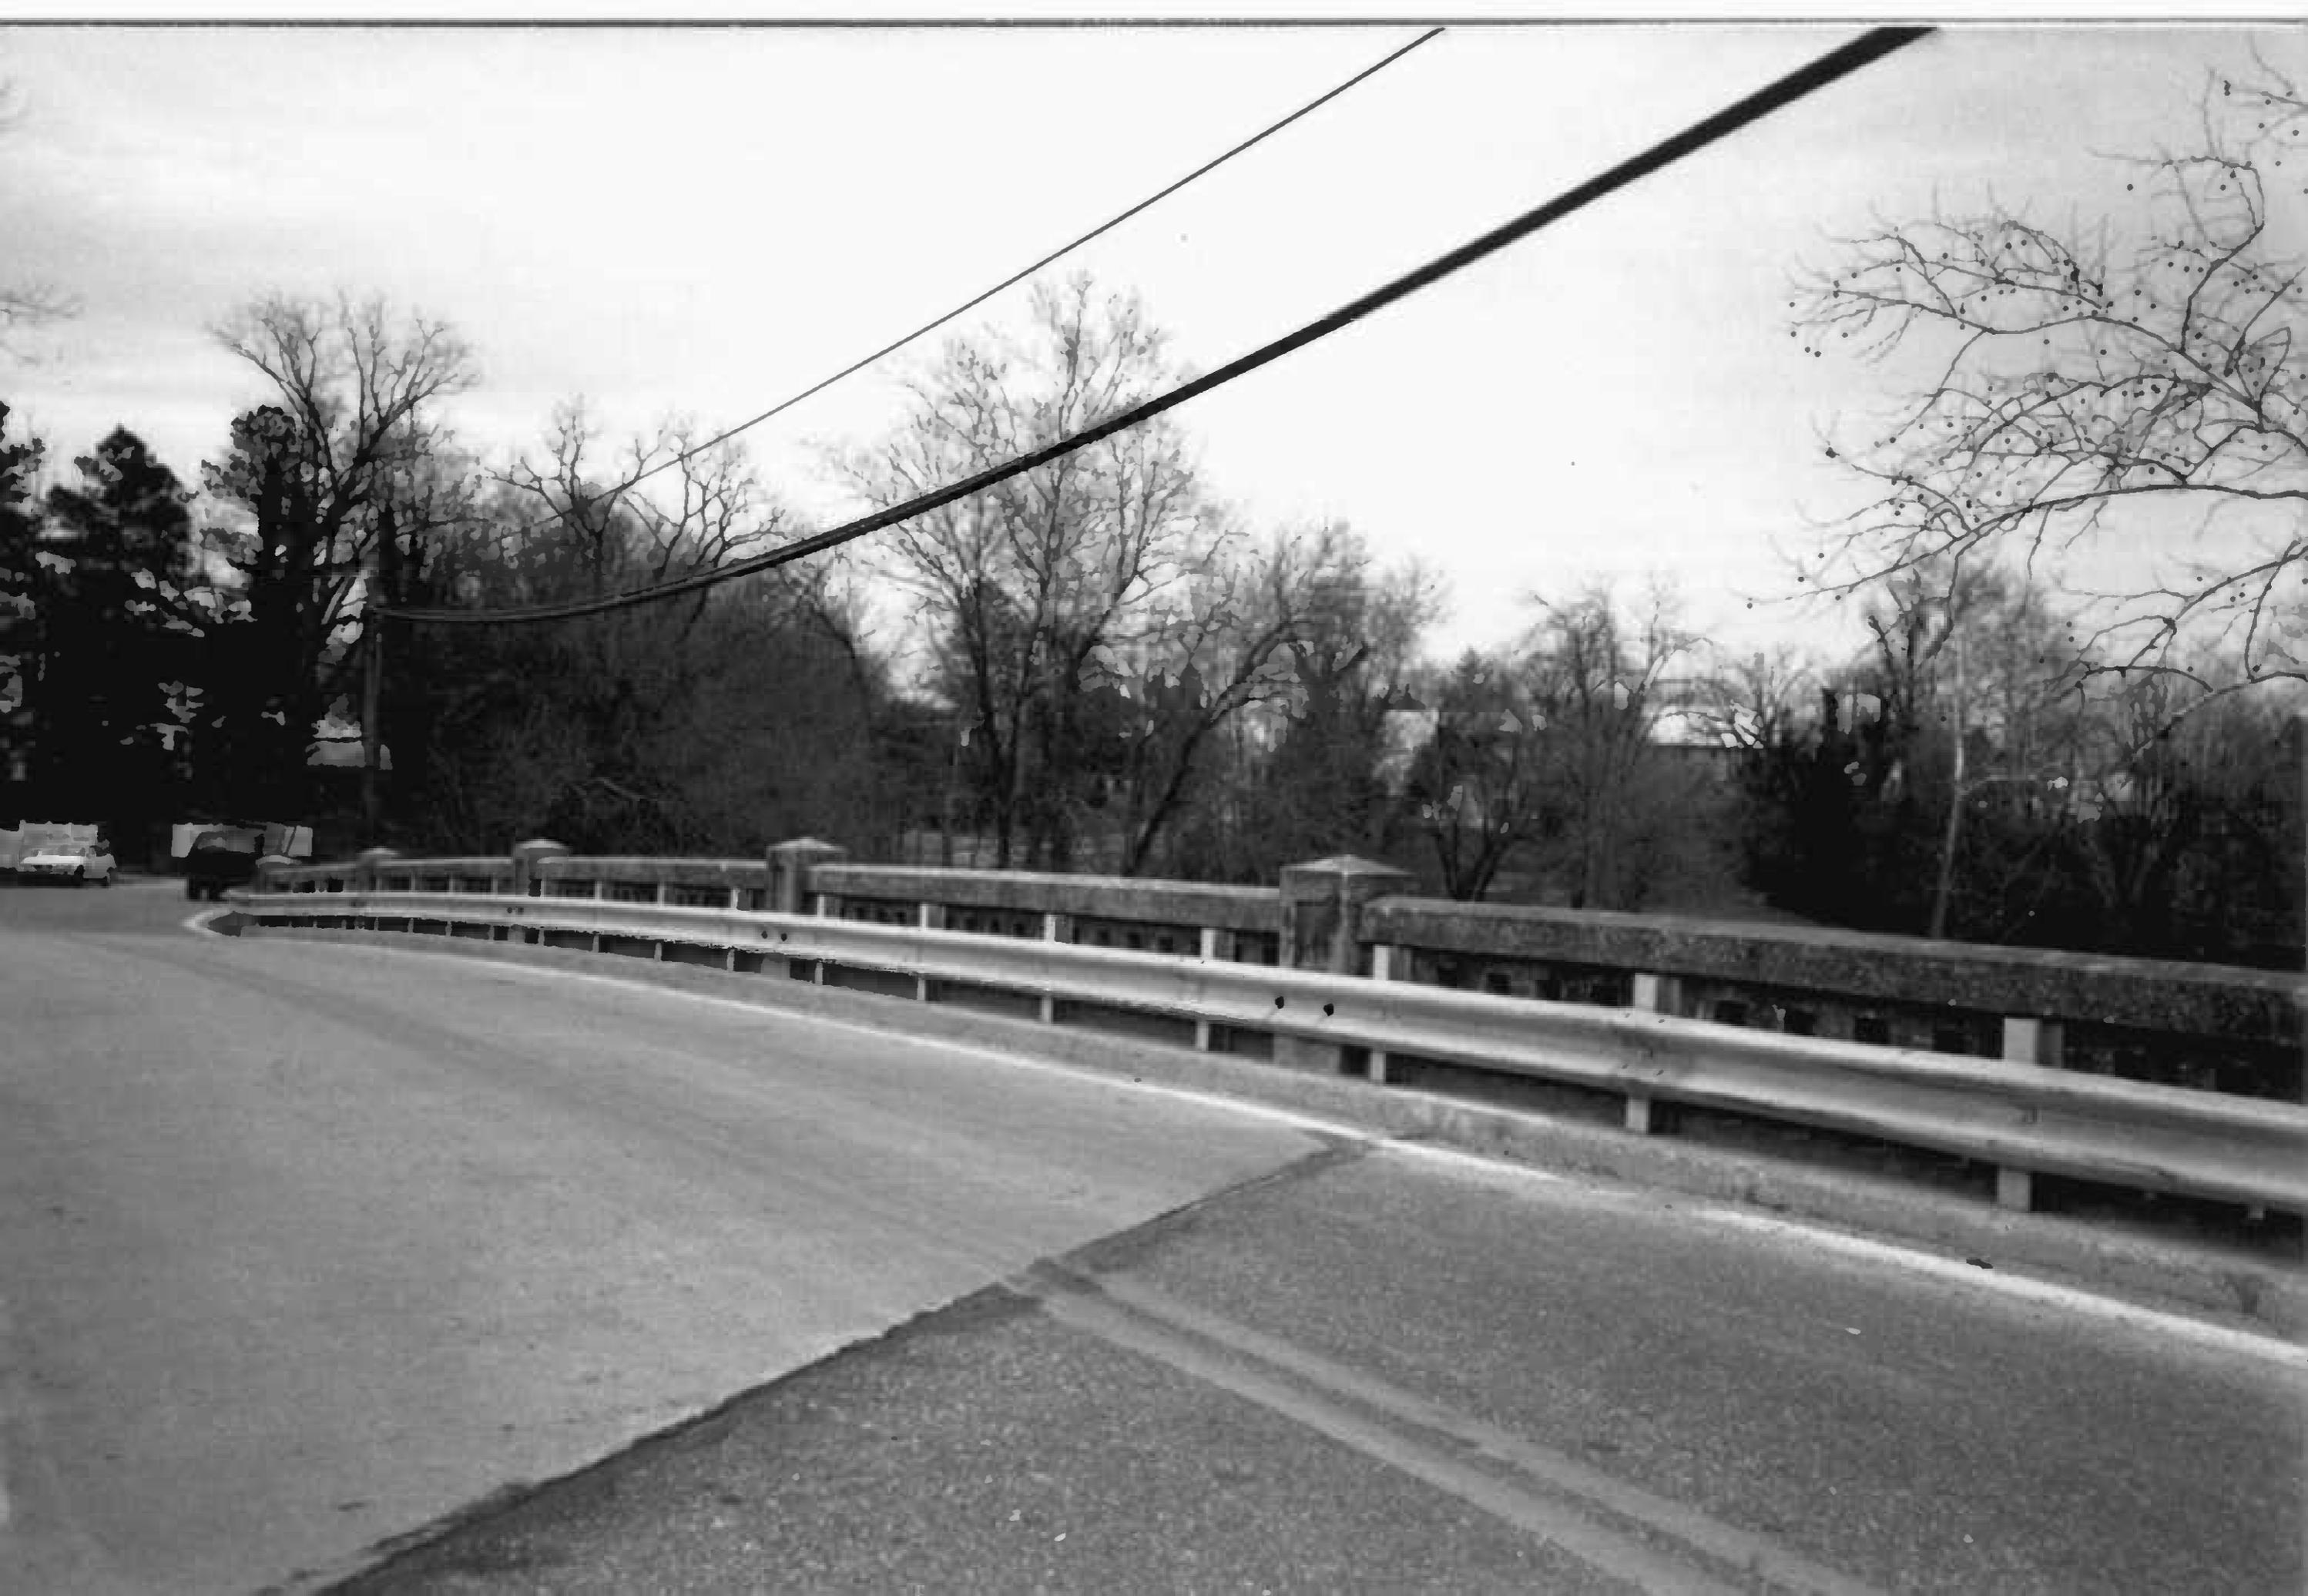
1. CAR-297
2. MD404 Alt. over Juckahoe Creek (5017)
3. Caroline County, MD
4. Caroline Hall
5. 3/97
6. MD SHPO
7. south parapet wall
8. 5 of 6

According to the 1996 inspection report, this structure was in satisfactory condition. The concrete girders had fine longitudinal and map cracking and some shallow popouts. The original concrete abutments had severe spalling and the concrete piers were in poor condition with severe spalling and section loss. The steel pile bents, which were added in 1980, had light rust and peeling paint. The wing walls had map cracking and some moisture stain. The concrete parapet had minor chipping and spalling on the base. The bases also have fine transverse cracking.
