Maryland Inventory of Historic Properties number: CE-1489

Name: 7008/MD7 over Stony Run

MARYLAND INVENTORY OF HISTORIC BRIDGES  
HISTORIC BRIDGE INVENTORY  
MARYLAND STATE HIGHWAY ADMINISTRATION/  
MARYLAND HISTORICAL TRUST

SHA Bridge No. 7008 Bridge name MD 7 over Stoney Run

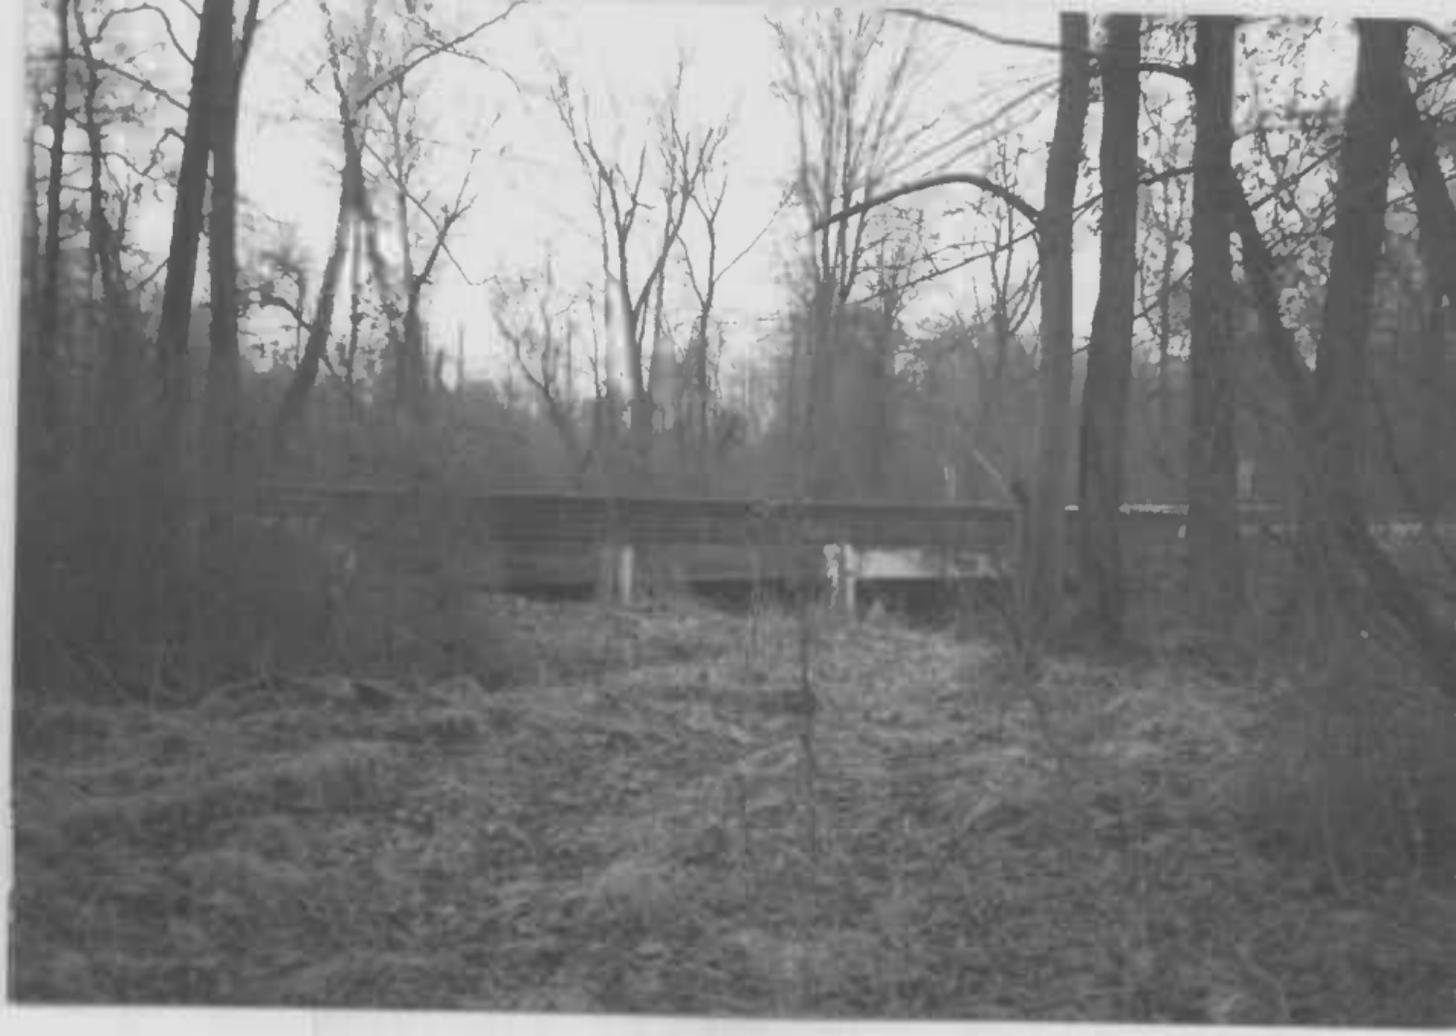
1. CE-1489
2. MD 7 over Stony Run (7008)
3. Cecil
4. Eric Griffiths
5. 3-97
6. MD SHPD
7. North Elevation of Bridge
8. 10 f 6

Bridge No. 7008 is a 4-span, 2-lane, concrete slab bridge. According to the inspection report the bridge was built in 1931; although the bridge may resemble earlier standard plans, there is no documentation of an earlier date. The structure is 57 feet long and has a clear roadway width of 22 feet. The out-to-out width is 24 feet. The concrete slab measures 3 feet, 2 inches thick, and it has a bituminous wearing surface. The structure has solid parapets with panel detailing, and the roadway approaches have w-section guard rails. The substructure consists of two (2) concrete abutments and three (3) concrete piers. There are four (4) flared wing walls. The bridge has a sufficiency rating of 49.3.

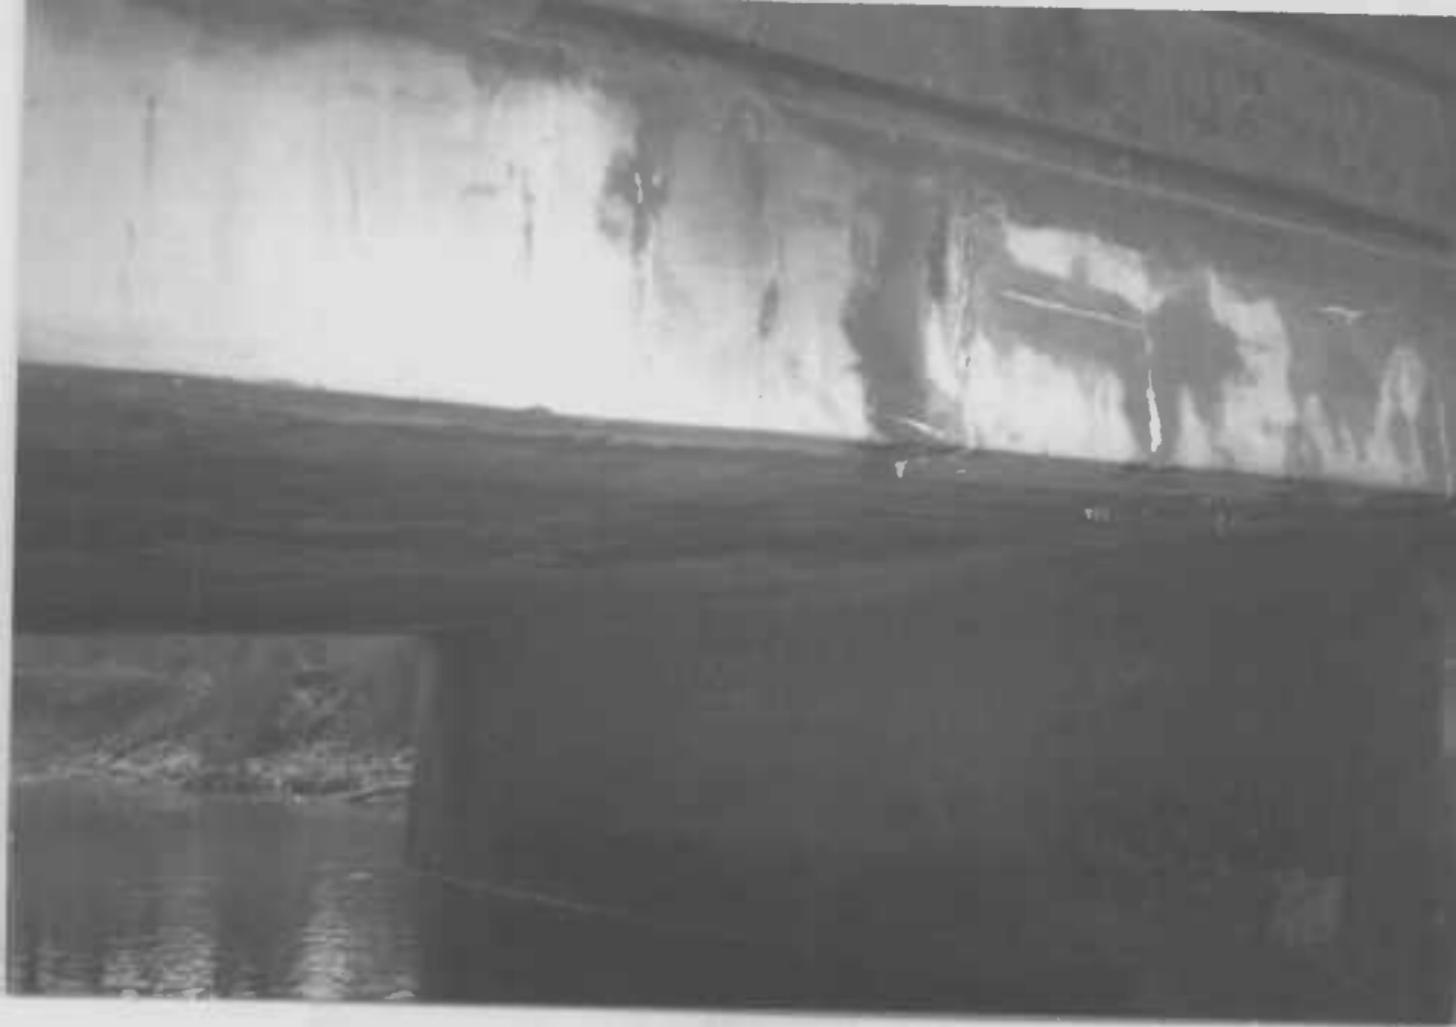
1. CE - 1489
2. MD 7 over Stony Run (7008)
3. Cecil
4. Eric Griffiths
5. 3-97
6. MD SHPO
7. Detail of Slab under Bridge
8. 2 of 6

According to the 1996 inspection report, this structure is in satisfactory condition with structural elements showing only minor deterioration. The concrete slab has minor spalls and cracks. The concrete parapet has some moderate and small isolated spalls. The abutments, piers, and wing walls have vertical and map cracking.

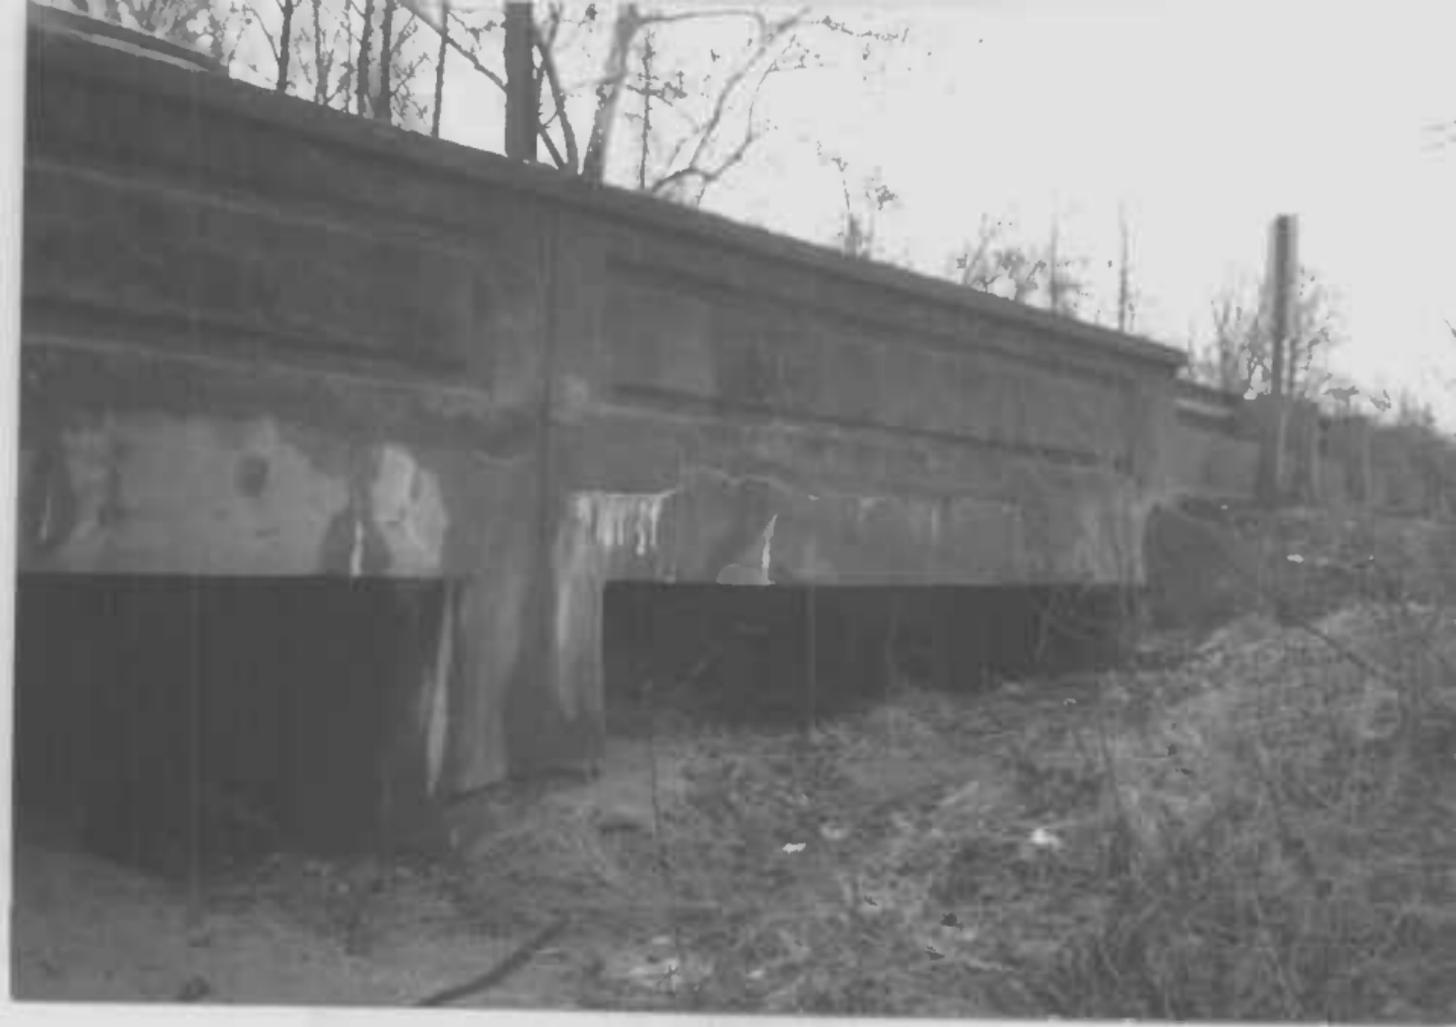
1. CE. 1459
- 2 MB 7 over Stony Run (7008)
3. Cecil
4. Eric Griffith #5
5. 3-97
6. MD SHPO
7. Detail of condition + Patchy  
South Elevation
- 8 4 of 6

Inspection reports from 1996 detail the patching of spalls and cracks in the wing walls and piers.
