CAPSULE SUMMARY SHEET

Survey No.: PG:85A-54 (PACS 2.1) Construction Date: 1939

Name: Theron Morrow Property

Maryland Historical Trust
 Maryland Inventory of Historic Properties Form
 MD 5 Brandywine Interchange

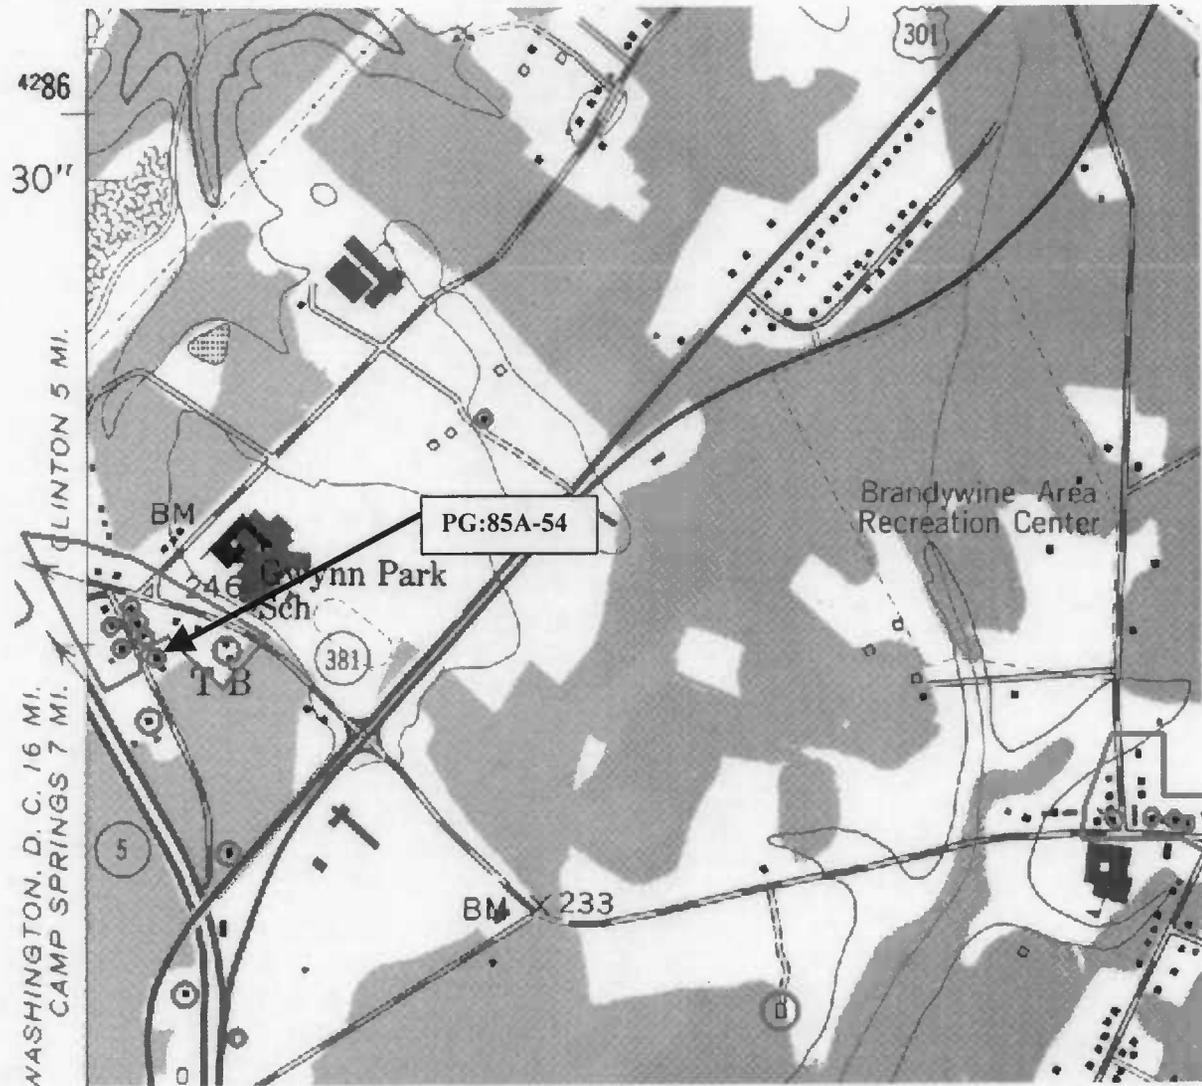
PG:85A-54
Theron Morrow Property
(Marshall Property)
13712 Old Brandywine Road
Brandywine quadrangle

The property is located on the east side of Old Brandywine Road, with residential properties to the west, south, and east, and the local telephone company building to the south. The property is separated from other properties by a line of trees which surround it on the north, east, and south. The property's setting is rural, and is unaltered from its historic setting.
