CAPSULE SUMMARY SHEET

Survey No.: CH-414 (PACS A20) Construction Date: circa 1870

Name: Mary E. Bowling Farm

Maryland Historical Trust
Maryland Inventory of Historic Properties Form
MD 5 - Hughesville Project

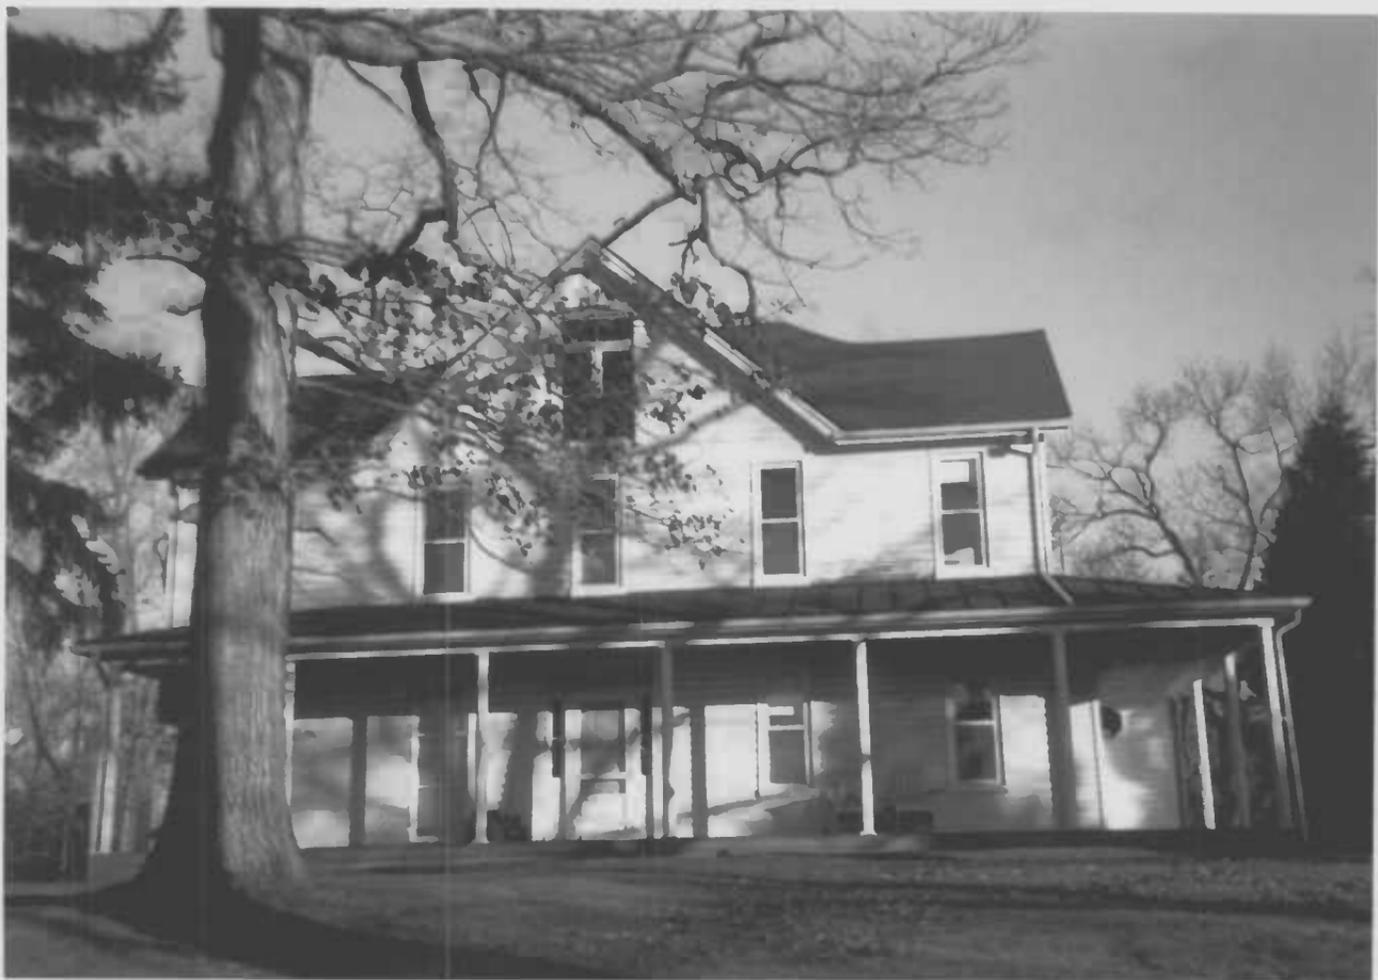
- 1 CH-414
- 2 Manj E Bowling Farm
- 3 Charles County, MD
- 4 Caroline Hall
- 5 January 1997
- 6 MD SHPO
- 7 Main house, south elevation, view N
- 8 1 of 11

The front, or south elevation has a full-width, front porch which wraps around the structure to the east elevation. The porch has a metal, shed roof and modern wood decking. It has modern aluminum columns and one decorative bracket is located at the west end of the elevation. The first story has a central, wood-paneled door with a 3-light transom and two, 2-light side-lights. The first and second bays on the first story are 2/4, full-height, double-hung, wood-frame windows. The windows in the fourth and fifth bays are 1/1 vinyl, replacement windows. The second story has five, 1/1 vinyl, replacement windows, while a pair of 1/1 wood windows with a 2-light transom are located in the center gable.

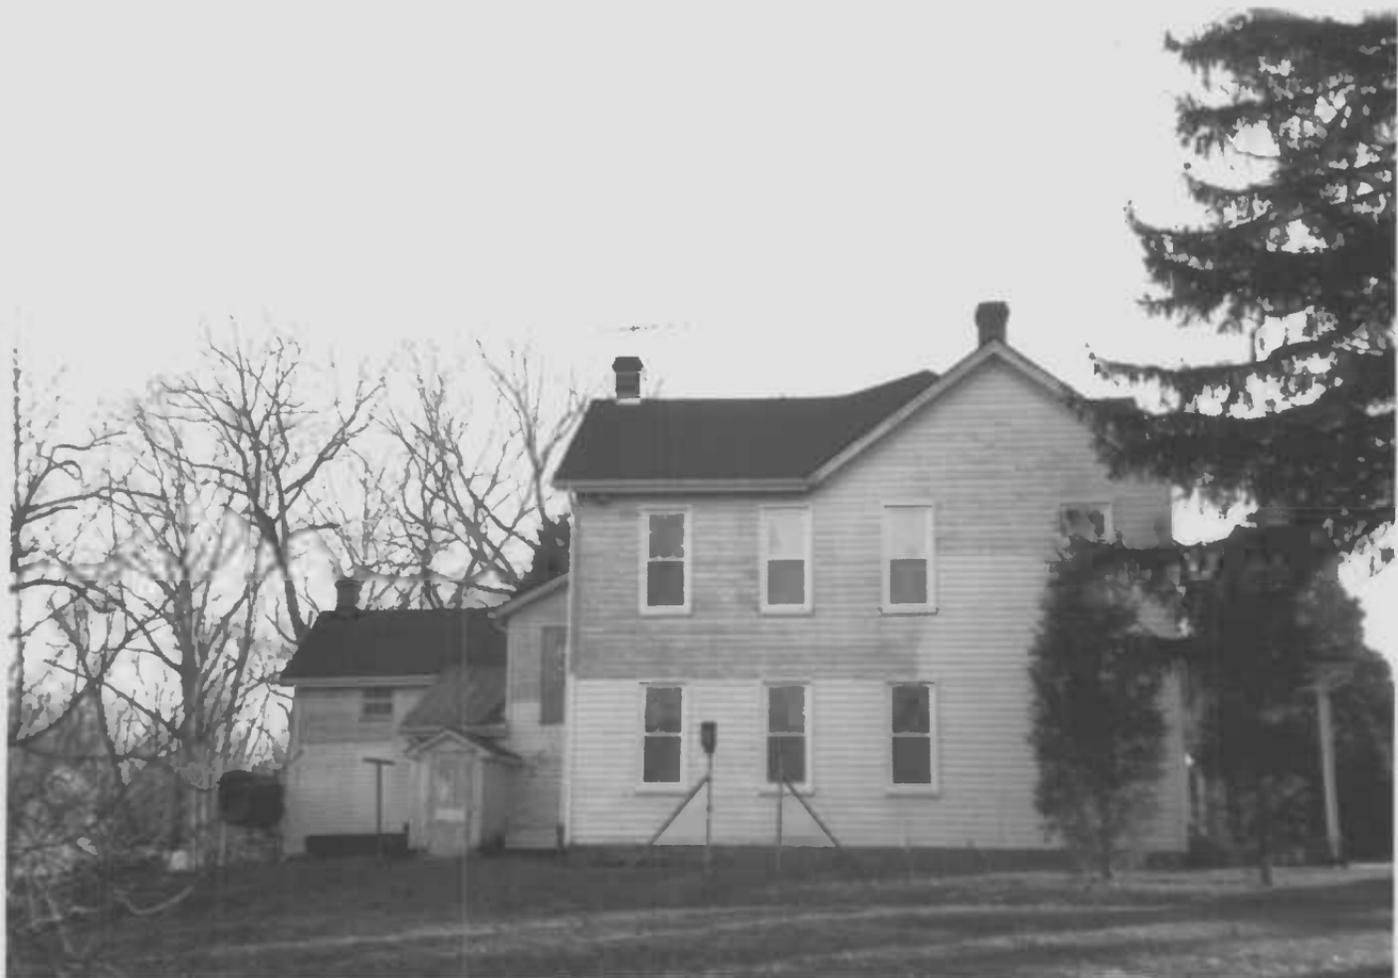
- 1 CH-414
- 2 Mary E. Bowling Farm
- 3 Charles County, MD
- 4 Caroline Hall
- 5 January 1997
- 6 MD SHPO
- 7 Main House, west elevation, view E
- 8 2 of 11

The west elevation includes the main block, the west, rear wing, the 2-story, shed-roof rear addition, and the 1½-story rear addition. The main block has two, 1/1 double-hung, vinyl windows on both the first and second stories. In addition, two, 1/1 double-hung, vinyl windows are located on both the first and second stories of the west, rear wing. The 2-story shed-roof addition has no fenestration on the first story. The second story has a doorway which has been enclosed with wood siding and a modern octagonal, fixed-light window. The 1½-story addition has a small, 1/1 double-hung, vinyl window and one window opening which has been enclosed with siding on the first story. One 3/3 double-hung, wood window is located on the second story.

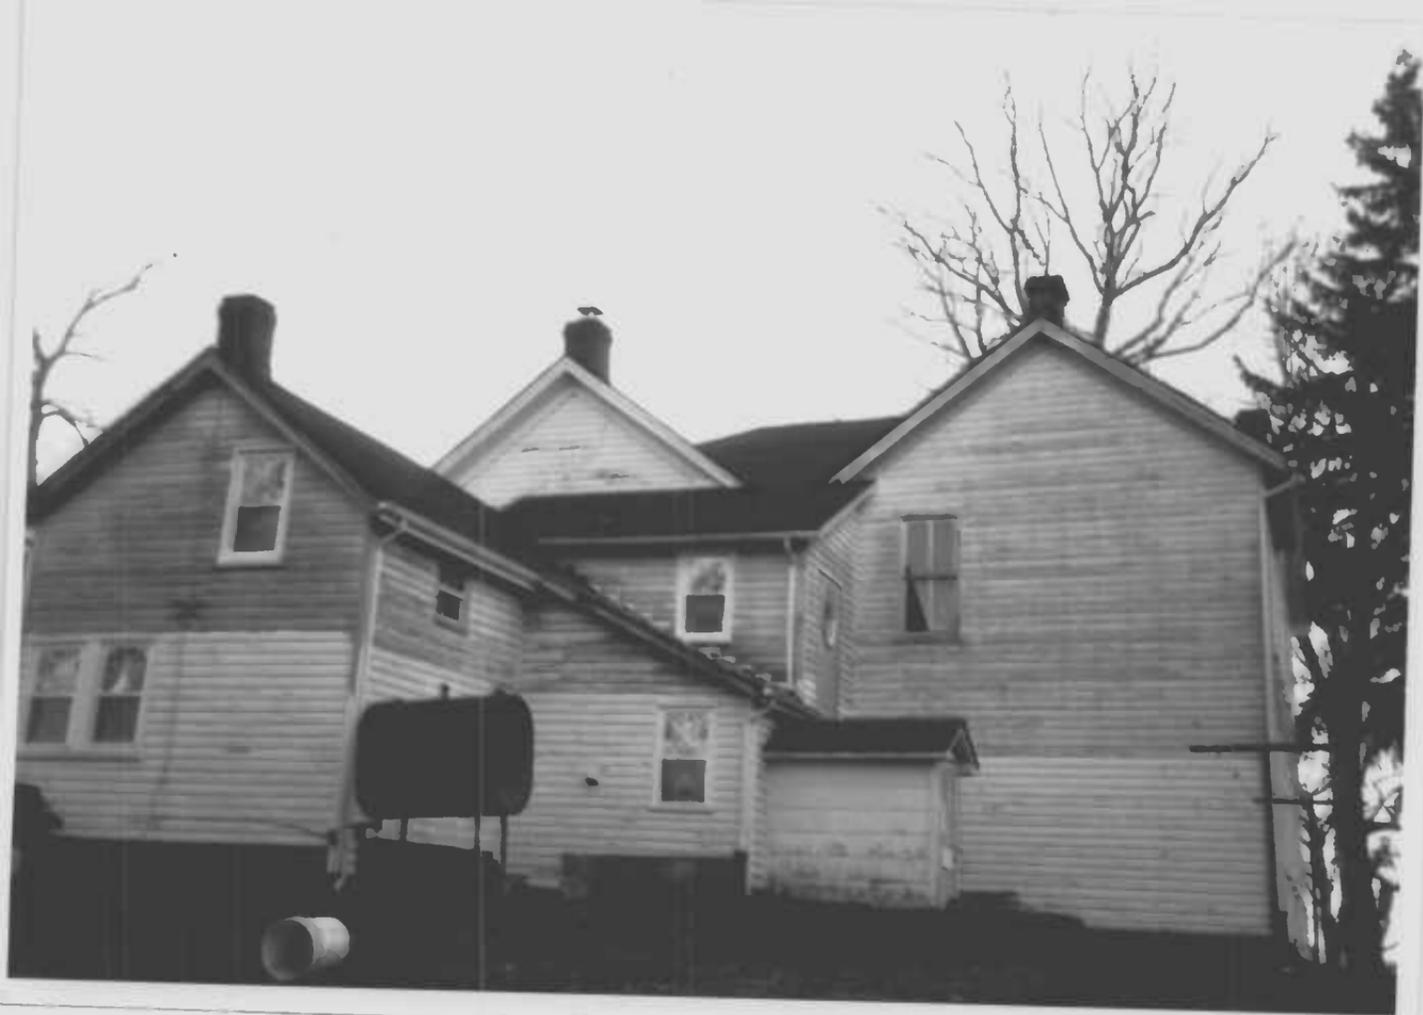
- 1 CH-418
- 2 Mary E Bowling Farm
- 3 Charles County, MD
- 4 Caroline Hall
- 5 January 1997
- 6 MD SHPO
- 7 North elevation, view S
- 8 3 of 11

The north, or rear elevation includes the west, rear wing, the east, rear wing, the 2-story rear addition, and the 1½-story rear addition. The west wing has no fenestration on the first story and one, 2/2 double-hung, wood window on the second story. The east wing has no fenestration. The 2-story addition has one, 1/1 double-hung, vinyl window on the first story and no fenestration on the second story. The 1½-story addition has paired, 1/1 double-hung, vinyl windows on the first story and one, 1/1 double-hung, vinyl window on the second story. A 1-story enclosed entry projects to the west from this addition. It has a metal, gable roof, asbestos siding and a wood-paneled door.

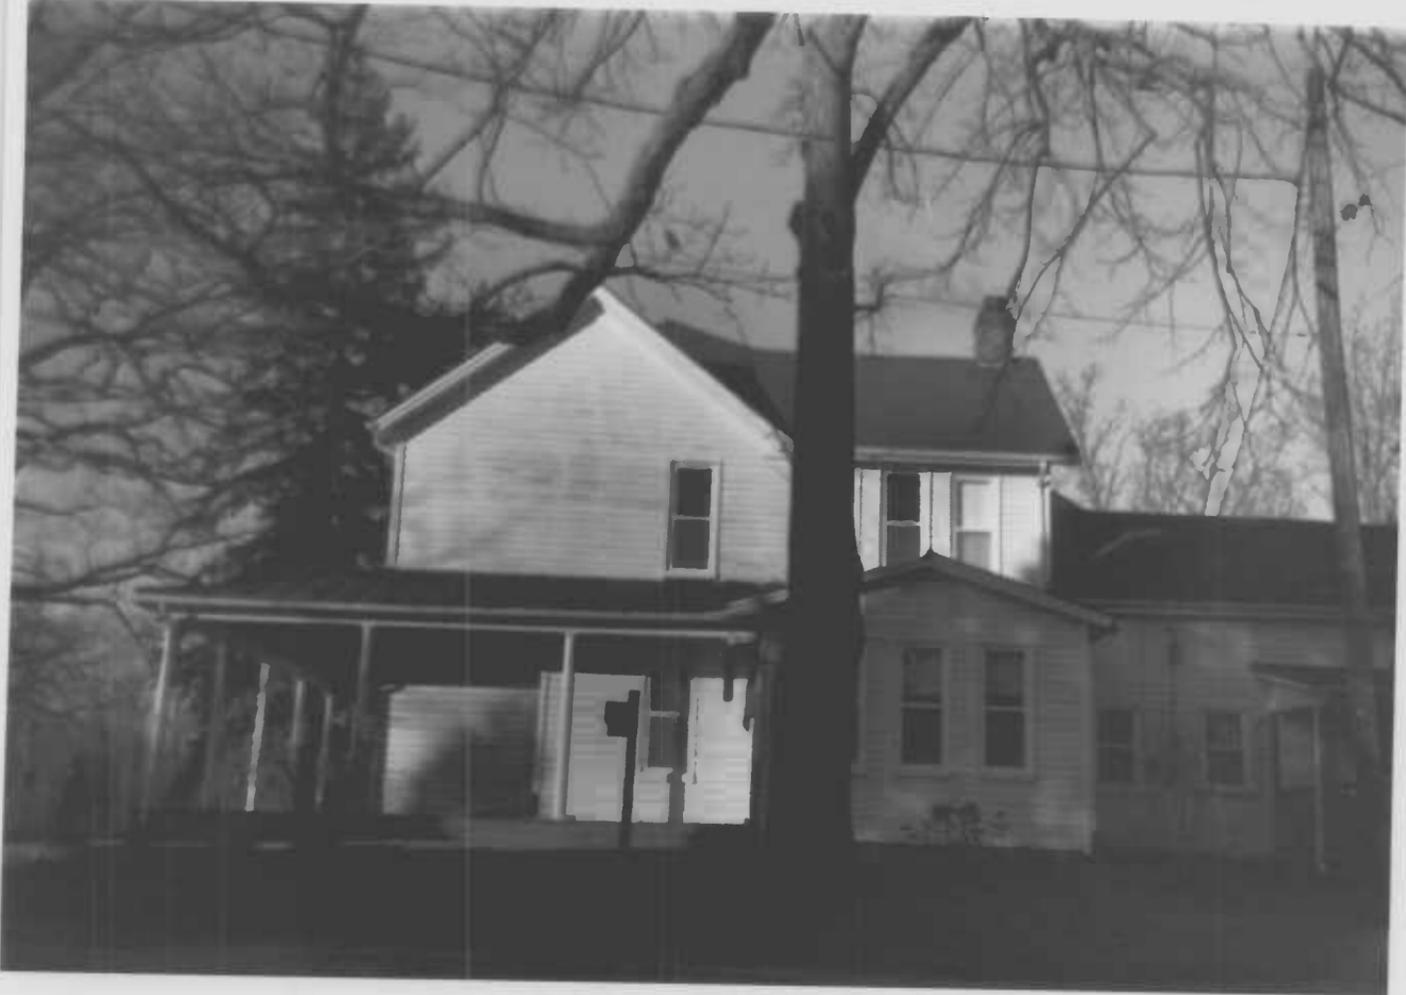
- 1 CTH-414
- 2 Mary E. Bowling Farm
- 3 Charles County, MD
- 4 Caroline Hall
- 5 January 1997
- 6 MD SHPO
- 7 east elevation, view W
- 8 4 of 11

The east elevation includes the main block, the east rear wing, and the 1½-story rear addition. The main block has one, 1/1 double-hung, vinyl window on both the first and second stories. In addition, the first story is covered by the 1-story porch which wraps-around from the front elevation. The east, rear wing has a 1-story, front-gable projection with three, 1/1 double-hung, vinyl windows. The second story of the wing has three, 1/1 double-hung, vinyl windows. The 1½-story rear addition has a 1-story shed-roof porch which projects to the east.

It has a metal roof, modern, wood decking and a modern, wood-lattice railing. In addition, the addition has two, 1/1 double-hung,, vinyl windows and a door on the first story. One, 3/3 double-hung, wood windows are located on the second story and two window openings have been enclosed with siding.

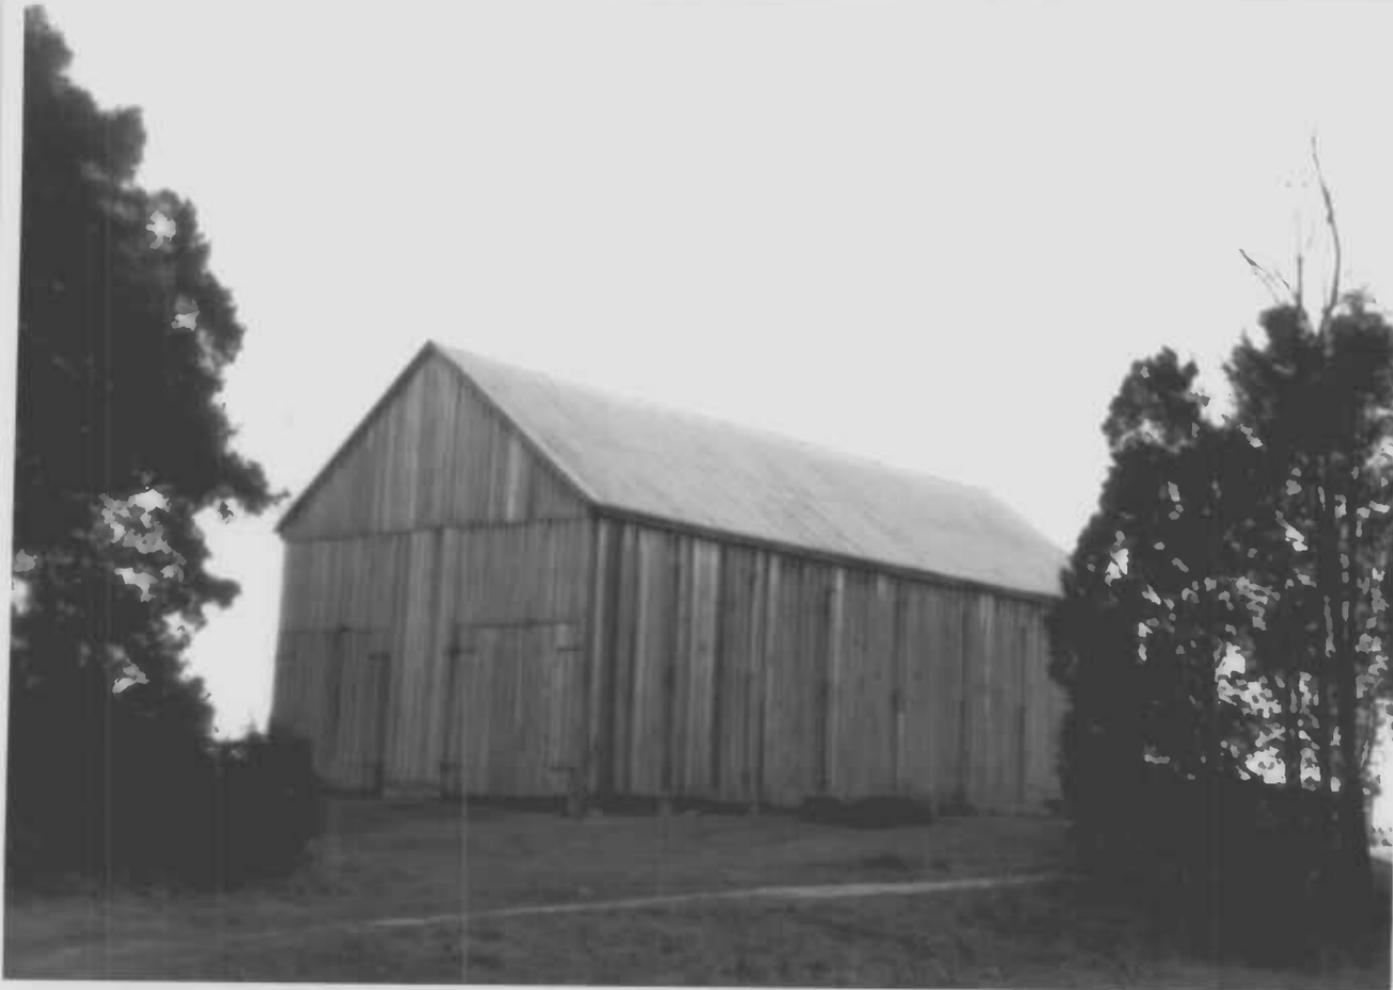
- 1 CH-414
- 2 Mary E. Bowling Farm
- 3 Charles County, MD
- 4 Caroline Hall
- 5 January 1997
- 6 MD SHPO
- 7 Barn 1, view SE
- 8 5 of 11

The fifth outbuilding is a barn with a front-gable, metal roof. This 2½-story structure is supported by concrete piers and has vertical wood siding. Two pairs of hinged, double-doors are located on both the north and south elevations. A 1-story, concrete block addition extends from the east elevation of the barn. The addition has a metal roof and a concrete block chimney. The barn is located southeast of the house, the small barn, and the garage.

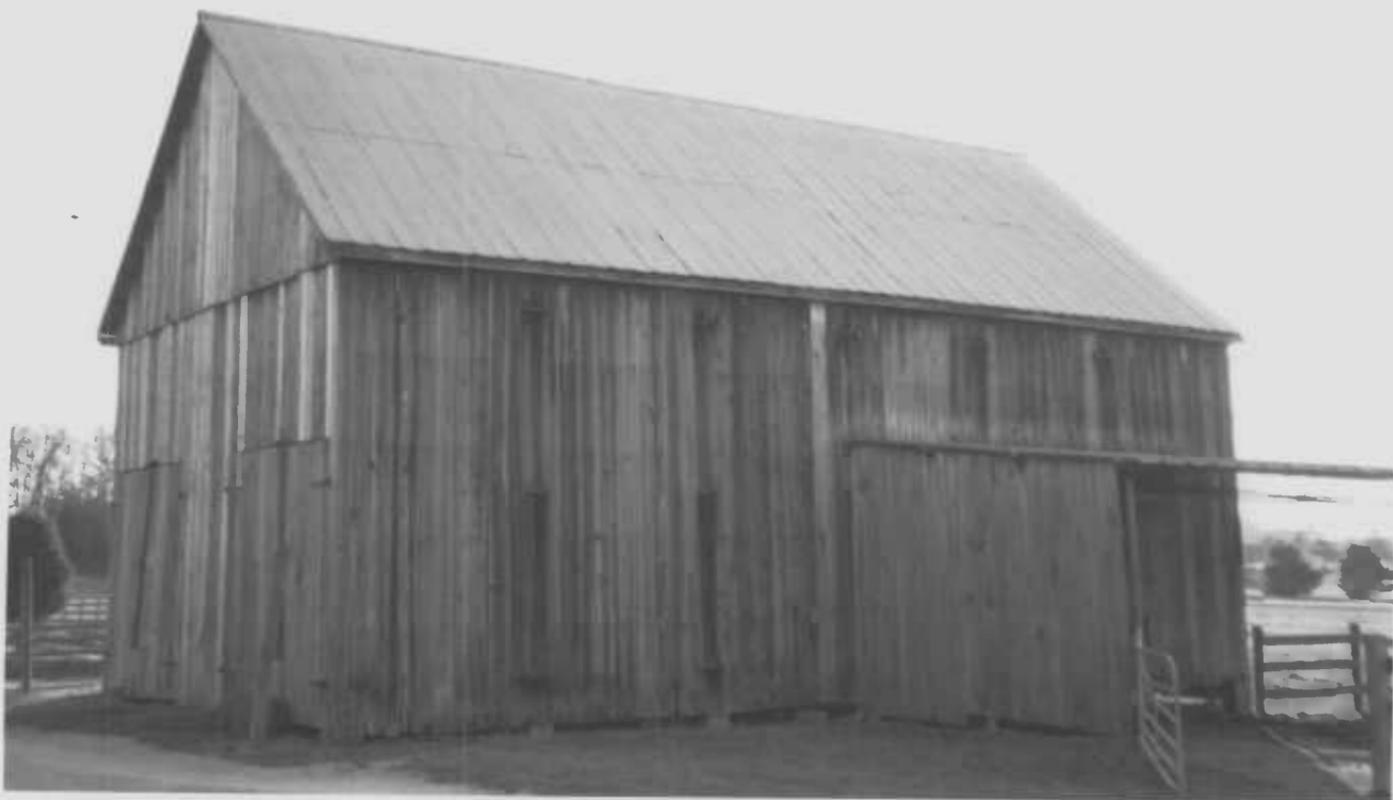
- 1 CH-414
- 2 Mary E Bowling Farm
- 3 Charles County, MD
- 4 Caroline Hall
- 5 January 1997
- 6 MD SHPO
- 7 Barn 2, view SE
- 8 6 of 11

The sixth outbuilding is a third barn. Like the first barn, it is supported by concrete piers and has vertical wood siding. Two pairs of hinged, double-doors are located on both the north and south elevations. The structure is located southeast of the house and the first barn.

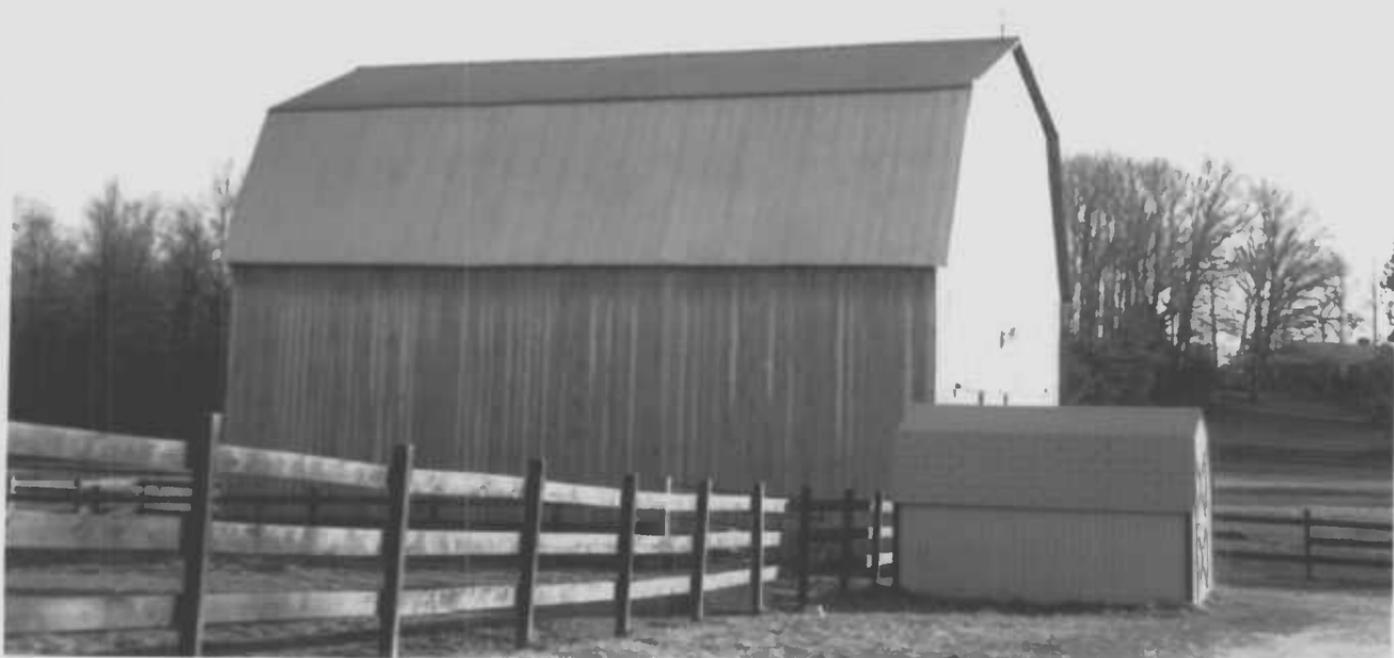
8 7 of 11

7 Barn 3 + Modern Shed 2, view NE

The seventh outbuilding is a fourth barn with a metal, gambrel roof and vertical wood siding. It is supported by concrete piers and sliding wood doors are located on the south elevation. A 1-story addition with a brick chimney, covered with metal sheets, projects from the east elevation. The barn is located southeast of the house, east of the first barn, and northeast of the second barn. According to the property owner, all of the barns were constructed circa 1950.

The eighth outbuilding is a modern, pre-fabricated shed with a gambrel roof. It is located at the southwest corner of the third barn.

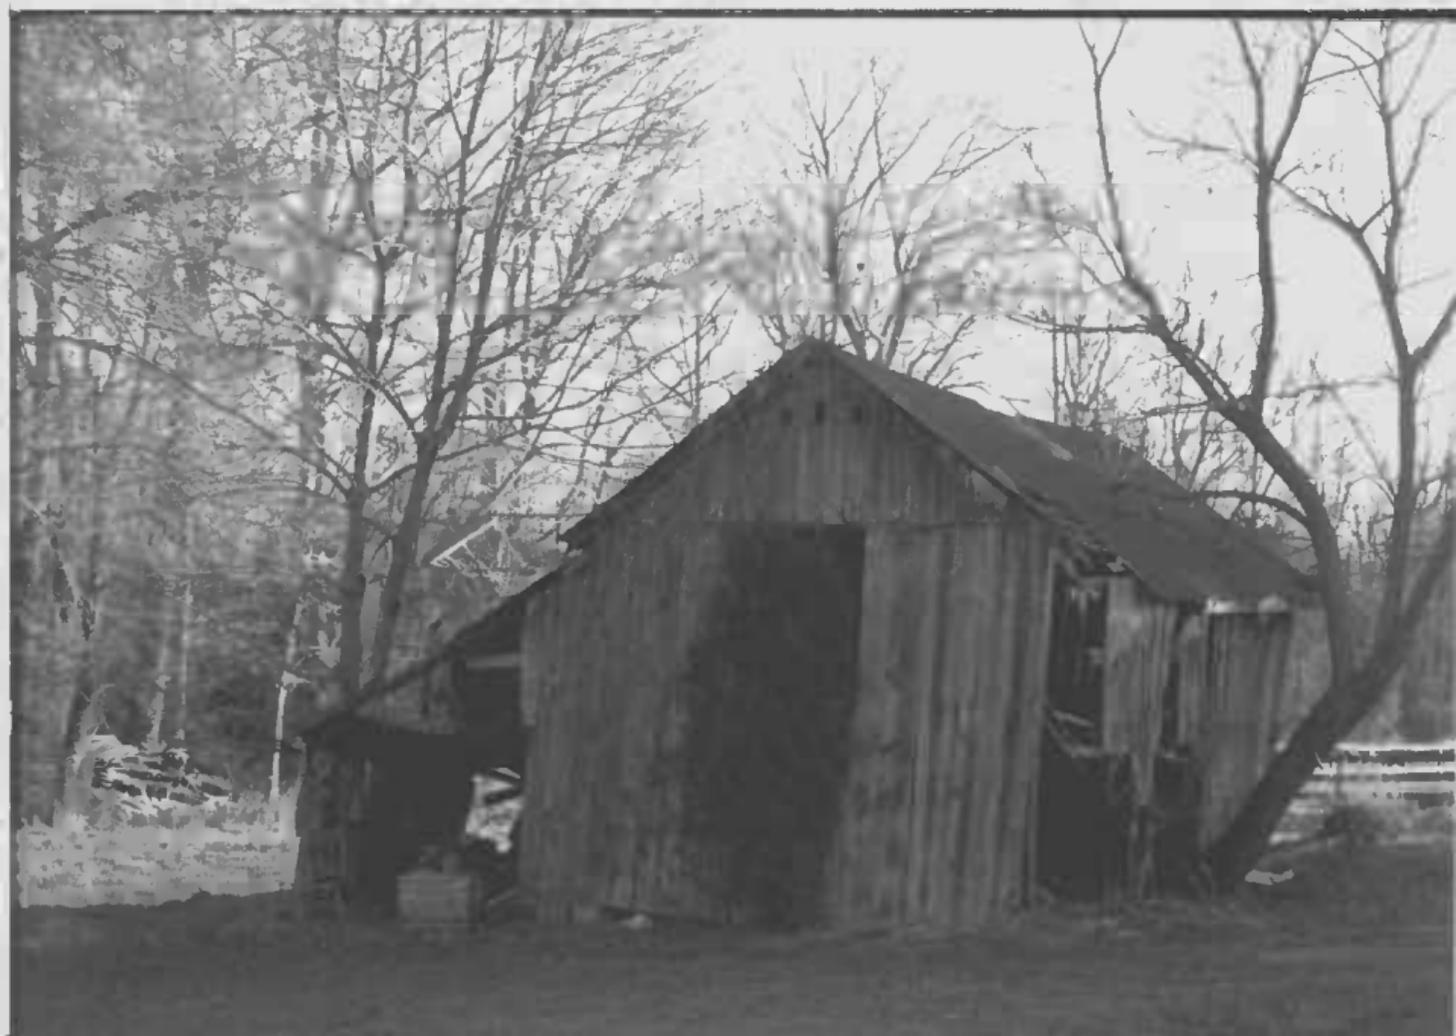
- 1- CH-414
- 2- Mary E Bowling Farm
- 3- Charles County, MD
- 4- Caroline Hall
- 5- January 1997
- 6- MD SHPO
- 7- Small barn, view E
- 8- 8 of 11

The third outbuilding is a small, 1½-story barn with a 1-story, shed roof extension to the north. It has a metal, gable roof and vertical wood siding. Located east of the house, and southeast of the garage, the structure is severely deteriorated. The fourth outbuilding is a modern wood playhouse. It is located east of the house, southwest of the small barn and south of the garage.

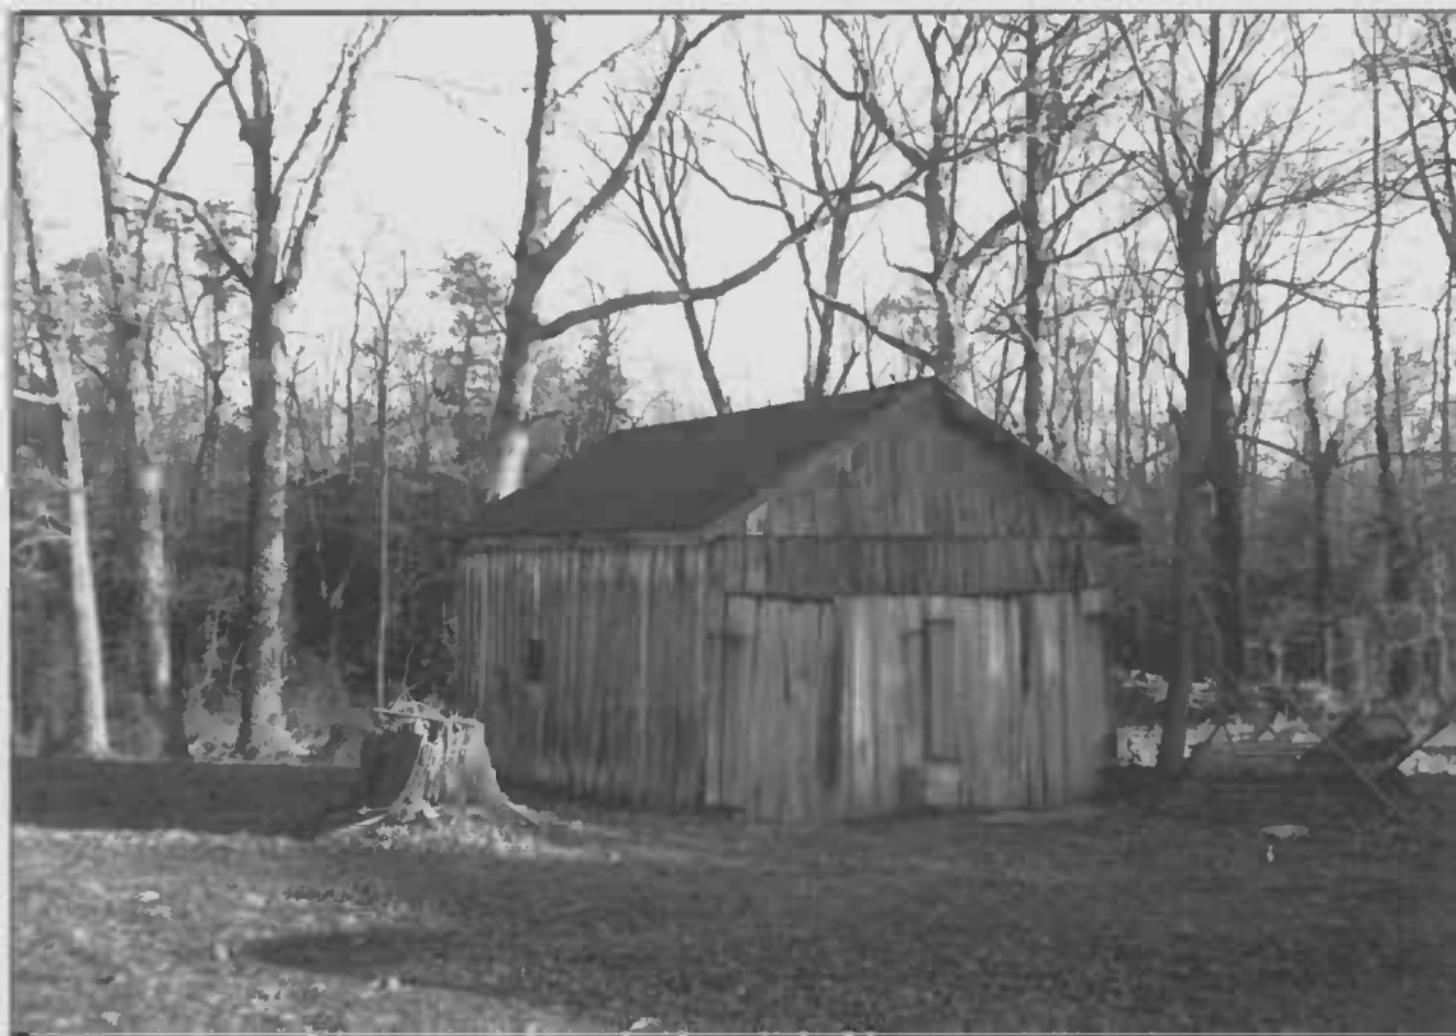
8- 9 of 11

7- Garage, near NE

The Bowling Farm includes eight associated outbuildings. The first outbuilding is a modern pre-fabricated shed with a gambrel roof. It is located northeast of the house. The second outbuilding is a 1-story garage located northeast of the house and east of the modern shed. It has a front-gable, metal roof and vertical wood siding. Hinged, wood double-doors are located on the south elevation.

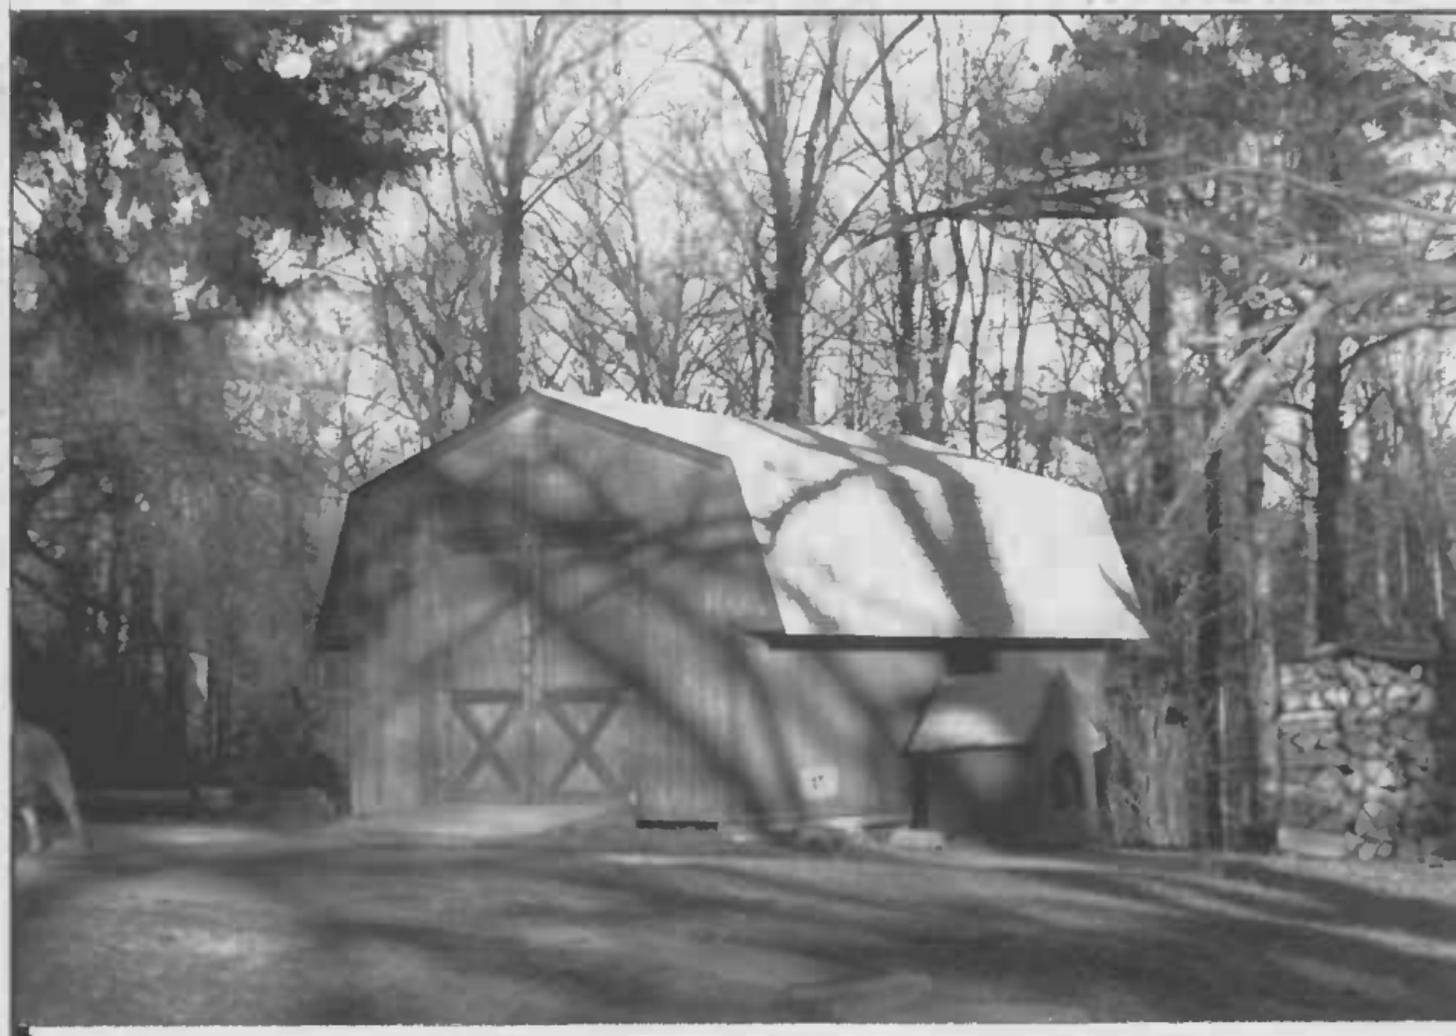
- 1- CH-44
- 2- Mary E Bowling Farm
- 3- Charles County, MD
- 4- Caroline Hall
- 5- January 1997
- 6- MD SHPO
- 7- Modern Shed 1, view NW
- 8- 10 of 11

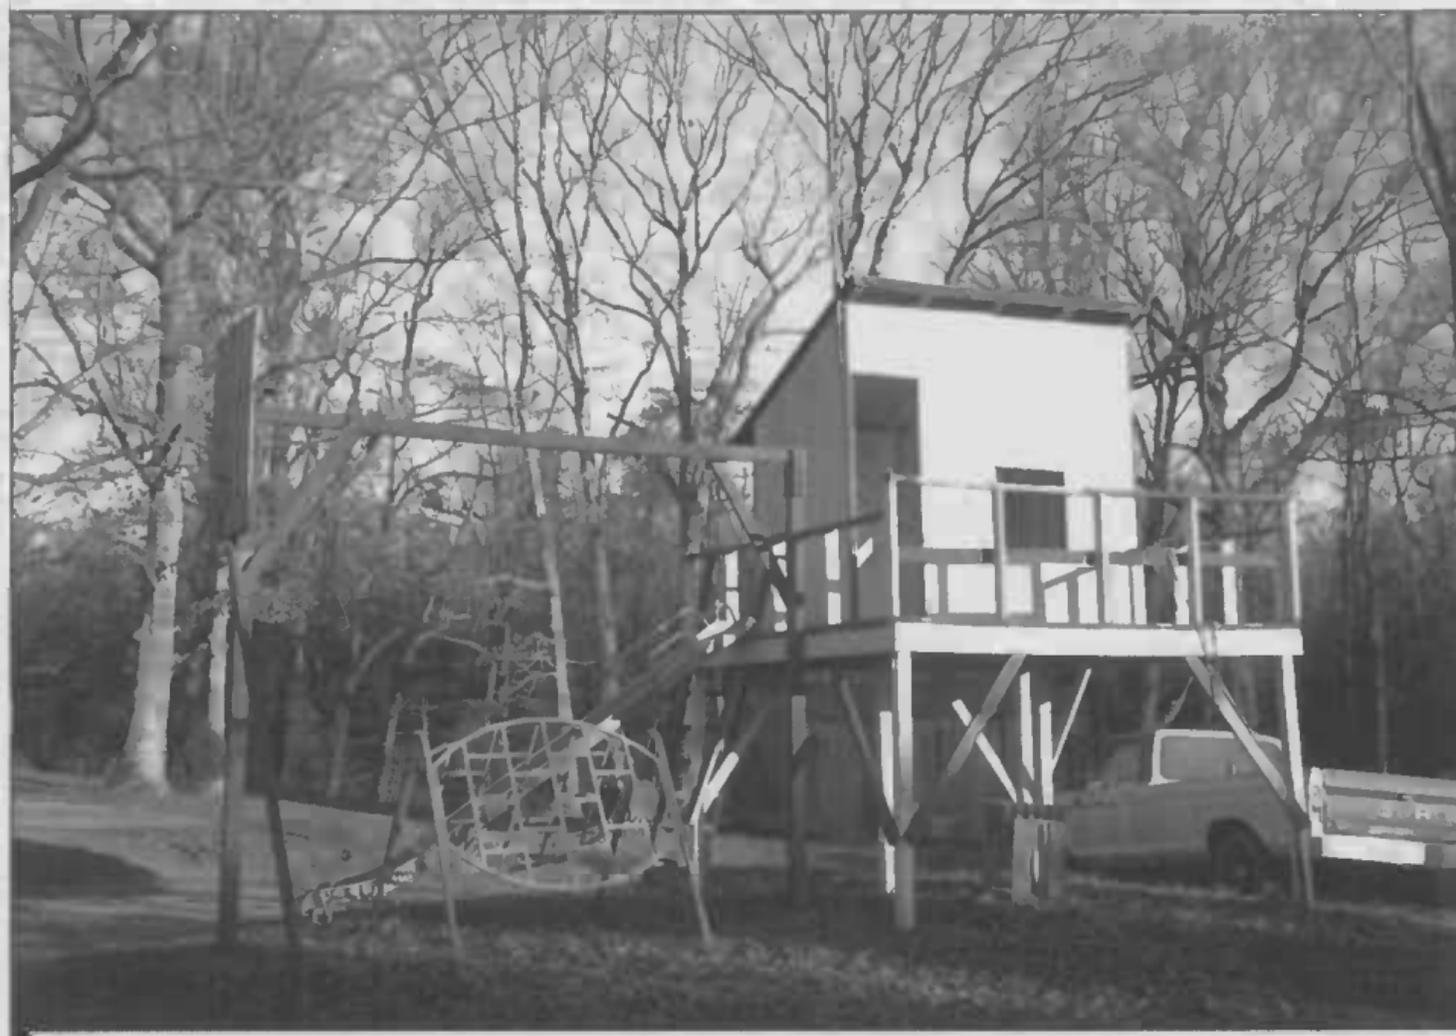
- 1- CH-414
- 2- Mary & Bentley farm
- 3- Charles County, MD
- 4- Caroline Hall
- 5- January 1997
- 6- MD SHPO
- 7- Playhouse, view NE
- 8- 11 of 11
