CT-44

LITTLE COVE FARM

INVENTORY FORM FOR STATE HISTORIC SITES SURVEY

**NATIONAL REGISTER OF HISTORIC PLACES
INVENTORY -- NOMINATION FORM**

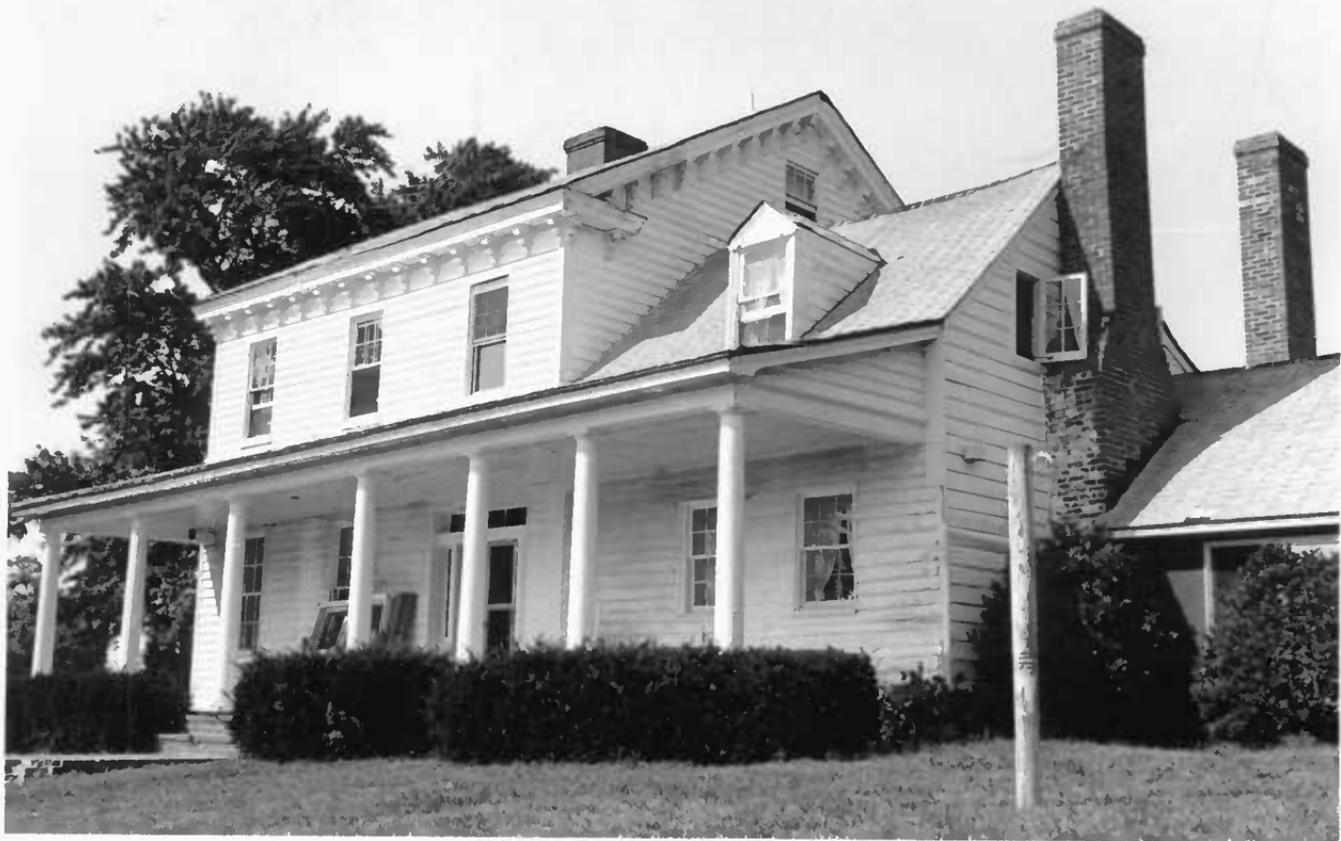
CT - 44
LITTLE COVE FARM
S.

What is presumed to be the main entrance to this house is on the southwest (towards river) side. Large double doors are framed by a transom with sidelights. These are filled with rose colored glass which creates a specific mood, especially towards the end of the day. These doors and the single door at the opposite end of the hall (north) have an obvious advantage in the summer.

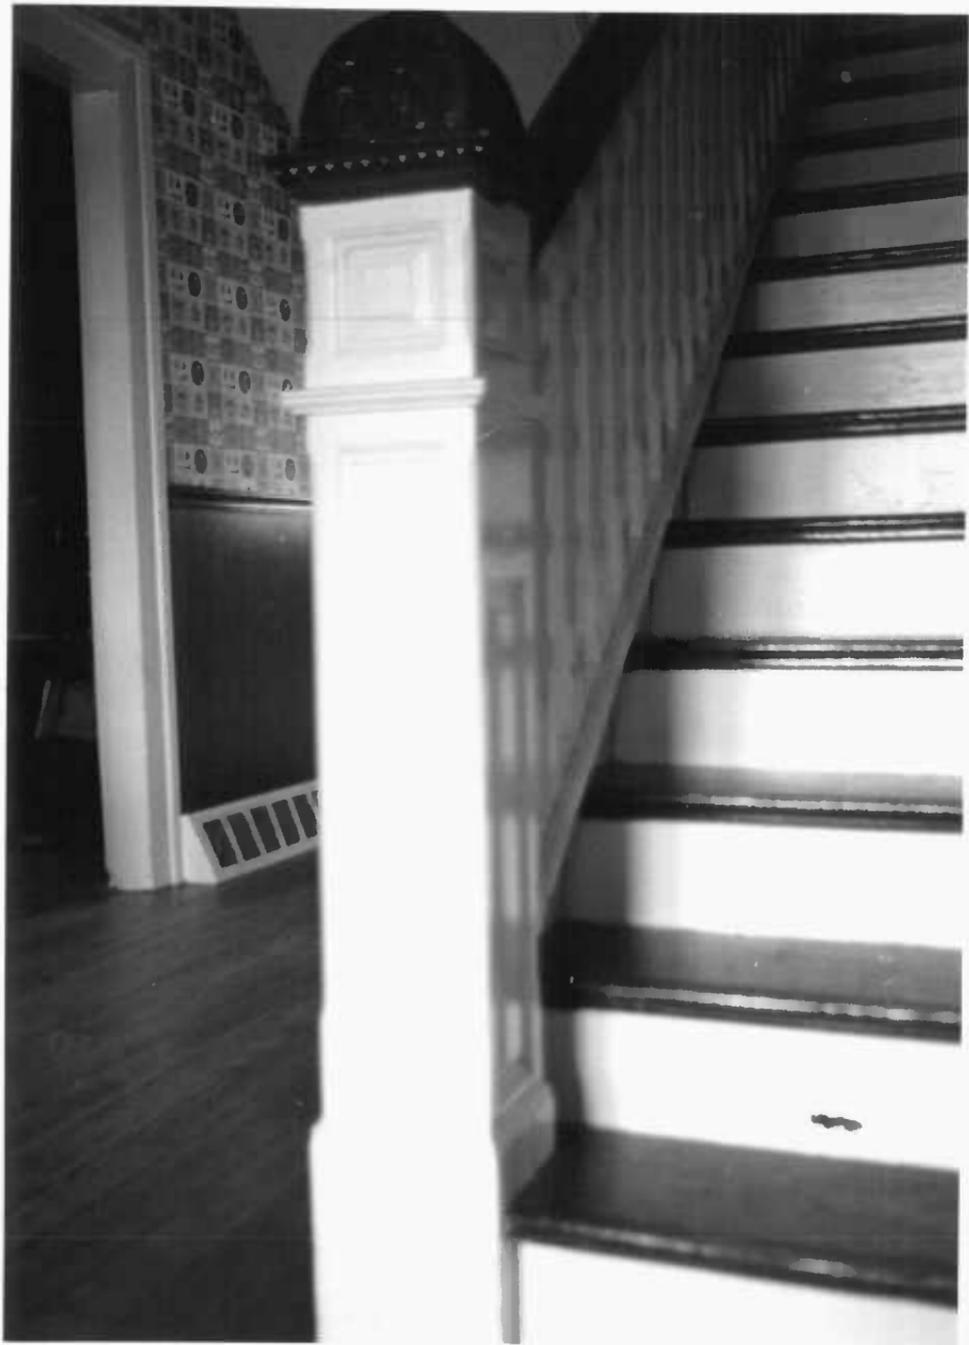
CT-44
LITTLE COVE FARM
INT. OF HALL

The portion of this house which literally and figuratively brings the east and west wings together is the hall. In many ways, it is the most architecturally expressive "room" of all. It features a grand staircase and entrances on opposite ends. One enters the old and the newer portions of the house by opposite side doors. The stairs have a panelled enclosure which contains a storage space. It is made nearly elegant by a newel post with an ornate oak cap that suggests the second Empire by its rounded Mansard Shape. These stairs serve all three levels where there are a total of four bedrooms. All but one of these has its own fireplace.
