INVENTORY FORM FOR STATE HISTORIC SITES SURVEY

John P. Williams Barn

Edgar Cranford Barn and Tenant House

Broomes Island Road (Maryland Route 264)

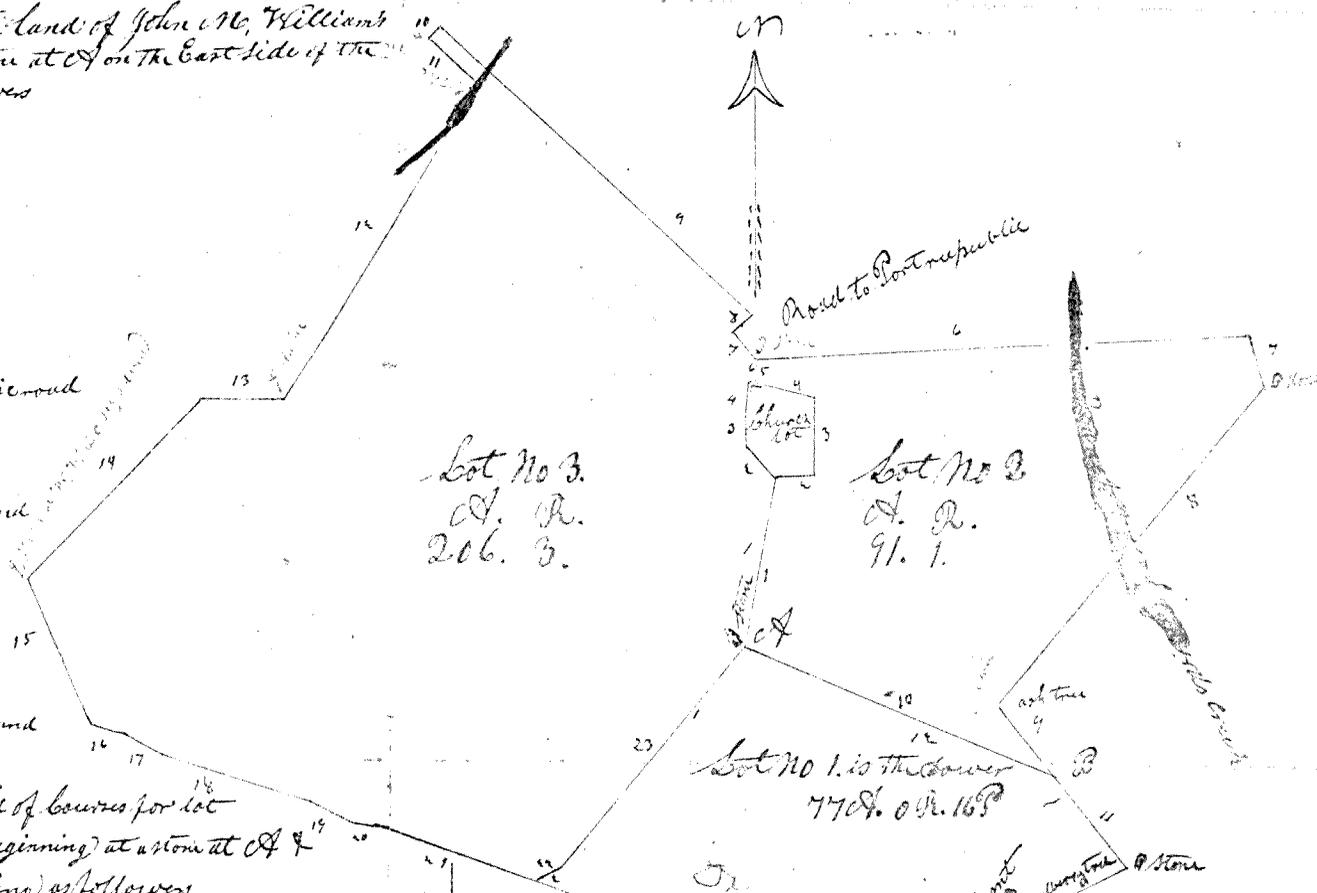
Plat # 5

- 1 N 10 E 54 1/2 to the church lot
- 2 N 39 E 12
- 3 N 1/2 E 24
- 4 N 73 W 11
- 5 N 15 E 7 1/4 to a stone east side public road
- 6 N 28 1/4 E 15 1/2
- 7 S 13 1/2 E 17 1/2 to a stone boundary of the land of J. Talbot & Perry of Mrs. Williams's
- 8 S 41 1/2 W 133 to a marked ash
- 9 S 28 1/4 E 28 1/4 to the divisional line at B
- 10 N W to the beginning at A containing 91 A. 2 R
