CT-296

Fannie Gibson House

Lower Marlboro

INVENTORY FORM FOR STATE HISTORIC SITES SURVEY

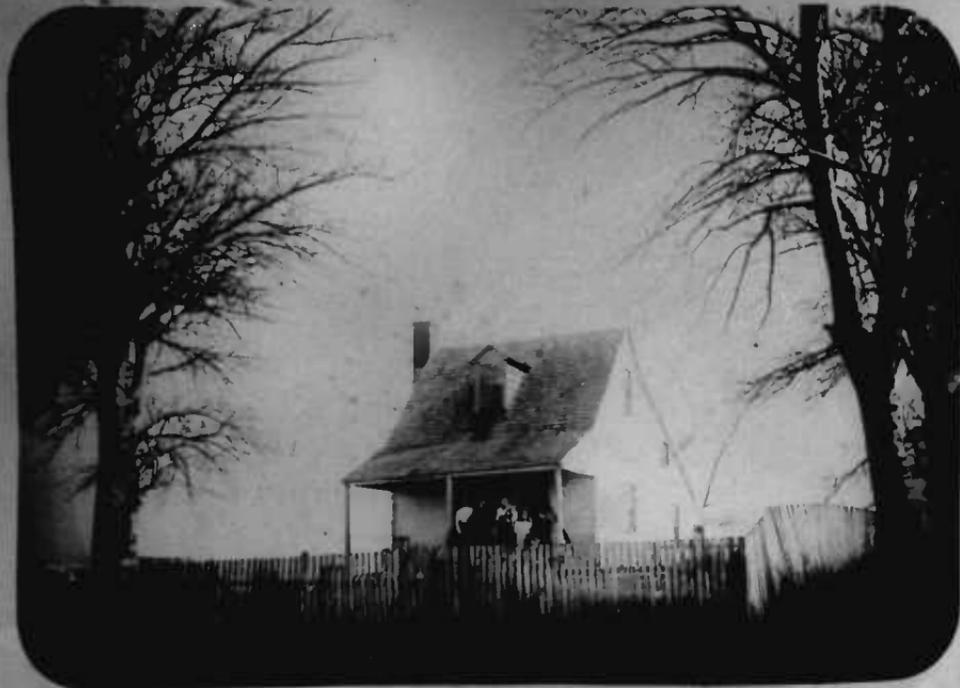
CT-296

Fannie Gibson Hs.
(from old photo)

SW

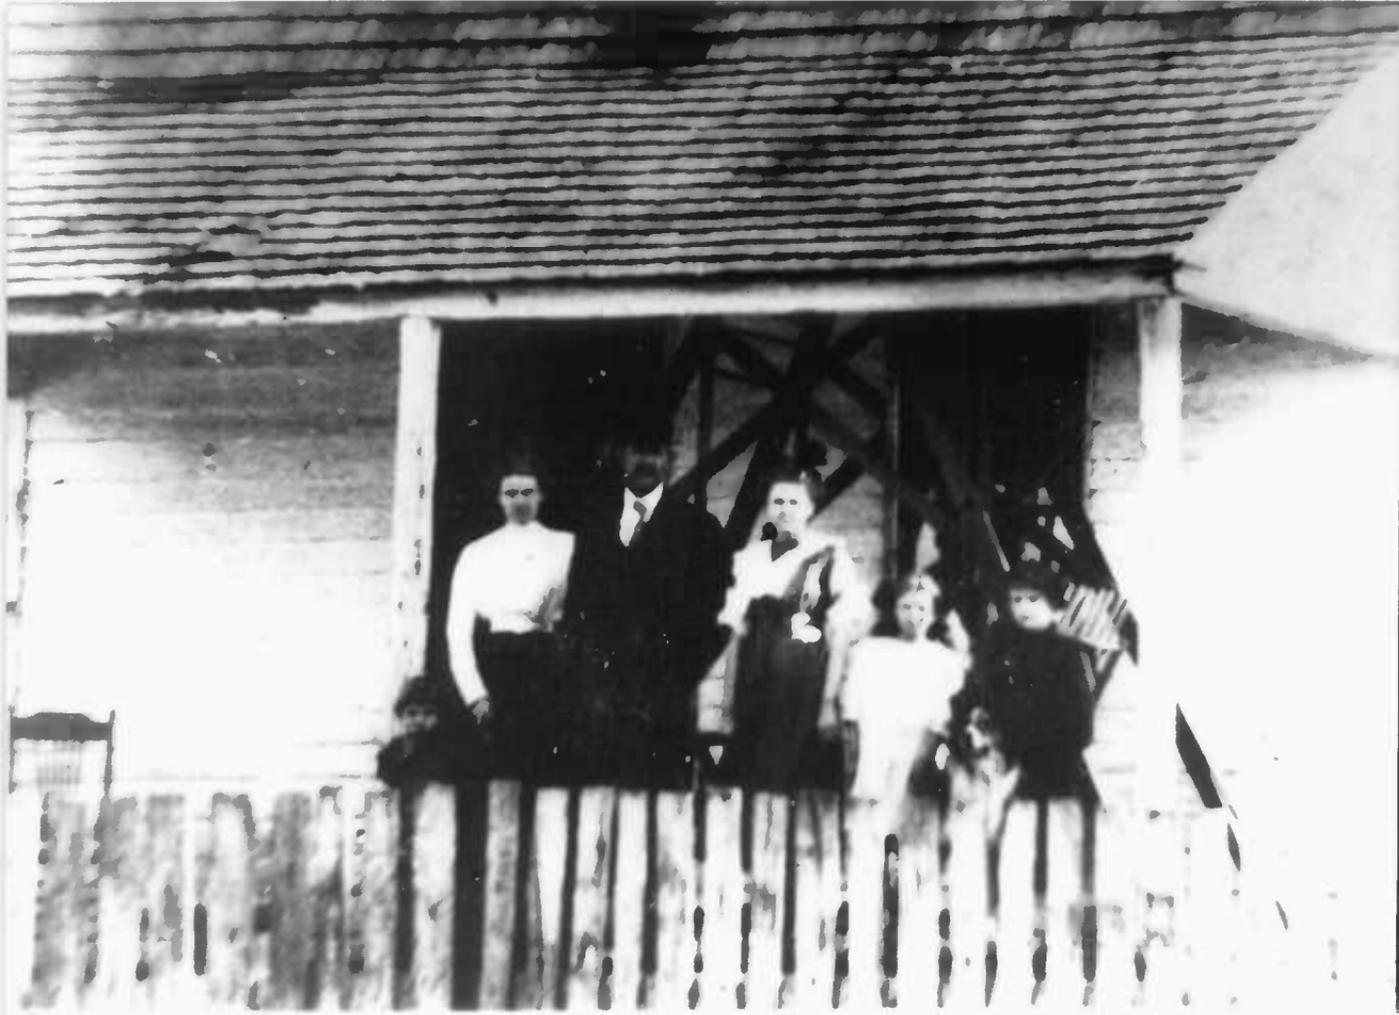
CT-296
Fannie Gibson House
(from old photo)

Although this appears to be a simple early 20th century frame house, an extant photograph shows the building's original appearance as a one-room, one-story cottage with a rear shed addition. Later another section was added to the south, and finally all three parts were raised to two full stories early in this century. The original rear addition sits over a stone cellar. The late 19th century photograph shows an exterior chimney and a single dormer. A picket fence surrounds the house, whose front porch shelters five people with their dog. An enormous contraption supporting a set of swings takes up most of the porch.

Although this appears to be a simple early 20th century frame house, an extant photograph shows the building's original appearance as a one-room, one-story cottage with a rear shed addition. Later another section was added to the south, and finally all three parts were raised to two full stories early in this century. The original rear addition sits over a stone cellar. The late 19th century photograph shows an exterior chimney and a single dormer. A picket fence surrounds the house, whose front porch shelters six people with their dog. An enormous contraption supporting a set of swings takes up most of the porch.

The original house was heated by a large exterior chimney at the north gable end. On the front elevation, a door occupied the north bay while a 9/6 sash window lit the south bay. This house comprised the north parlor and the stair hall of the present house. The south addition's interior chimney at the south end, visible in the attic, retains metal flashing for the gable of a 1 or 1½ story house.
