CAPSULE SUMMARY - GRACE BARN 'A' (CT-1081)

Maryland Historical Trust State Historic Sites Inventory Form

and/or common Grace Barn

Survey No. CT-1081

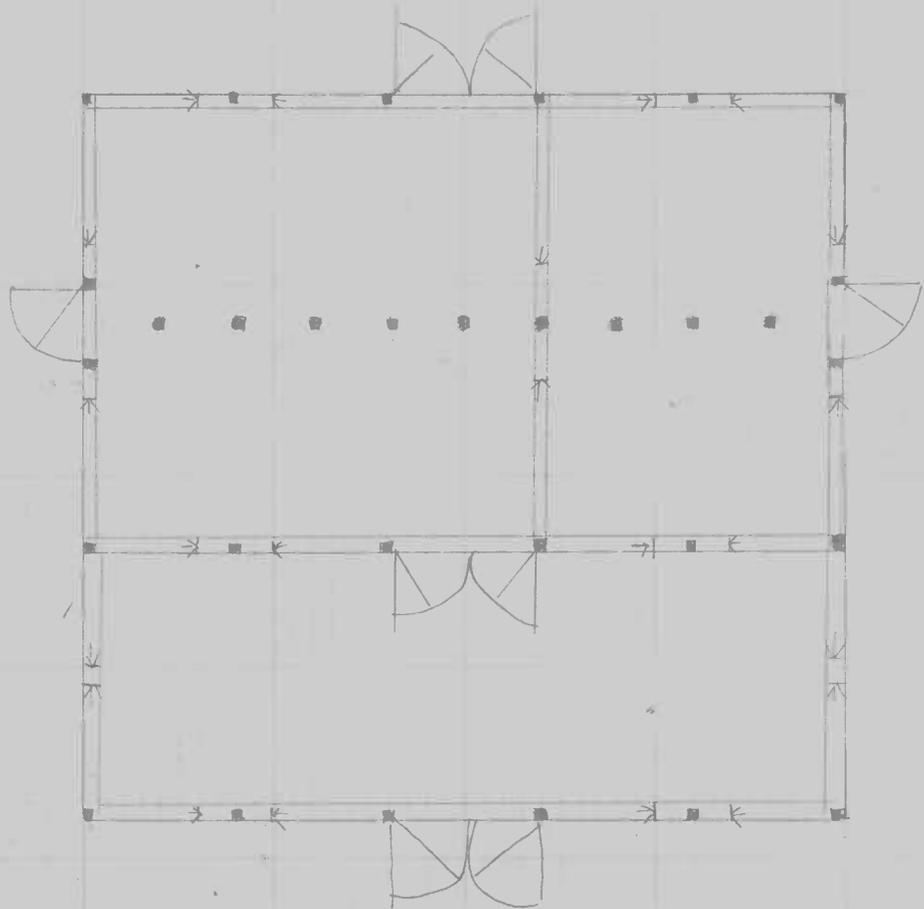
BARN # 2054 4/6/90 GRAPE BARN
CT-1081

There are double doors on the east and west sides, and four foot wide doors on the north and south. The barn frame is supported on concrete block masonry piers. Each of the bays measure eight feet. The posts are circular sawn, nailed with wire nails, and joined via mortise and tenon joints. The down braces, nailers, and other timbers are circular sawn, mortised, and nailed with wire and fully mature machine cut nails. A cross-sill divides and supports the frame. Widely spaced vertical wall siding with hinged ventilation doors covers the exterior. Some of the siding is original and is attached with fully mature machine cut nails. The west side of the roof has no shingle nailers and is covered with corrugated metal. The east side of the roof has shingle nailers underneath the corrugated metal. The roof rafters are on four foot centers and rest on a flat false plate. There are windbraces on each diagonal and three collars that support the roof. The tier poles are peeled logs separated by forty one and one-half inches vertical distance. The posts down the center, separated by four feet, are circular sawn. Tobacco is still hanging in the barn, and the circular wooden forms used to press tobacco lie on the barn's dirt floor.

There is a fourteen foot wide shed on the east side of the barn. It is divided into eight foot bays, the same as the barn. The frame of the shed is built of circular sawn lumber and wire nails. There are no fully mature machine cut nails visible in the shed, therefore it appears that it was added after the use of wire nails became common (post 1882). The siding on the shed is vertical and has hinged ventilation doors. Wide spaces are left between the boards of the siding. Shingle nailers are visible underneath the corrugated metal roof of the shed.

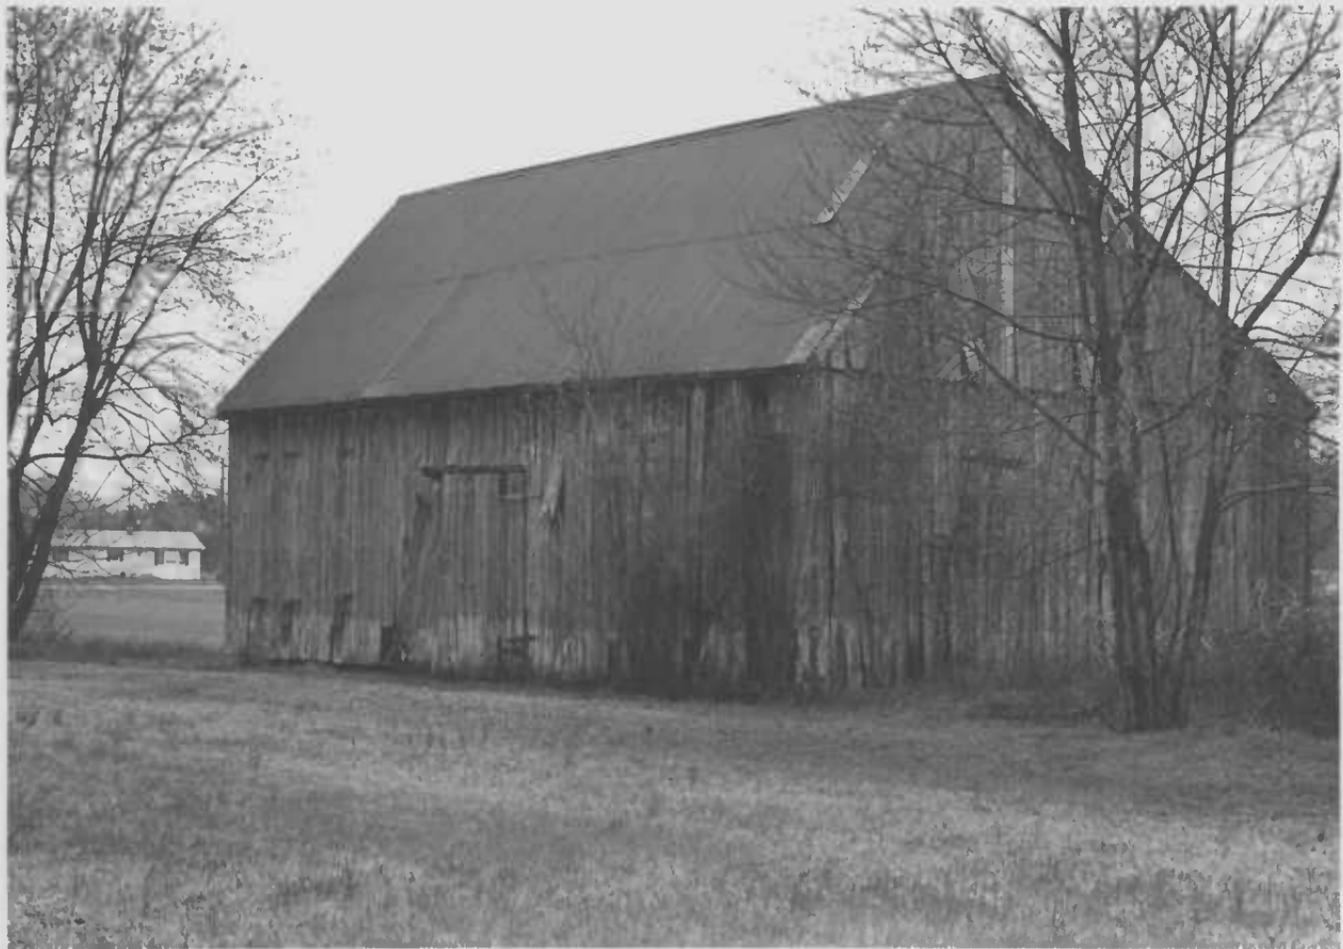
CT - 1081

Grace Barn A

Southwest
