CAPSULE SUMMARY CT-1144

Survey No. CT-1144

and/or common Norfolk Barn C

7. DESCRIPTION CT-1144

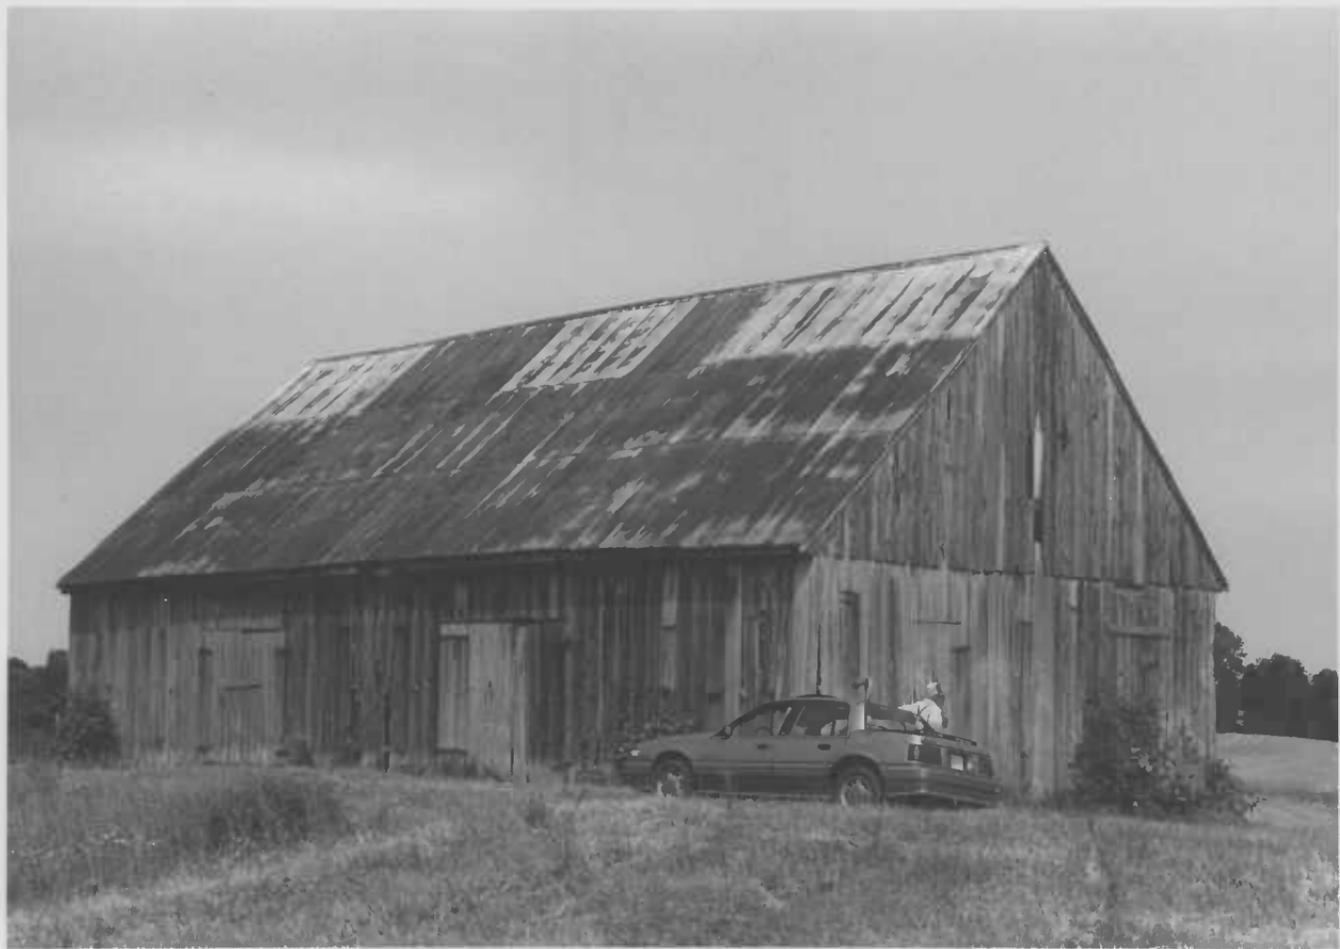
NORFOLK BARN C

SOUTHEAST
