SM-7A
SOTTERLEY FIELD HAND'S QUARTER
Hollywood
Private, open to the public

MARYLAND INVENTORY OF
HISTORIC PROPERTIES

Survey No. SM-7A

and/or common Slave House at Sotterley

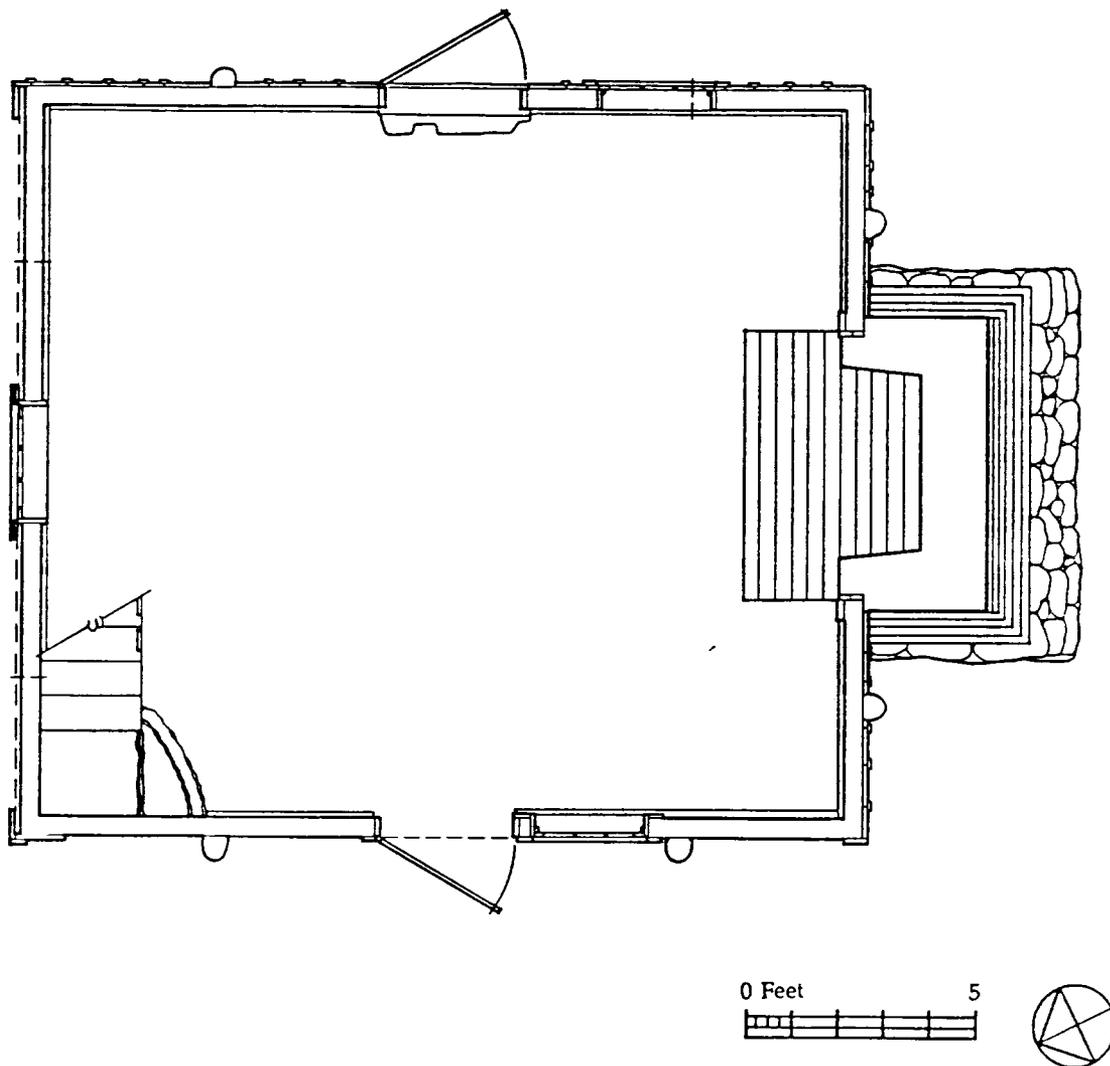
fig. 8. First-floor plan. This and subsequent drawings are by Jeffrey Bostetter, Colonial Williamsburg Foundation.

The interior consists of one room with a hearth located at the south end and a stair in the northwest corner. Headroom in the first-floor room is now 6'8". The main floor was originally clay, although a wood floor was added in the early twentieth century and later removed. Around 1950, the clay floor was brought up nearly to the top of the sills.

The brick around the firebox is exposed and an iron lintel supports ordinary bricks laid as a flat arch above the opening. The opening measures 4'1" wide, 1'10" deep, and 3'6" high. An iron trammel bar in the flue suggests that the fireplace was intended for work, including cooking, as well as heating, and there is no visible evidence for the fireplace being converted for use with a stove. A mantel shelf supported by curved brackets surmounts the fireplace opening.

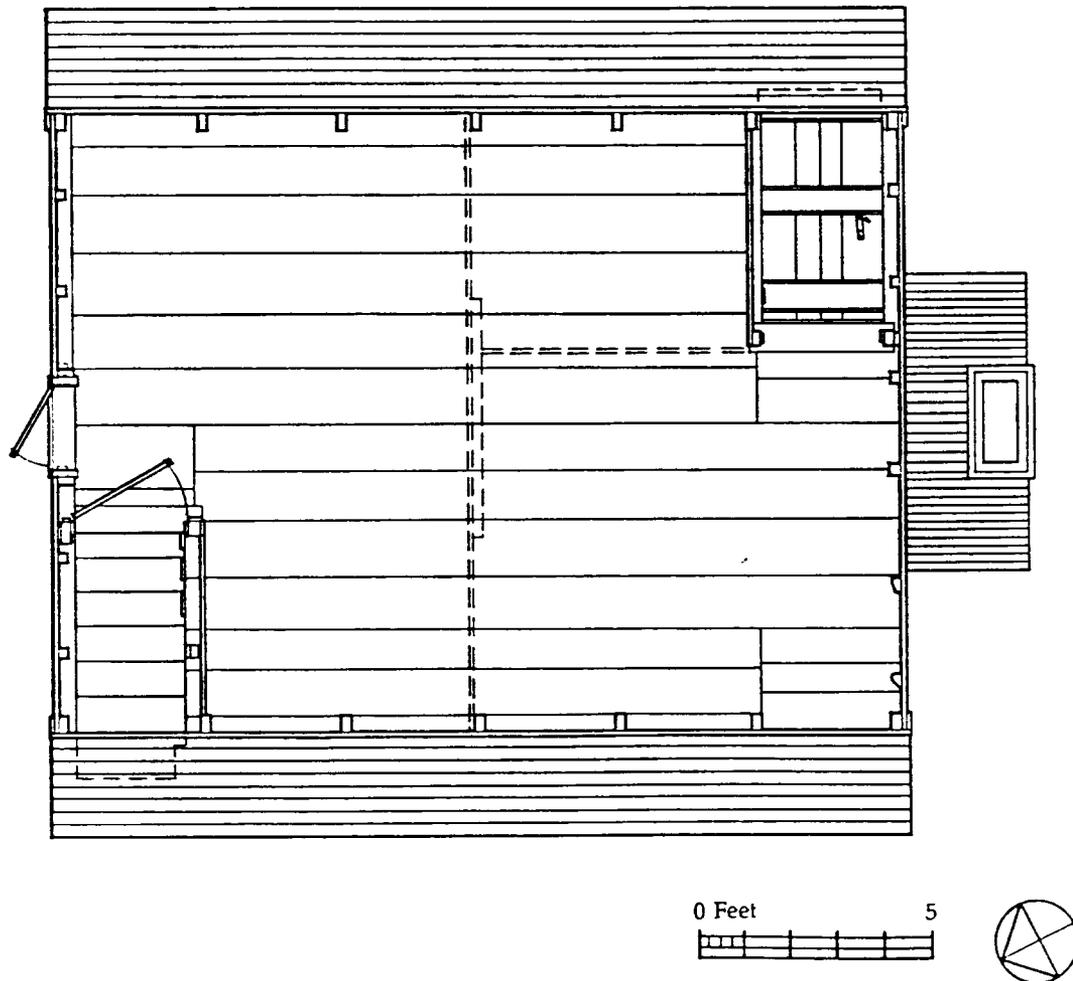
fig. 9. Attic plan.

The attic was left unfinished, with rafters, roof collars, and shingle lath exposed. Where the stair formerly rose to the southeast corner of the loft, there is an enclosure which was created by nailing rough, unplaned boards to the side and top of a door frame hung with a board-and-batten leaf on cast-iron butt hinges. Once the old stair was torn out, the original stair enclosure was converted for use as a doorless closet. A hole drilled in the side of the stair at collar height may indicate that a cloth was hung along the back (east) slope to separate a small space there for privacy or storage. Like the old stair, the new stair was enclosed with a similar box constructed of thin, rough boards and hung with a door of the same character. A partition of similar thin, rough boards was built to separate two attic spaces, presumably to create two separate bedrooms upstairs.

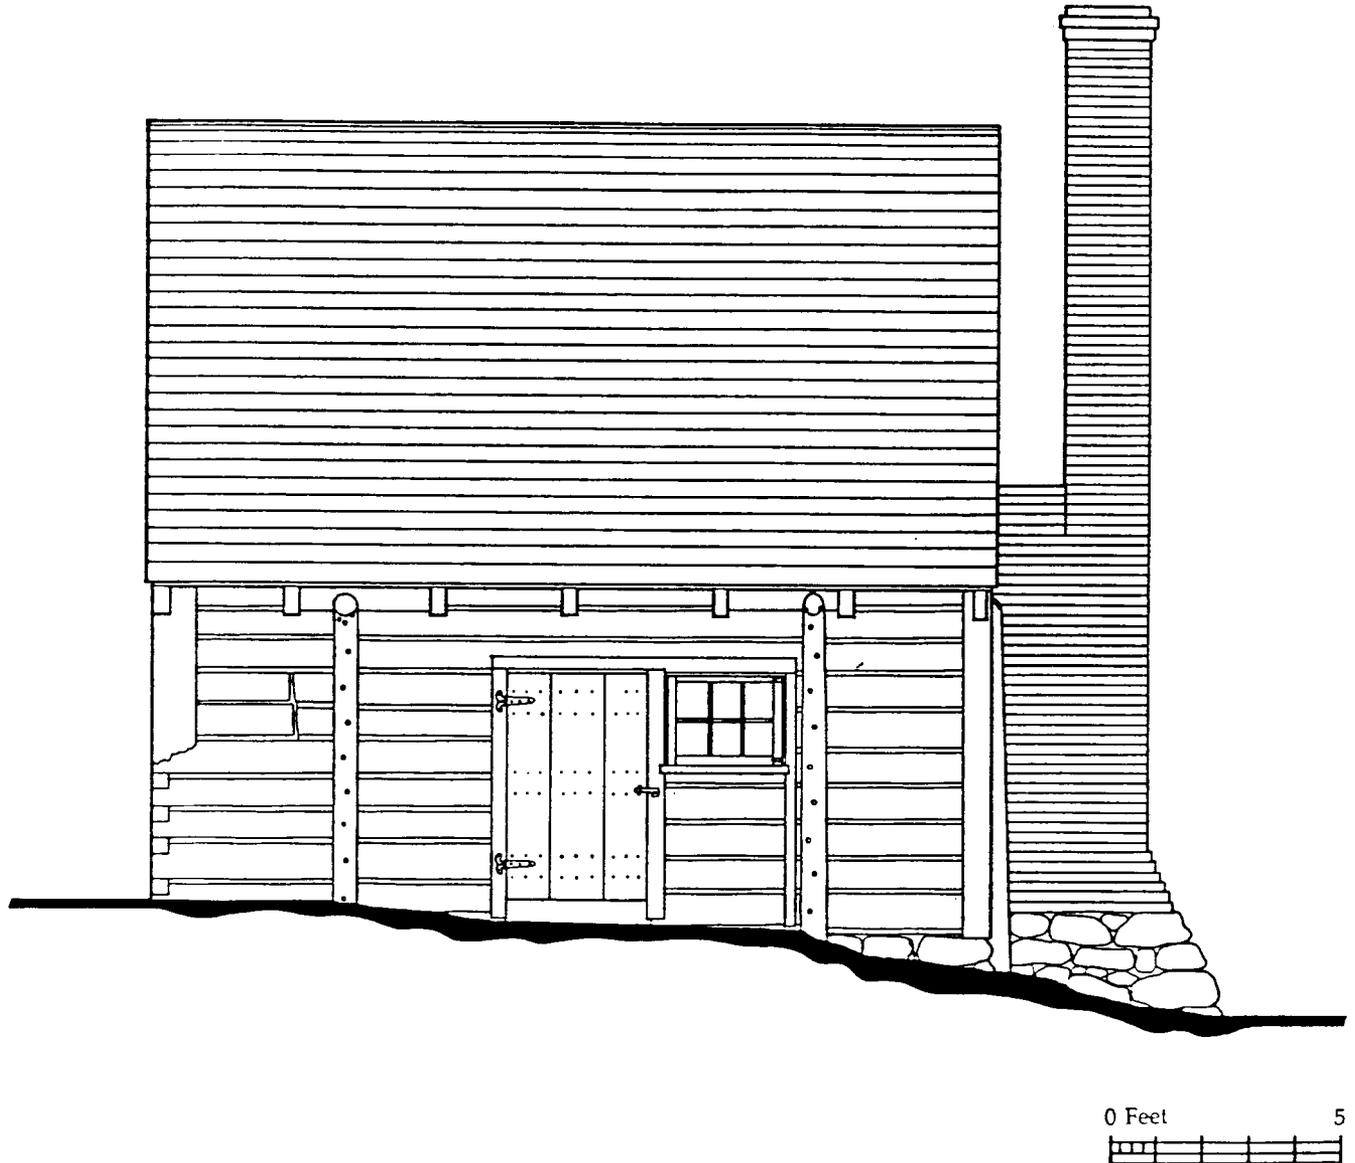
fig. 10. Front (west) elevation.

The west (main) elevation is pierced by a central entrance door measuring 5' X 2'11." The door swings out rather than into the room. The remnants of leather door hinges remain visible. There is an interior wall pocket for the door's original slide bar. Posts which serve as door jambs have been pegged into the ends of the logs where the door opening was cut. A six-light casement window abuts the southern door jamb. Originally shuttered, the plank shutter for this window has been removed and is stored on the interior of the building. The window, like all of those on the first floor, is finished

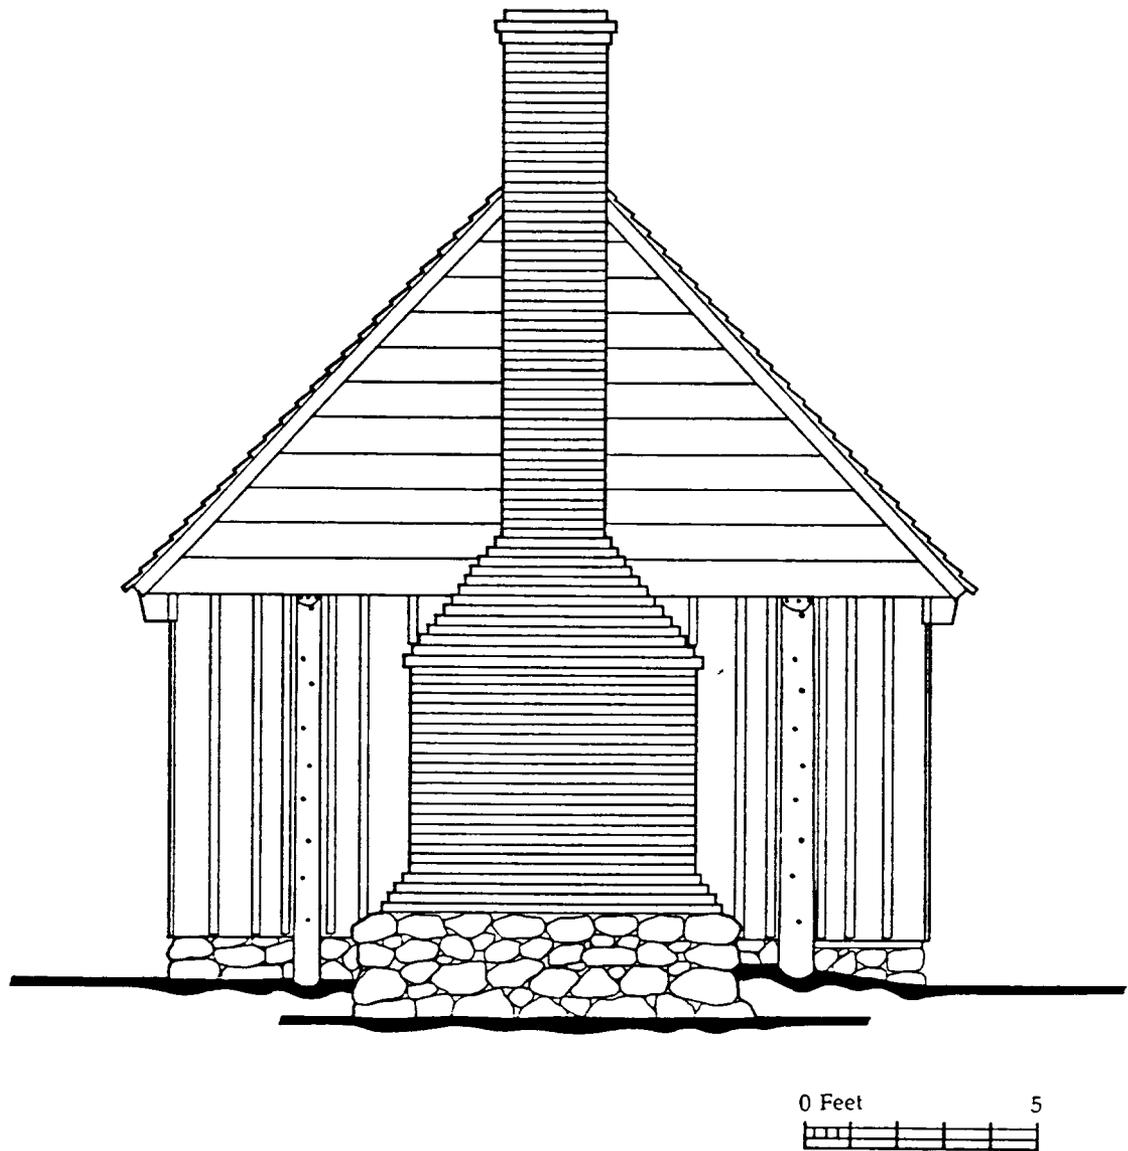
fig. 11. Right (south) elevation.

The first floor of the south elevation is blind. An exterior brick chimney with a field stone base stands against this gable end wall. The brickwork consists of hard-fired red brick laid in four- and five-course American bond with lime mortar in joints that taper back at their base. The brickwork steps out at the base and sits on a wide and rough platform of unworked brown sandstone intended to prevent the chimney from falling down the steep hillside to the south. The brick stack rises free of the gable since there is no attic fireplace.

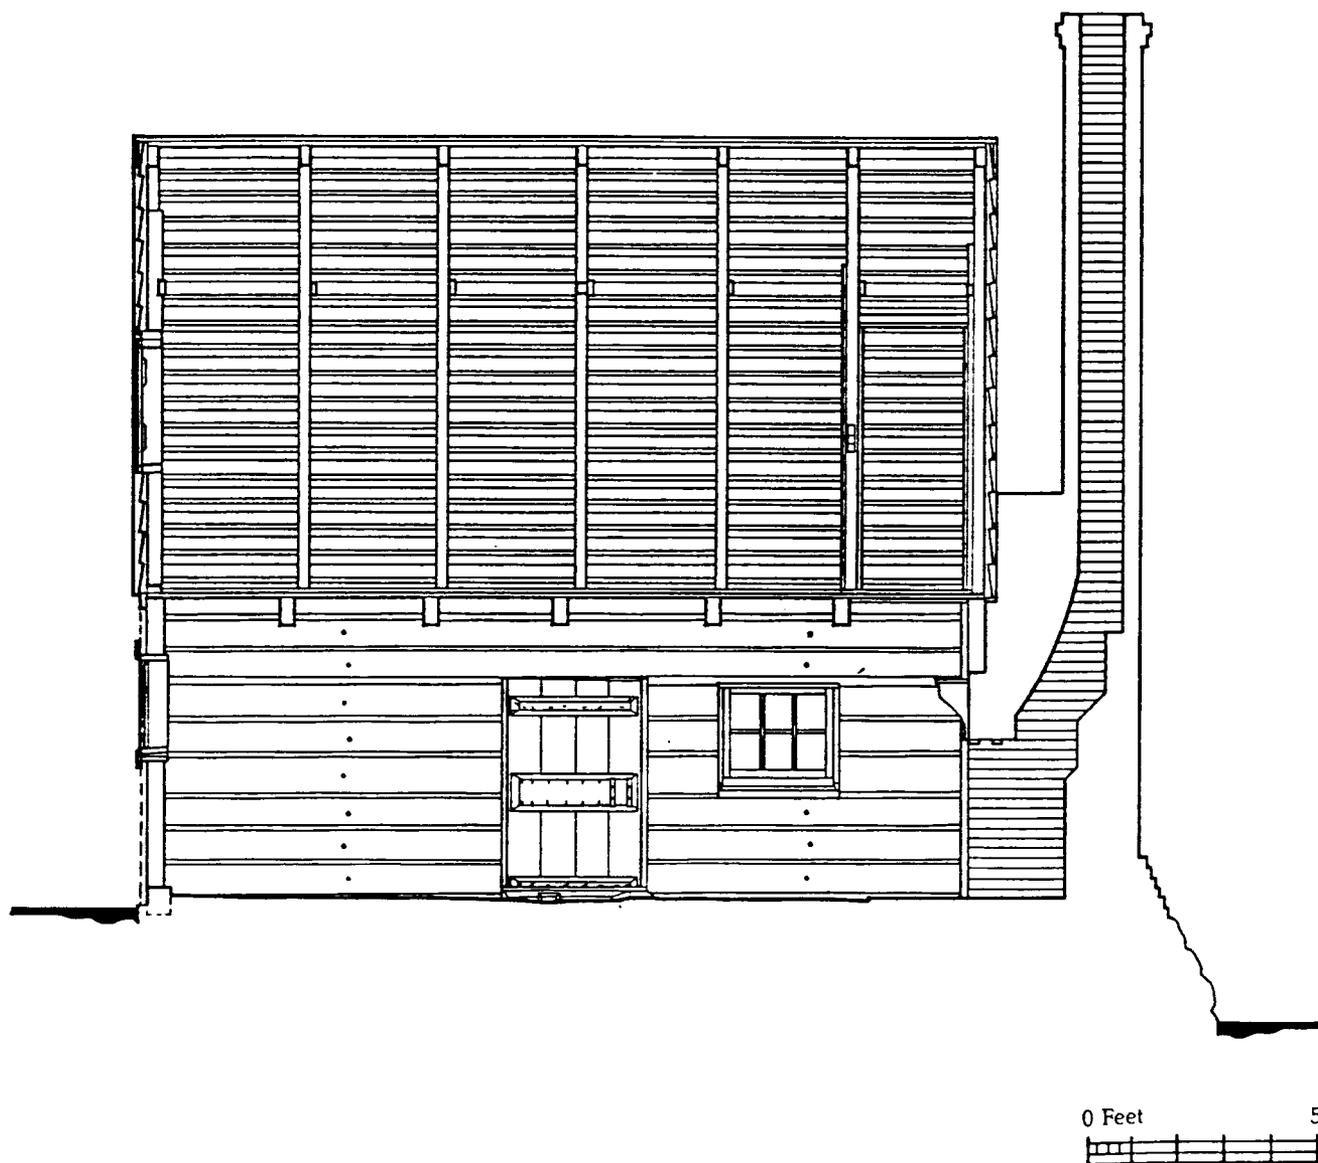
fig. 12. Longitudinal section, looking east.

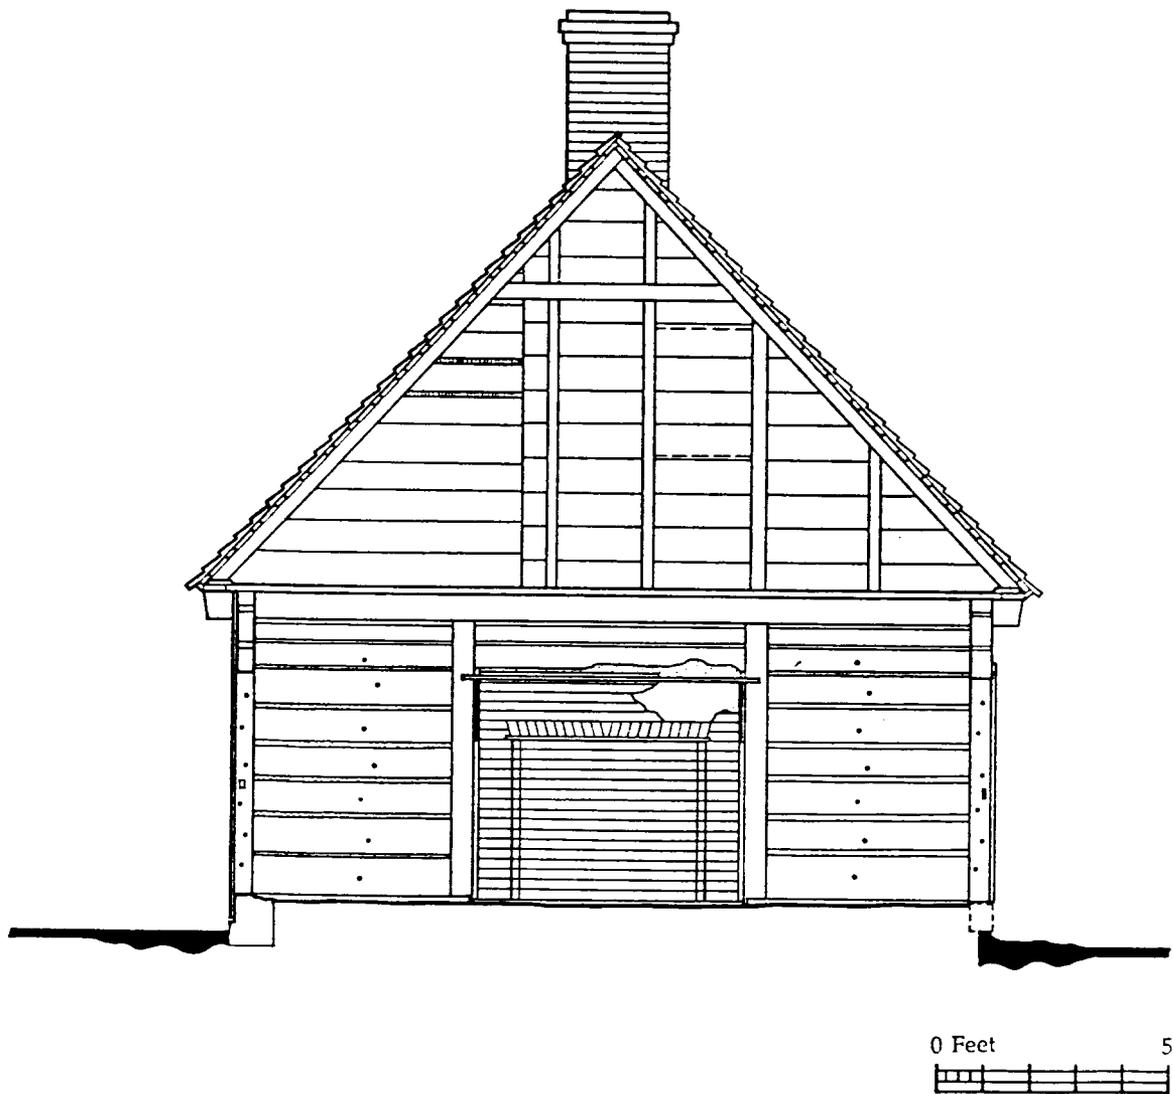
fig. 13. Transverse section, looking south.

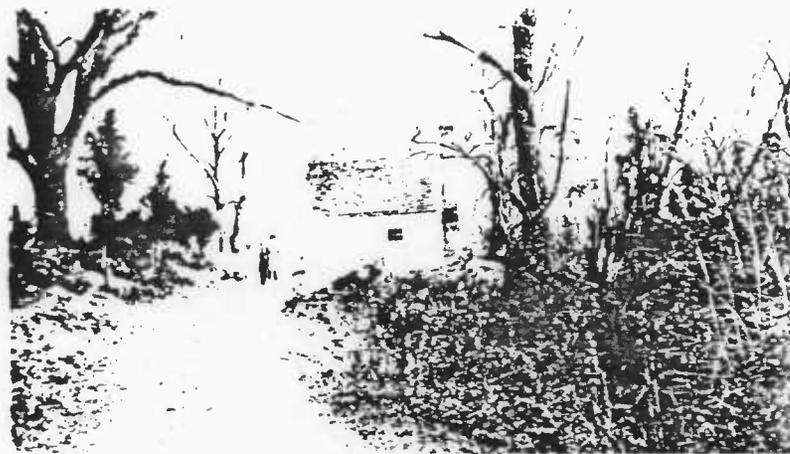
SM-7A, Slave House at Sotterley
Hollywood
7.10 Description

Historic photo of Slave House with caption "Sotterley Thanksgiving, 1936."
Source: Green Photo Album, Sotterley Mansion Foundation Archives.

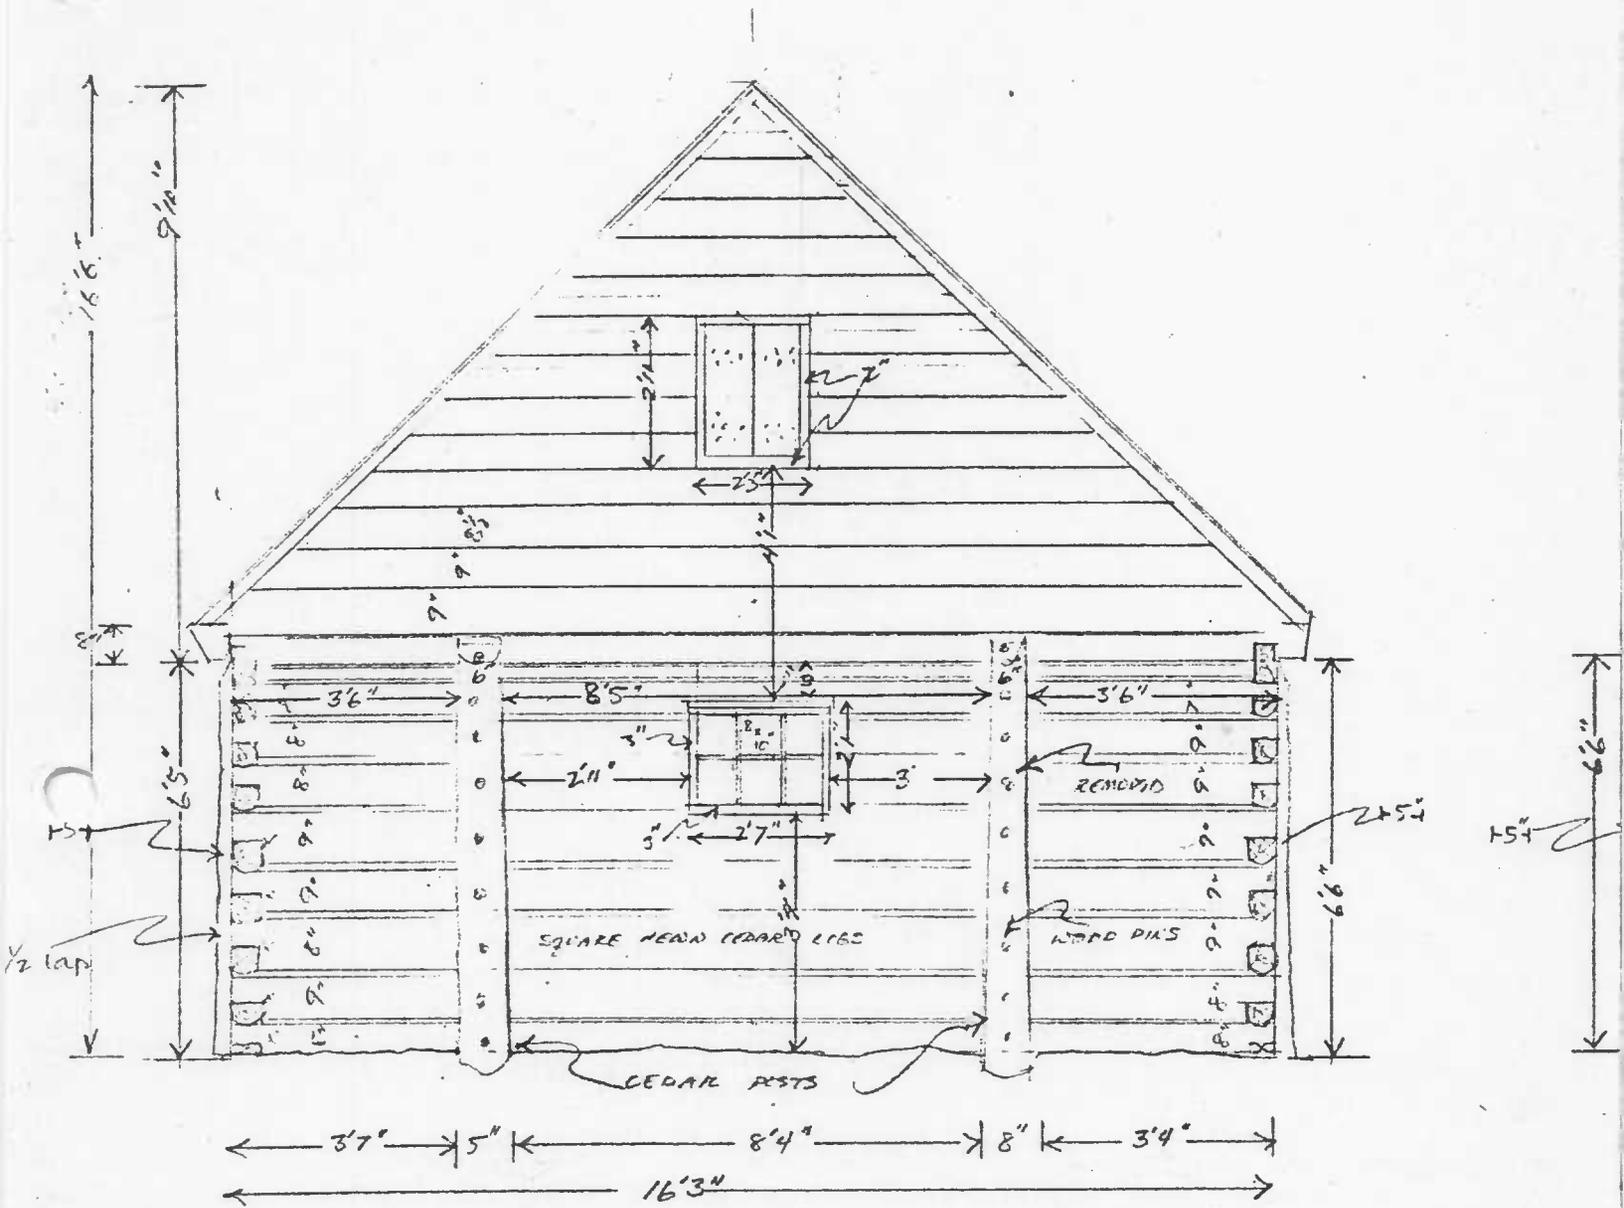
Ground Floor

all nails used in construction are cut
 door stripped with w. nails

entire ext. crib. sheathed in vert plank
 siding. (8" lapped?)
