Robert Henry Collins House
Abell
Private

INVENTORY FORM FOR STATE HISTORIC SITES SURVEY

HISTORIC Robert Henry Collins House
AND/OR COMMON

Robert Henry Collins House
St. Mary's County
Maryland

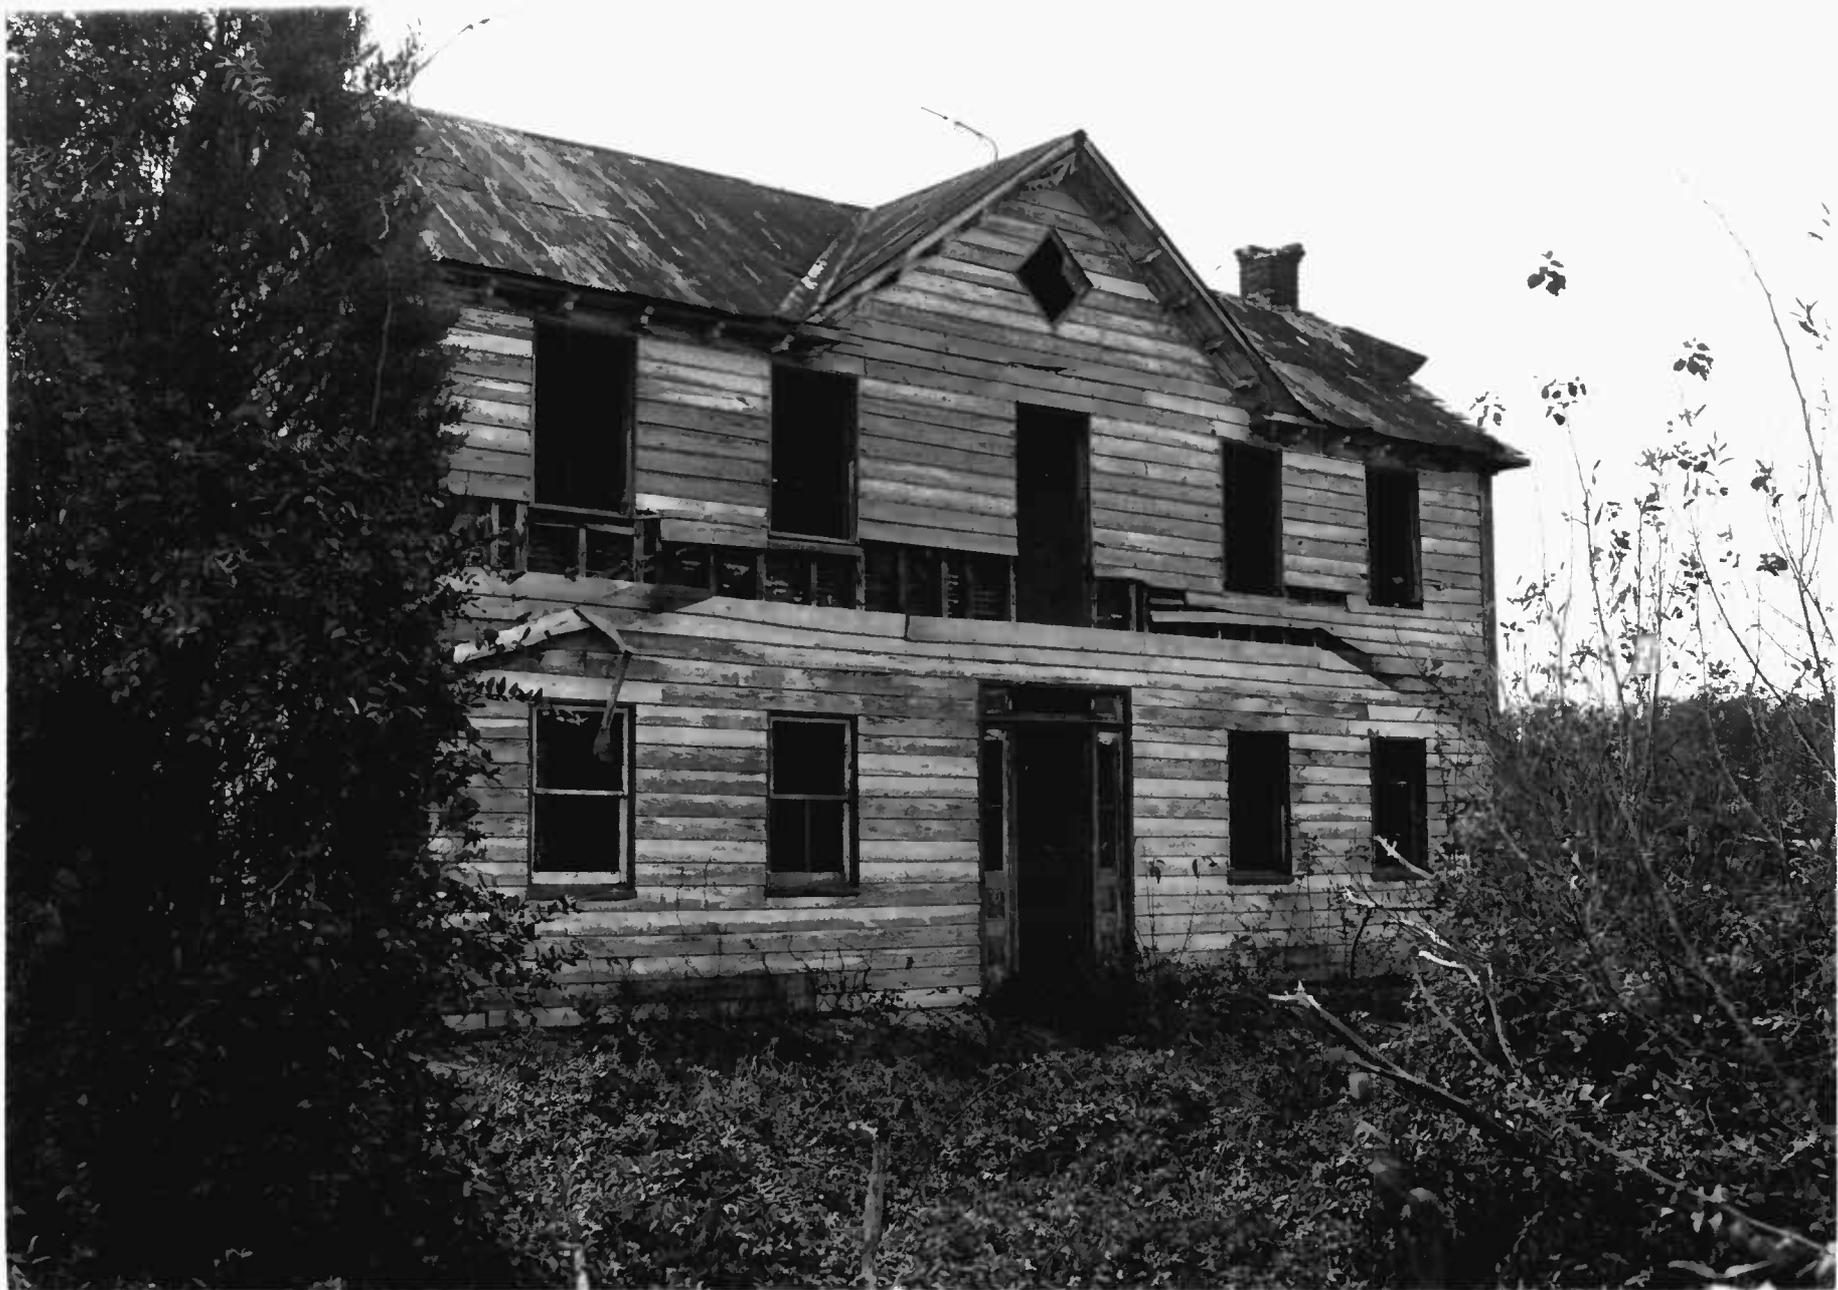
STMA 278

The structure was a large two-story frame dwelling, built in the form of an "I house," a type that was especially popular in the 19th century among prosperous middle class farmers, both black and white. Along the entire facade extended a shed porch, which has since been knocked down. The facade was five bays in length, with a door centrally located, flanked by two windows on each side, with matching windows above, giving the house a symmetrical appearance in the front. The house was one bay in depth, with no window opening in either gable end, an arrangement not uncommon among houses of this design. To the southwest corner was attached a two-story appendage which served as kitchen and which was one bay in length and width. From the kitchen and across the rear length extended a shed porch, which served as a storage space, and as an intermediate zone between the farm yards in the back and the house itself.

SOUTH Lacade

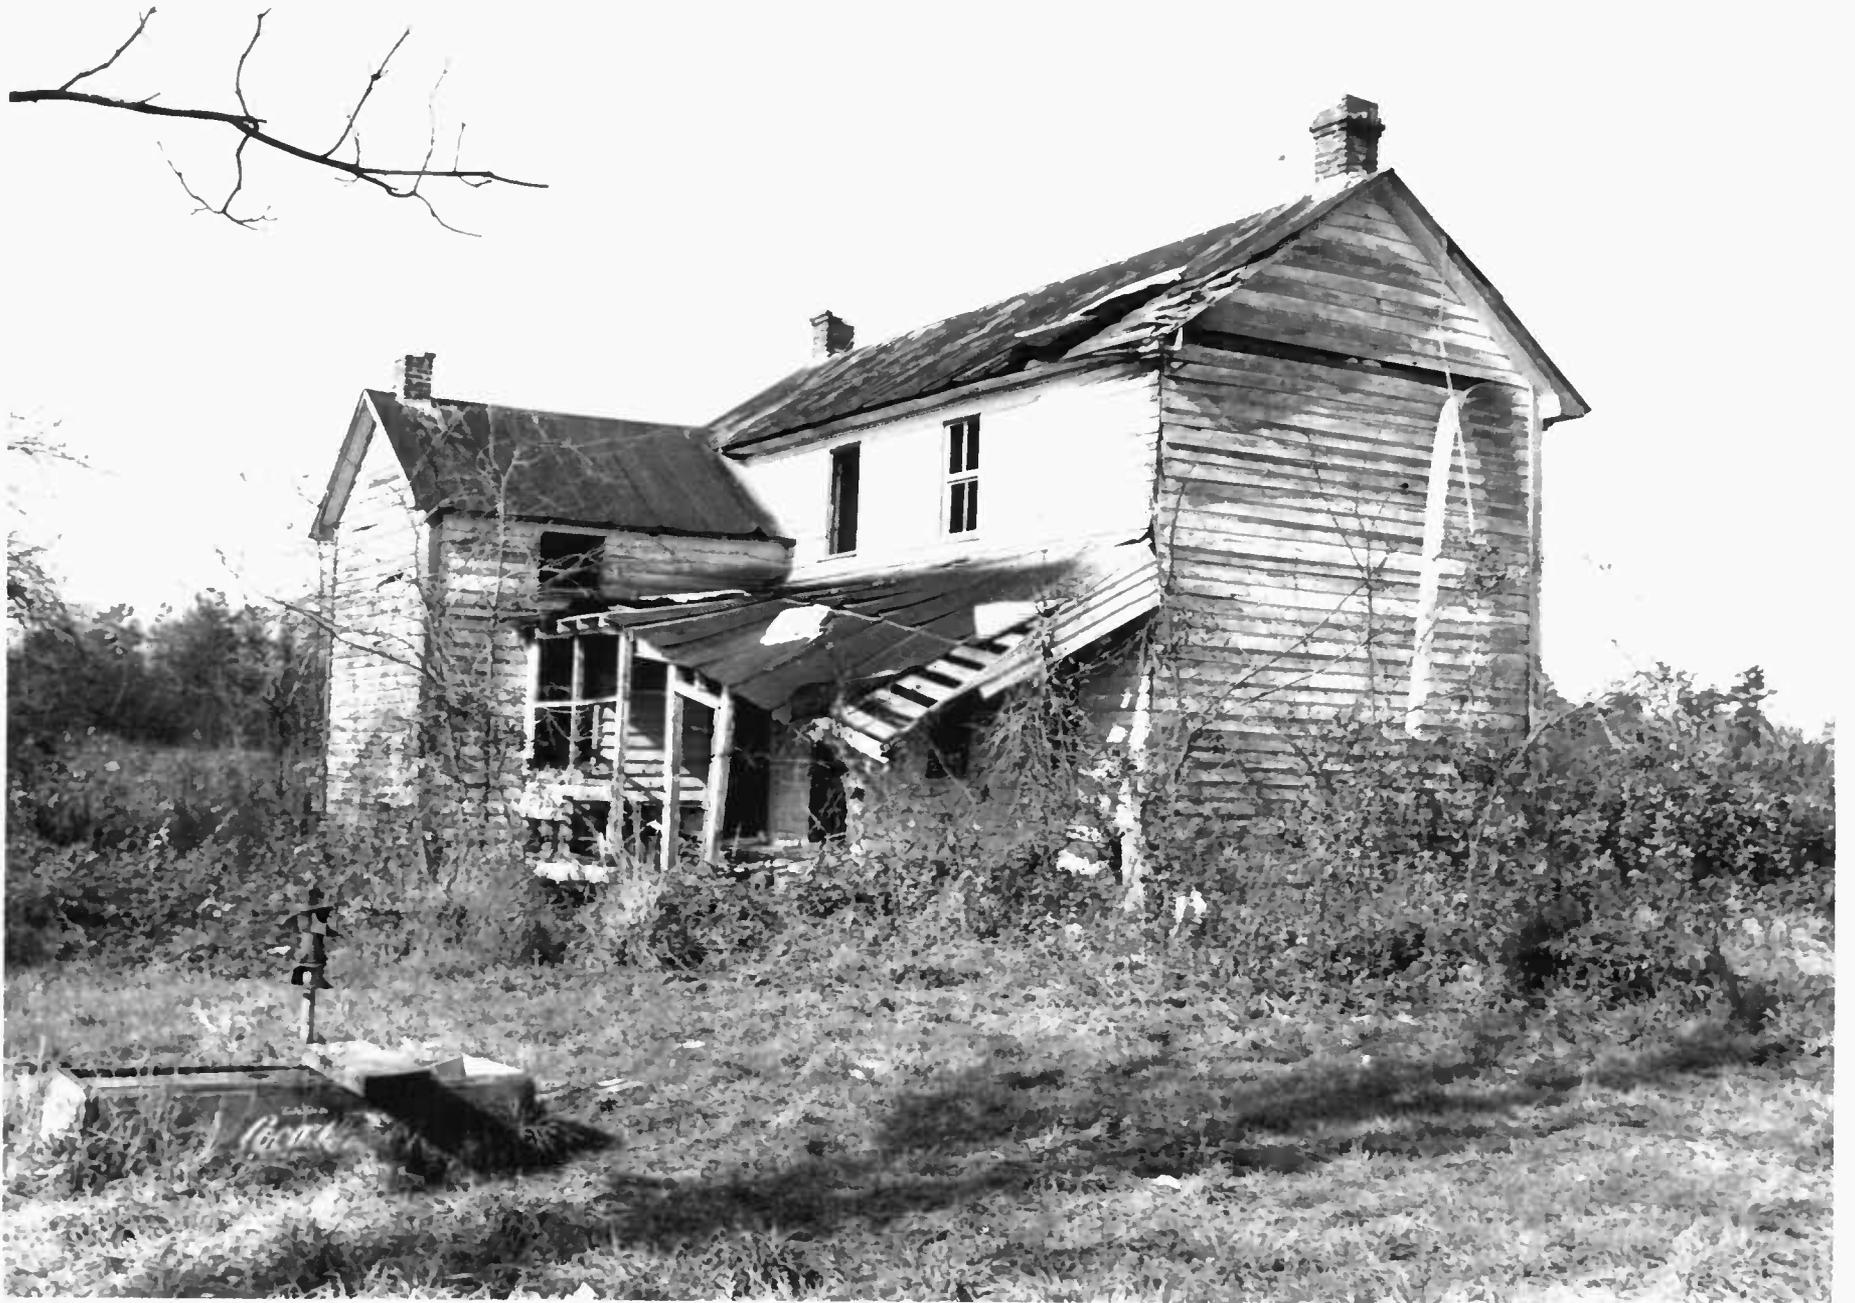
STMA 278

NORTHWEST View

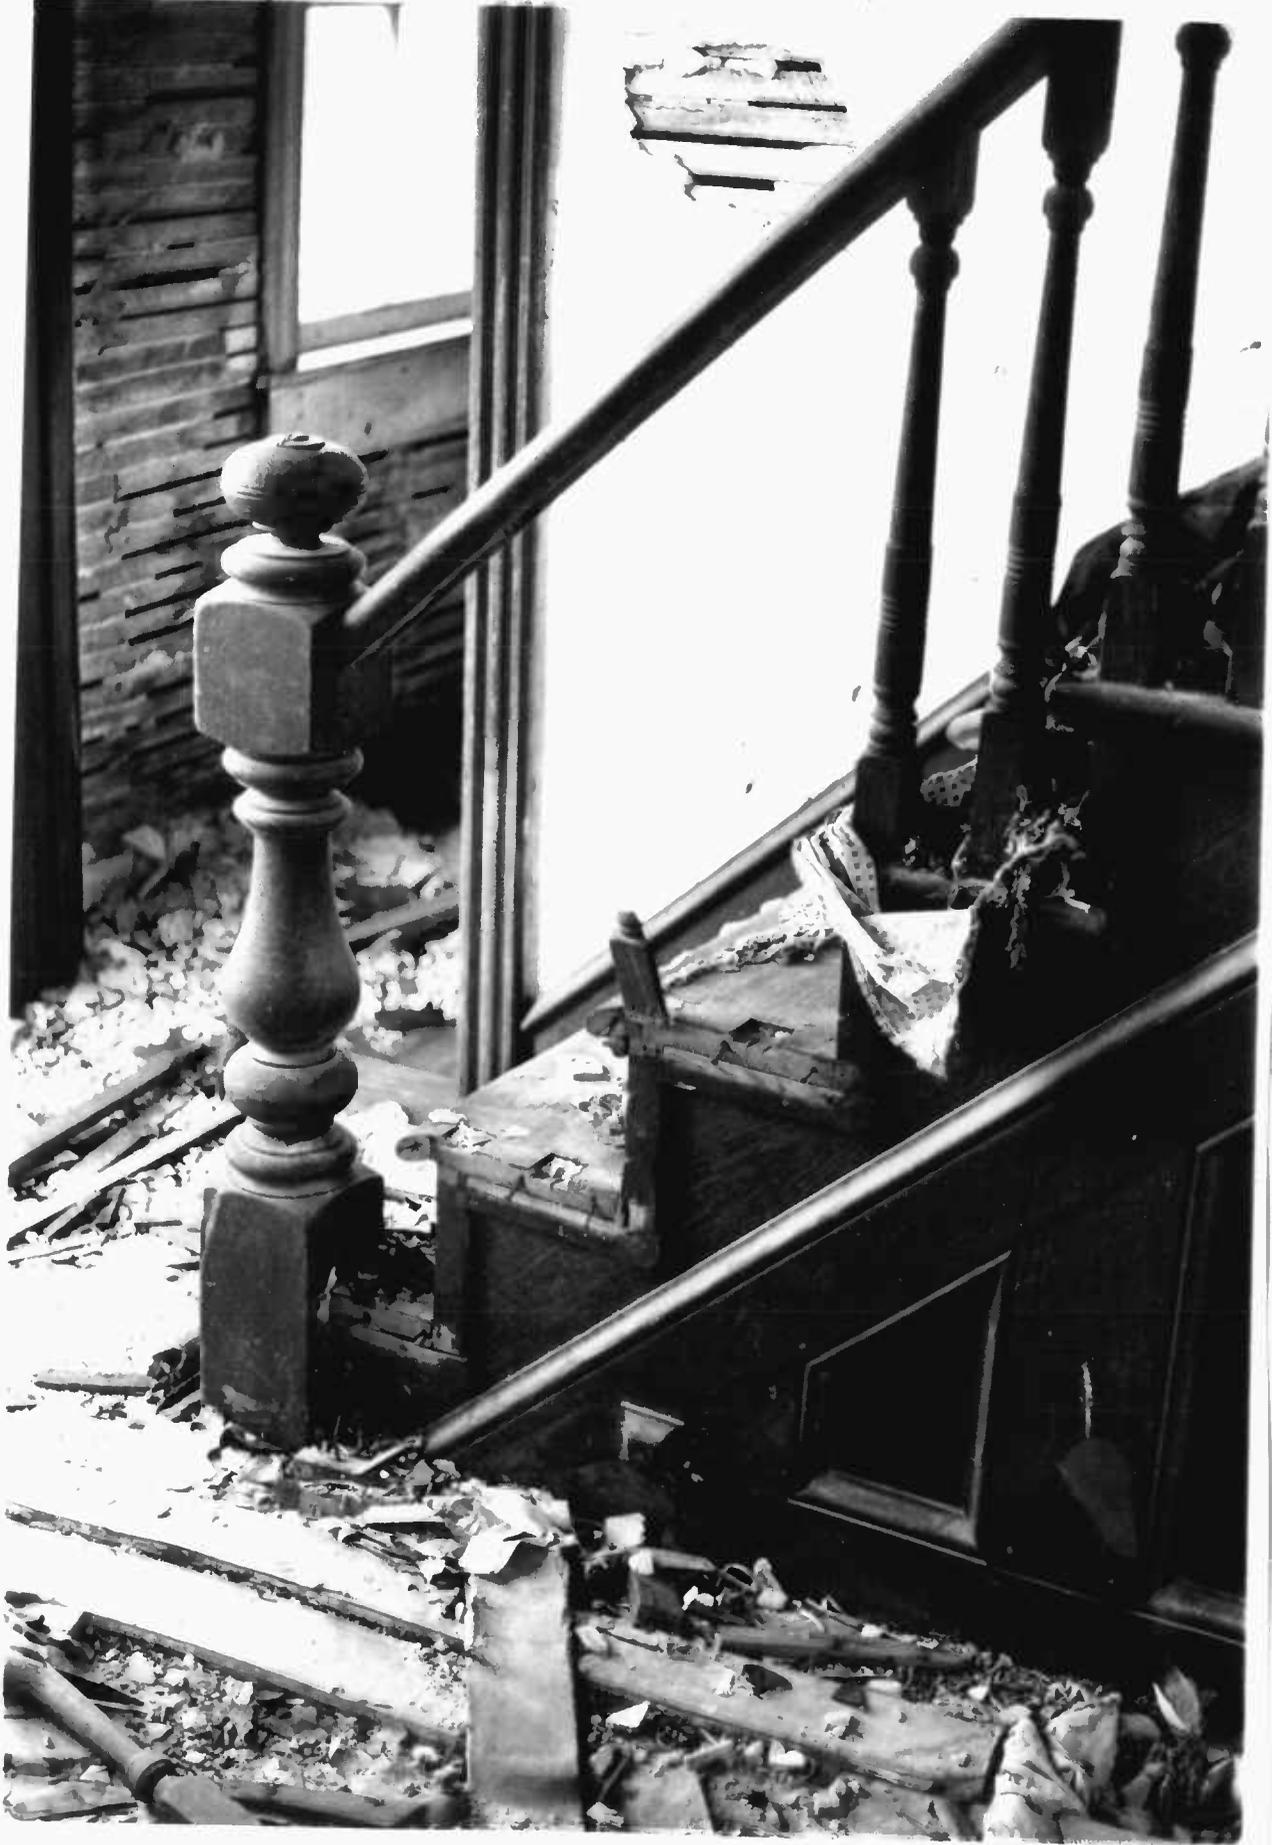
STMA 278

The floor plan consisted of a central hallway flanked by two rooms downstairs, the one on the east probably serving as the parlor, while the room opposite served as the dining room since it led directly into the kitchen. The central passageway was spacious and held a single flight of stairs with turned balustrade and massive turned newel post at the bottom, and another smaller one at the top. The staircase was clad in panels of pine with raised square blocks in the center of each. The pine was painted a rich brown, probably to simulate the finer, more fashionable dark woods of the late 19th century.

Stairway

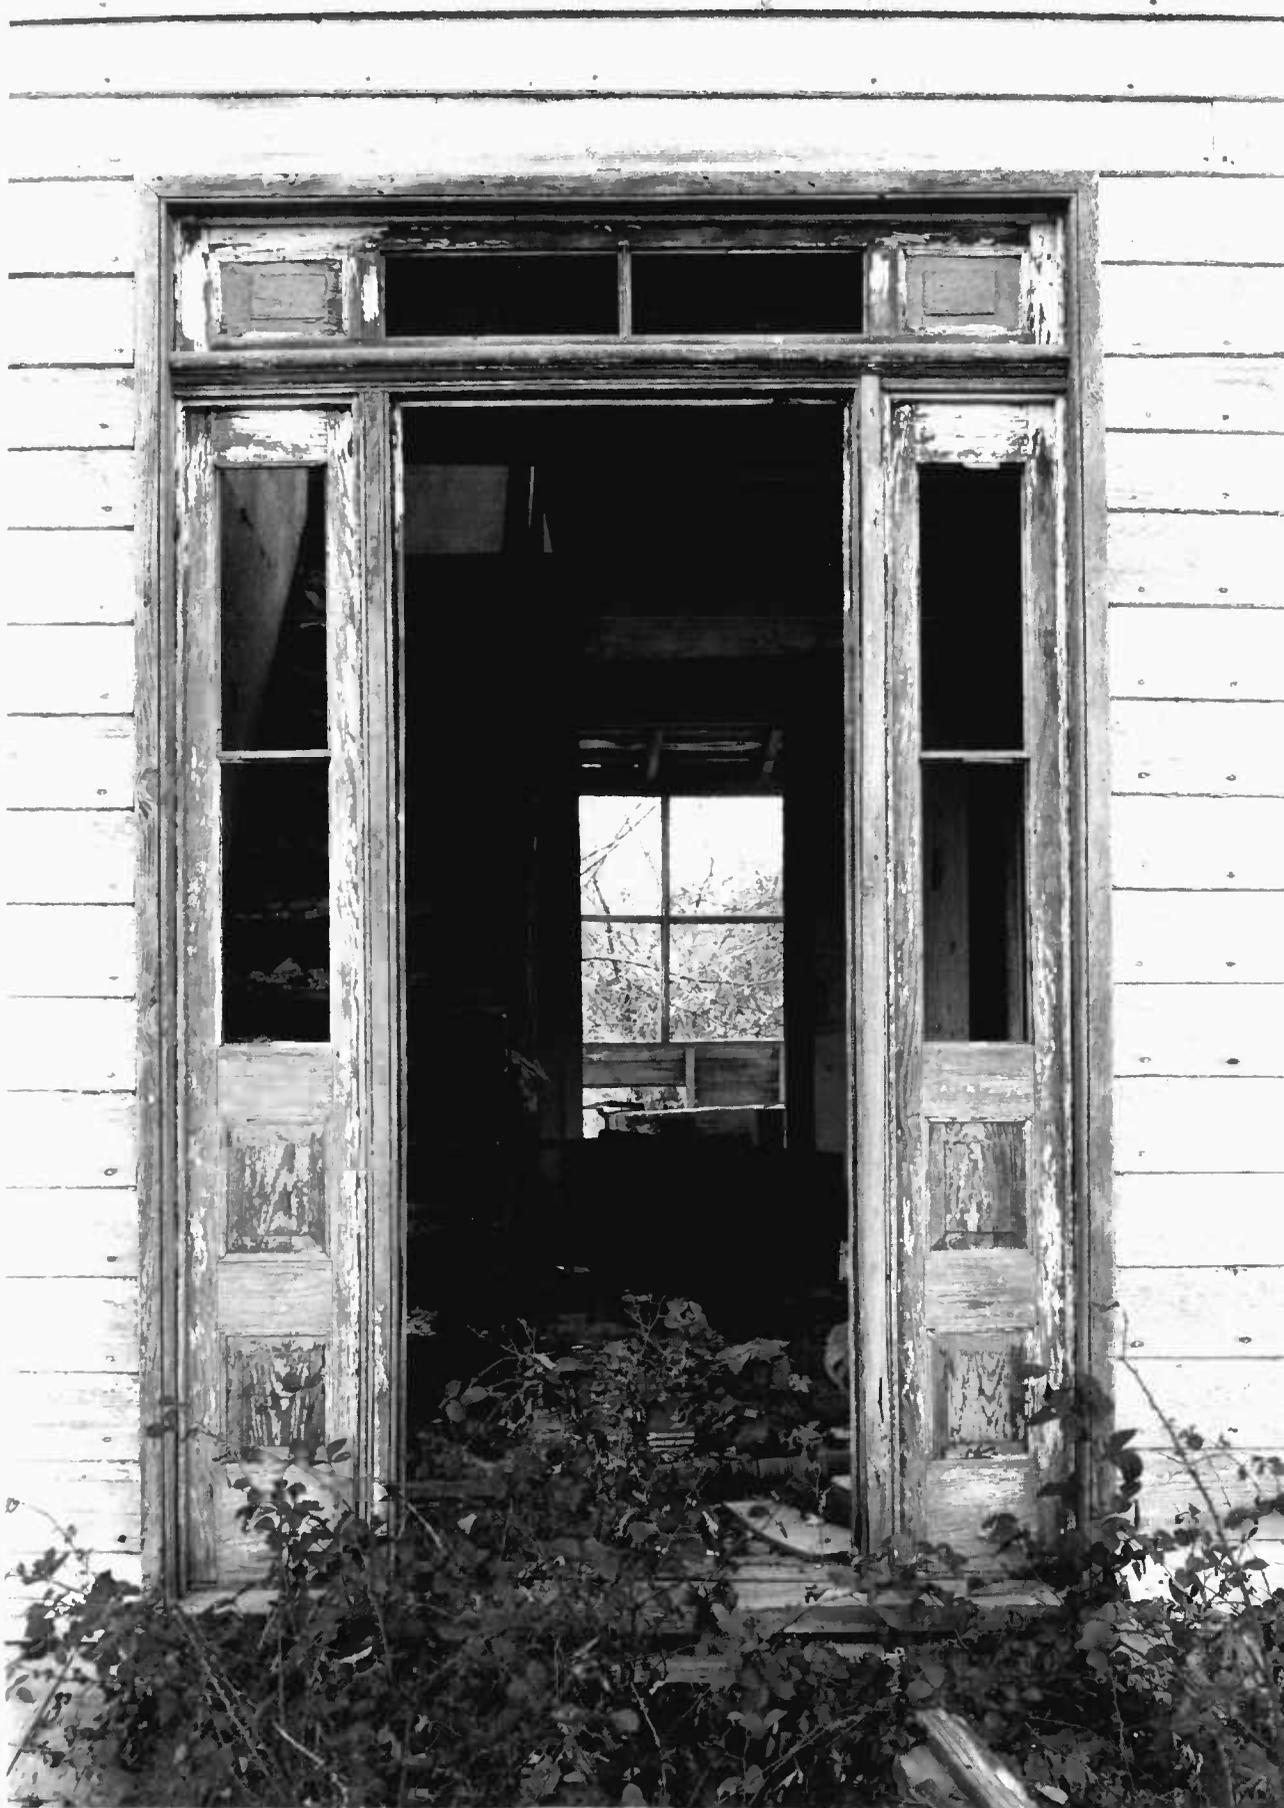
STMA 278

The structure was balloon frame, with the members toed into place with a mixture of cut and wire nails, and with no handmade joining as found in earlier houses. The skeleton was clad with overlapping weatherboards, that were painted white, with green trim around the door and window openings. Inside of the latter were hung double sash windows with two ^{over} two lights. The front door is missing, but the doorway was panelled on either side, and the ^{horizontal} transom had three lights.

Doorway

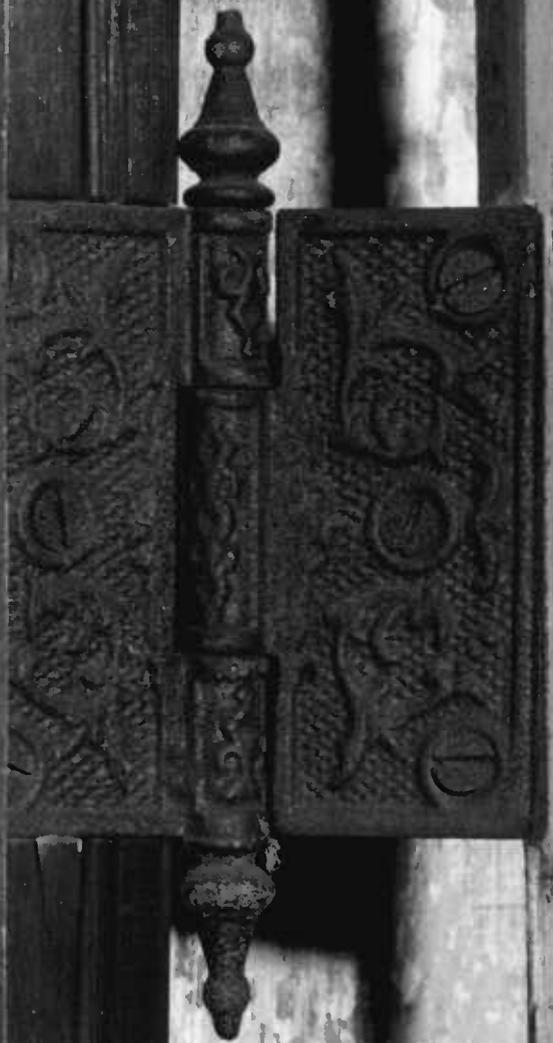
ROBERT Henry Collins
STMA 278
Abell, Md.
Hinge
GWM — 5/77
