Maryland Inventory of Historic Properties number: SM-618.

Maryland Inventory of Historic Properties  
Historic Bridge Inventory  
Maryland State Highway Administration  
Maryland Historical Trust

SHA Bridge No. 18019 Name: MD 242 over Locust Run

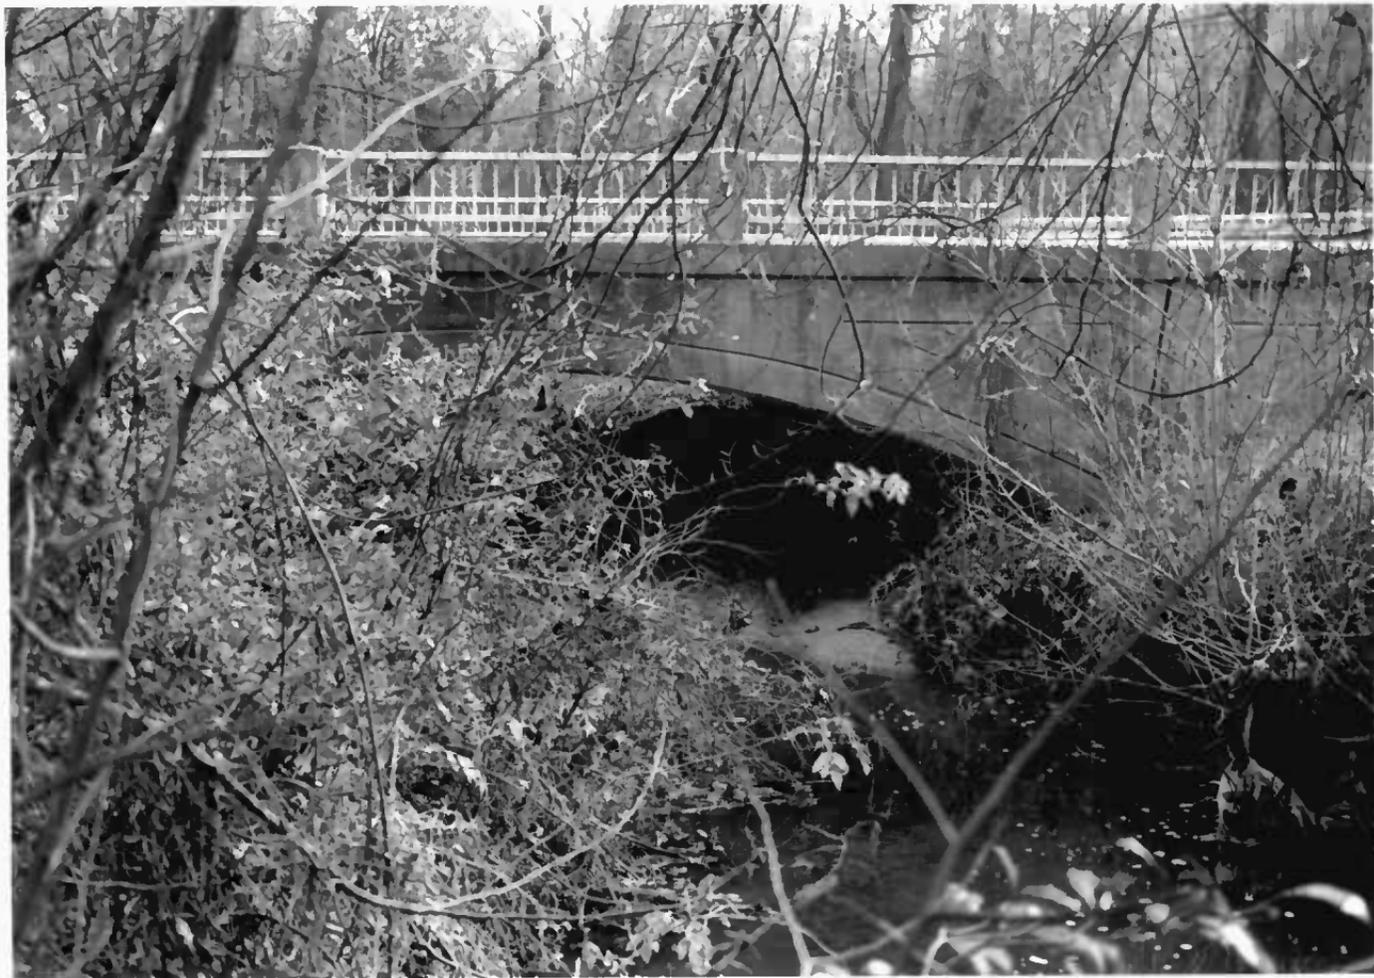
1. SM-618
2. MD 242 over Locust Run
3. St. Mary's Co., MD
4. Wallace, Montgomery & Assoc.
5. 12/97
6. MD SHPO
7. Elevation looking upstream
8. 1 of 4

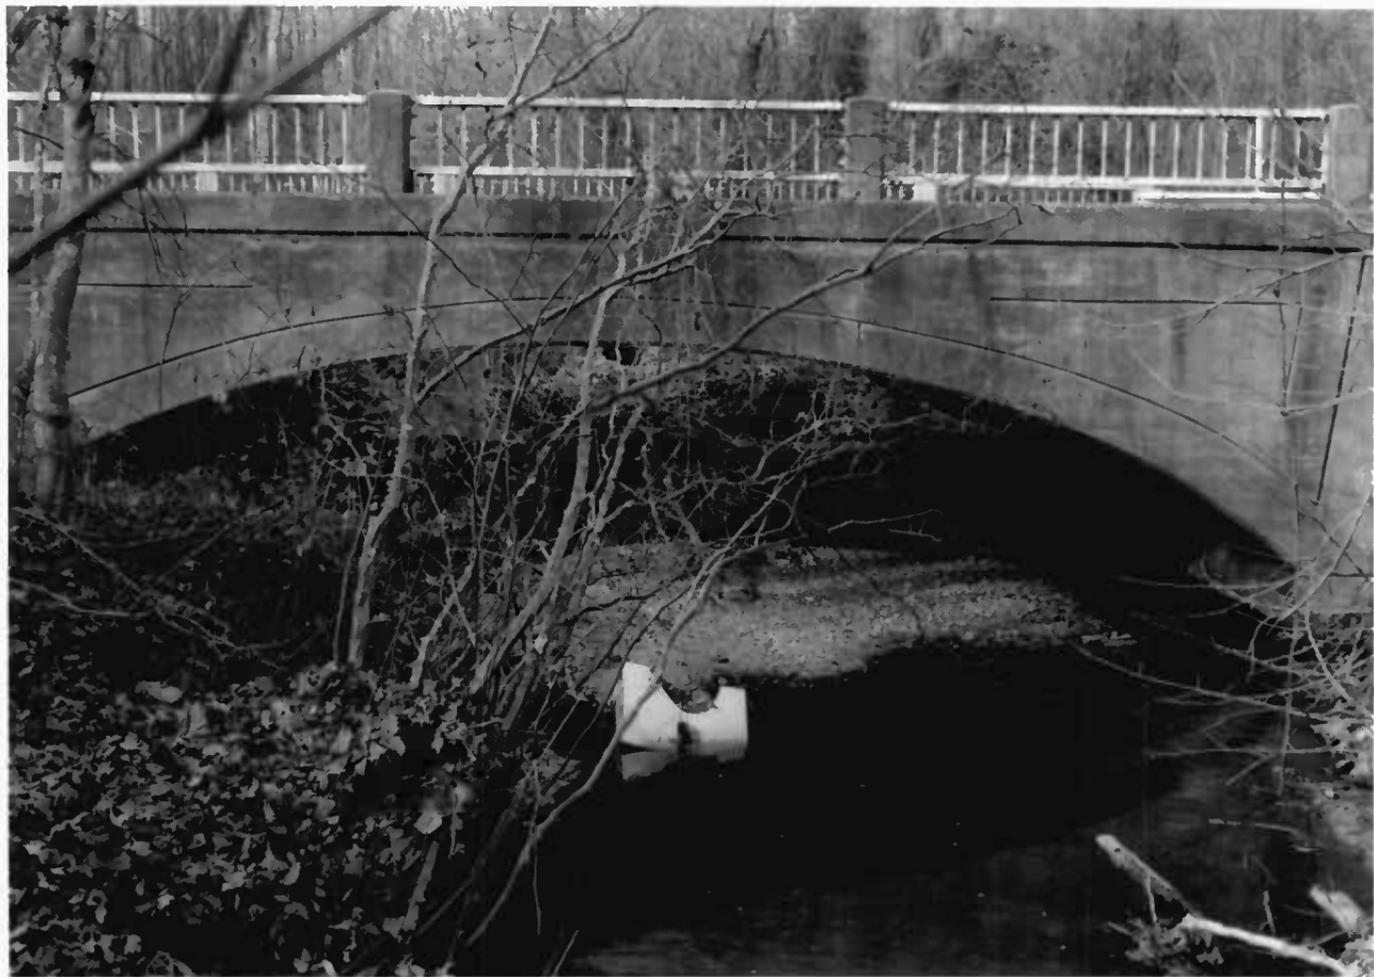
1. SM-618
2. MD 242 over Locust Run
3. St. Mary's Co., MD
4. Wallace, Montgomery & Assoc.
5. 12/97
6. MD SHPO
7. Elevation looking downstream
8. 2 of 4

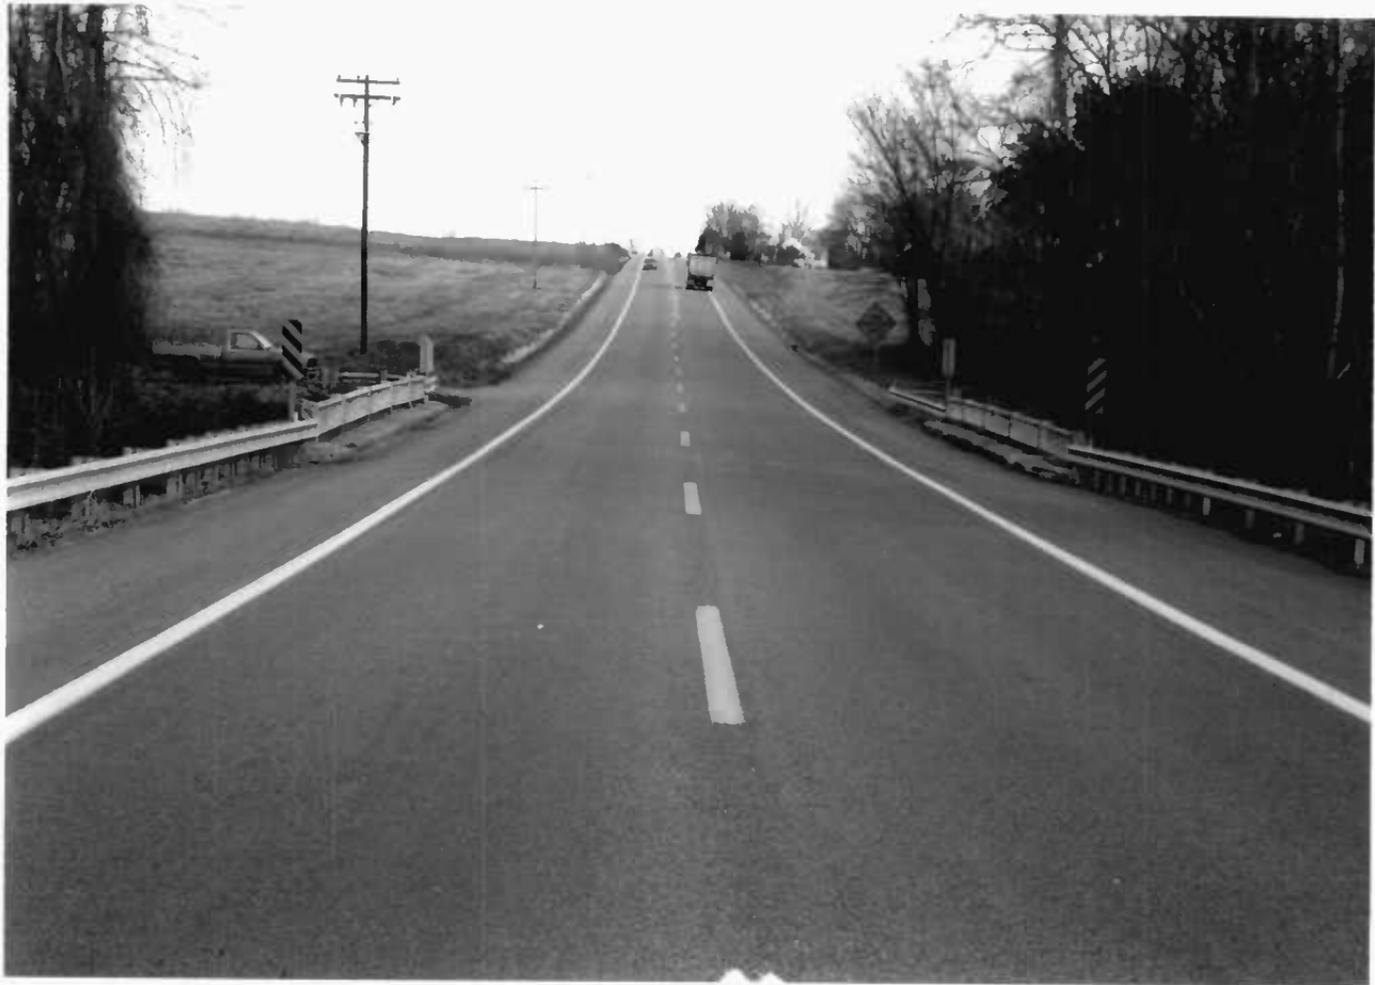
1. SM-618
2. MD 242 over Locust Run
3. St. Mary's Co, MD
4. Wallace, Montgomery & Assoc.
5. 12/97
6. MD SHPO
7. Looking Northeast
8. 3 of 4

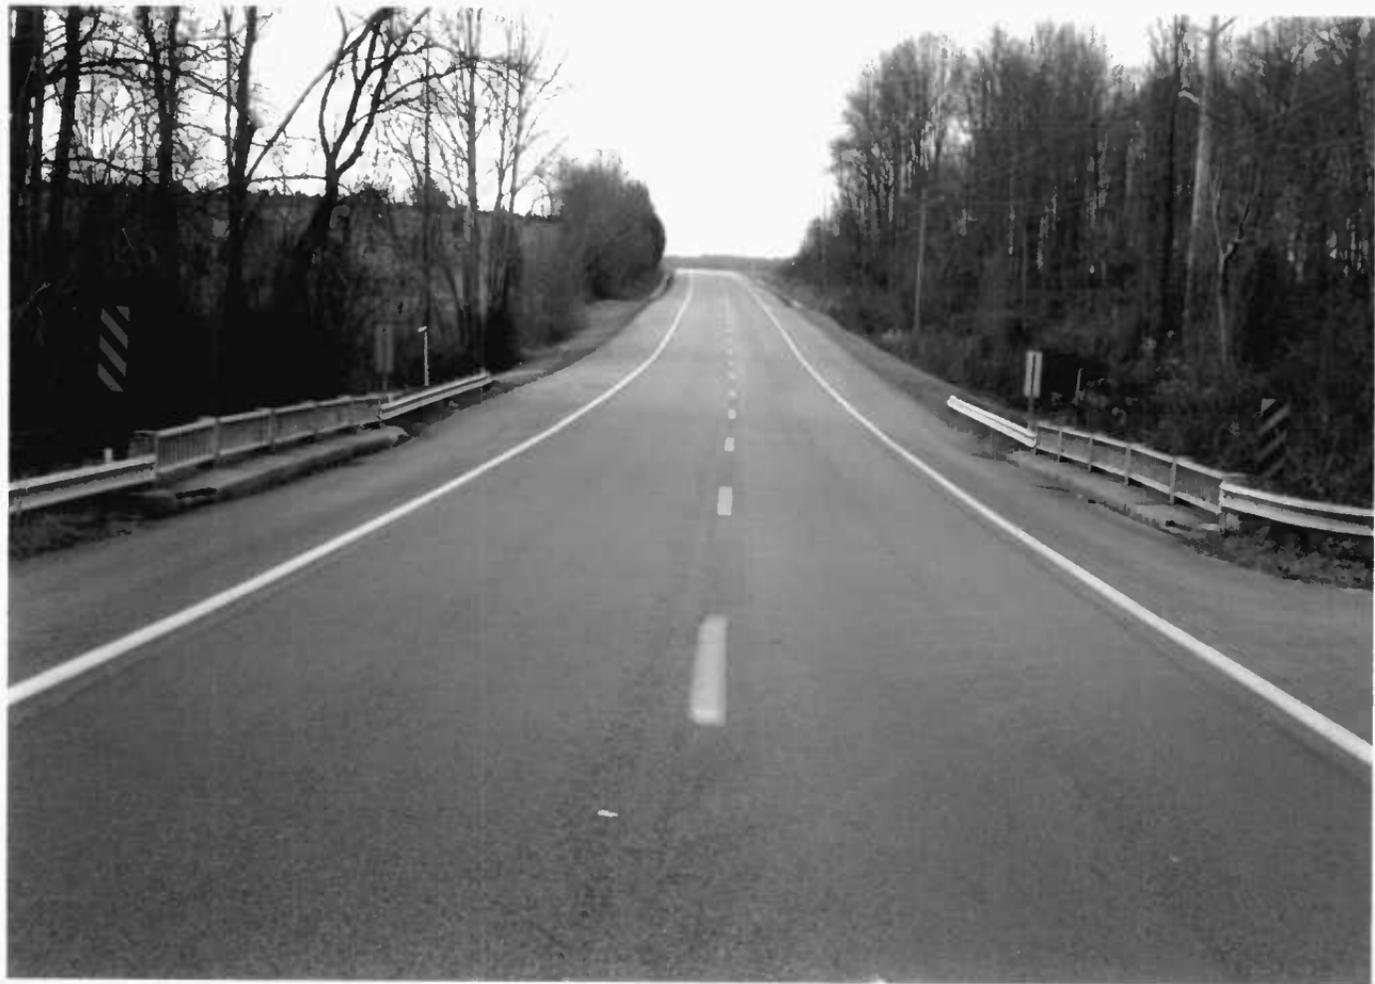
1. SM-618
2. MD 262 over Locust Run
3. St. Mary's Co., MD
4. Wallace, Montgomery & Assoc.
5. 12/97
6. MD SHPO
7. Looking Southwest
8. 4 of 4
