K-407

COREY FARM  
Melitota, Maryland  
(mid-19th century)

INVENTORY FORM FOR STATE HISTORIC SITES SURVEY

HISTORIC COREY FARM

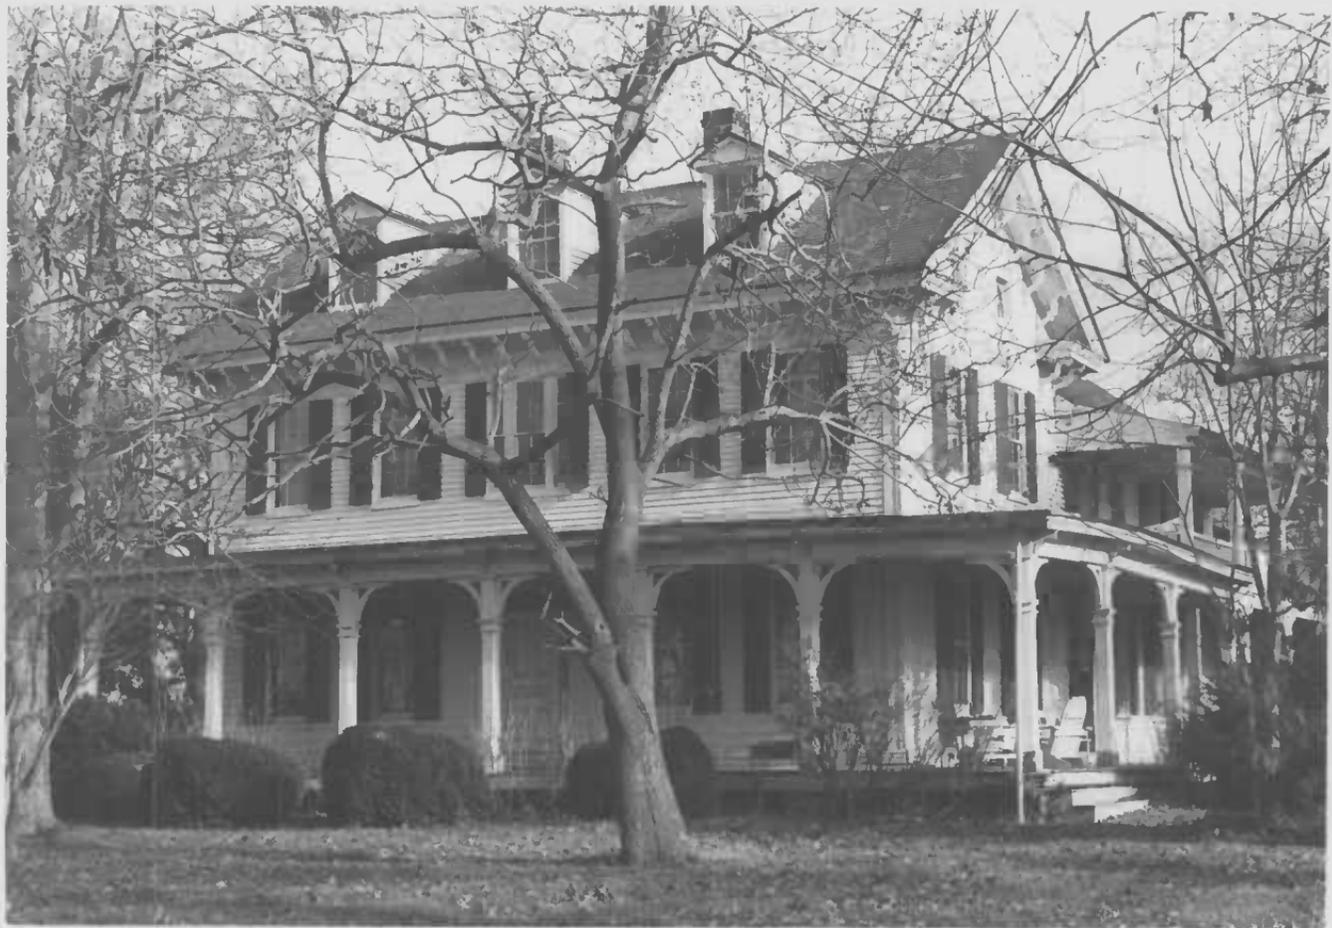
K-407

Corey Farm

View to northeast

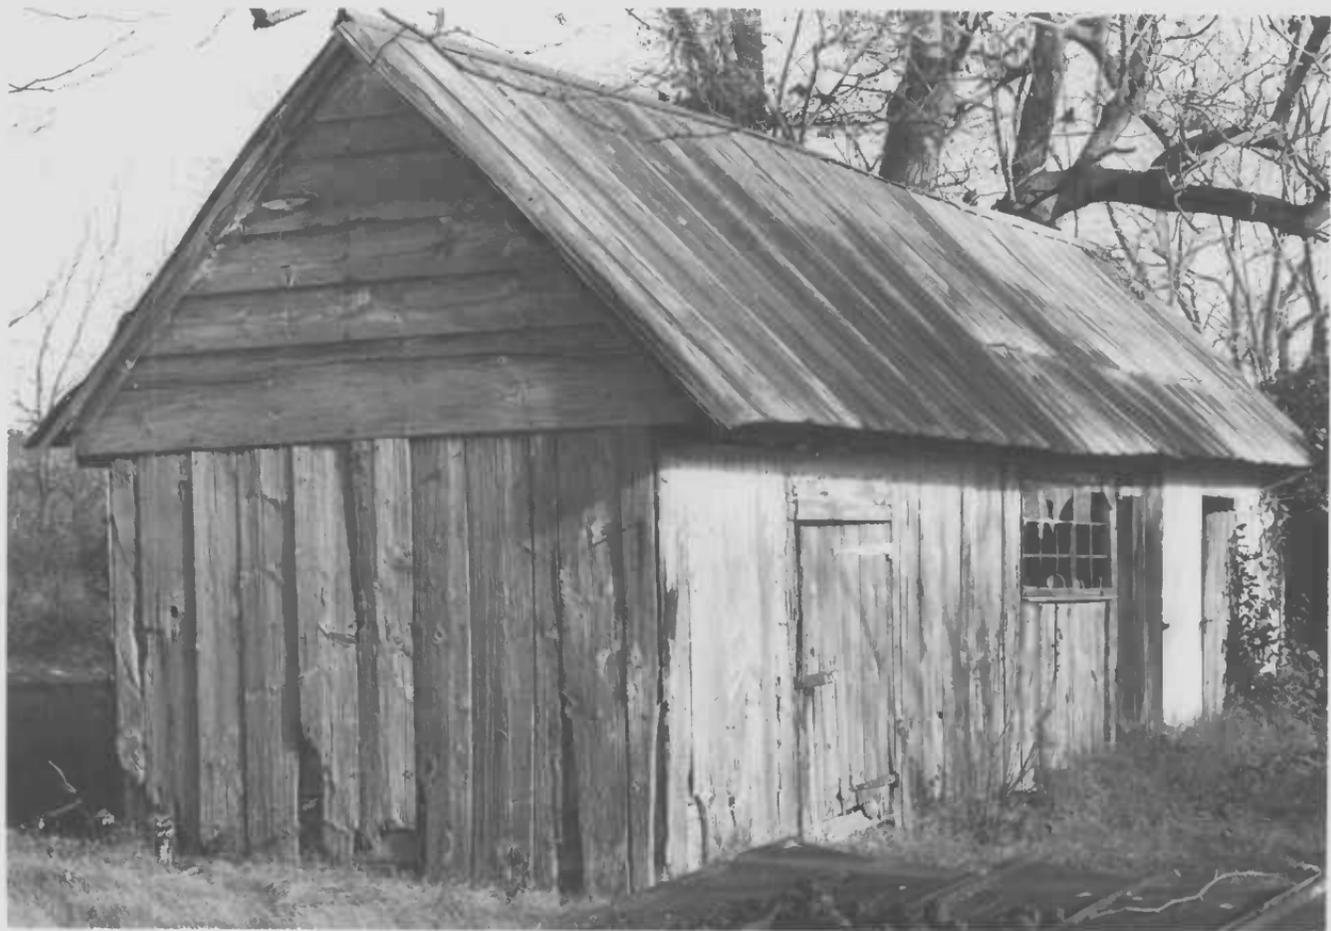
K-407

Behind the early 19th century kitchen is an early plank smokehouse, doubled in size by the addition of a frame wing.

Corey Farm Plank Outbuilding  
view to northeast
